Analysis of Daylight Control in a Chateau Interior

Abstract: Assessment of daylighting in the residential hall of a historical chateau is presented. The evaluation is based on both the daylight measurement and simulations. Illuminance levels in the interior were controlled in accordance with requirements for light exposition of light sensitive materials. Valuable paintings and claddings as well as wallpapers and furniture upholstery in the hall are extremely light sensitive and they need to be protected from light damage. The daylight measurements and simulations give an overview of daylight conditions in the annual profile for clear sky conditions and for different levels of window shadings.

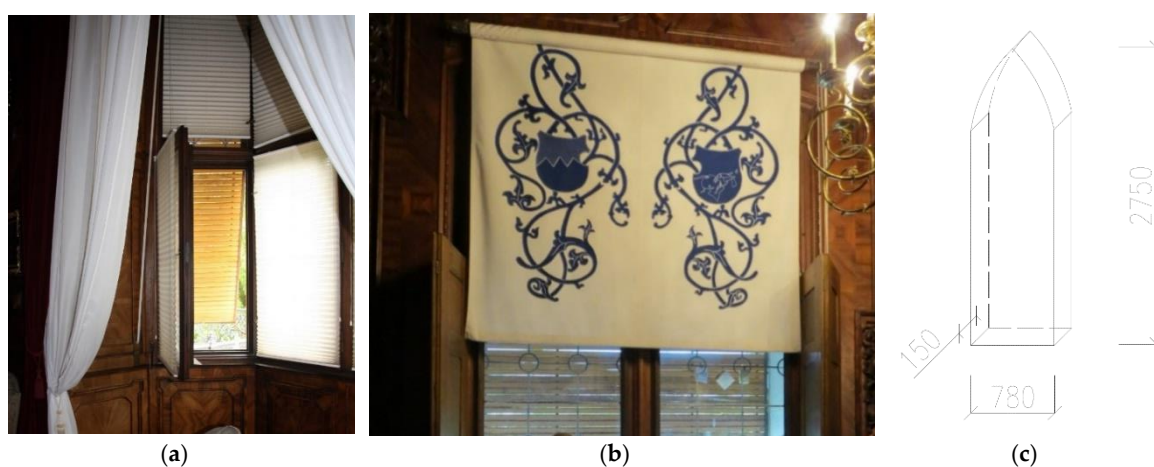
The Morning Salon has been selected for long-term indoor climate comfort controlling [9] and daylight illuminance assessment [10,11]. The main task is to evaluate the influence of the hall daylighting on light-sensitive materials and artefacts. The eastern wing of the chateau is opened for public tours. It means that this part of the chateau is frequently visited. The Morning Salon has a specific location in the chateau. It is situated on the first floor in the east wing. It is illuminated through side-lit bay windows and two glazed doors in side walls. Windows are not shaded by the upper floor overhangs [4]. The internal space of the salon is overheated and exposed to high daylight illuminance because of excessive solar gains through the windows. Especially in mornings, irradiance and illuminance in the salon is very high [9]. The external wall with windows is opposite the internal wall with wood paneling and paintings. Windows have their original shading of external wooden lamellae shutters, and new internal curtains and paper-folded blinds, as well as textile roller blinds, Figure 10. The use of internal blinds and curtains is the commonly recommended solution. However, the blinds are not permanently activated. For that reason, some windows may remain with the binds up [4,9].

Figure 10. Window and its interior shadings (a) internal curtains and paper folded blind; (b) textile roller blinds (authors' photo archive); (c) window segment dimensions (mm).

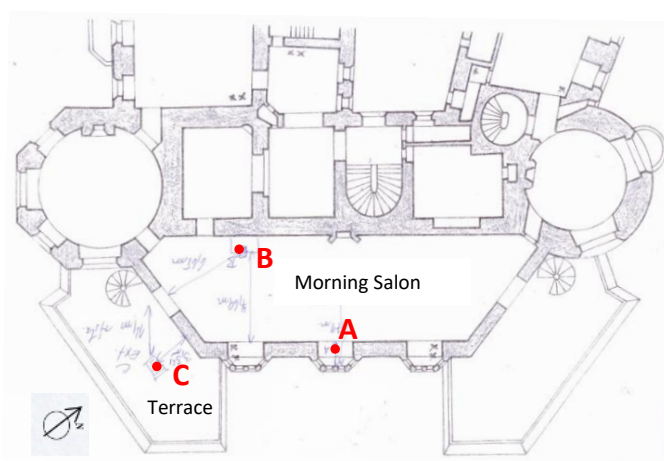
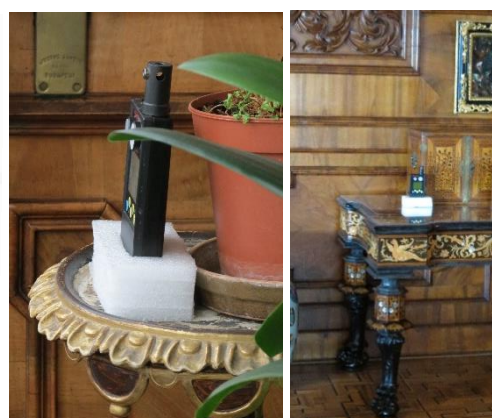
Complex measurements using data-loggers with light, UV and temperature sensors ELSEC 765C were done in May 2016. The purpose of the measurement was to find illuminance in two different places of the salon compared to the exterior illuminance, Table 1 and Figure 13.

Figure 13. Positions of dataloggers ELSEC 765C for illuminance and UV radiation and temperature measurements in May 2016 (positions A, B and C). Position A—on the central window sill, height 0.9 m; Position B—on the desk next to the fire place, height 0.8 m; Position C—terrace in the middle, the floor level.

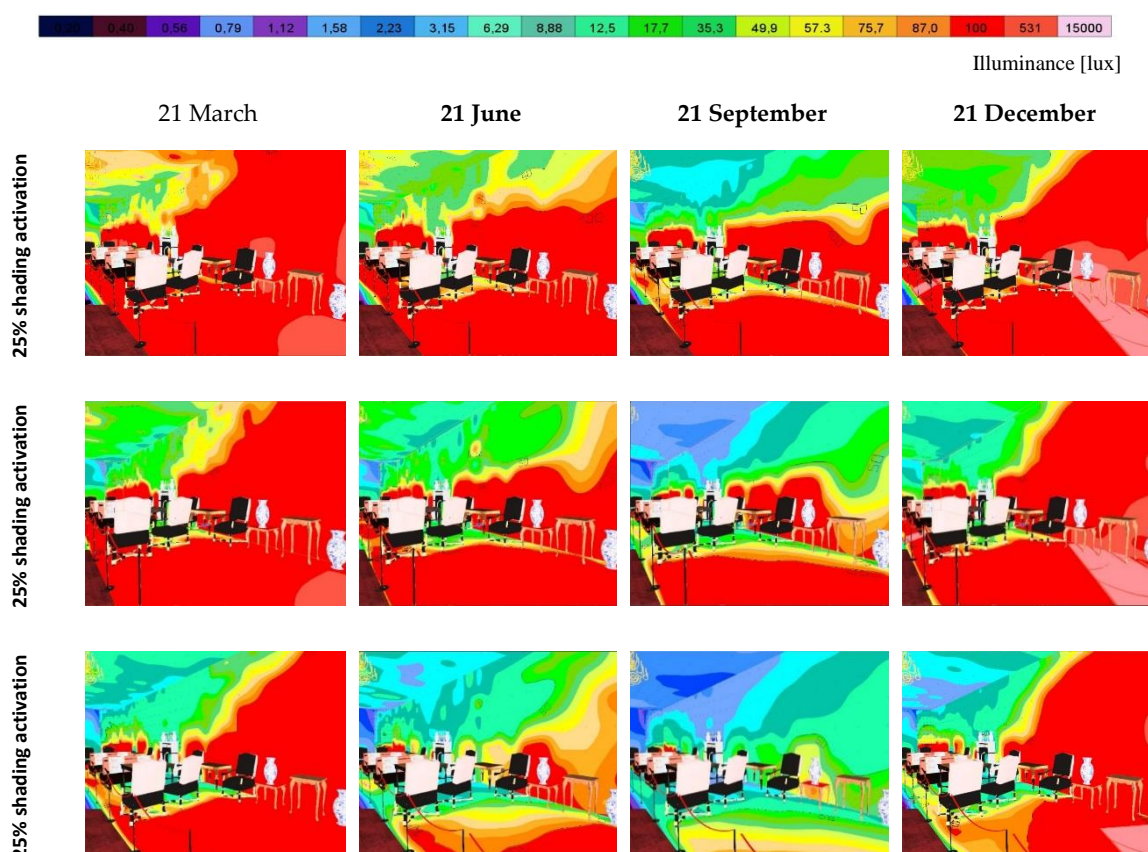
The false color schemes shown in Figures 16 and 17 give an overview of the illuminance in the viewed part of the salon. The light limit of 50 lux is shown in yellow; the orange part is for illuminance between 50 and 100 lux. The red color in the simulations means the places where illuminance level exceeds 100 lux. It means these parts are affected by very high illuminance, which is negative for the light-sensitive interior materials. It is obvious that the wide part of the wall with painting and floor and furniture in the morning time is exposed to very high light limits in case the windows are without shadings. The daylight simulations were completed for the variations with the window shading activation at 25, 50, and 75% (25% unshaded glazed area close to the window sill), simulated for noon (Figure 18).

Figure 18. View to the wall opposite windows with shadings activation for 25%, 50% and 75%.

The salon interior and furnishing needs to be protected from the high light intensity and solar gain. Excessive direct solar radiation causes glare discomfort and overheating of indoor climate [36]. It is recommended that strict shading control is maintained. As any automatic shading systems are not permitted in such a historically valuable place, the full-time activation of the rollers and shading blinds is recommended in mornings for the whole year, especially during summer. Full-time activation of the shading blinds, especially in the morning because of the south-east orientation of the Morning Salon is also recommended. Especially at sun rise and then until about 10:00 or 11:00 the Morning Salon should be protected by blinds at 100 percent full blind shading. The Salon should be controlled by at least 75 percent shading activation at noon. In the afternoon, the shading can be reduced, but the illuminance should be controlled all the time.

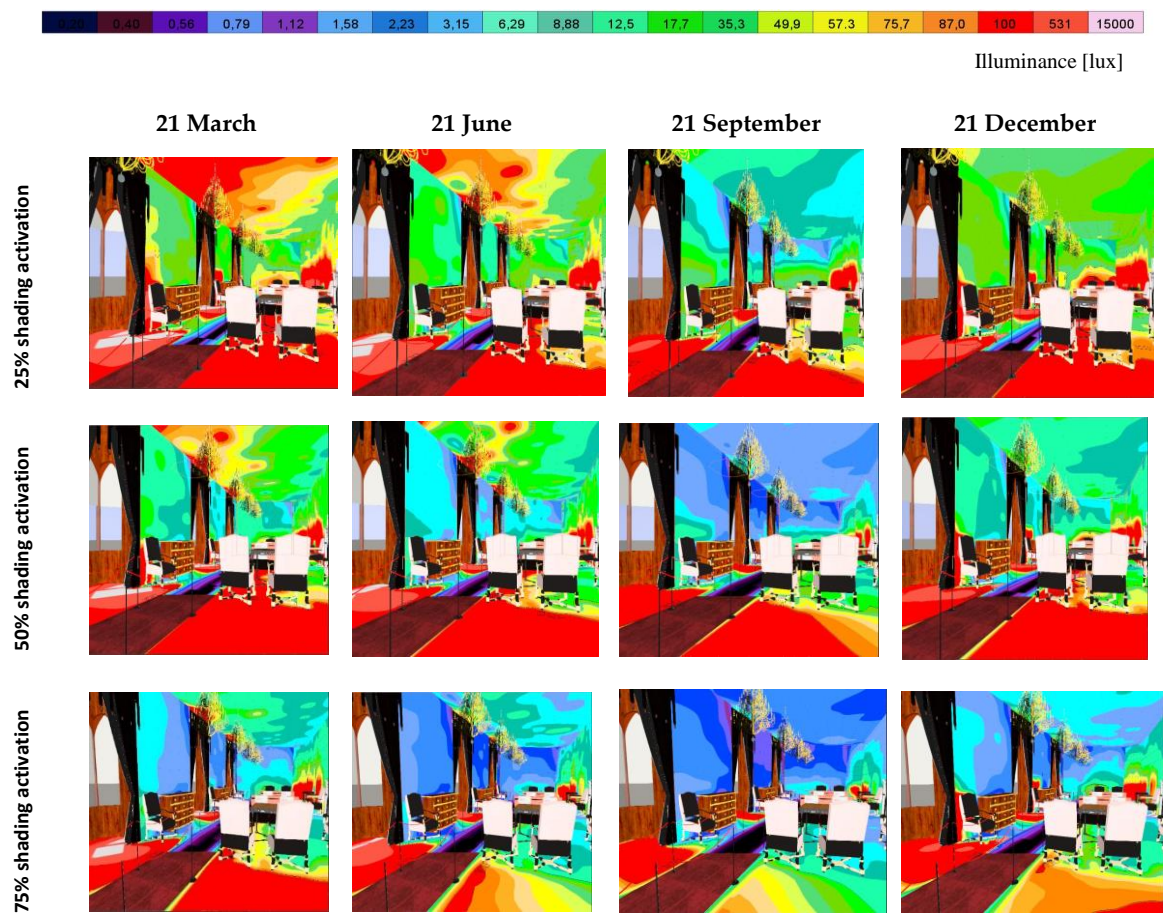
The simulations for the view to the windows shows that the high rise of illuminance is between 10:00 and noon. The floor area is highly affected. Ceiling soffit has increased illuminance level from March to June and between September to December. The view to the windows was also simulated for shading activation at 25%, 50%, and 75% (Figure 22).

Figure 22. View to the salon with windows shadings activation for 25%, 50% and 75%, illuminance [lux].

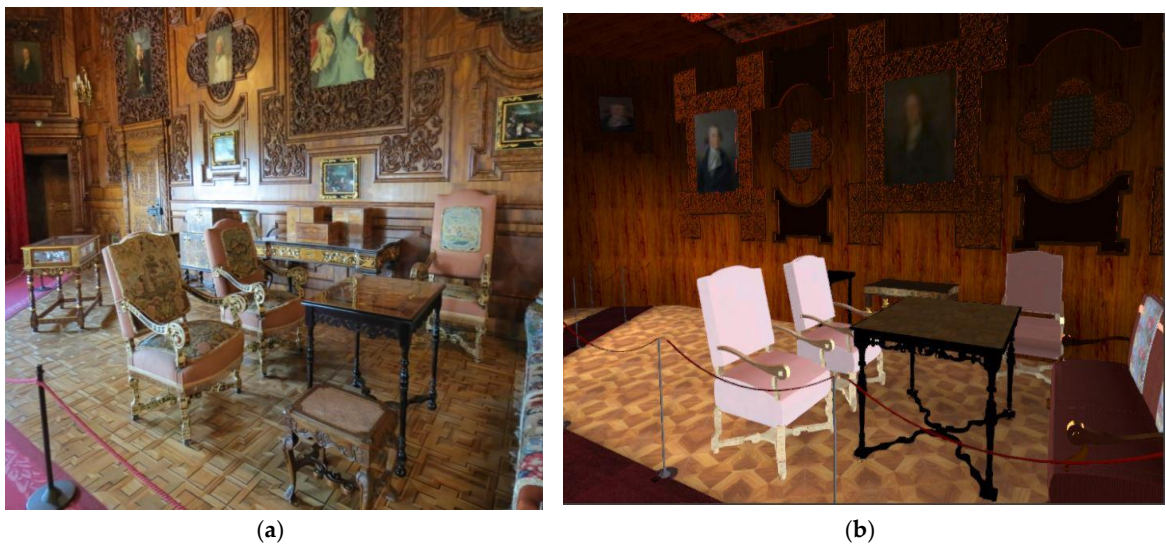
The area of the furniture location in the middle of the salon is all the time exposed to high illuminance level, as it is seen from the simulations in Figures 24 and 25. This is a problem influencing the quality of textiles of armchairs and sofa upholstery in the salon. The furniture area was also simulated for variations with the window shading activation for 25%, 50%, and 75% shown in Figure 26.

Figure 23. Furniture, (a) photograph; (b) DIALux model.

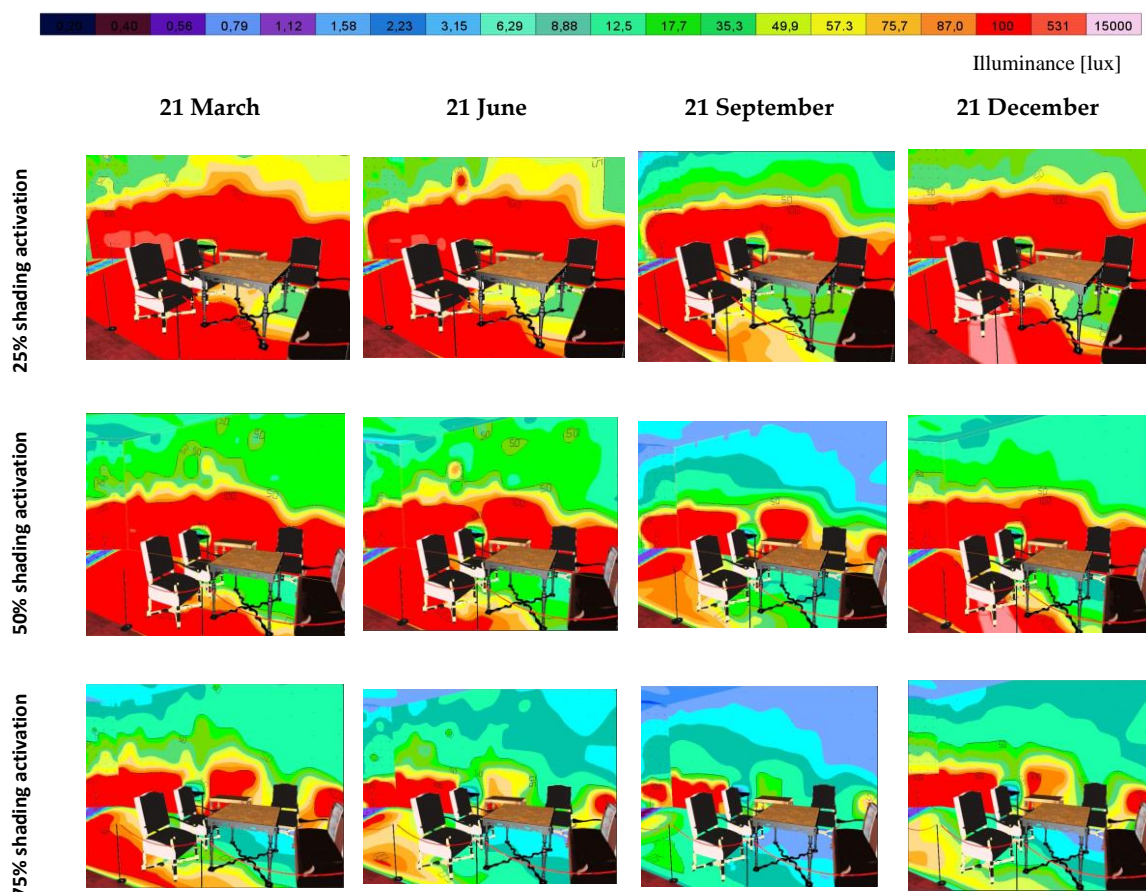
Figure 26. Furniture in the salon with window shading activation for 25%, 50% and 75%.

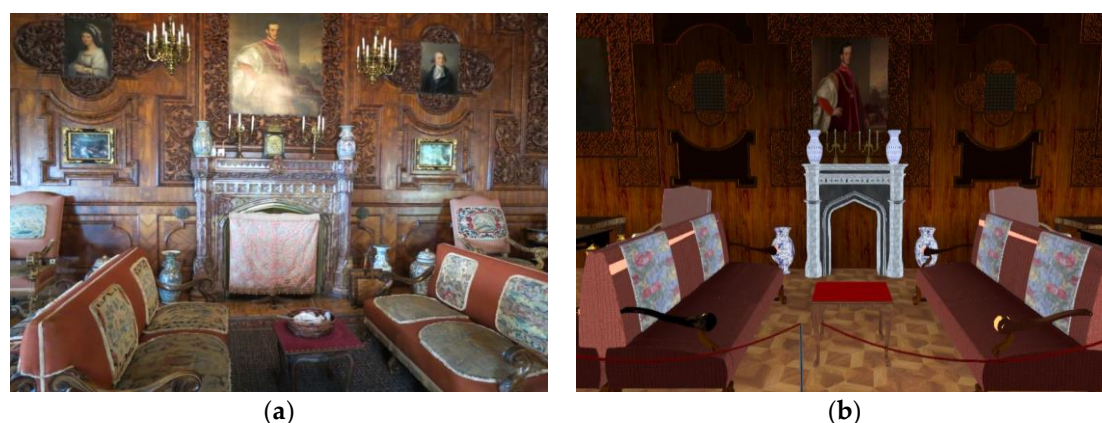
Valuable oil paintings on the wall opposite the windows are light-sensitive artefacts. The view to the painting from the window side is shown in Figure 27 and in graphical distribution of illuminance levels in Figures 28 and 29.

The area of the painting is overexposed for a substantial part of the year. It represents a high potential damage of painting degradation and color bleaching. The view of the painting was simulated for shading activation at 25%, 50%, and 75%, as shown in Figure 30. The light level on the vertical plane close to the painting (Figure 31) is shown in detailed evaluation in Figures 32 and 33.

Figure 27. View to the painting of the chateau possessor, (a) photograph; (b) DIALux model.

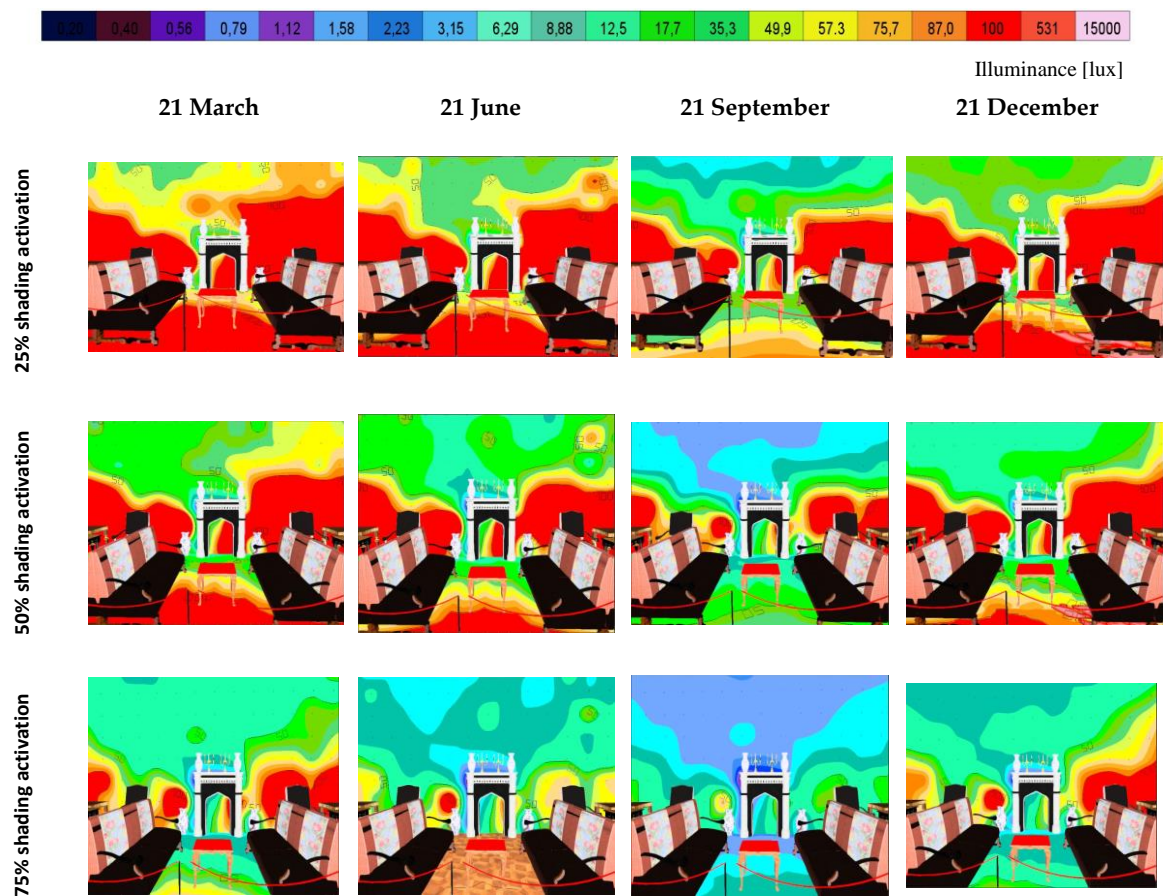
Figure 30. View to the painting simulated for window shading activation for 25%, 50% and 75%.

If possible, some ultraviolet filters which are known for conservation [37] are recommended. Special protective coatings could be applied to protect the paintings against ultraviolet radiation bleaching [38]. If the historical value of glass panels allows application of special shading systems, these might be completed with transparent spectrally selective glazing [39]. Special glass is used for reduction of transmission of ultraviolet and infrared ranges of solar radiation into the interior. Switchable glazing could solve demands for reduction of daylight transmission in time of intensive solar shining and transparency for diffusive skylight conditions [40]. Nevertheless, selected glazing must not influence the architectural style of the historical monument. In special cases, advanced daylight guiding and redirecting systems can also be applied [41]. All these special system applications must be consulted over with architects and historical monument preservation authorities.

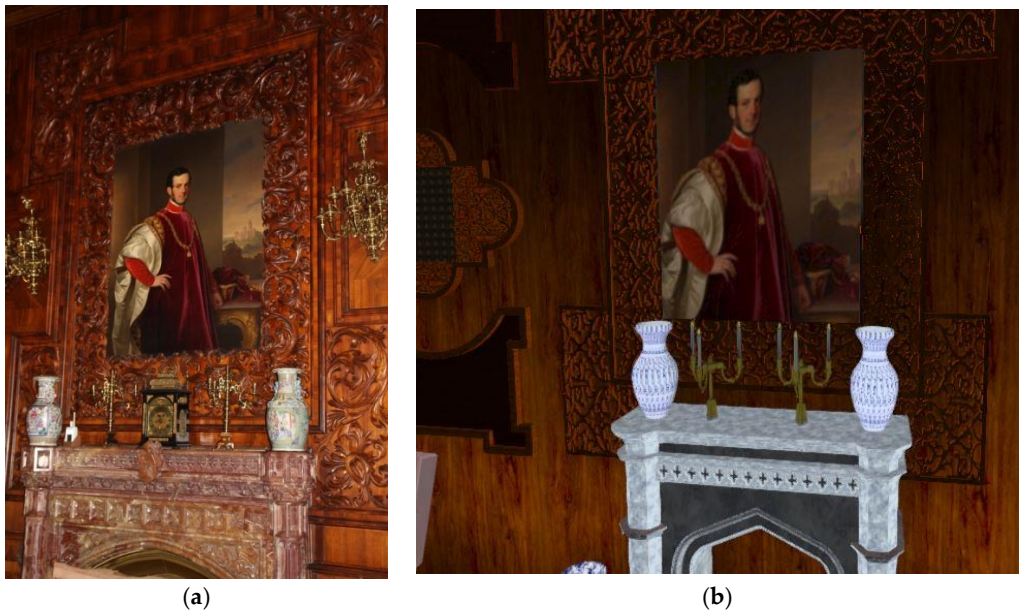
Figure 31. Painting in detail, (a) photograph; (b) DIALux model.

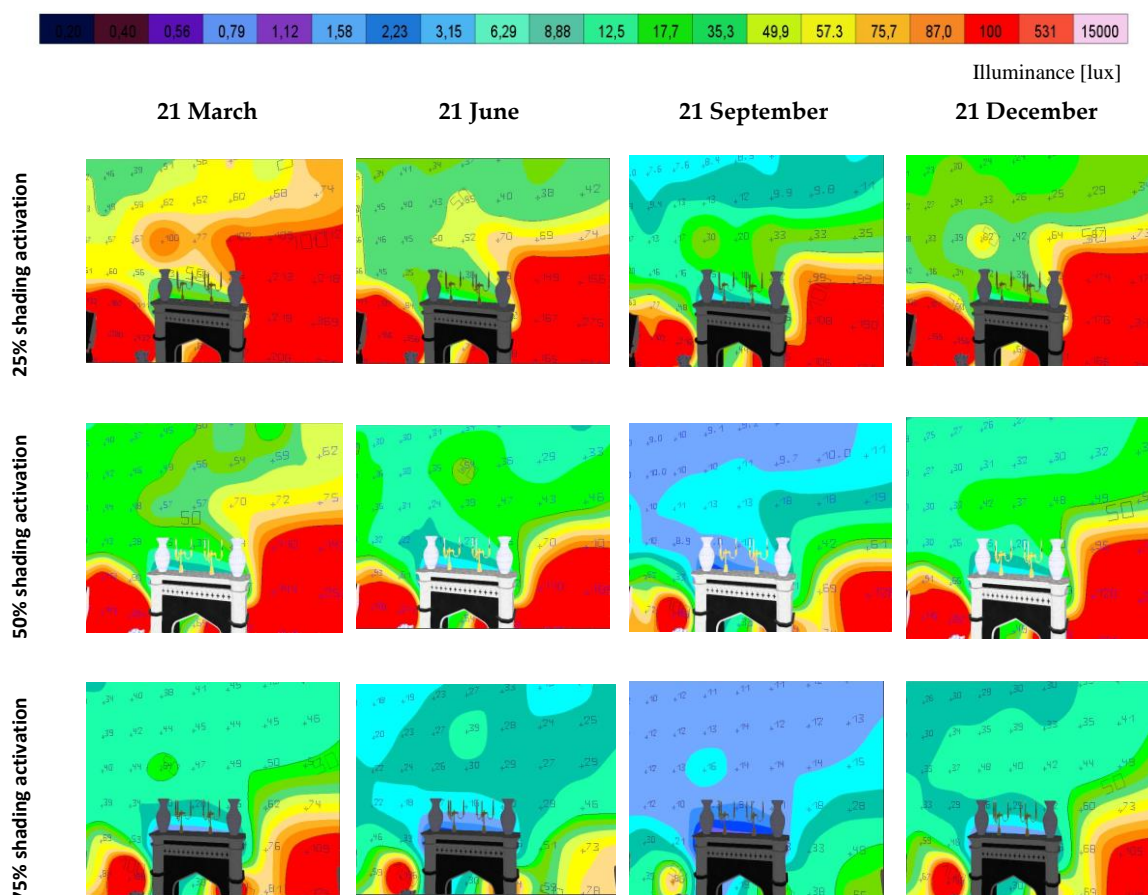
Figures 32 and 33 give an overview of the illuminance level of a part of the vertical plane close to the painting is over the 50-lux limit all year except in the early morning time in December. The painting light exposition was also studied for window shading activation at 25%, 50% and 75%, as shown in Figure 34.

Figure 34. View to the painting simulated for window shading activation for 25%, 50% and 75%.

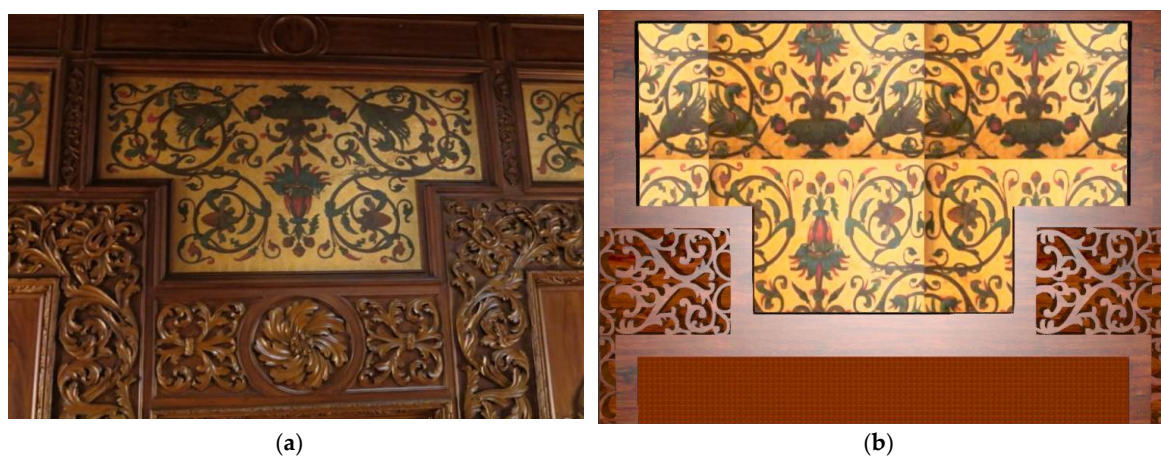
The extremely light-sensitive material is the original wallpaper on the ceiling soffit, Figure 35. The illuminance on the horizontal plane close to the soffit was simulated for the specified daylight conditions.

The simulation outputs in Figures 36 and 37 show that the wallpapers are exposed to higher illuminance levels in the period of year between March and June at noon. The rest of the year the wallpaper decoration is not damaged because illuminance level close to the ceiling wallpaper surface is not for more than 50 lux.

Figure 35. Detail of the ceiling wallpaper decoration, (a) photograph, (b) DIALux model.
