Seismic Strengthening of the Bagh Durbar Heritage Building in Kathmandu Following the Gorkha Earthquake Sequence

Keywords: seismic assessment; Greco-Roman construction; masonry building; seismic retrofitting; heritage construction; structural restoration

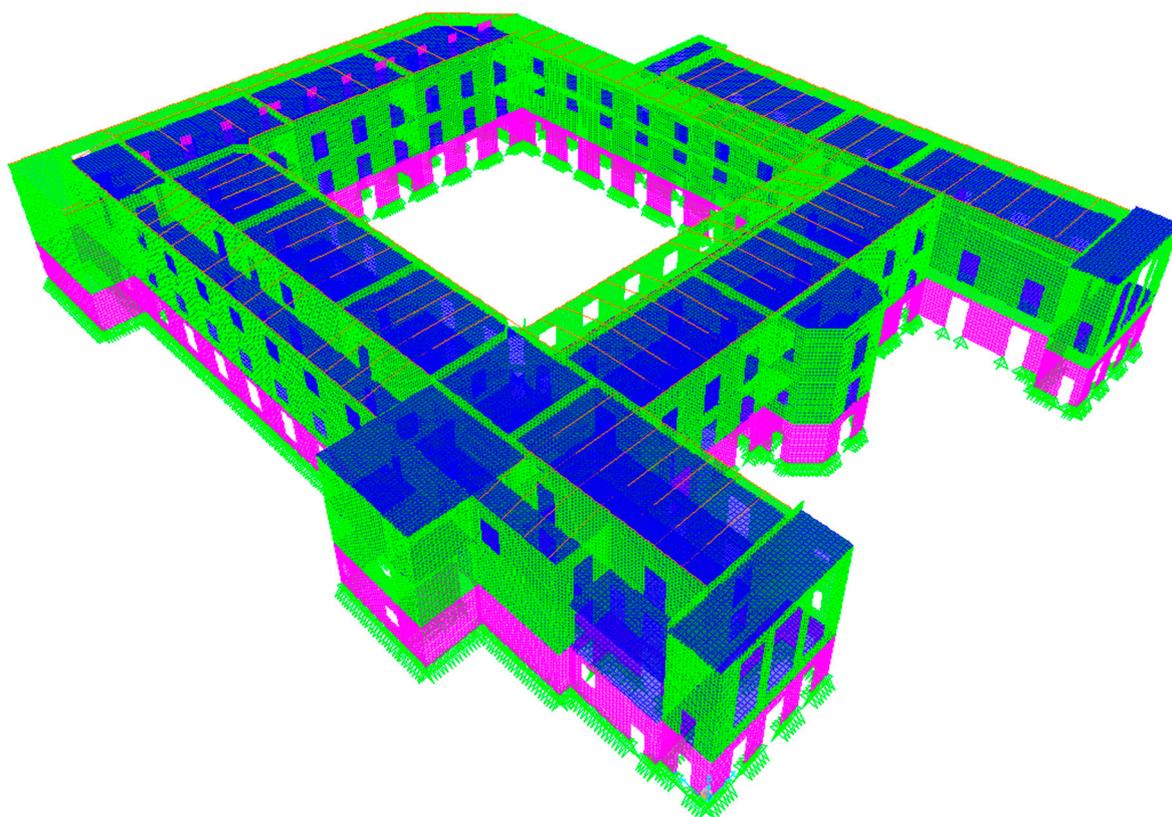
A three-dimensional finite element model was created in SAP2000 v.20 [30] based on the concept of homogenized wall materials assuming the building to be supported at the plinth level by hinges as shown in Figure 7. The hinge support assumption allows capturing the redistributed stress after formation of tension cracks near plinth, which is more realistic than the assumption of the fixed base analysis. Thin shell elements (iso-parametric 4-nodded and 3-nodded area elements) were used to model the structural masonry walls. Two-nodded frame elements (line elements) were used to model beams and timber joists in the floor and roof. Timber floors were modeled with thin shells equivalent to the provided timber planks that provided partial in-plane rigidity. The building has over 10,500 square meters of wall and floor area in the model that demands very high input in modeling and analysis of the structure. Further, the accurate assessment of material properties, accurate constitutive model of masonry element, and rigorous non-linear analysis are important for rational performance evaluation. Owing to the fact that nonlinearity characteristics of masonry play a dominant role in discrepancies that arise during nonlinear dynamic analysis, a detailed study regarding nonlinear properties of materials is needed. However, to do so, sophisticated facilities are needed, and such facilities are not available in Nepal. Thus, because of accurate damping characteristics, natural periods, Poisson's ratio, friction between different materials, and other parameters, a simplified modeling technique was adopted using a homogenized macro element for the wall modeling.

Figure 7. Three-dimensional finite element model of Bagh Durbar.

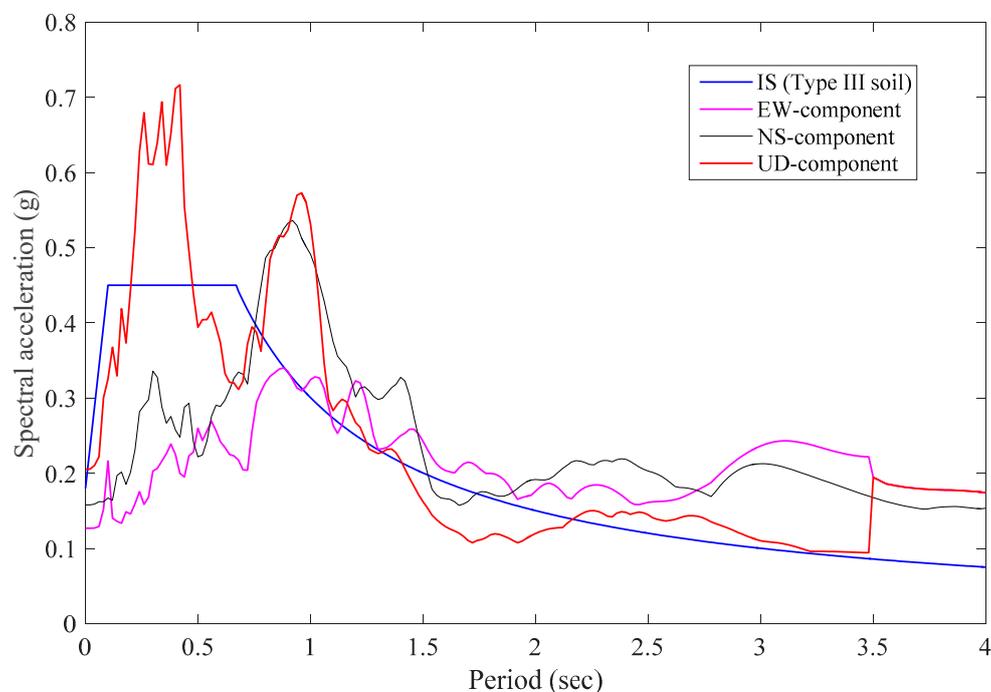
Figure 8. Response spectra of the recorded accelerogram at the Department of Mines and Geology plotted along with Indian Standard code response spectrum for soft soil. In the figure, EW indicates the east-west component of acceleration, NS indicates the north-south component of acceleration, and UD indicates the vertical acceleration component.

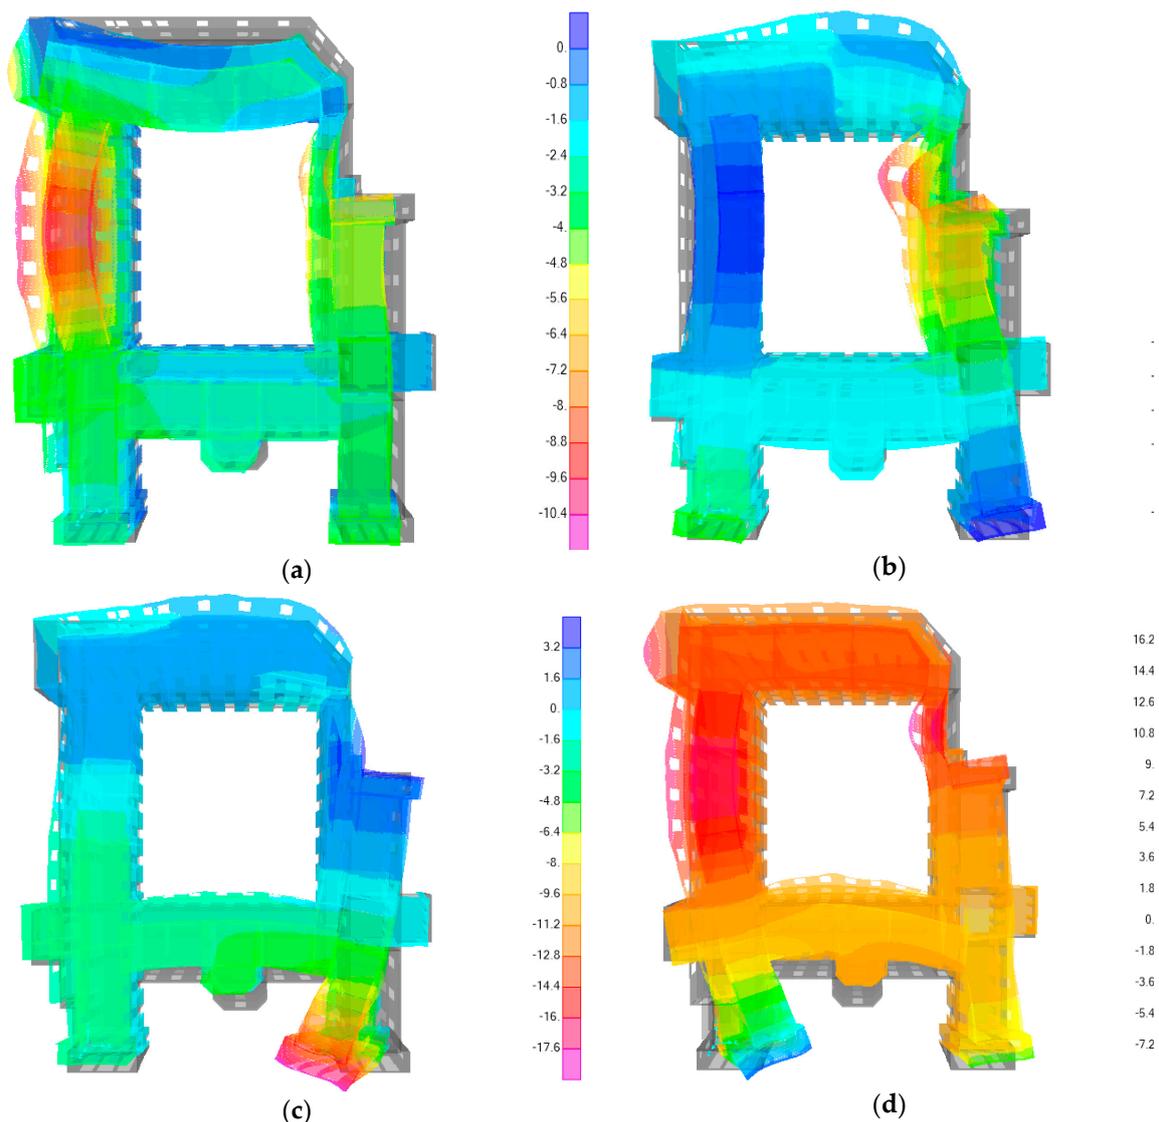
The modal analysis highlighted that the first four modes contributed significantly, leading to 60% mass participation in the x-direction and 50% in the y-direction. Mass participation of 85% was achieved by processing 44 modes. The period of the structure was 0.295, 0.292, 0.276, and 0.272 s, respectively, in the first four modes. After the seventh mode, mass participation was less than 5% for both directions in any individual mode except the 12th mode which showed 6% mass participation in the y-direction. A summary of significant mass participation, along with the period of each mode, is presented in Table 2. Figure 9 shows the mode shapes for the first four modes. The first mode reflects that the walls in the western portion experienced higher deformation in the first mode (Figure 9a). The second mode shows that higher deformation was concentrated in the east side of the aggregate in the narrow corridor (Figure 9b). Similar damage occurrence was also noted in the walls of the east side of the aggregate as shown in Figure 5. The arching of the north side of the aggregate should have caused in-plane damages to the cross-walls as shown in Figure 5. The damage mechanisms are represented in Figure 4 by uppercase letters E, F, and G on the third floor and, E', F'G', and H on the second floor. The third mode depicted that the projection in the south-east direction experienced the largest deformation as shown in Figure 9c. Consistently, in-plane damage as shown in Figure 6c was observed due to the earthquake which is indicated by the uppercase letter 'O' in Figure 2. As shown in Figure 9d, the fourth mode shows higher deformation in the south-west projection of the structure. Consistently, the damage also occurred in the same wall due to the Gorkha earthquake.

Figure 9. Deformed shape (a) mode 1 at the period of 0.295 s, (b) mode 2 at the period of 0.292 s, (c) mode 3 at the period of 0.276 s, and (d) mode 4 at the period of 0.272 s.

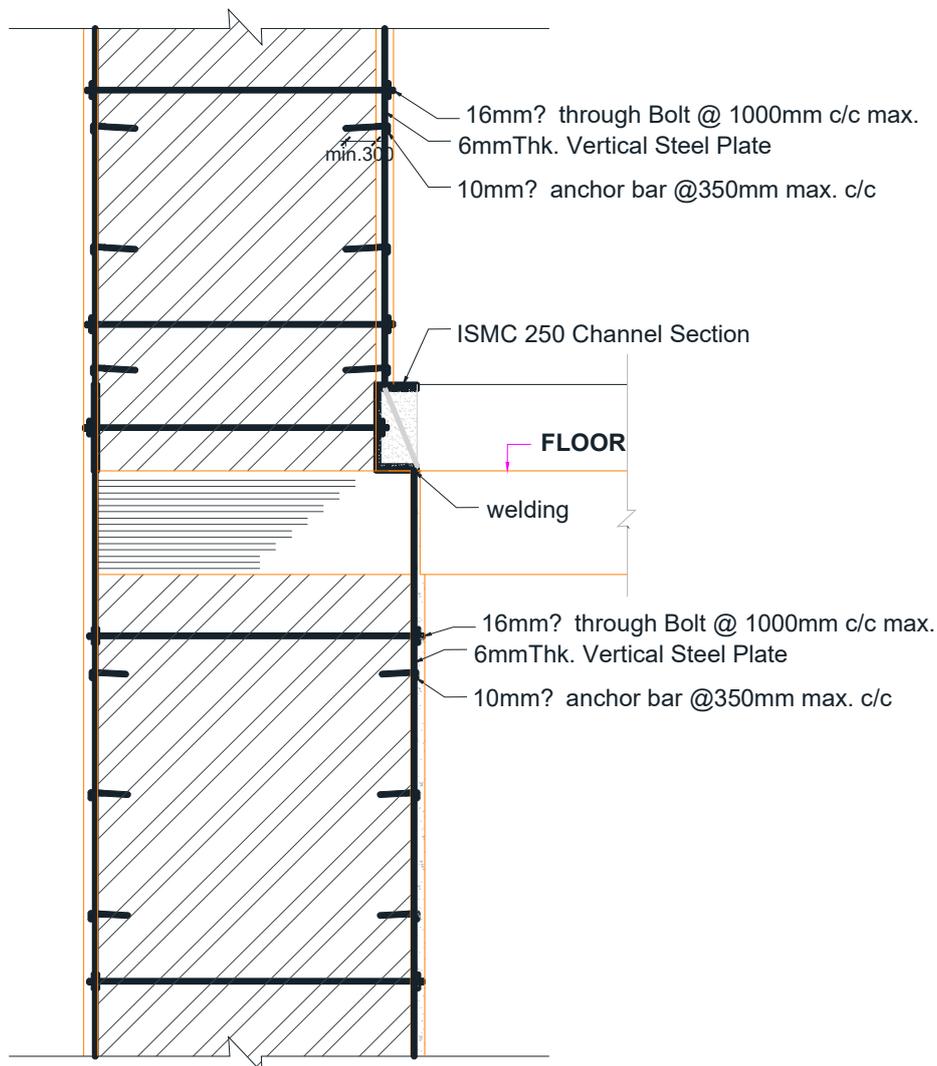
Figure 11. Details of band per floor.

In flat roofs, coats of water proofing materials are required to prevent seepage. The timber in existing staircases was deteriorated. Hence, all staircases needed to be replaced by new, but similar, ones. The staircase projecting in the north-west corner was found to be especially vulnerable from analysis. The staircase of the exterior walls needed to be stiffened and anchored by the addition of ISMC-250 sections underneath the landing. Secure connections and ductility of the exterior architectural columns and porch were necessary for life safety. Decorative masonry columns were confined with vertical steel bars embedded around the columns by cutting the grooves, and the entrance porch was tied with the main structure using horizontal bands at two levels. Provision of vertical bands around all openings and wide horizontal bands above openings help to redistribute the stress concentrated around openings. Arches were observed to be especially vulnerable in lateral shaking during past earthquakes, hence steel strips were used around arches to hold them to the nearby vertical band and horizontal lintel band.

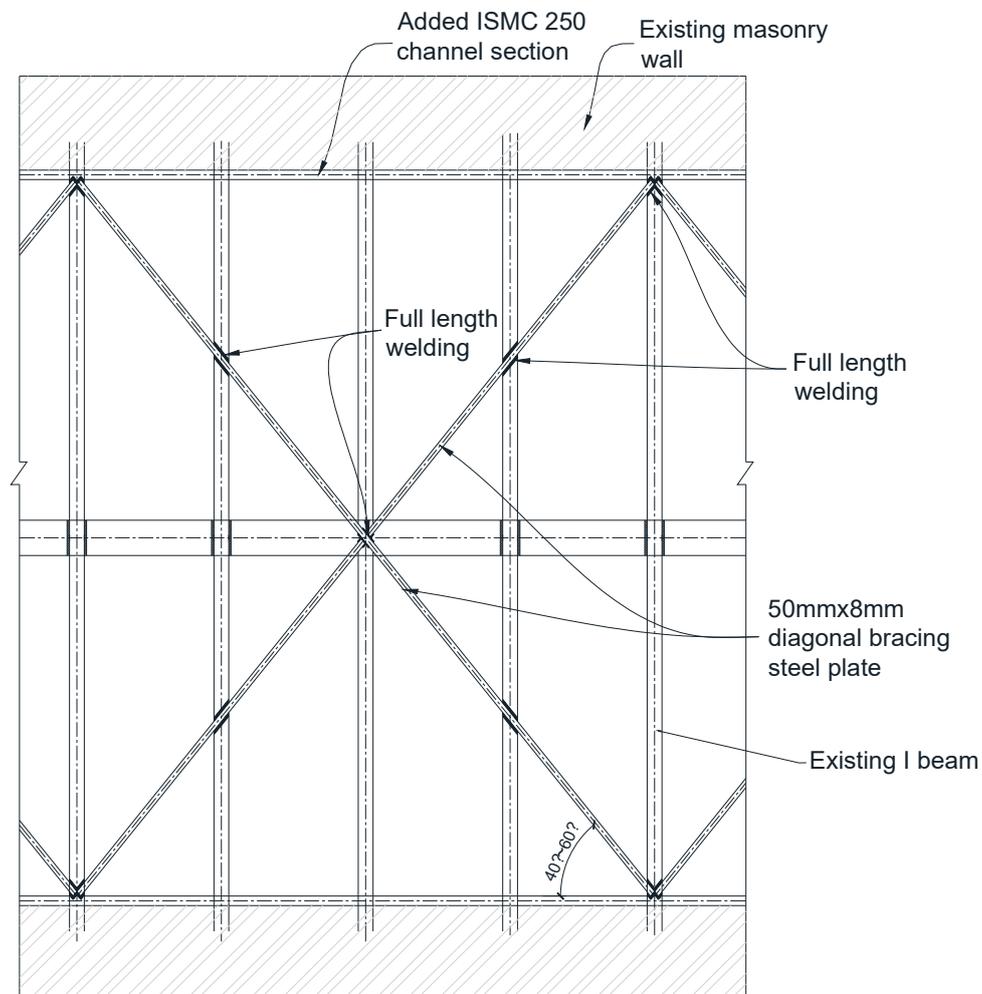
Figure 12. Details of bracing.

The primary intervention system is composed of vertical and horizontal steel members which integrates and confines the masonry system; all such interventions would be hidden under the plaster to preserve the morphology of the monument. Strengthening of floors is done by providing floor braces and continuous beams at the floor levels. The shear strength of walls is enhanced by providing vertical steel members at the ends with horizontal bands and diagonal braces on walls at the selected

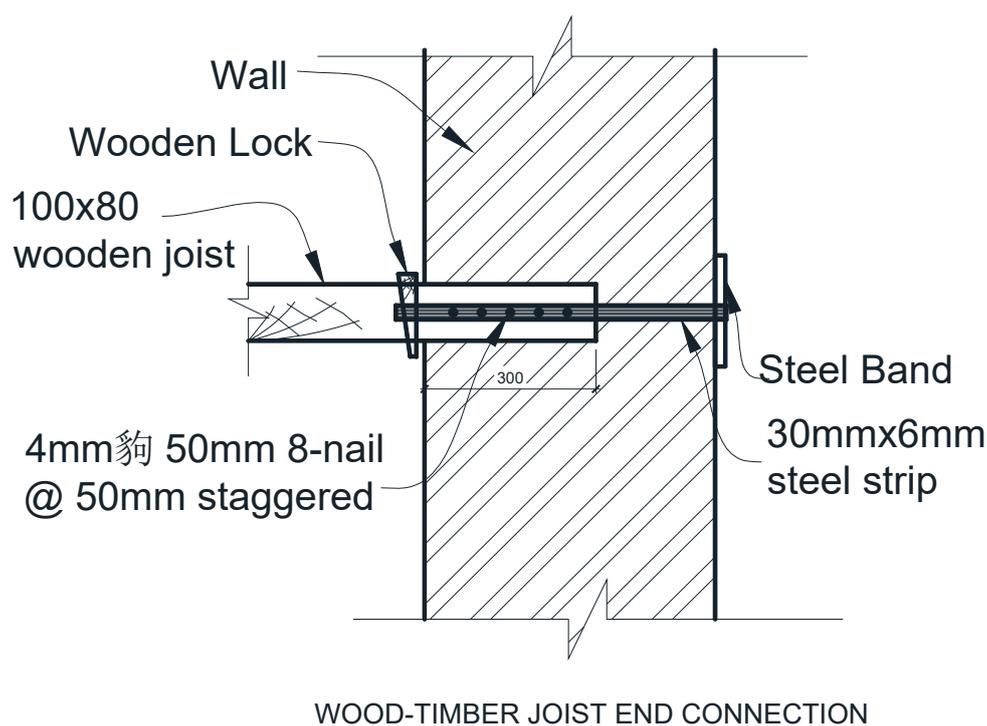
Figure 13. Details of timber joist end connection.

For timber floors, since most of the visible timber in the floors had deteriorated, all flooring timber was replaced by seasoned timber with a strip of plastic damp-proof course underneath and related protection work, especially at the embedded length. Wooden floors were stiffened in-plane by the provision of two layers of timber plank flooring oriented in the perpendicular direction. Furthermore, wooden joists were connected to supporting walls by steel strips welded to the horizontal band on the exterior side of the wall for proper anchorage as detailed in Figure 13. The roof truss was observed to be displaced in some locations and some timber portions were damaged and deteriorated. The entire roof required dismantling and reconstruction. On average, 40% of the existing timber needed to be replaced and the rest could be reused with necessary protection works. Vertical bands were required to be extended up to the roof level. Gable band and roof band consisting of wooden joists were required to be placed and the roof truss required to be reconstructed per the existing design and detail. Then diagonal braces were needed between rafters and the rafters needed to be connected to the roof band using steel strips. Further, the roofing sheets required replacement by new corrugated galvanized iron (CGI) sheets and were anchored firmly to the roof truss.

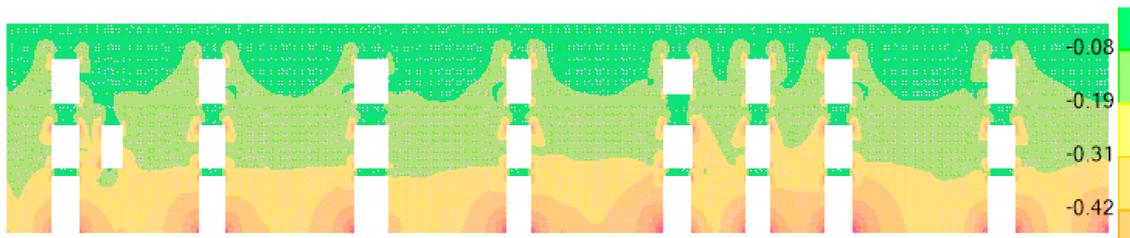
Figure 15. Compressive force per meter at section cut-3 (Figure 10) under load combination dead + live + response spectrum-x.

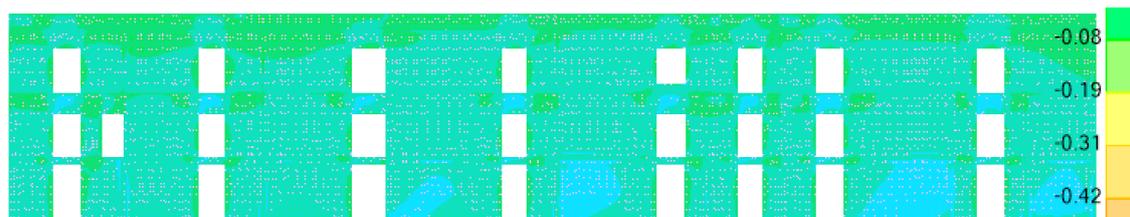
Figure 16. Shearing force per meter at section cut-3 (Figure 10) under load combination dead + live + response spectrum-x.

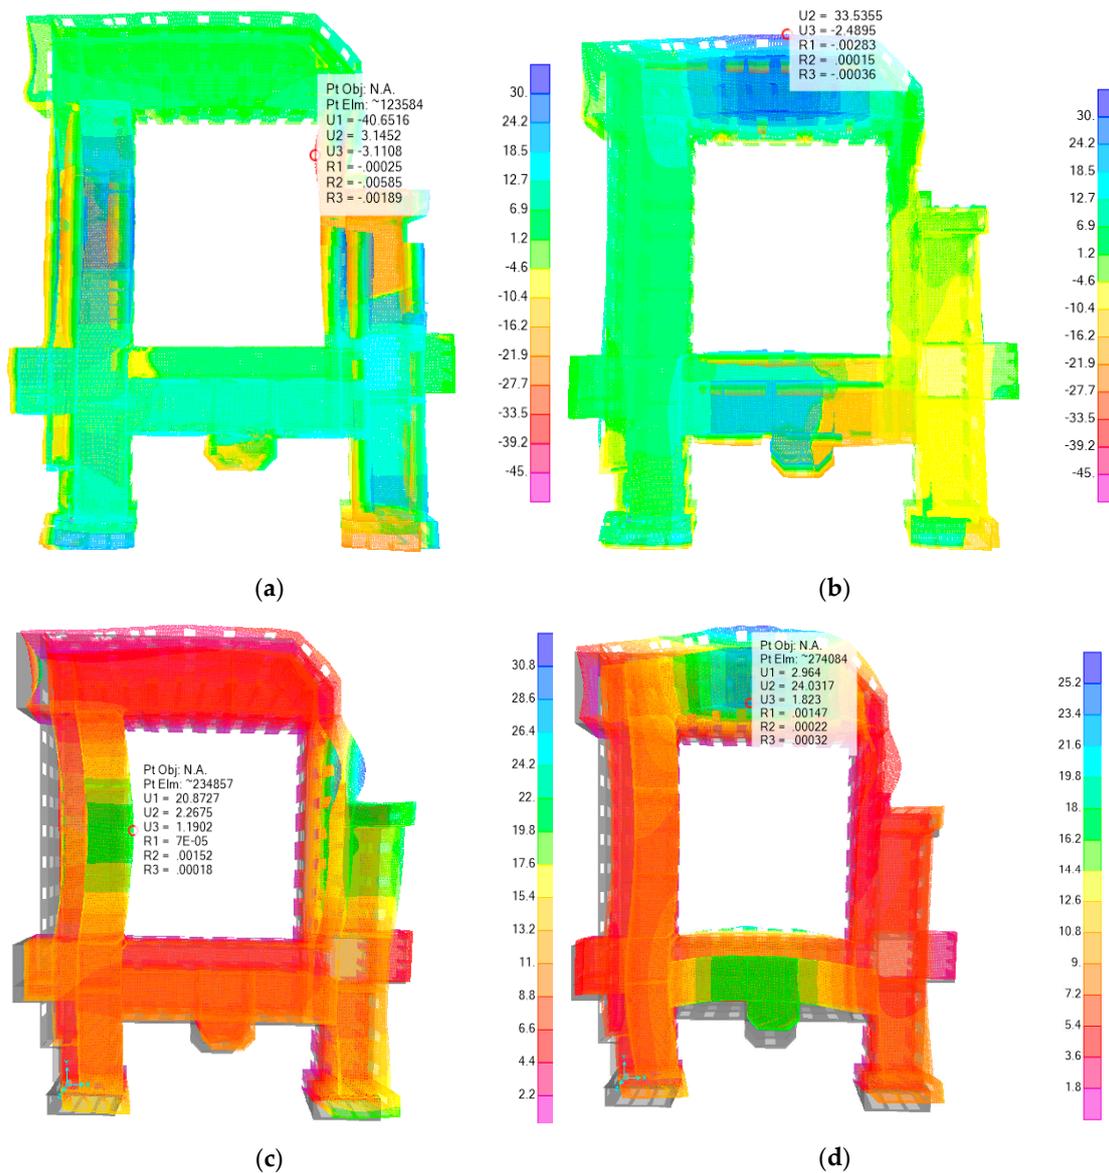
Figure 17. Deformation of the monument (a) before retrofitting along the x-direction, (b) before retrofitting along the y-direction, (c) after retrofitting along the x-direction, and (d) after retrofitting in the y-direction.
