# Preservation of Historical Underground Sites in Soft Rock: A Case Example

**Abstract:** Rehabilitation works are often needed to preserve historical underground galleries built in soft carbonate rock. The Kalemegdan fortress galleries, located in Belgrade (Serbia) were built during the 18th century using the room-and-pillars method. Instabilities have been caused by the detrition and weathering of the rock which formed the pillars. Regardless of the fact that they lost their bearing capacity, the main requirement of the authorities was that the pillars be preserved in their current state. This controversial and difficult task was achieved by the suspension of the roof in the gallery using a combination of pre-stressed geotechnical anchors and passive rock bolts. Control of the mobilization of the anchors and the geodetic survey of the target benchmarks proved that the rehabilitation was successful in the long-term. The results of the geological investigation of the site, research solutions and remedial works are described in this paper.

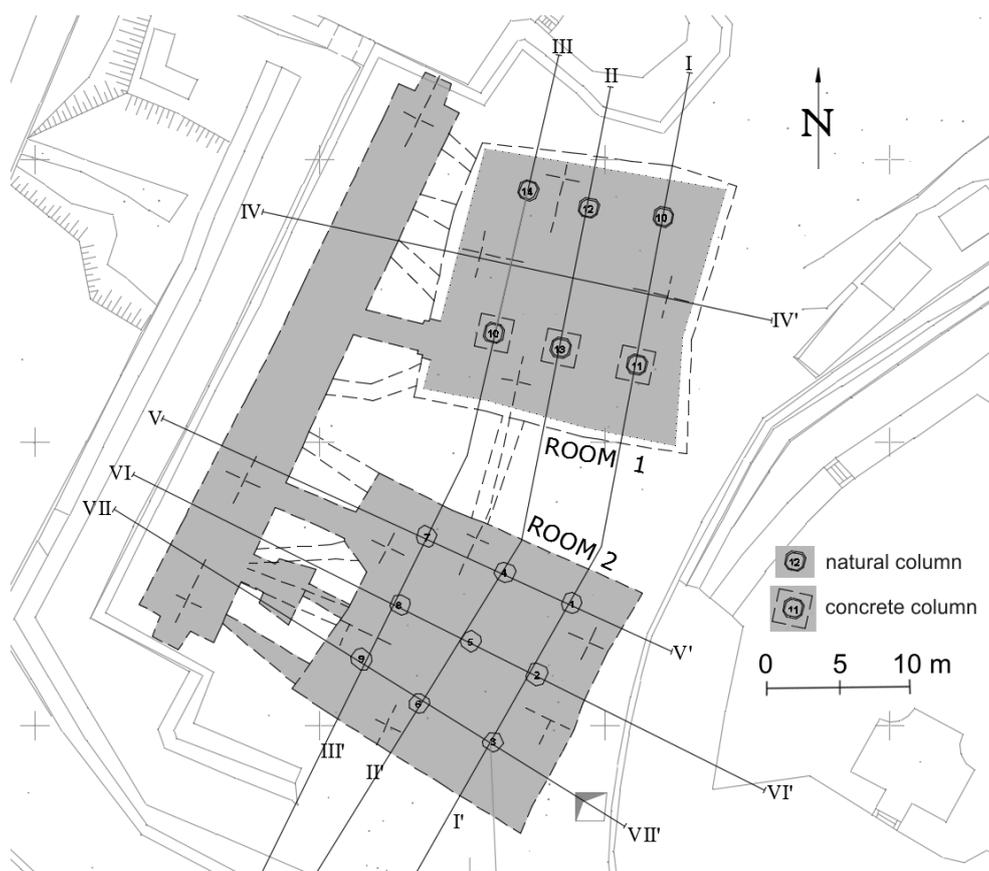
**Figure 1.** The current layout of the big gunpowder depots of the Kalemegdan fortress.

The stability of the columns in the galleries was seriously damaged during World War II, when the depots were used in their purpose-built function for the last time. In the 1950s, the nine damaged columns in Room 1 were replaced using six concrete columns, as indicated in Figure 1. At that time, the second gallery was considered stable and no remediation measures were applied.

These requirements were prompted by the inappropriate conservation of Room 1 carried out in 1950s, in which the nine columns of natural material were replaced by six columns made of reinforced concrete. The curved shapes of the columns were not replicated, so with no pendentive in place the concrete columns were not able to ensure the complete stability of the ceiling. Thus, in the middle of Room 1 there were notable signs of the abatement in the roof along the section of the missing columns IV-IV (see Figure 1).

The weathering caused the columns to peel off gradually and thus reduce in size. One of the columns in Room 2 (No. 3 annotated in Figure 1.) collapsed together with a part of the ceiling. There were therefore eight columns left in a damaged state in Room 2. Lessening of the active bearing surface caused the overloading of the columns, which resulted in partial buckling around the newly formed vertical discontinuities. In order to preserve the current state in Room 2 the client installed temporary scaffolding with the aim to aid the stability of the ceiling, as shown in Figure 3b.
