# Reconnaissance of the Effects of the $M_W 5.7$ ( $M_L 6.4$ ) Jajarkot Nepal Earthquake of 3 November 2023, Post-Earthquake Responses, and Associated Lessons to Be Learned

**Keywords:** 2023 Nepal earthquake; Jajarkot earthquake; earthquake damage survey; building damage; aftershocks; masonry structures

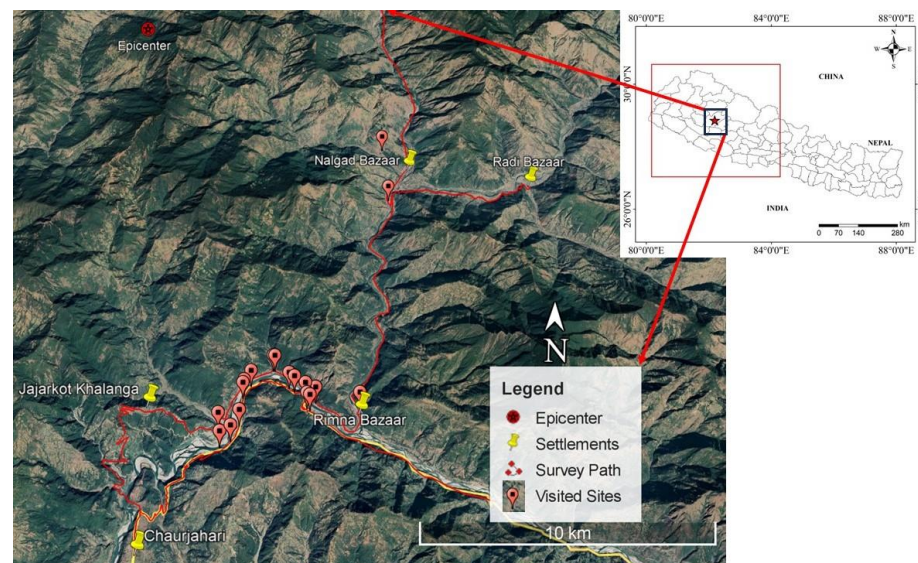
**Figure 17.** Survey paths (red lines), the locations of the sites visited for geotechnical impact assessment, and the main shock's epicenter.
