Article

Evaluation of Slope Stability Considering the Preservation of the General Patrimonial Cemetery of Guayaquil, Ecuador

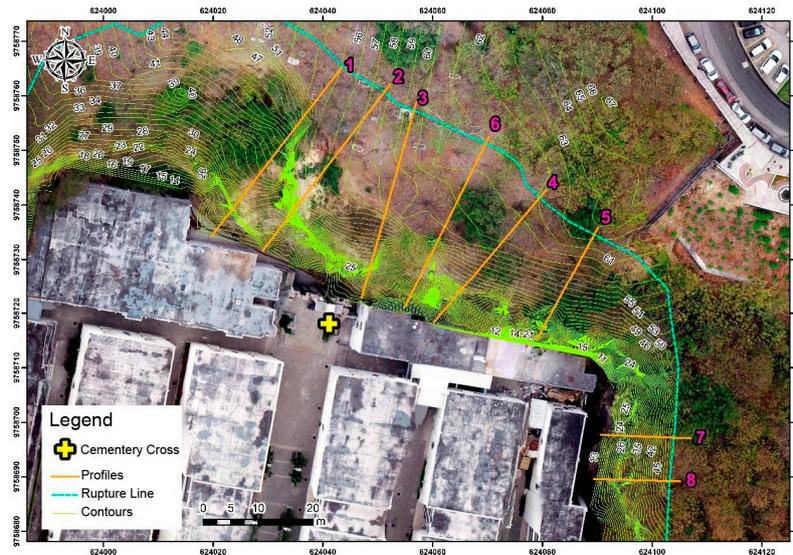
Figure 7. Location map of profiles for calculation of safety factor.

Eight profiles were developed in the slope (Figure 7), considering the different zones in which the slope was divided, its changes of direction, and extension. The safety factor was calculated for each profile using the Morgenstern–Price method [39], choosing for the analysis the lowest result of the safety factor.

The safety factor illustration (Figure 9) corresponded to the topographic profile no. 4 (Figure 7), the average dip of the strata was 19°, and the lithology is shown in Figure 8. The possible detachment surfaces follow lithostratigraphic changes, such as the one around 23 m in the stratigraphic column. This fits the value of the real SF of Figure 9, a fact that offers a relationship between the safety factor values and physical–mechanical properties of the rock.

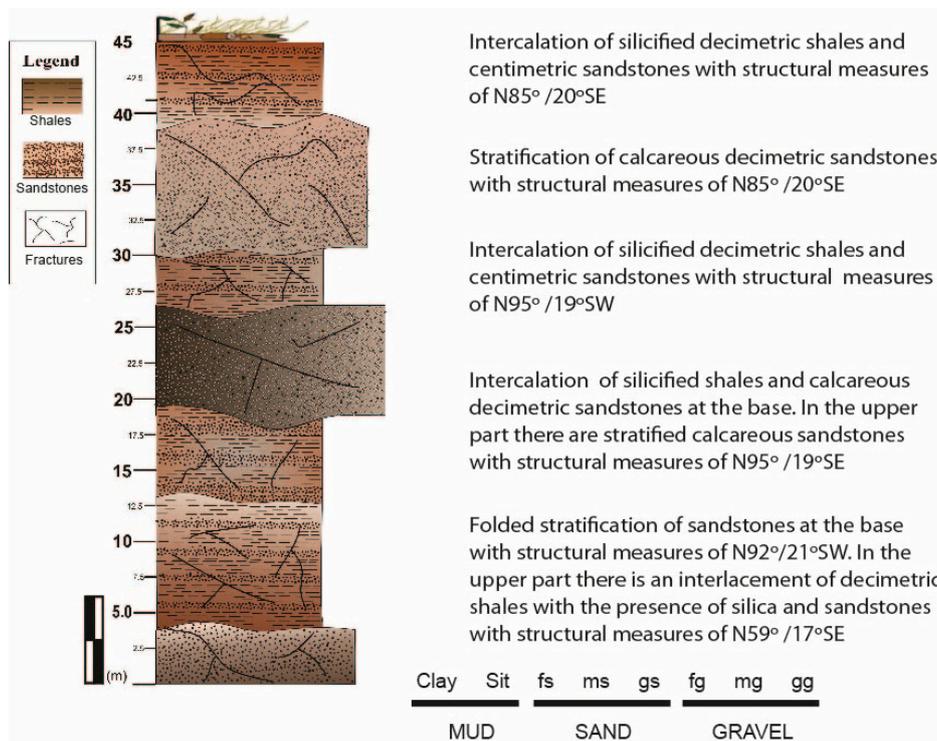
Figure 8. Slope stratigraphic column.

The data collected in the field revealed a stratigraphy of silicified shales of shades of brown-to-gray color with the presence of calcareous material and calcareous sandstone intercalations of beige and dark gray color, with a granulometry that varies from fine to coarse throughout the outcrop and with an approximate thickness of 50 m (Figure 8). The stratification has a strike of N 93° and general dip of 19° SW approximately, with thicknesses of strata that vary from centimetric to decimetric.
