Experimental Investigations on the Effects of Fatigue Crack in Urban Metro Welded Bogie Frame

Abstract: The welded bogie frame is the critical safety part of the urban metro vehicle. This paper focuses on finding out the factors inducing the fatigue cracks initiated from the positioning block weld toe of metro bogie frame. Fracture morphology and metallographic analysis were conducted to identify the failure modes, and on-track tests about the dynamic stress at the positioning block weld toe and vibration acceleration were performed. The typical signals of dynamic stress and acceleration were analyzed from time and frequency domain. The relationship between wheel polygon, rail corrugation, running speed and dynamic stress in amplitude and frequency are investigated in details. Research results show that the micro cracks induced by welding at the weld toe of positioning block propagate to the spring sleeve under relatively high alternating dynamic stress, which is strongly influenced by the wheel polygon, rail corrugation and the train running speed.

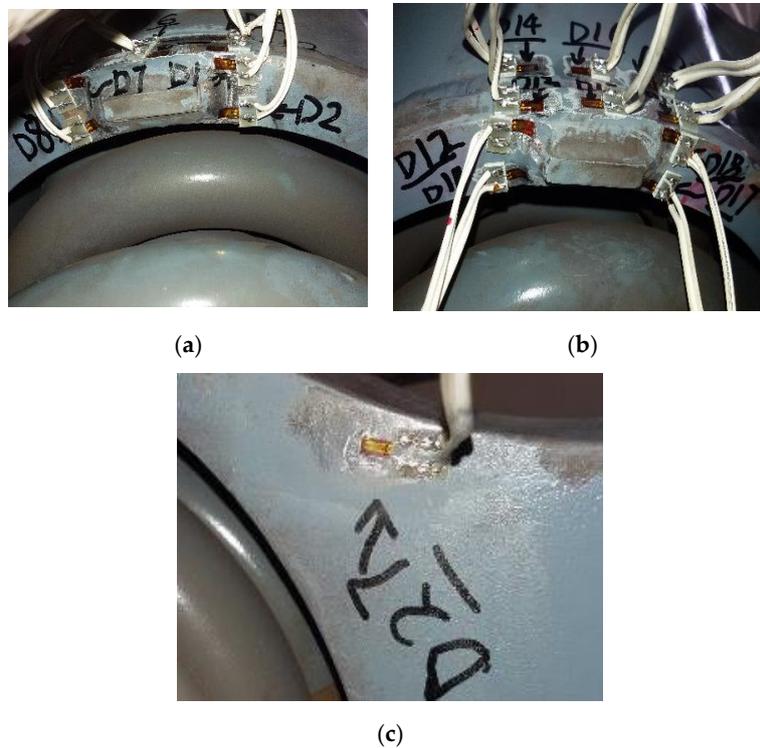
Figure 5. Strain gauge tested points around the positioning block: (a) D02; (b) D11 and D17; (c) D27.

Digital dynamic signal acquisition system (IMC) was employed in this investigation due to its high precision and fast response during the whole process. The dynamic stress and acceleration sampling frequencies were set to 2500 Hz to ensure the completeness and reliability of the test data. The dynamic stress testing points (denoted such as D2, D11, D17) were mounted around the positioning block as a critical zone and on the lower cover of the side beam (such as D27), as shown in Figure 5. Note that points D02/ D11/ D17 were specially designed vertically to the weld toe of positioning block

because mode I crack was generally assumed in engineering applications. The acceleration sensors were fixed on the axle box, spring sleeve and the motor, respectively, to measure the vibration induced by wheel-rail excitation, as shown in Figure 6.

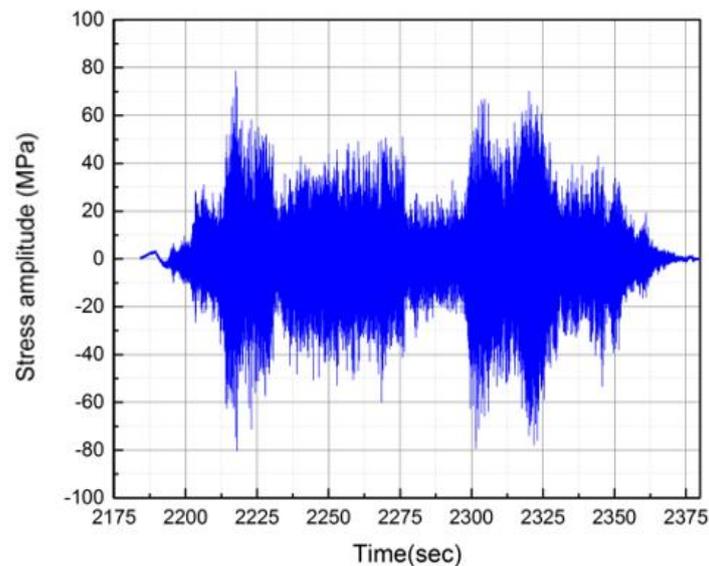
Figure 8. The stress waveform at point D02.

A typical stress time history signal of point D02 shown in Figure 8. The power spectral density (PSD) analysis and the speed-time-frequency relationship analysis of point D02 in some section are shown in Figures 9 and 10, respectively. It could be observed that the dominant frequencies are 71 Hz, 89 Hz and 94 Hz and strongly relevant to the operating speeds. This demonstrates that these frequencies are not the structural natural frequencies and there is no obvious behavior of the resonate vibration.

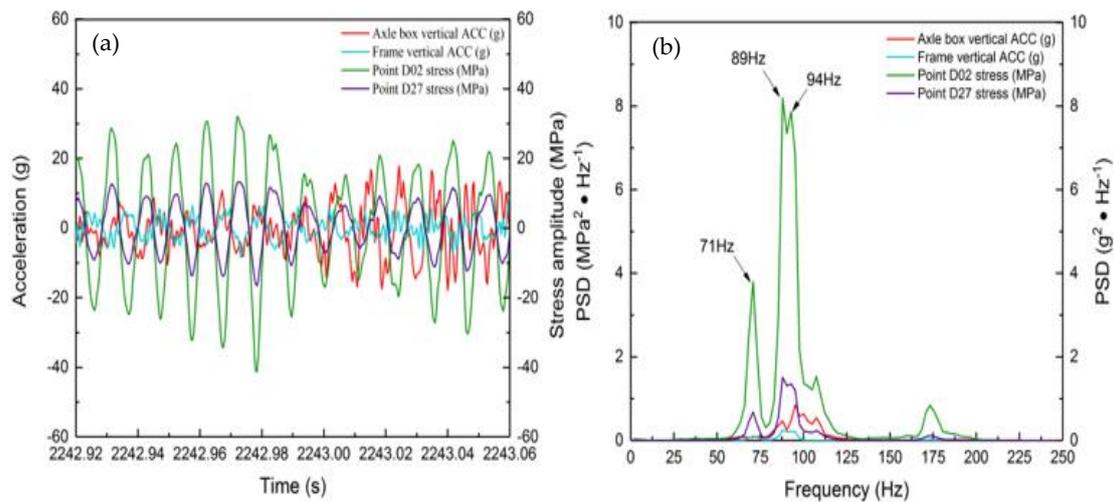
Figure 11. Relationship between the vibration acceleration and stress response: (a) time domain diagram; (b) power spectrum diagram.

The intrinsic relationship between the vibration acceleration and stress response of the bogie frame was conducted by analyzing the dynamic stress response at D02/D27 and the vertical accelerations of the axle box and frame, shown in Figure 11. It can be concluded that: (1) the vertical accelerations of the frame and the axle box are coincident with frequency bands at 71 Hz, 89 Hz and 94 Hz. Moreover, they have a significant following behavior in the time domain; (2) dynamic stresses of Point D02 and D27 are highly coherent with the vibration acceleration of the axle box and frame in the time domain and frequency domain, and Point D02 has much higher stress amplitude and PSD value due to the positioning block local stress concentration. The dynamic stress and acceleration analysis clearly indicate that the dynamic stress response at D02/D27 has obvious main frequencies and consistent with the speed. Combined with the vibration acceleration test results, the following conclusion can be drawn that the dynamic stress response at the positioning block weld toe is directly caused by the vibration of frame, which mainly derives from the wheel-rail excitation.

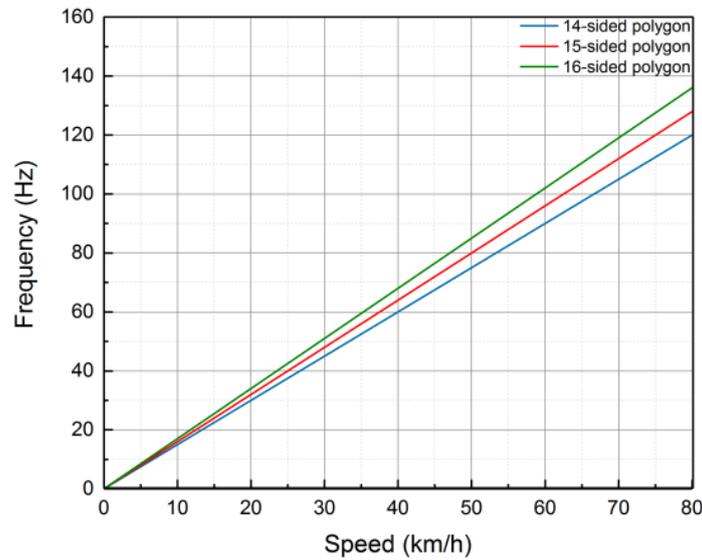
Figure 13. Relationship between wheel polygon and running speed.

The wheel polygon will worsen the wheel-rail force and cause the high vibration of the axle box and bogie frame. The excitation frequencies of 14- to 16-side polygon wheel are coincided with the running speed linearly, shown in Figure 13. As indicated by the 15-sided wheel polygon analysis, for an example, when the operating speed is 54 km/h, the dominant frequency of the wheel-rail excitation is 86 Hz. Further, according to the analysis results of Figures 8 and 10, it can be observed that the dominant frequency of the wheel-rail excitation (86 Hz) is similar to the dominant frequency (89 Hz) of dynamic stress amplitude at point D02 in 54 km/h.

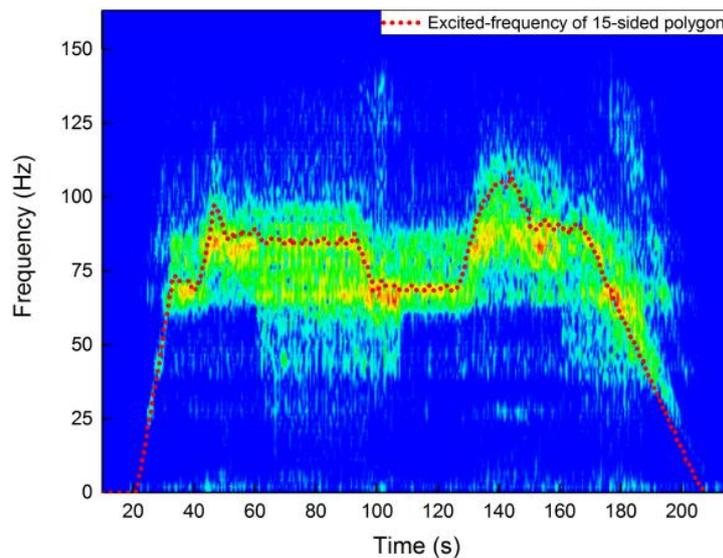
Figure 14. The frequency comparison between dynamic stress at point D11 and excitation from the wheel polygon phenomenon.

Figure 14 indicates the comparison results between the time-frequency diagram at point D11 and the frequency excited by the wheel polygon. It can be observed that the characteristic frequency of 15-sides polygon (red points in Figure 13) is highly consistent with the dominant frequency of dynamic stress.

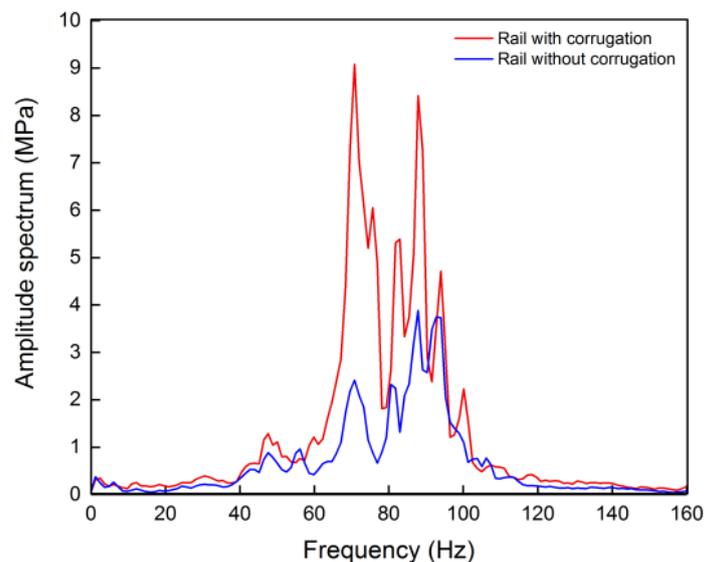
Figure 18. The amplitude spectrum comparison of the dynamic stress of the frame with and without the rail corrugation.

Meanwhile, Figure 18 shows a comparison of the characteristics of frequency domain with and without rail corrugation. It can be observed that in the frequency range of 60–90 Hz, the dynamic stress amplitude with rail corrugation is significantly greater than that without rail corrugation, especially in 71 Hz. In summary, the rail corrugation phenomenon has a significant effect on the dynamic stress amplitude at the cracked area.

(3) The fractography and the on-track tests show that optimizing the weld technology, improving the weld quality, profiling the wheels, grinding the rails and decreasing the train running speed are all effective to reduce the failure probability and elongate the bogie frame life.

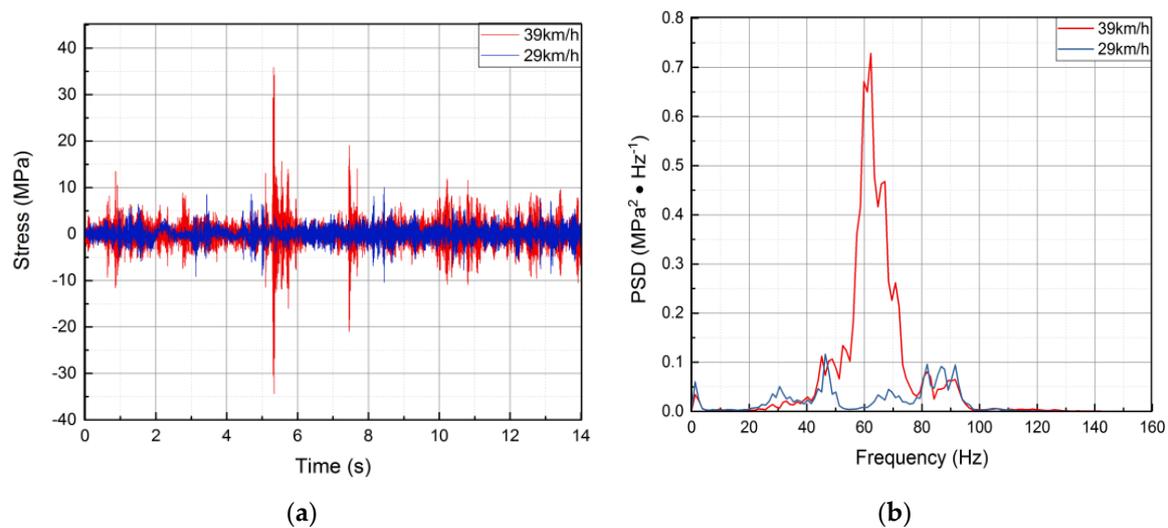
Figure 19. Round-trip time-frequency domain stress diagrams at different speeds: (a) time domain diagram; (b) time-frequency diagram.

The wheel/rail vertical force increases with train running speed rising [17]. To investigate the relationship between the running speed and the dynamic stress amplitude, it is necessary to eliminate the influence of the rail condition. Therefore, a round-trip section was chosen to analyze. The round-trip speeds were 39 and 29 km/h, respectively, as shown in Figure 19. It can be observed that when the interval round-trip speeds were 29 and 39 km/h, respectively, the maximum values of dynamic stress amplitude were 10 and 36 MPa, and the main frequencies were 46 and 62 Hz. In conclusion, the

amplitude and frequency of dynamic stress are significantly increased with the higher speed, which produces higher damage to the frame.
