# Seismic Evaluation and Methods of Rehabilitation of Old Masonry Buildings in the Bay of Kotor (Montenegro)

**Citation:** Tomanović, D.; Marković, L.; Gadžić, N.; Rajković, I.; Aleksić, J.; Tomanović, T. Seismic Evaluation and Methods of Rehabilitation of Old Masonry Buildings in the Bay of Kotor (Montenegro). *Appl. Sci.* **2021**, *11*, 3544. <https://doi.org/10.3390/app11083544>

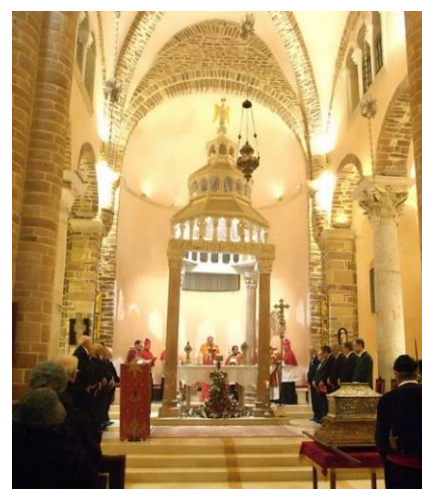
As tall buildings are very rare in traditional construction (towers, bell towers), cases of overturning are also exceptional. Such a catastrophic case happened in 1667 with the Romanesque bell towers of the Cathedral of St. Tryphon (Figure 3a,b), which collapsed and damaged nearby buildings on the square. The extent to which this earthquake influenced the strengthening of the local aseismic culture has been demonstrated by the fact that the present bell towers, built at that time, did not show the slightest constructive damage in the 1979 earthquake.

**Figure 3.** (a) Cathedral of St. Tryphon—Romanesque bells collapsed in the 1667 earthquake. (b) The cathedral was designed as the three-aisled basilica.

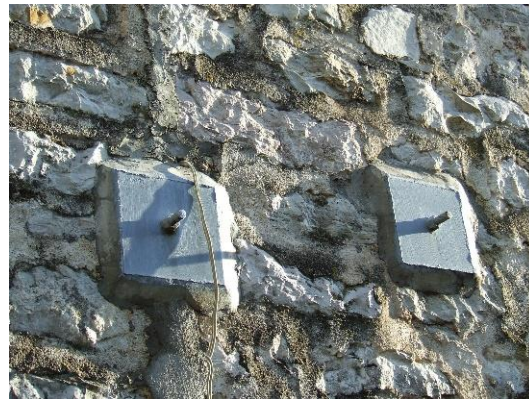
The tightening of the building, which shows smaller cracks in the stone walls and does not indicate any major damage, was done with steel bars  $\Phi 20$  mm, anchored to the fitting steel 10 mm thick plates or transverse reinforced concrete beams, to ensure its durability (Figure 23).

**Figure 24.** Cross-section—Positioning of tie-beams at each floor level.

Reinforced tie-beam profile is requisite, because the walls are planned to be tightened only from the inside, so that the exterior facade does not deteriorate.

Reinforced concrete beams for stiffening are made next to the existing walls in the area above the inner door to the ceiling. In the height of the existing roof cornice, a reinforced concrete ring beam with a new cornice was made, connected with transverse beams for stiffness (without dismantling the roof structure).

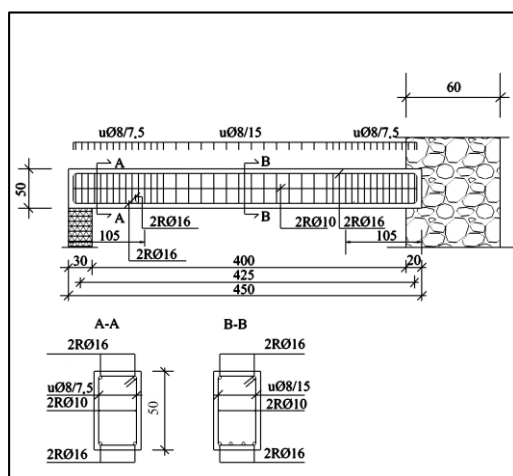
Figure 36. RC cornices with stone slabs.

The dispositional solution of the roof structure, as well as the arrangement of the partition walls of the attic space, urged the construction intervention at the level of the floor structure at the attic (Figure 36). The roof essentially consists of two hipped roofs placed one on top of the other. The lower, larger, covers the dimensions of the house, while the other is placed transversely to it above the central superstructure.

A pair of continuous RC suspended beams were constructed, having the function of the load-bearing base of the side walls of the attic belvedere structure, as well as the associated RC pillars with another attic cornice. The mentioned RC pillars, as well as the previous ones in the lower floors, are clamped in massive facade stone walls. A typical roof structure consists of construction elements made of second-class coniferous wood. The roof is made with thermal and waterproofing provided for a given climate zone.
