Investigation of the Causes of Premature Rain Erosion Evolution in Rotor Blade-like GFRP Structures by Means of CT, XRM, and Active Thermography

Abstract: Premature rain erosion damage development at the leading edges of wind turbine rotor blades impair the efficiency of the turbines and should be detected as early as possible. To investigate the causes of premature erosion damage and the erosion evolution, test specimens similar to the leading edge of a rotor blade were modified with different initial defects, such as voids in the coating system, and impacted with waterdrops in a rain erosion test facility. Using CT and XRM with AI-based evaluation as non-destructive measurement methods showed that premature erosion arises from the initial material defects because they represent a weak point in the material composite. In addition, thermographic investigations were carried out. As it shows results similar to the two lab-based methods, active thermography has a promising potential for future in-situ monitoring of rotor blade leading edges.

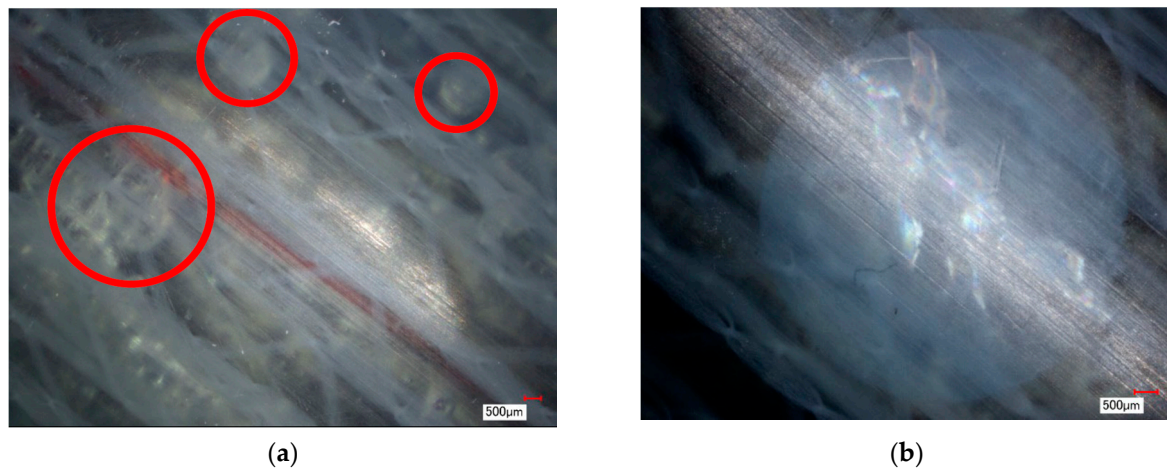
The voids in the GFRP composite material (L) were introduced during the production of the test specimens in the vacuum process. In this process, undefined defects were generated in the GFRP specimen in terms of localization and shape, as they can also occur in the real manufacturing process, see Figure 2a.

Figure 2. Photograph of part of the GFRP specimen with initial defects as (a) introduced voids (within the red circle) and (b) introduced delamination, adapted with permission from [19].

The delaminations in the GFRP composite material (D) were already introduced during the layer-by-layer buildup of the GFRP test specimen. For this purpose, round Teflon foil cutouts with a diameter of 7 mm–10 mm were positioned at defined points between the GFRP layers, see Figure 2b. The Teflon foil provides local debonding between the individual fiber layers. The styrofoam balls for imitating voids in the coating system (S) have a diameter of $\sim 1 \text{ mm} \pm 0.4 \text{ mm}$ and were introduced manually directly during the coating process of the filler, see Figure 3. Due to the electrostatic properties of the styrofoam balls, they had to be adhered to the specimen surface using a thin underlayer. This underlayer was applied as thinly as possible to the putty material using a flexible comb. On top of the underlayer with applied styrofoam balls, a covering layer of the putty material was applied. After a sufficiently long drying time, the putty was ground off mechanically to produce the geometrically correct shape of the specimens and to generate a sufficiently rough surface in preparation for the coating of the specimens afterward.

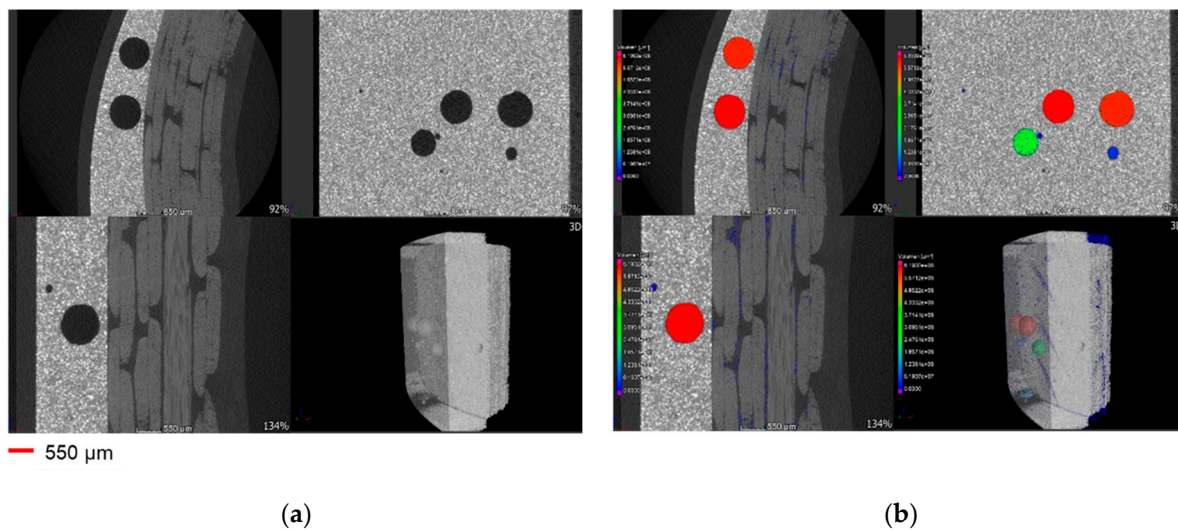
Figure 14 shows the resulting images of a test specimen section with inserted voids in the initial state from the high-resolution XRM measurements. Styrofoam spheres were placed in the area of the filler where their imprints left circular structures of different diameters in the sectional images. The spherical structures only become visible in the 3D images. The voids can be analyzed according to position, size, sphericity, and size distribution in VolumeGraphics, or their volume can be visualized in color-coded form, see Figure 14b. However, the analysis is time-consuming, so deep learning methods were further used for data analysis.

Figure 14. Image analysis on high-resolution XRM data of a specimen with voids in the filler. In (a) sectional images and 3D view in VoliumGraphics without analysis. In the area of the trowel application, there are particles with high density (bright dots) as well as artificially generated voids (dark circles) in the test specimen in (b) void analysis with color-coded volume sizes, adapted with permission from [19].

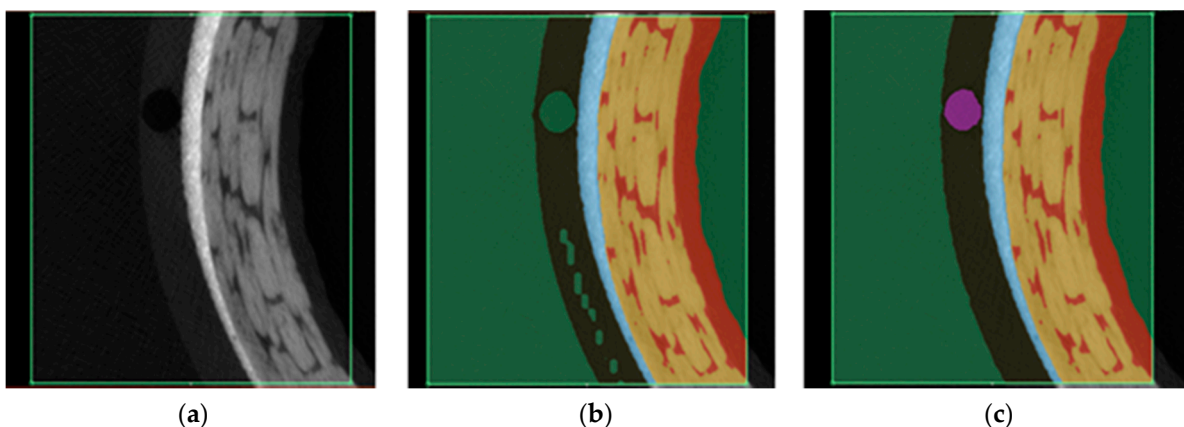
Figure 15 shows the results of the employed deep learning methods. In Figure 15a, one slice of the CT images is shown. The different layers of fibers and the filler are clearly visible. The void in the coating, the coating itself, and the resin of the GFRP laminate are barely visible due to their almost similar density. Therefore, the XMR data segmentation was done using U-Net (see Figure 15b). The U-Net was trained 12 times and an additional virtually labeled frame from different parts of the specimen was fed into the training data during each training. The average training duration was around 35 min. Since the results of the segmentation were inaccurate in the coating layer and did not ameliorate with further training, a Sensor 3D [25] CNN with a different architecture was examined for better results. The results using the Sensor 3D shown in Figure 15c were obtained after five training sequences, i.e., with five virtually labeled frames. Nevertheless, the training of the Sensor 3D is more time-consuming than that of the U-Net, with an average training duration of 68 min. The comparison of the achieved segmentation results using the U-Net and the Sensor 3D models depicts a clear advantage of the sensor 3D over the U-Net for the current purpose. The Sensor 3D CNN could not only differentiate between different material layers and the background, but the defects were also completely and correctly located.

Figure 15. (a) CT slice (no. 303 out of 2014 images), (b) segmentation using U-Net, (c) segmentation using Sensor 3D [19].
