# Article Analysis of Truck Tractor Tire Damage in the Context of the Study of Road Accident Causes

Kazimierz Drozd<sup>1</sup>, Sławomir Tarkowski<sup>1</sup>, Jacek Caban<sup>1,\*</sup>, Aleksander Nieoczym<sup>1</sup>, Jan Vrábel<sup>2</sup>, and Zbigniew Krzysiak<sup>3</sup>

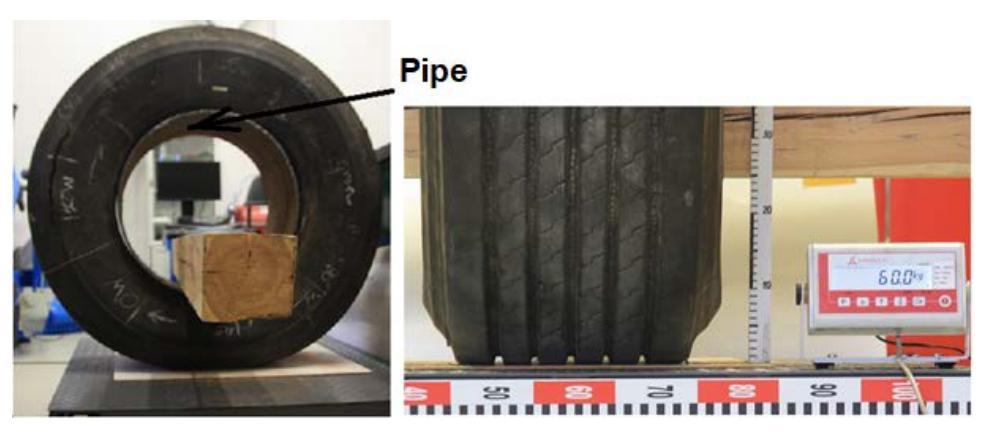
**Figure 11.** Method of loading the test tire and measuring the initial deflection of a tire loaded with a mass of 60 kg.

Moreover, a method of testing a disassembled tire was developed in order to simulate the conditions in which the material around its circumference, described as a "belt", could be worn, could be simulated (Figure 5). Tests were carried out in which the tire in question was pressed against a flat surface with a steel pipe with a diameter of 550 mm, which was smaller than the diameter of the tire seat by about 20 mm. The use of a pipe as a clamping element was justified, among others, by the inability to put a rim in the tirewithout mechanical impact on the tire (during the necessary assembly and disassembly), which could cause further damage and an attempt to press the tread face against the surface evenly. The pressure on the pipe was transmitted by a beam through two belts anchored to the ground. When loading the tire, the pressure value was read using an electronic scale indicator (accuracy class III) on which the tire rested. The method of applying the load and the profile of the tire loaded with the mass, resulting only from the mass of the pipe and the beam (60 kg), is shown in Figure 11. Before starting the test, the tare equal to the weight of the tire and the beam with belts was taken into account. The measured height of the lower part of the beam above the surface of the weighing table (before starting the test) was 250 mm (Figure 11).

During the analysis of the successive stages of loading the tire, it was noticed that the side of the tire was deforming in the place where the "belt" was located (Figure 5). The static deflection of the tire profile, loaded with a mass of 603 kg, was equal to 250-140 = 110 mm. The results of deflection vs. load of the tire tests are shown in Figure 15. For a sample size of 20, in five levels of tire deformation, a regression function was found as well as a 95% confidence interval for the regression equations. These parameters were determined in accordance with the rules applicable in scientific works [56,57]. The method of deformation of the profile (and "belt") with a mass of 603 kg is shown in Figure 16a. With such deflection, the side of the non-rotating tire did not touch the ground surface. The static deflection of the tire profile, loaded with a mass of 676 kg, was equal to 250-120 = 130 mm. The method of deformation of the profile (and the "belt" of the tire), when loaded with a mass of 676 kg, is shown in Figure 16b.
