Technological Aspects of a Reparation of the Leading Edge of Helicopter Main Rotor Blades in Field Conditions

Abstract: The Polish Air Force operates more than one hundred helicopters of the Mi family (manufactured by Mil Helicopters), equipped with metal main rotor blades. The main rotor blades are among the most stressed components of these structures. For this reason, they are subject to more frequent inspections during operation than other components. One type of damage detected during inspections is the local disbonding of fragments of the anti-erosion layer from the leading edge. This harmless-looking damage is very dangerous, since it quickly leads to the complete detachment of the layer. The leading edge, unprotected by the metal cover, erodes rapidly. The detached layer, when thrown away at high speed, endangers other parts of the helicopter, such as the tail rotor, and may cause damage to other helicopters if flying in formation. The technology supplied by the manufacturer to date has not encompassed the field repair of this type of damage. Therefore, efforts were made to develop repair technology for rapid repairs of blades in field conditions during missions of the Tas

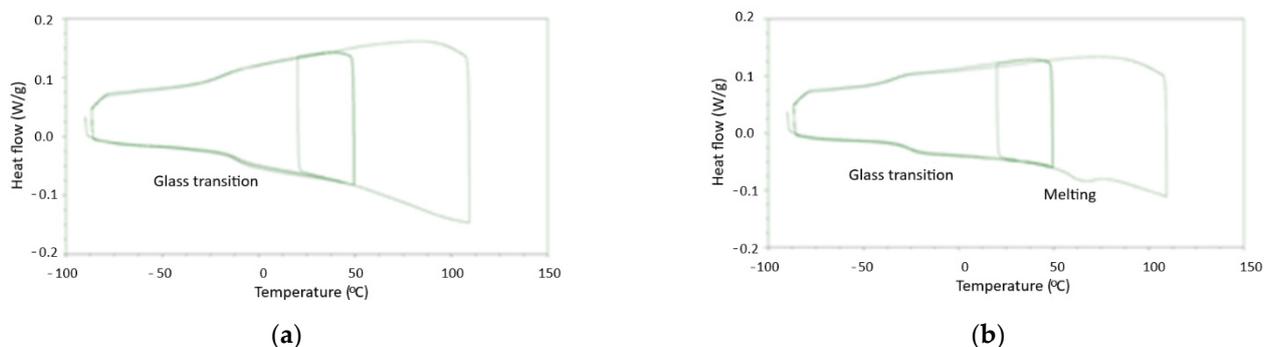
Figure 6. Results of the DSC tests of the rotor blade edge components: (a) Bonding ply; (b) Rubber.

The glass transition temperatures were determined for both the rubber and bonding ply. They were -26 °C for rubber and -11 °C for bonding ply. Moreover, the DSC curves for the rubber showed an endothermic peak at 65 °C with low enthalpy. It can be supposed that this peak is related to the moisture content of the rubber. For bonding ply in the temperature range of -20 °C to 110 °C, no permanent transformations were observed due to the action of both the simulated temperature changes alone during service and those resulting from the thermal cycle during curing. This indicates that both materials are thermally stable over the studied temperature range.

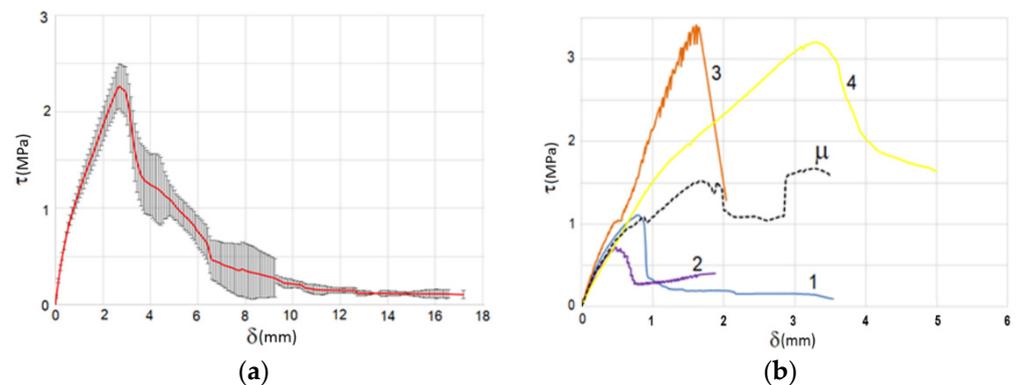
The results of the bonding 2216B/A + BR primer samples without aging and after aging obtained during the shear strength test are given in Figure 15. In the case of the samples after aging, the spread of the results was considerable, and, for this reason, the average value and standard deviation were not calculated.

Figure 15. Results of the bonding 2216B/A + BR primer obtained during the shear strength test: (a) Samples without aging; (b) samples after aging.

The reason for the large discrepancy in the strength test results of the joint (Figure 15b) may be the degradation of the polymeric materials in the joint. Degradation is referred to as the partial disintegration of a polymer—not into low-molecular-weight products, but into fragments of high but lower molecular weight than the initial polymer. Factors initiating degradation may be physical or chemical interactions, such as radiation, temperature, or exposure to chemicals, including water [51–54].

Based on the research, it was found that the bonding 2216B/A + BR-127 primer could not be used to repair the leading edge. This was mainly due to the too large deviation of the strength test results for the samples after aging. Material with unstable properties should not be used in aviation. Therefore, it was decided to terminate the research with the use of this adhesive system.

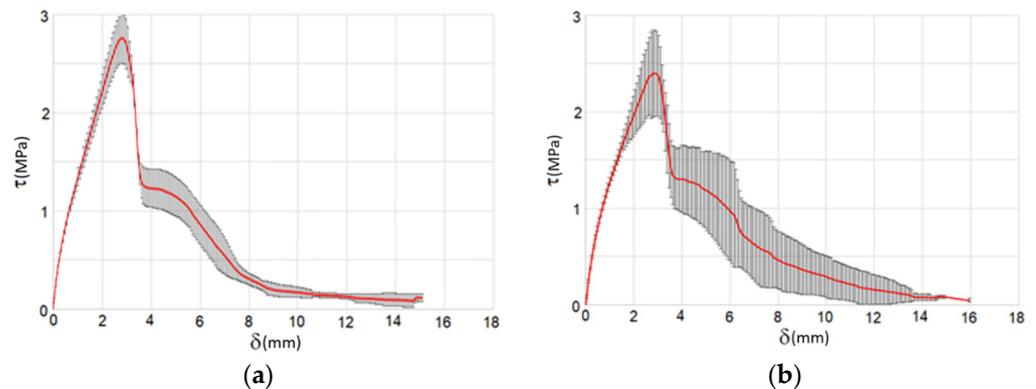
The average values of the shear stresses and standard deviation of the bonding DP490 samples are given in Figure 16. Despite the fact that the shear strength was less than $\tau^{\text{ult}} = 3.92$ MPa, the rubber was damaged instead of the bonding. Therefore, it should be assumed that the strength criteria were met for samples after aging and without aging. It

should be noted that the strength of the bonding after aging was lower in relation to the strength of the bonding without aging. Moreover, the standard deviation of the samples after aging was greater.

Figure 16. Results of the bonding DP490 obtained during the shear strength test: (a) samples without aging, (b) samples after aging.

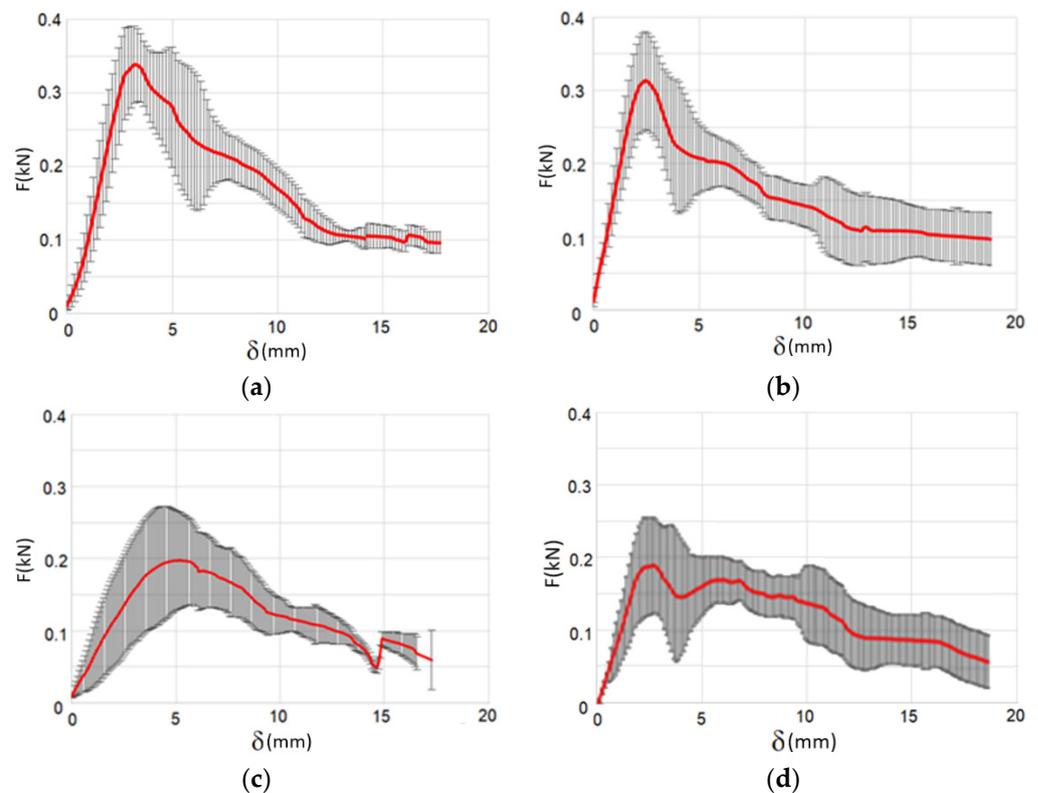
Figure 19. Results of the comparative tests of the tearing off of the shield from the leading edge: (a) Factory-bonded sample without aging; (b) Factory-bonded sample after aging; (c) DP490 bonding sample without aging; (d) DP490 bonding sample after aging.

The strength of the DP490 bonding was lower by about 30% in comparison to the factory bonding. The determined standard deviation indicated that the dispersion of the results was greater in the case of the DP490 bonding. The exposure in the climatic chamber did not affect the strength of the bond, both in the case of the factory bonding and the DP490 bonding.

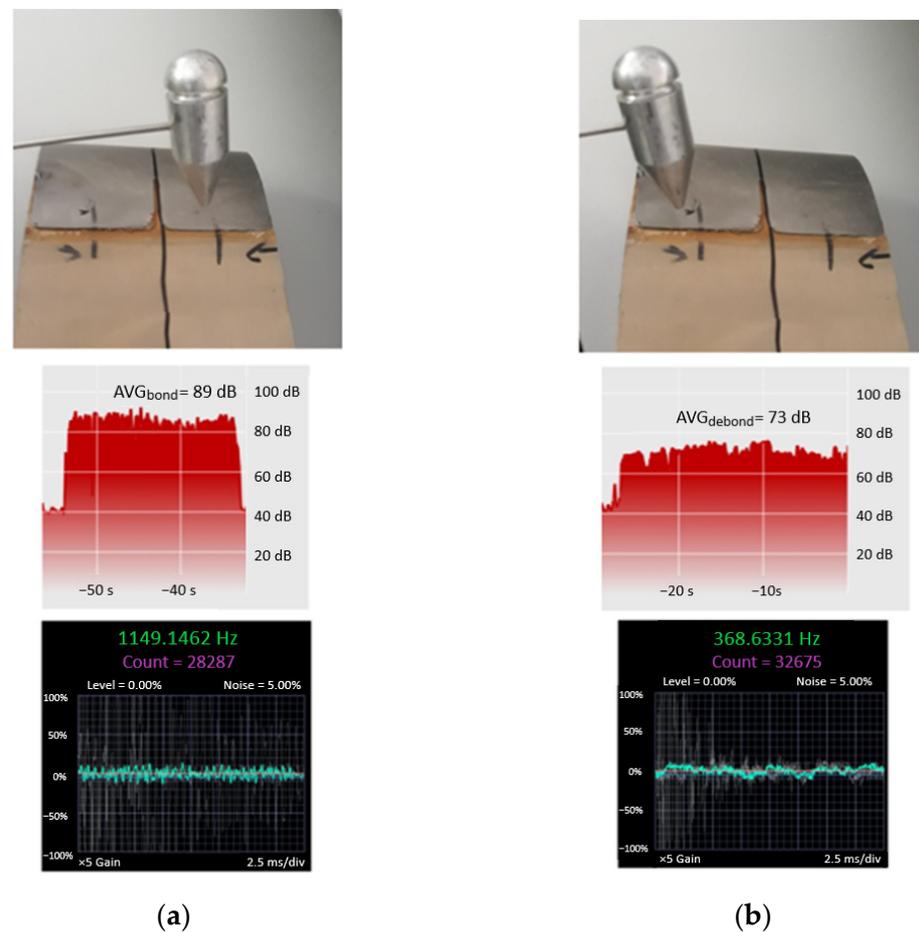
The tap-test method was used to check the adhesive bond [55,56]. The test showed that the difference in sound frequency between the undamaged and damaged bonding ply was 780 Hz and the difference in amplitude was 16 dB. Such large differences in parameters allow assessing the condition of the bonded joints. The test was conducted with an environment noise level of about 40 dB (Figure 20).

Figure 20. Tap-test of a reference sample with sound intensity and frequency measurement: (a) Shield bonded; (b) Shield disbonded.

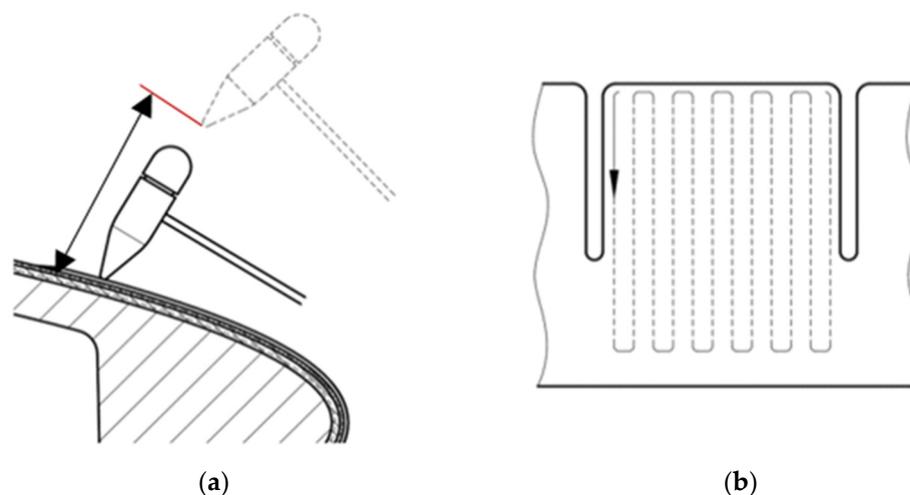
The tap-test of the edge after repair was applied according to Figure 21 starting approximately 1 mm from the edge of the shield.

Tap-tests were carried out on the repaired structure (Figure 9d) as described above. The tests showed 100% adhesion over the entire area to be repaired—four sections of the shield. This means that the adhesive layer was evenly spread and the designed mounting tool applied the correct pressure.

Figure 21. Non-destructive testing: (a) Method of tap-test with an inspection hammer; (b) Trajectory of the tap-test.
