# Long-Term Durability of Cement-Treated Soil Used in Offshore Airport Island Construction

Hidenori Takahashi <sup>1,\*</sup>

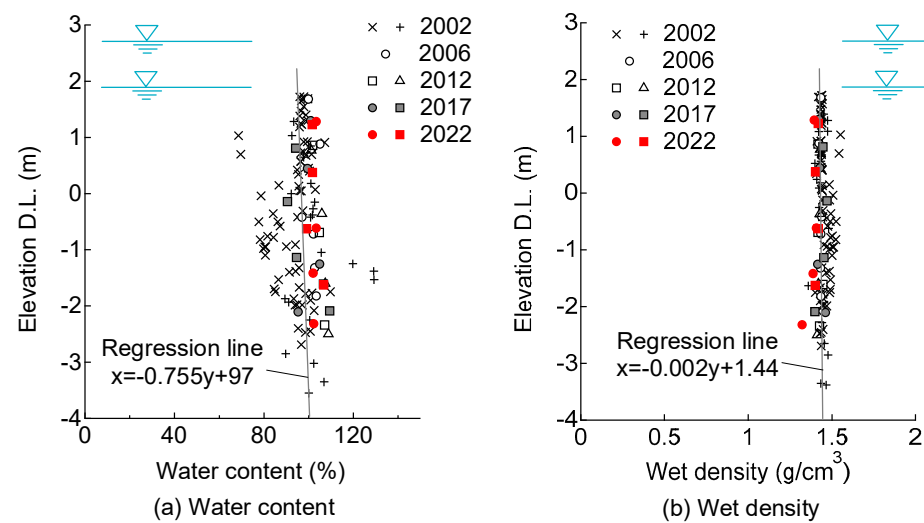
Figure 8. Distributions of water content and wet density in the depth direction.

Figure 8 shows the distributions of the water content and wet density in the depth direction. As a result of the large number of test results immediately after reclamation, only the results for samples collected at sites P23 and H24 are shown, because these sites were close to the survey locations used since 2006. The figures show the changes in groundwater levels (highest and lowest values) measured between April 2011 and January 2012, together with the regression lines of the water content ratio and wet density against the depth. The water content ratio immediately after reclamation had little variation for depths shallower than 1.1 m, but for depths deeper than 1.1 m, the variation was in the range of 70–110%. The water level in the embankment at the time of reclamation was at a depth of 1.1 m, and it is possible that the water content ratio varied because the soil was cast into the water at depths deeper than this. Uniform values were obtained at depths shallower than 1.1 m, where casting was implemented in air, and the quality control in the field was considered successful to a certain extent. The difference in water content in the depth direction was slightly higher at deeper depths; however, this difference was not significant. The wet density of the samples was approximately  $1.44 \text{ g/cm}^3$ , with little variation and almost no difference in the depth direction. These results show that the properties of the improved soil were uniform and stable, with no differences between the investigations conducted in different years.

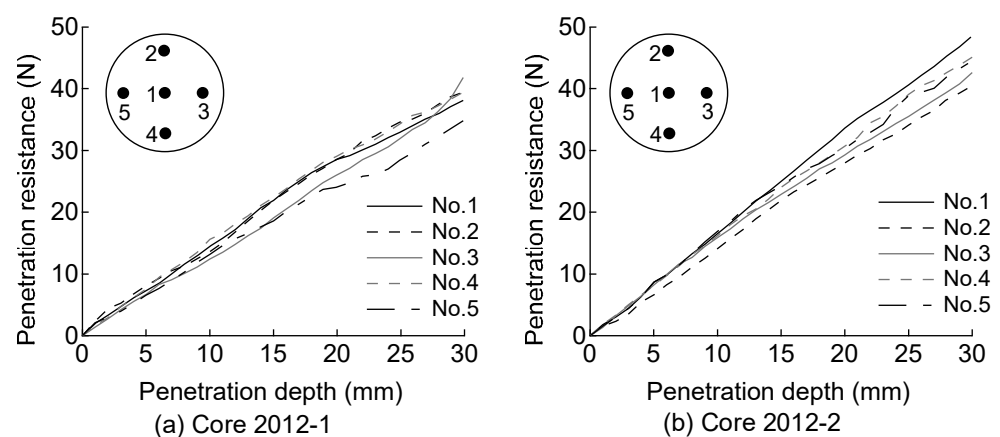
Figure 10. Needle penetration resistance at the inner surface of cement-treated soil (10 year survey).

In the 2006 and 2012 surveys, needle penetration tests were conducted on cuttings from the interiors of the treated soil samples. As representative examples, Figure 10 shows the results of the 2012 survey, which was conducted ten years after construction. These results

demonstrate the relationship between the penetration depth and penetration resistance. For the uniformly treated soil, the relationship is proportional, as shown in the figure, and this gradient represents the stiffness and strength of the treated soil. If the strength had been reduced by deterioration, the gradient would be smaller. Conversely, in areas where the strength was higher, the gradient would be larger. No changes in these gradients were observed in the results presented in the examples, indicating that the strength of the treated soil was uniform. According to the Japanese Geotechnical Society Standards [21], a gradient up to a penetration of 10 mm is referred to as the needle penetration gradient. The relationship between this value and the unconfined compressive strength of a specimen in the vicinity of the needle penetration test is shown in Figure 11. This figure also shows the correlation between the two obtained in previous studies [24]. The plotted data show that the correlations did not deviate significantly from those obtained in a previous study and were typical of cement-treated soils.

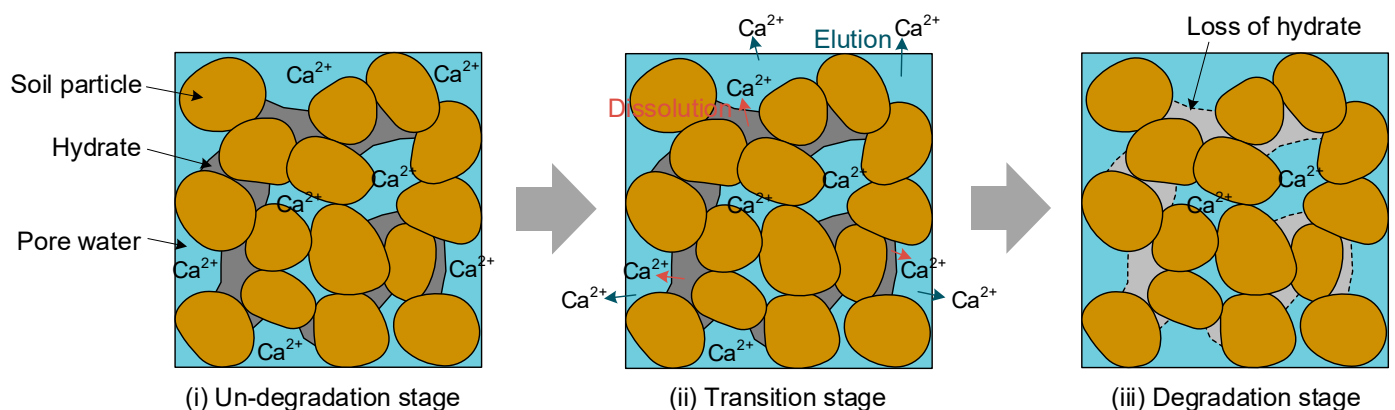
**Figure 16.** Deterioration mechanism of treated soil due to calcium dissolution and diffusion.

The treated soils deteriorated from the exposed surface over the long term. The deterioration of treated soils from exposed surfaces has been demonstrated in previous studies [4–13]. The mechanism of this degradation is thought to be as shown in Figure 16. The calcium ion concentration in the pore water decreases owing to diffusion from the exposed surface. Calcium is supplied spontaneously to the pore water from the cement hydrates and other materials to increase the calcium ion concentration in the pore water. This supply breaks down the hydrates. The hydrates reinforce the structural framework; thus, the breakdown of the hydrates leads to a reduction in the strength of the treated soil. Previous studies have confirmed that the calcium concentration near the exposed surface decreases, and a correlation between the decrease in strength and calcium concentration has been obtained. However, this degradation is slow and takes years. The authors confirmed that the calcium ion concentration was reduced by forcibly replacing the pore water, which degraded the treated soil [25]. It has also been found that when treated soil is exposed to seawater, the magnesium salts in the seawater react with the cement hydrates, resulting in faster deterioration of the treated soil [4,8,10,12].

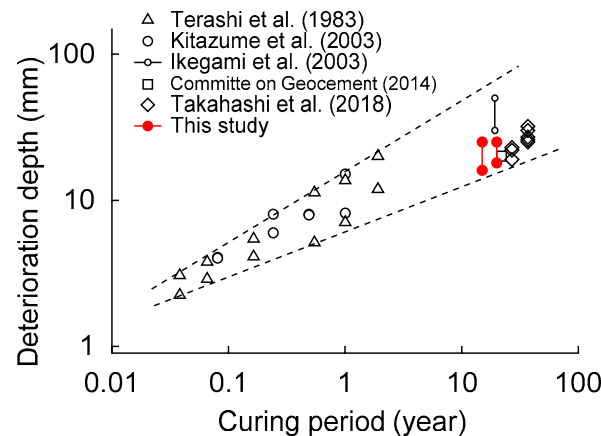
**Figure 17.** Relationship between duration of exposure and depth of degradation (Addendum to [13]).

Takahashi et al. [13] graphically summarised the relationship between the duration of the exposure and the depth of the degradation, which was linear in a double logarithmic graph, as shown in Figure 17. This figure shows the results of the present study, which fall within the range of variation of the results of previous studies. Although the figure includes the results for both specimens of treated soil cured in laboratories and those produced by the deep mixing method in situ, the differences in the depth of degradation owing to different soils, cements, and improvement methods are within the range of variability. In practice, the rate of degradation should vary depending on the properties of the treated soil and the exposure conditions; however, within a realistic range of conditions, the rate of degradation is likely to fall within the range of variation. The treated soil in the pumping pipe at the site did not deteriorate rapidly, although its strength was not high.
