Article Debris Management in Turkey Provinces Affected by the 6 February 2023 Earthquakes: Challenges during Recovery and Potential Health and Environmental Risks

Spyridon Mavroulis ^{1,*}, Maria Mavrouli ², Emmanuel Vassilakis ³, Ioannis Argyropoulos ¹, Panayotis Carydis ⁴ and Efthymis Lekkas ^{1,5}

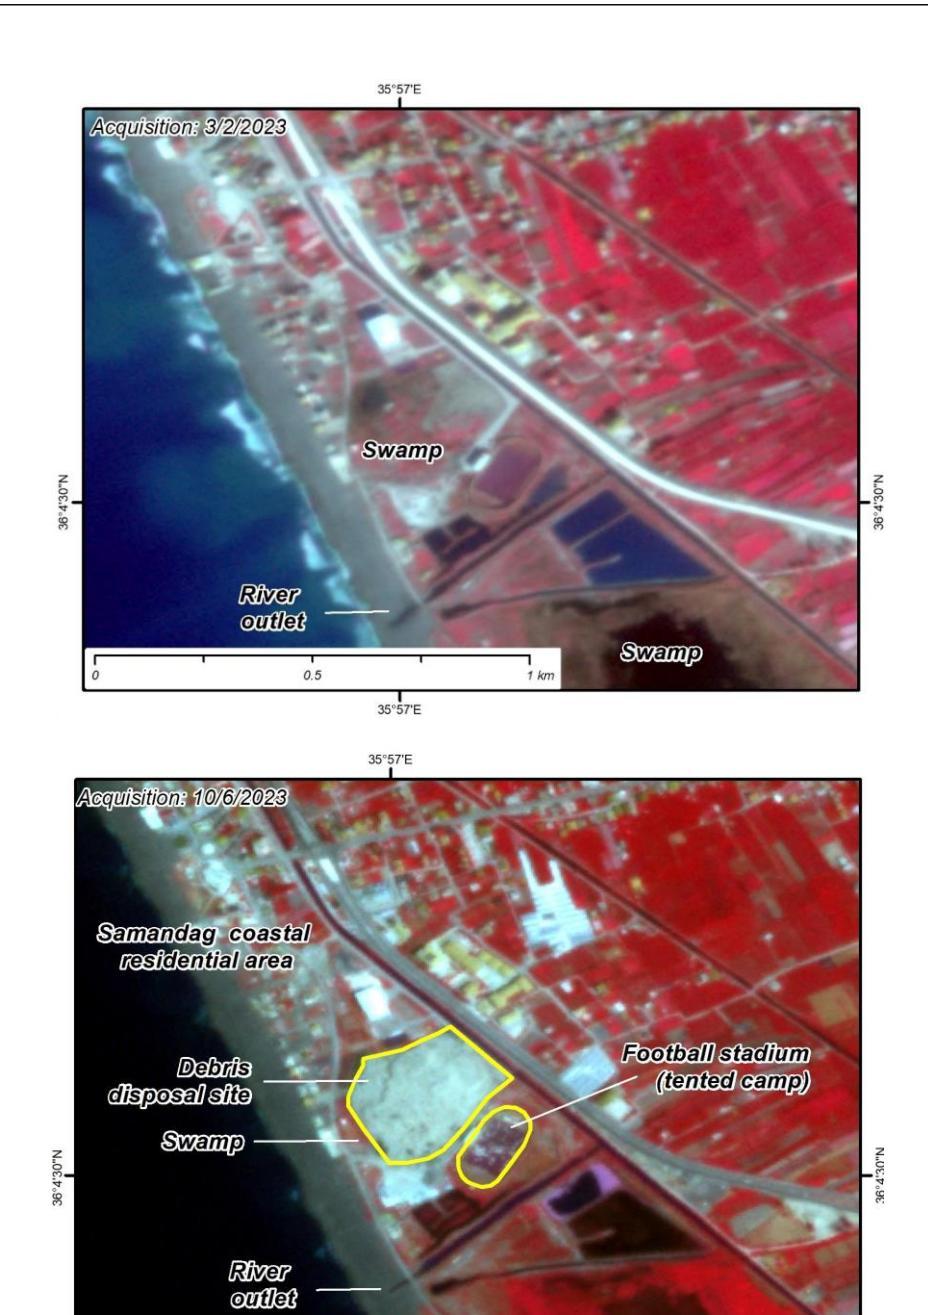
Figure 4. Pseudocolor image maps in the Samandağ disposal site area before (first map, acquisition on 3 February 2023) and after (second map, acquisition on 10 June 2023) the initiation of earthquake debris removal. Four months after the earthquake the unsorted earthquake debris pile has entirely covered the former swamp area formed north and west of the stadium.

This disposal site is located just 20 m southwest of the above field, 30 m from the coastal road, and 150 m from the coastline (Figure 4). During our field survey in the southernmost end of the earthquake-affected area in early May 2023, we found that due to the continuous dumping of debris from the earthquake at this location, a wide and high pile had been formed (Figure 5a). It was higher than the adjacent stand of the stadium (Figure 5b), while it also occupied a large part of the marshy area west of the field (Figure 5a,c).

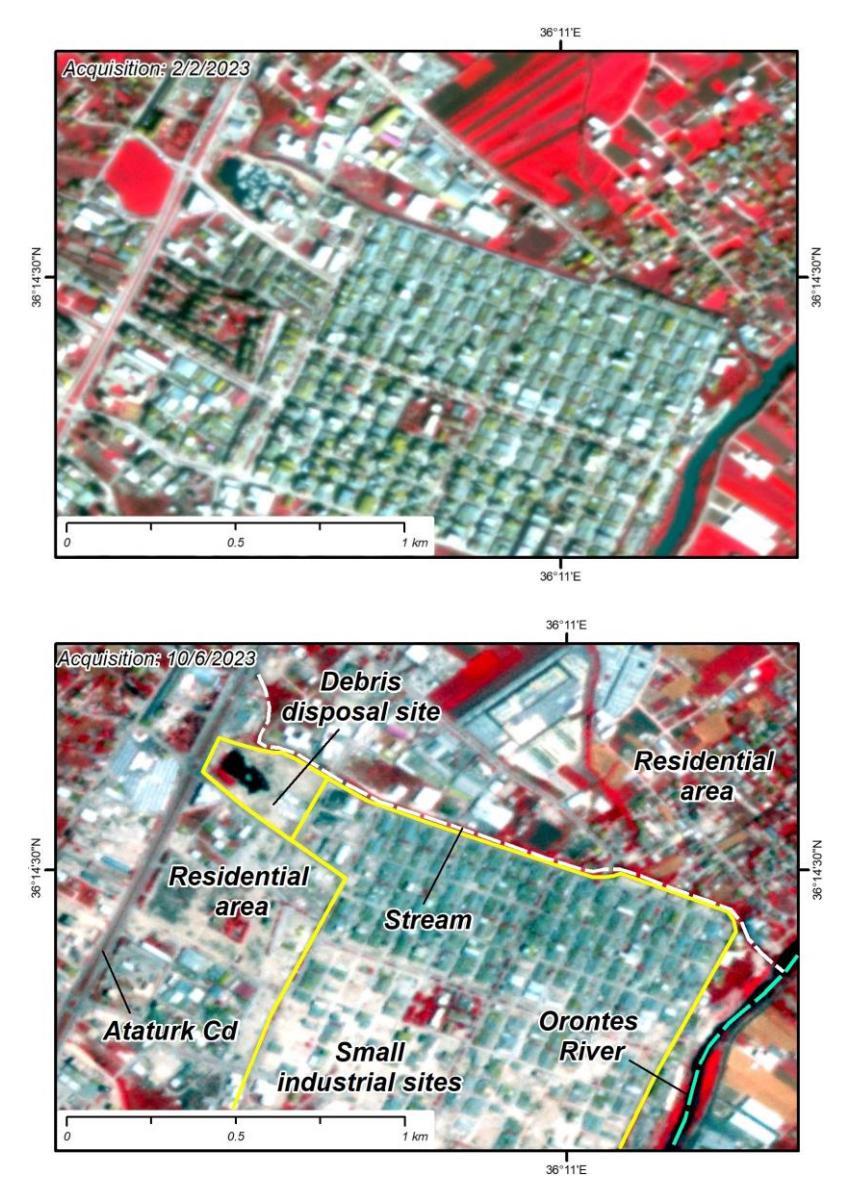
During our field survey in Hatay province, we found that the demolition of buildings and the removal of debris in Antakya City was in progress. We also identified disposal debris sites that did not meet even the basic criteria for their setup. One of these sites was located at the northwestern boundary of an area with small industrial sites (Figure 6).

Figure 6. Pseudocolor image maps in the Antakya disposal site area before (first map, acquisition on 2 February 2023) and after (second map, acquisition on 10 June 2023) the 6 February 2023 earthquakes.

One of the main disadvantages of this location as a debris disposal site is its small distance from areas where people live and work. This site was immediately east of Atatürk Cd, one of the main roads in Antakya with a lot of traffic leading from the main urban fabric of the city to its northern suburbs and small industrial sites (Figure 6). In addition, it is located right next to a branch of the drainage network that flows from northwest to southeast and ends in the main branch of the Orontes River (Figure 6) that crosses

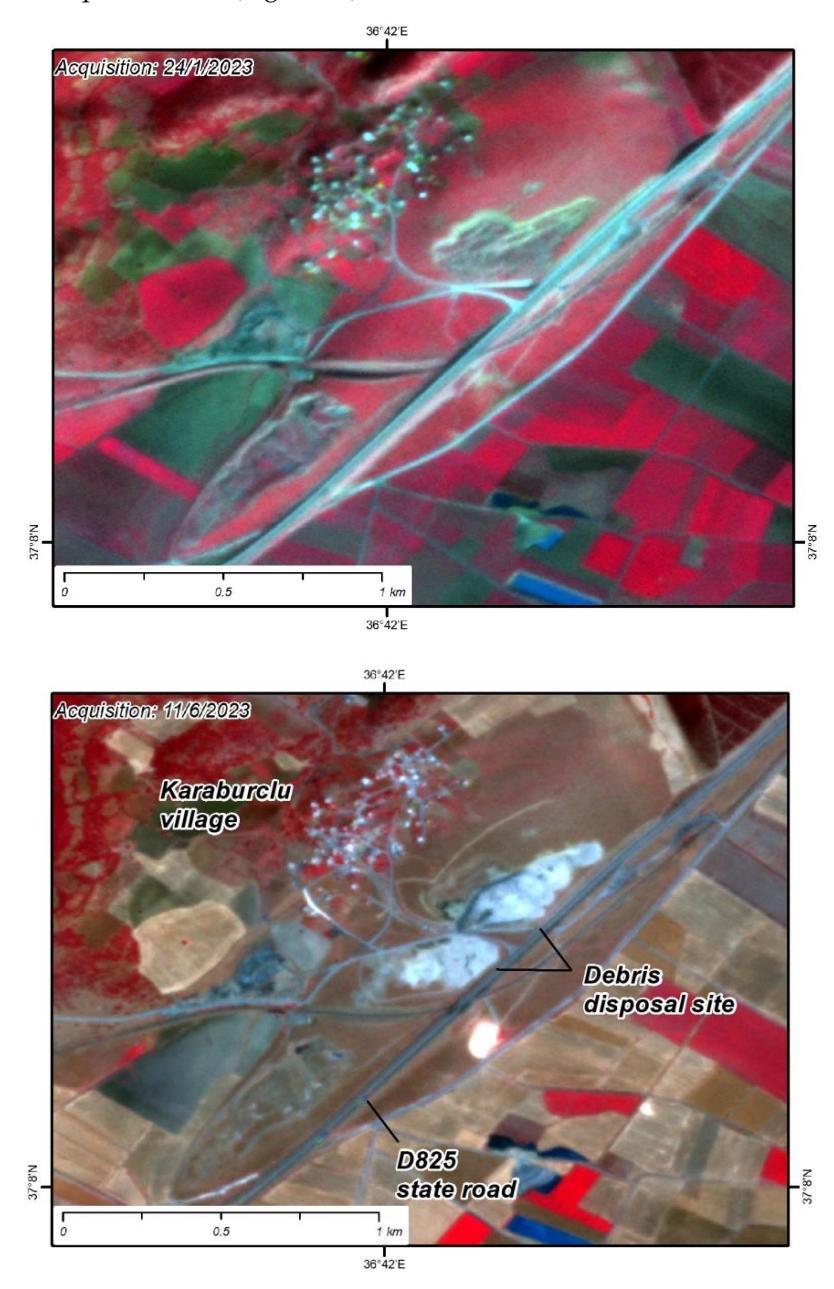
site is located between the D825 state road and the Karaburçlu settlement at a distance of about 100 m from its eastern boundary (Figure 8). Prior to the earthquake, the site was used as an aggregate extraction site with a perimeter of almost 1.2 km and an area of 0.07 km². Two months after the earthquake, the site was converted for treatment and disposal of the earthquake debris (Figure 9a).

Figure 8. Pseudocolor image maps in the Karaburçlu disposal site area before (first map acquired on 24 January 2023) and after (second map acquired on 11 June 2023) the 6 February 2023 earthquakes.

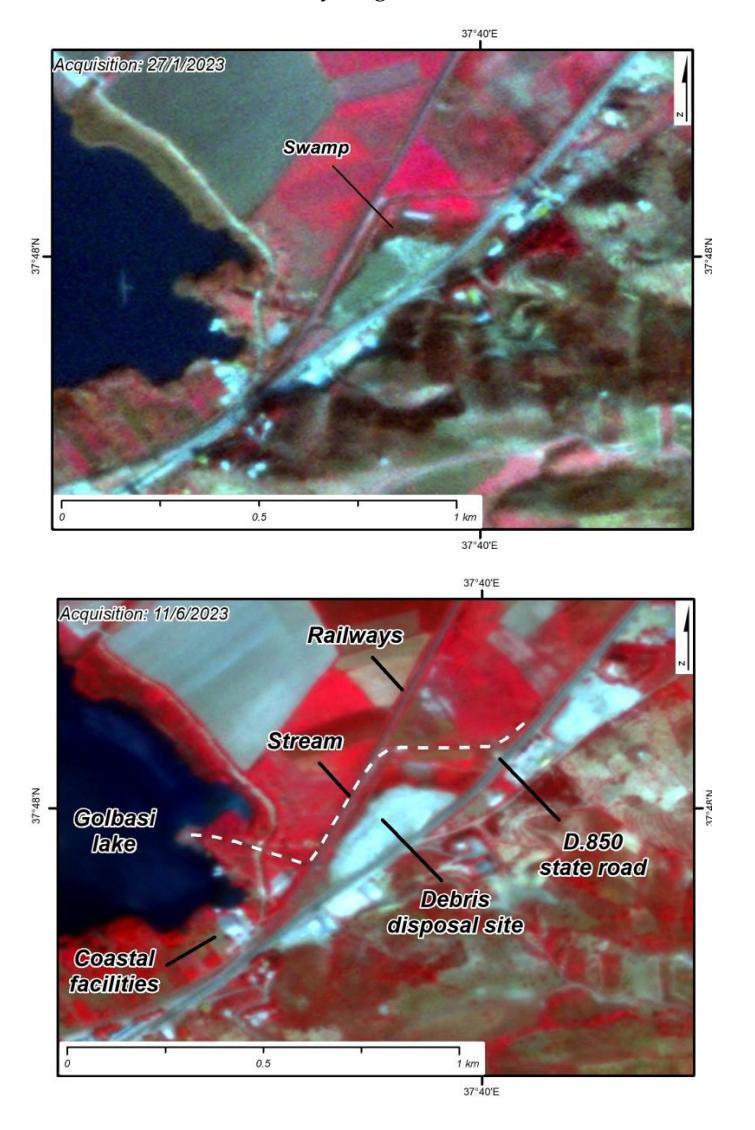
Figure 10. Pseudocolor image maps in the Gölbaşı disposal site area before (first map, acquisition on 27 January 2023) and after (second map, acquisition on 11 June 2023) the 6 February 2023 earthquakes.

Before the earthquake, a limited area of marshland occurred in the same location (Figure 10). It was fed by the aforementioned stream from a small opening in its banks. On 2 April 2023, this marshland was almost completely covered by the debris disposal activities (Figure 10). In terms of proximity to a residential area, this site is less than 200 m from the aforementioned recreational facilities and less than 1 km from the first residential buildings in the northeastern part of the town. Furthermore, the eastern boundary of the site is the D.850 state road that passes through the area (Figure 11). This road was very busy, especially during the emergency response after the earthquakes and then during the recovery phase.

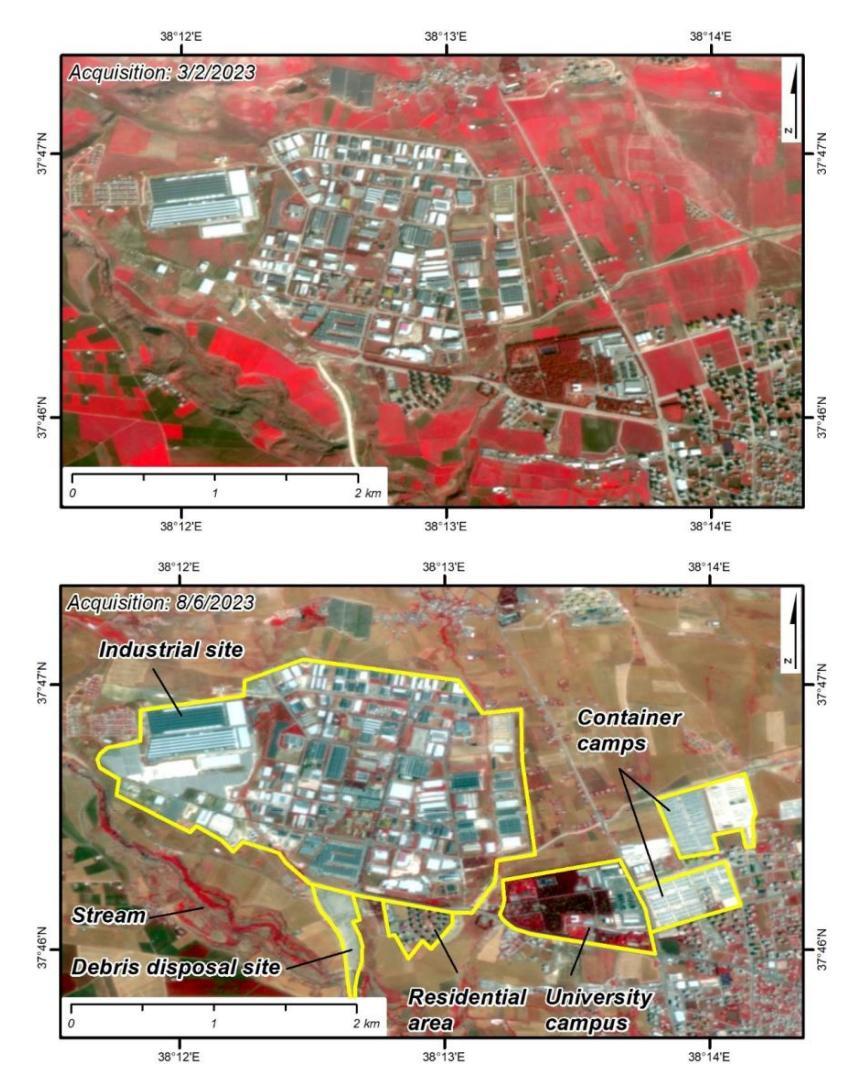
Immediately east of the site, 30 high-rise residential buildings have been constructed in an area of 0.04 km² and a perimeter of approximately 1 km (Figure 12). Further to the east, at a distance of 2 km from the site, the main residential area of Adiyaman begins (Figure 12), while in the wider area to the south of the site, mainly farmland is developed. The debris had been deposited within the agricultural land (Figure 12). A local stream which originates from the northwest runs through the disposal site (Figure 12). Almost parallel to the stream, a canal has been constructed apparently for irrigation purposes to the surrounding land and crops (Figure 12).

The above characteristics of the surrounding area and the debris management reveal that the site is not suitable for debris disposal due to its establishment too close to residential areas where a large part of the population lives and works, agricultural land for crops, which were partially covered by debris and surface water bodies (streams and artificial irrigation channels). Furthermore, the constant arrival and departure of trucks and operation of heavy machinery at the debris disposal site without any measure for the reduction of the generated dust severely limit the suitability of this earthquake debris disposal site.

Figure 12. Pseudocolor image maps in the Adiyaman disposal site area before (first map, acquisition on 3 February 2023) and after (second map, acquisition on 8 June 2023) the initiation of the debris removal from the earthquake-affected area.

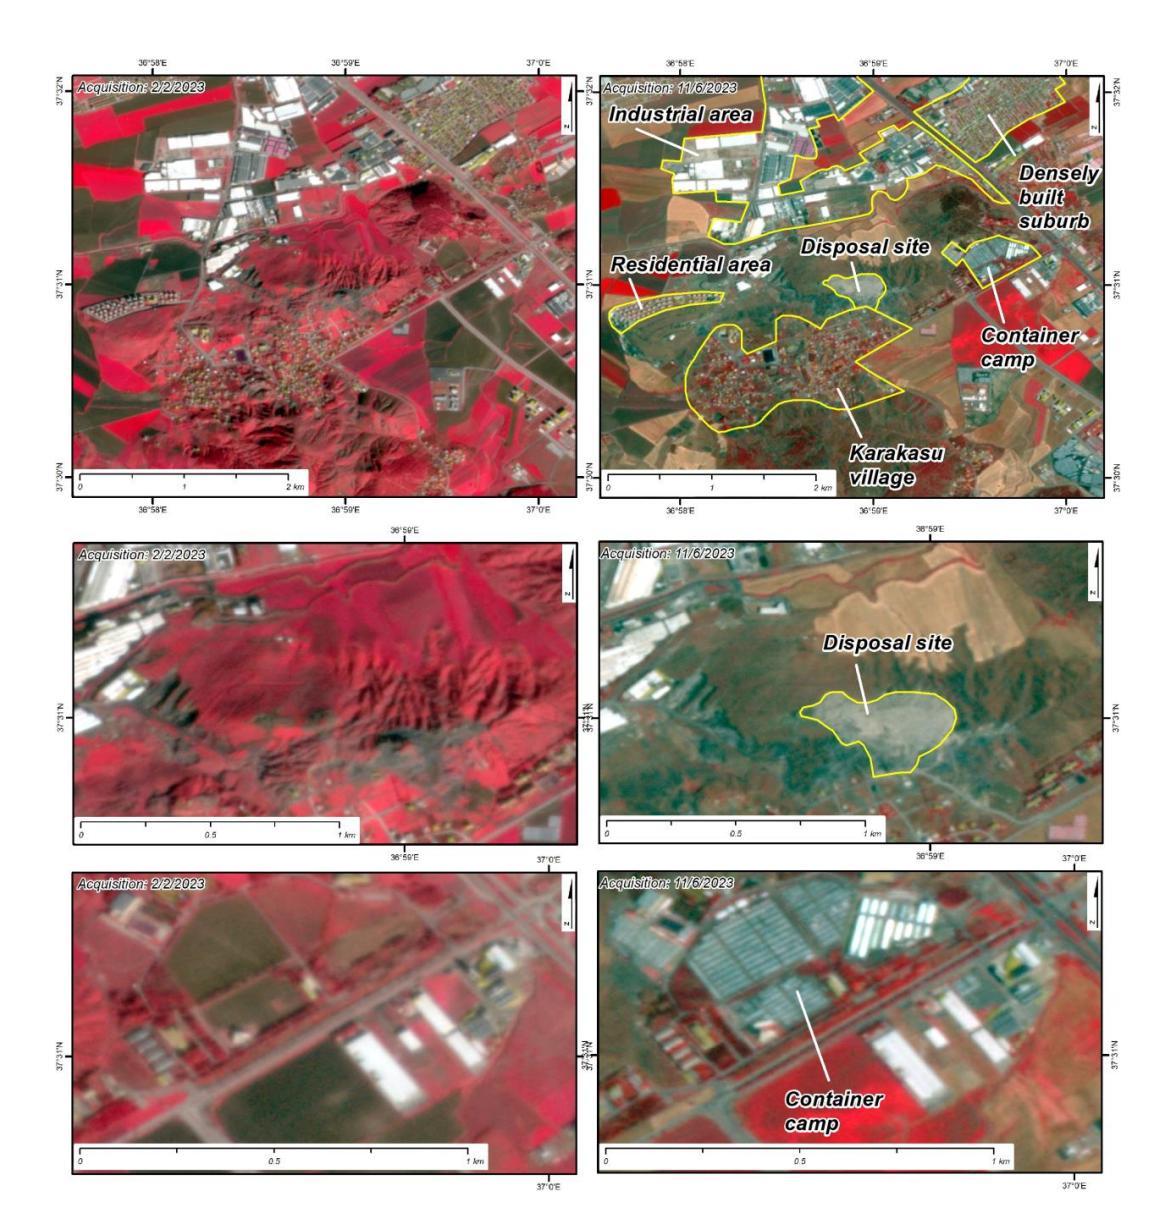
However, there are areas at shorter distances where a large part of the population is active, such as the industrial zone, the suburbs of the city, and the university campus (Figure 14), just as we have seen in the previous case of the Adiyaman city. At a distance of about 1 km to the northeast a densely populated suburb is developed with a perimeter of about 5 km and an area of 1.15 km² (Figure 14). Even closer, at a distance of less than 300 m to the southwest is the Karakasu settlement with a number of old houses and new high-rise mainly residential buildings (Figure 14). Less than 1 km to the east, a camp with almost 800 (763 in early May 2023) containers for the temporary accommodation of the earthquake-affected people had been set up (Figure 14). If we consider the minimum number of people accommodated in each such structure to be 4, we can understand that more than 3000 people are accommodated in this camp located very close to the debris disposal site. Similarly, the university campus, which also hosts a lot of people, is located at a distance of about 1 km from the disposal site.

Figure 14. Pseudocolor image maps in the Kahramanmaraş area before (**left** column, acquisition on 2 February 2023) and after (**right** column, acquisition on 11 June 2023) the 6 February 2023 earthquakes. The maps in the third row present the container camp set up at a small distance from the eastern part of the site. The capacity of the camp is approximately 3000 people.
