Health and Durability of Protective and Thermal Barrier Coatings Monitored in Service by Visual Inspection

Abstract: Protective and Thermal Barrier Coatings (TBC) applied on gas-turbine blades gradually degrade due to oxidation, aluminum depletion and impacts of environmental particles. Among various non-destructive coating testing methods (NDT), visual inspection can be undertaken regularly in service, but it provides little quantitative information, and only surface defects can be detected. This work aims at in-service monitoring of turbine blades with multilayer coatings applied by atmospheric plasma spraying (APS) in a few variants. They were validated during a series of accelerated mission tests of a retired military turbofan engine in a test cell together with five other technologies. The fifty-hour rainbow test focused on assessing coating durability. Between engine runs, 12 borescope inspections were conducted to monitor the health of the blades. Finally, the blades were disassembled and examined using computed tomography (CT) and metallographic methods. Throughout the testing, 31 newly-coated blades (66%) withstood the tests, producing results comparable to the reference

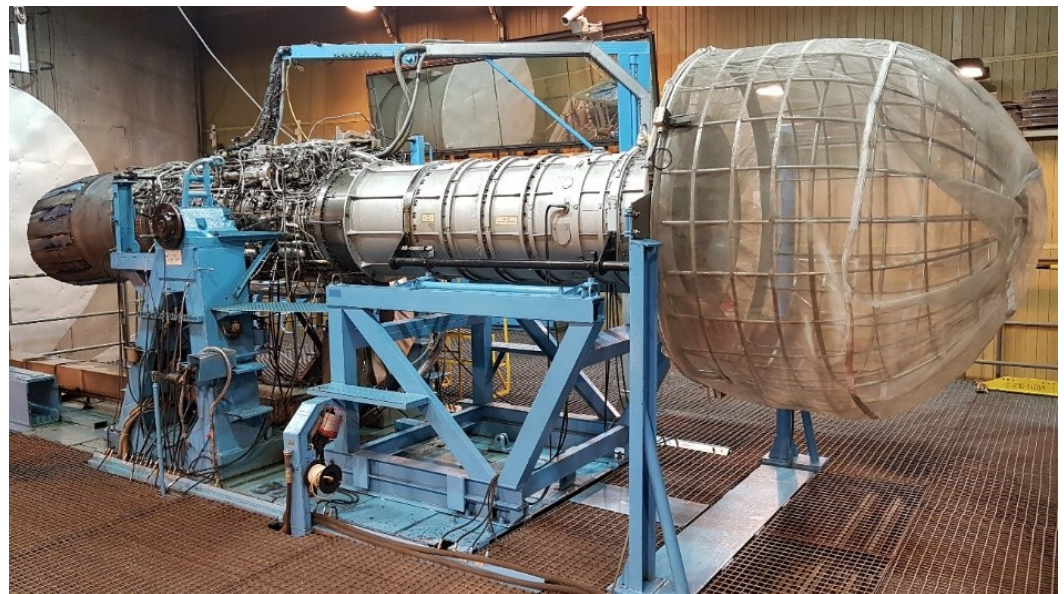
total (Figure 1). It turned out that, throughout the test, the unrepaired compressing section and combustor produced particles which impacted some newly coated turbine blades.

Figure 1. Tested RD-33 engine viewed from the right side.

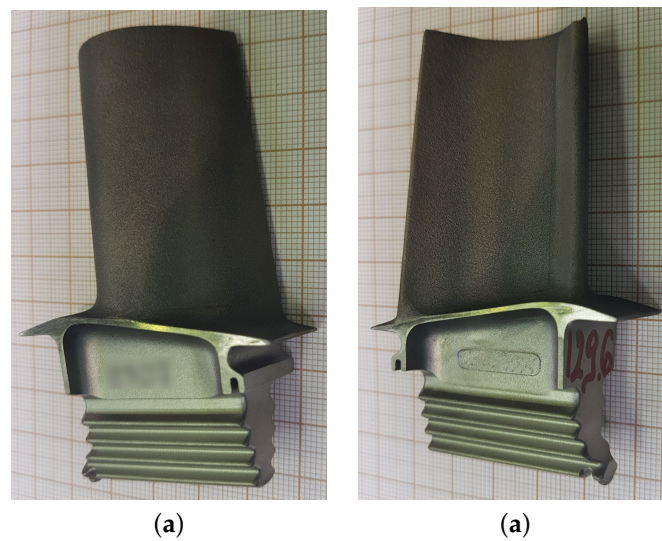
Figure 2. HPT blade No 3 coated with APS + VPA. (a) Convex side, (b) concave side.
