Article Contribution of High Mechanical Fatigue to Gas Turbine Blade Lifetime during Steady-State Operation

Sung Yong Chang ^{1,2} and Ki-Yong Oh ^{3,*}

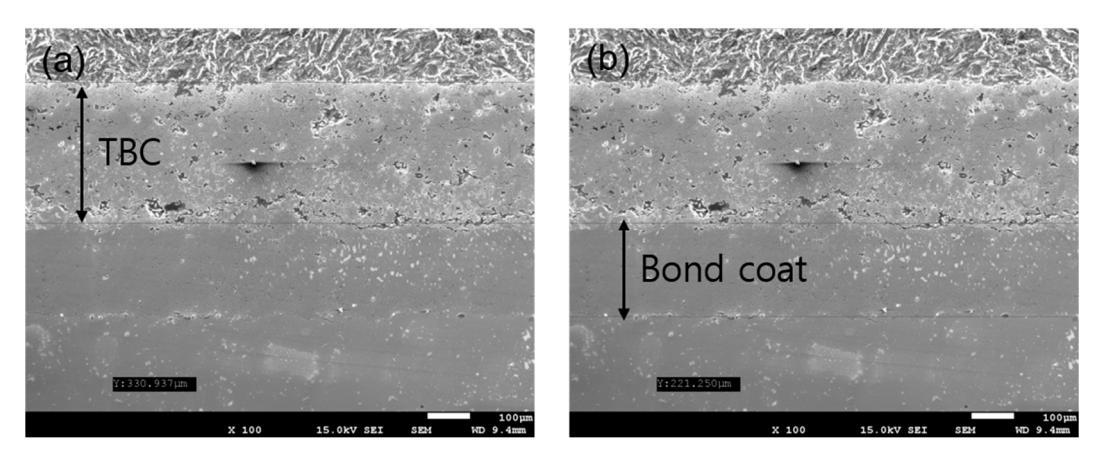
The thicknesses of the TBC and bond coat of the coupon specimens were measured 10 times via a scanning electron microscope (JSM-7001F, JEOL, Akishima, Tokyo; Figure 2) to verify that the coupon specimens were fabricated as designed. The accuracy and resolution of JSM-7001F were 0.1 and 0.01 μ m, respectively. The mean thicknesses of the TBC and bond coat for one coupon specimen were 310.8 and 231.1 μ m, respectively. Their respective standard deviations were 15.2 and 13.2 μ m, respectively. The thicknesses of other specimens were of a similar order. A reference roughness (i.e., initial roughness) was also measured on one specimen without the isothermal heat treatment as 11.2 μ m. This reference roughness (i.e., initial roughness) is shown as a green circle in Figure 3a. The initial roughness was in the preferred range of 8.9–11.4 μ m for the plasma sprayed TBC performance [37], suggesting that coupon specimens could be employed to represent the coatings of blades and vanes deployed on F-class gas turbines.

Figure 2. The scanning electron microscope images of a coated specimen: the measured thickness of (**a**) the thermal barrier coating (TBC) and (**b**) the bond coat.

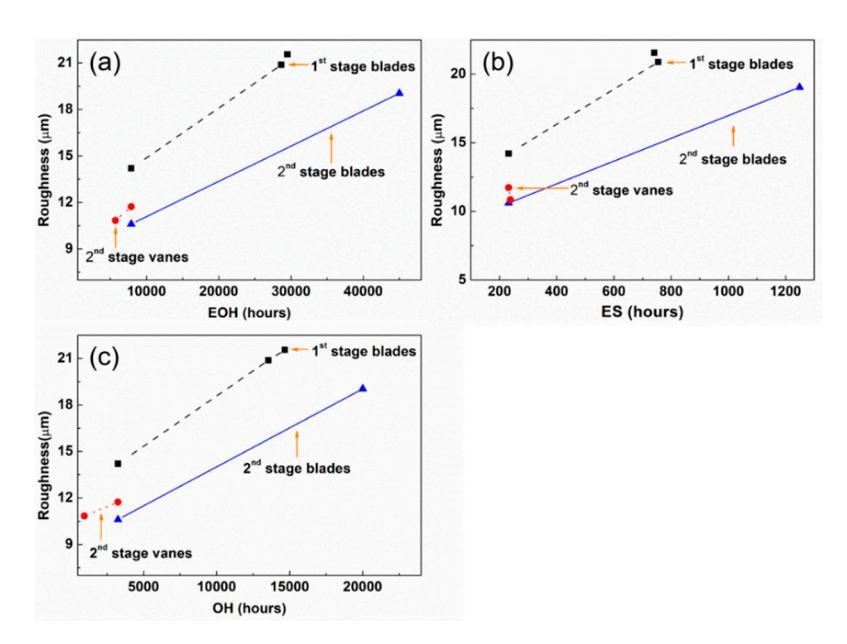
Figure 4a shows the relationship between EOH and roughness. The roughness shows a linear dependence on EOH for all blades and vanes. Moreover, the slope of roughness with respect to EOH in the first stage is larger than that of blades and vanes exposed in the second stage, suggesting that the blades in the first stage are affected by a severe operating condition, namely a high operating temperature. These results indicate that an increase in roughness correlates directly with EOH and operating temperature. However, the limit of the result is that the contribution of a steady-state operation cannot be distinguished from that of a transient operation in these data.

Figure 4. The controls on blade and vane roughness: The effect of (**a**) the equivalent operating hours (EOHs), (**b**) equivalent stop (ES), and (**c**) operational hours (OH) on the blade and vane roughness.

Figure 4b shows the contribution of transient operations, such as the start, stop, and trip operations, to fatigue. A low-cycle fatigue results in rumpling and ratcheting due to thermal shock loading [21,23]; therefore, the roughness should be proportional to ES. Overall, roughness should be proportional the roughness trends for all blades and vanes increase with ES. Moreover, the slope of roughness with respect to ES in the first stage is larger than that of blades and vanes exposed in the second stage, also suggesting that an increase in roughness is directly related to ES and the operating temperature. However, the roughness of the first-stage blade exposed to an ES of 741 h (sample 1) is larger than that exposed to ES of 755 h (sample 2). Although the ES of sample 1 is smaller than that of sample 2, the OH of sample 1 is larger than that of sample 2. Similarly, the roughness of the second-stage vane exposed to an ES of 232 h (sample 7) is larger than that exposed to an ES of 238 h; however, the OH of sample 7 is over three times larger than that of sample 6. These observations suggest a hypothesis that a steady-state operation can contribute to an increase in roughness: the longer the steady-state operation, the larger the roughness. However, the variation in the roughness of two vanes at the second stage is not significant, suggesting that the contribution of a steady-state operation to fatigue may be smaller than that of a transient operation.

Figure 4c shows the contribution of a steady-state operation duration to the evolution of roughness. Interestingly, the roughness of all blades and vanes increases with the number of operating hours. This result differs from the results of laboratory experiments with coupon specimens, where the roughness does not vary with the duration of the steady-state operation. There are two possibilities to explain the linear dependence of roughness on the steady-state operation. One is that power plants in Korea use a load-following mode and thereby control the power generation depending on the electricity demand. Hence, the effect of the transient response (i.e., the effect of ES) would be stochastically included in Figure 4c. The other possibility is that another reason exists for the increase in roughness during a steady-state operation. An in-depth analysis of the first hypothesis is not possible with service-exposed blades and vanes because the detailed operational history of the roughness evolution during transient and steady-state operations is not available. Regarding the second hypothesis, it is possible that the temperature is not constant during a steady-state operation. It is our view that both hypotheses contribute to the increased roughness in Figure 4c.

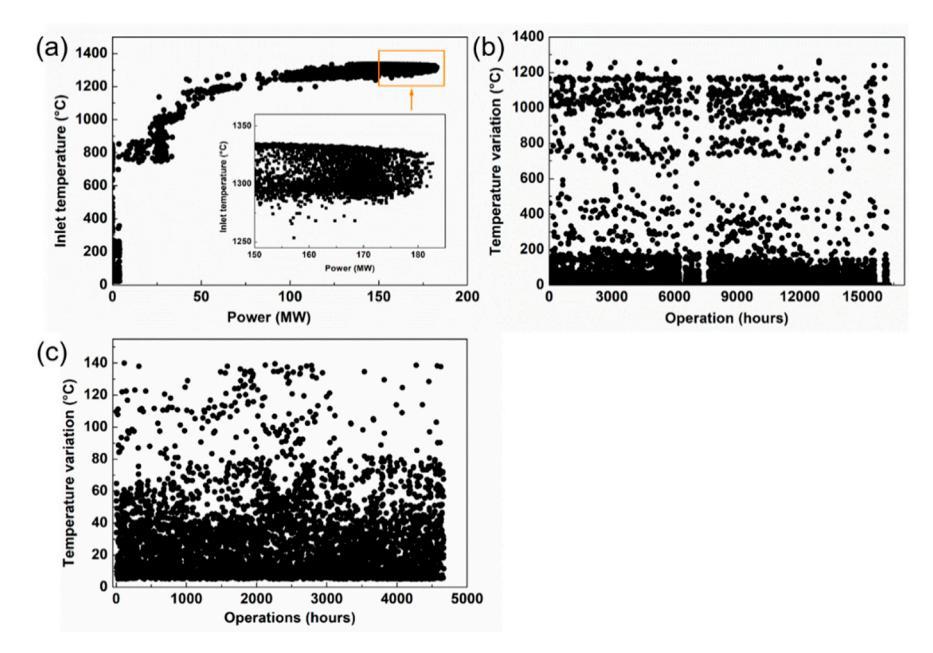
Figure 6a shows the inlet temperature with respect to the generated power. The generated power of over 150 MW is generally in a steady-state operation (inset of Figure 6a). However, the generated power in the other ranges also includes a steady-state operation because power plants in Korea have introduced a load-following mode. Hence, the inlet temperature during a steady-state operation should be separated from that during a transient operation by considering the inlet temperature over the generated power together with the operational trend. The temperature during a steady-state operation is generally in the range of 1250–1340 °C, whereas the temperature in the transient state changes over a wider range, from room temperature to 1340 °C. The maximum variation of the inlet temperature is approximately 140 °C at steady state, suggesting that temperature variations during a steady-state operation can also result in thermal stress, in addition to transient operations.

Figure 6b shows the temperature variations with 1-h intervals. Within this time interval, temperature variations above 140 °C generally occurred during transient states including the start, stop, and trip operations, whereas temperature variations below 140 °C occurred during the steady-state operation. This figure also demonstrates that the operating temperature varies even during a steady-state operation.

Figure 6c shows the temperature variations during a steady-state operation. The steady-state operation accounted for approximately 4600 h during the entire period of operation. The figure clearly shows that the inlet temperatures of the gas turbine during the steady-state operation are not constant, with a maximum variation of approximately 140 °C. Thus, it can be inferred that temperature variations during a steady-state operation contribute to rumpling and ratcheting and can contribute to thermal fatigue caused by thermal stress. Note that the coefficient of thermal expansion at a temperature of 1000 °C is 1.5 times greater than that at room temperature [39], suggesting that thermal stress during a steady-state operation also significantly affects coating degradation, although the

steady-state temperature variations are significantly smaller than those during transient operations. This high thermomechanical fatigue (HMF) observed during a steady-state operation is defined as HMF hereafter.

Figure 6. The temperature variation during operation: (**a**) The inlet temperature of a gas turbine against the generated power, (**b**) the variations of the inlet temperature during the entire operation, and (**c**) the variations of the inlet temperature during a steady-state operation.

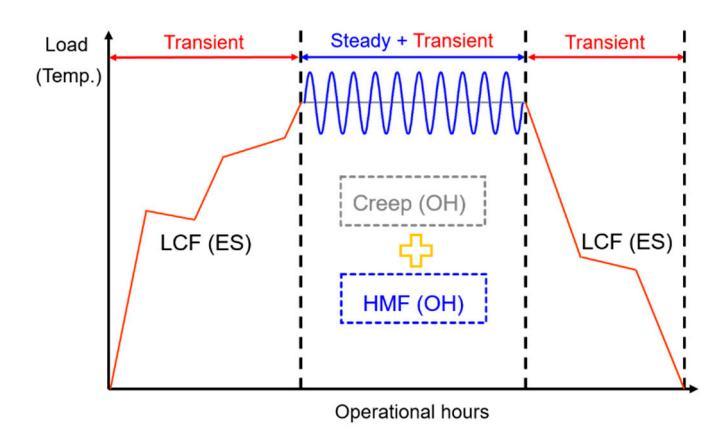
Figure 7. The proposed approach for predicting the remaining useful lifetime (RUL) and coating failure of blades and vanes in a gas turbine.

Our analysis of the operational data clearly demonstrates that EOH cannot fully account for the lifetime of HGPCs in a gas turbine because the coatings laminated on the surfaces of the HGPCs have different failure mechanisms compared to other components. Hence, HMF during steady state should be considered to accurately predict coating failures of HGPCs, as proposed in Figure 7. The current approach accounts for only two phenomena: low-cycle fatigue during transient states and creep during steady states. However, HMF during steady states also contributes to coating fatigue. Hence, HMF during steady states should be combined with a low-cycle fatigue to calculate the accumulated fatigue as

$$EOH = \alpha \times ES + \beta \times HMP$$
(2)

where α and β denote the contribution factors of each effect.
