Research of ZnO Arrester Deterioration Mechanism Based on Electrical Performance and Micro Material Test

Keywords: EMU; arrester; explosion; microscope test

Citation: Zhang, Q.; Wang, S.; Dong, X.; Liu, M.; Ou, Q.; Lv, F. Research of ZnO Arrester Deterioration Mechanism Based on Electrical Performance and Micro Material Test. *Electronics* **2021**, *10*, 2624. <https://doi.org/10.3390/electronics10212624>

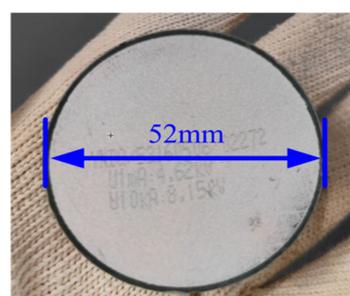
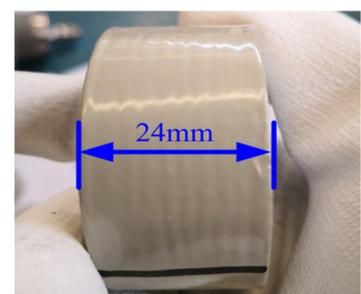
Figure 4. Typical appearance of a normal arrester varistor.

The surface of each normal arrester varistor is flat and clean, and it is free of abnormalities. The typical appearance of a defective arrester varistor is shown in Figure 5.

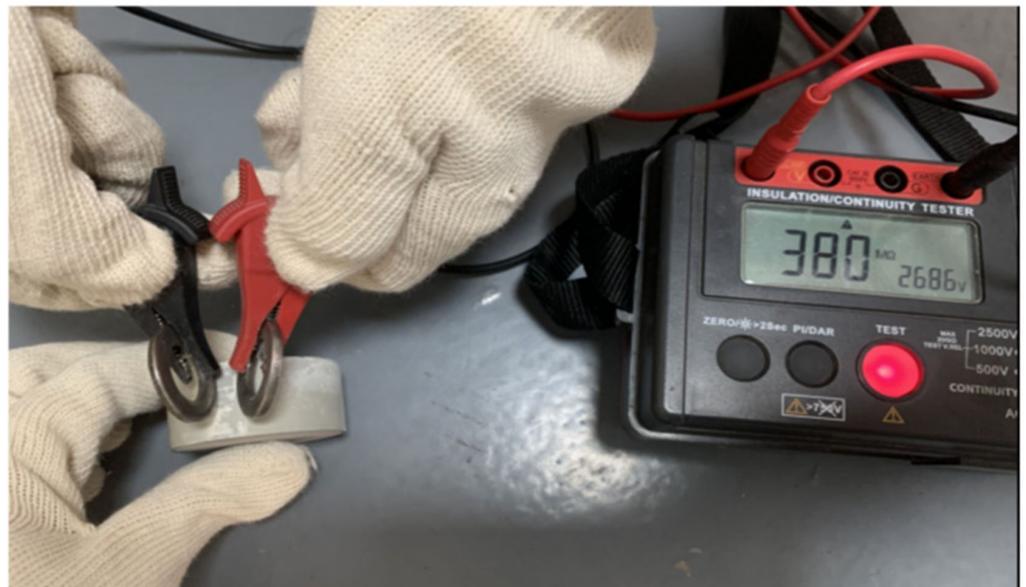
In order to establish the relationship between micro changes and macro symptoms in the process of varistor deterioration, experimental research was carried out. The insulation resistance of varistors in normal, defective, and exploded conditions is tested. An insulation resistance tester is used to test the insulation resistance of the side insulation of varistors. The distance between the test electrodes is 5mm. The test site is shown in Figure 10.

Figure 10. Insulation resistance test.
