# Degradation and Sustainability: Analysis of Structural Issues in the Eduardo Caldeira Bridge, Machico

Raul Alves <sup>1</sup>, Sérgio Lousada <sup>2,3,4,5,6,7,\*</sup>

This paper presents a detailed analysis of the severe structural anomalies that led to the urgent rehabilitation of the Eduardo Caldeira Bridge in Machico, Madeira. Situated in a challenging coastal environment with complex volcanic geology, the bridge exhibited a critical failure of its bearing devices, which were assigned the highest defect severity rating (Grade 5). A multidisciplinary diagnostic methodology, combining visual inspection data, non-destructive testing, and geotechnical analysis, was employed to identify the root causes of this degradation. The investigation concluded that the bearing failure was not due to widespread material deterioration but was directly linked to significant lateral structural displacements, exacerbated by localized geotechnical instabilities. This paper details the data-driven rehabilitation strategy that was subsequently implemented, including the complete replacement of the bearings and substructure stabilization measures. The study provides a valuable case study of a comp

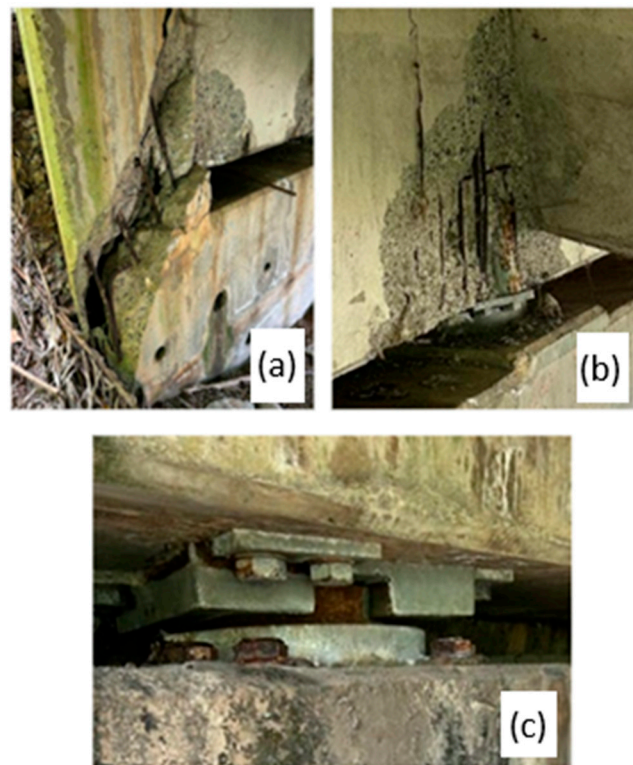
To better illustrate the types of structural degradation frequently encountered in concrete bridges, Figure 3 presents a collage showcasing common defects such as various forms of cracking, rebar corrosion, and deterioration of bearing devices.

**Figure 3.** Common structural defects observed in concrete bridges. (a) Concrete cracks; (b) rebar corrosion; (c) bearing deterioration.
