The Selected Issues of Adaptation of 19th and 20th Century Post-Industrial Buildings in Łódź [†]

Tadeusz Urban and Michał Gołdyn *

Abstract: The paper deals with selected technical problems related to the adaptation for new uses of the structure of existing post-industrial buildings from the turn of the 19th and 20th centuries. A major difficulty is the fact that the strength and geometric properties of cast-iron, steel, and masonry elements often differ significantly from the values characterizing contemporary materials. Due to uncertainty regarding the load-carrying capacity of historical structures, in many cases there is a need to carry out destructive tests of elements taken from the buildings. As the example of cast-iron girders in the former spinning mill of “I. Poznański” demonstrated, such tests can prove a significant margin of load-carrying capacity and confirm the possibility of adapting the structure to new purposes. The paper also presents examples of strengthening the existing wooden ceilings by joining with the reinforced concrete structure, which allowed the keeping of the original elements and an increase of the allowable load. Selected problems related to the a

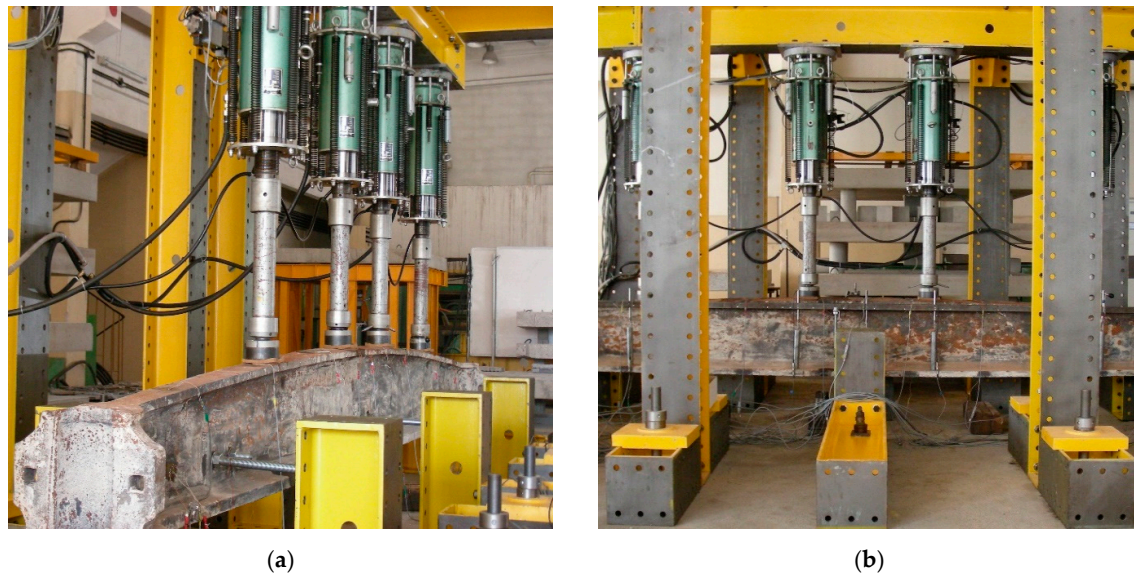
The cross-section of I-beam girders was adjusted to the course of bending moments resulting from uniformly distributed load. The aim of the destructive tests [5] was to determine the allowable load of these structural elements. Two girders were taken from the existing structure, which were then tested in the Laboratory of the Department of Concrete Structures at Lodz University of Technology. In order to reflect the actual way of load as closely as possible, the tests were carried out in a six-point system (girder loaded with four point loads by means of hydraulic jacks)—see Figures 9 and 10.

Figure 9. View of the test setup [5] with: (a) the girder no. 1, (b) the girder no. 2.

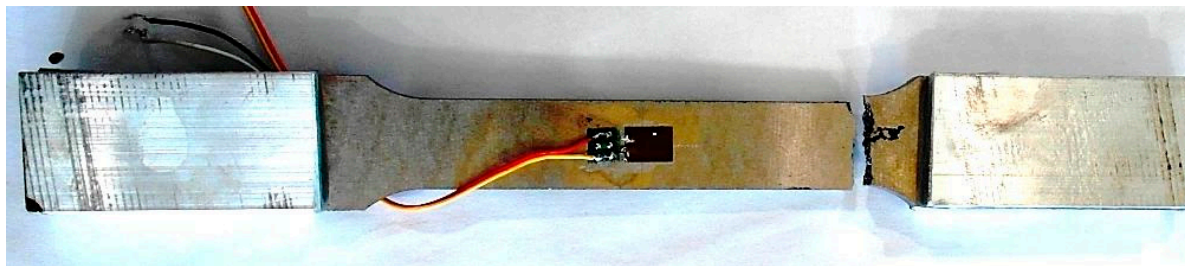
A number of destructive tests were also carried out in the laboratory to determine the mechanical properties of cast-iron—see Figures 11 and 12. The average tensile strength from six samples was $R_t = 128$ MPa with a coefficient of variation $COV = 4.7\%$, and the compressive strength $R_c = 526$ MPa with a significantly lower $COV = 2.1\%$. The ratio of tensile to compressive strength was 1:4. At this point, it is worth noting a significant difference between the strength characteristics of cast-iron and contemporary structural steel. Currently, the most popular steel grades are S235–S355 with a yield strength of 215–355 MPa—the same by compression tension. Due to the significant difference between the compressive and tensile strength of cast-iron, as well as the lack of a yield plateau, contemporary design rules for steel structures cannot be applied directly. For example, in the case of cast-iron columns, it was recommended in [6] to reduce the overall instability coefficient by 10–70% compared to steel columns of the same slenderness.

Figure 12. Cast-iron specimen after tensile test.

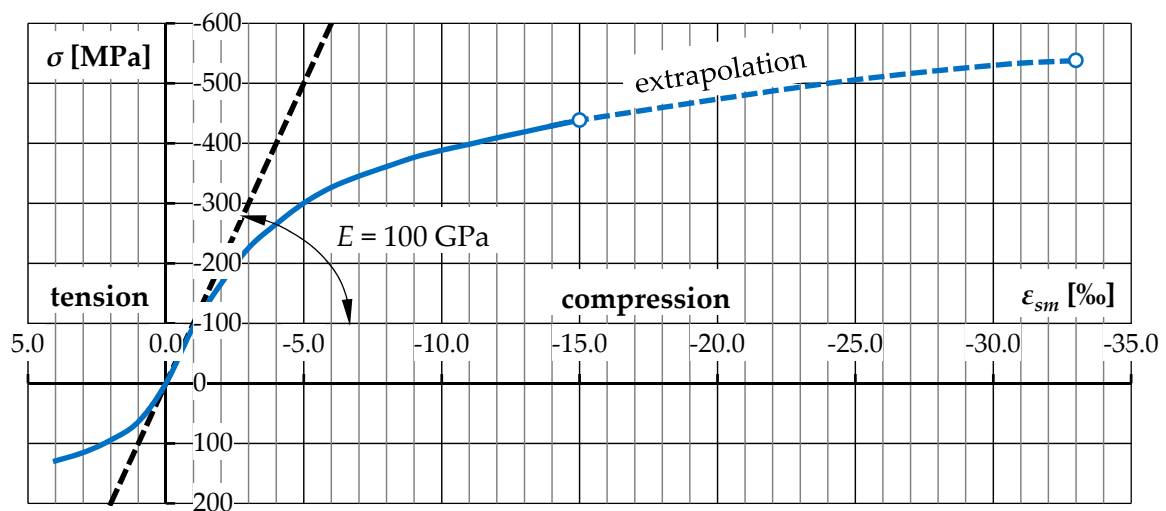
Based on the strain gauge measurements it was possible to determine the exact stress–strain relationship of the tested material—see Figure 13. The deformability of the cast-iron proved to be surprising. The measuring range of the strain gauges ended with a shortening of about 15‰. The section of the curve marked in Figure 13 with a dashed line is an extrapolation of strains up to the ultimate stress calculated according to the maximum applied force. The ultimate shortening could thus be estimated at over 30‰.

Figure 13. Stress–strain relationship of the cast-iron from which girders were made.

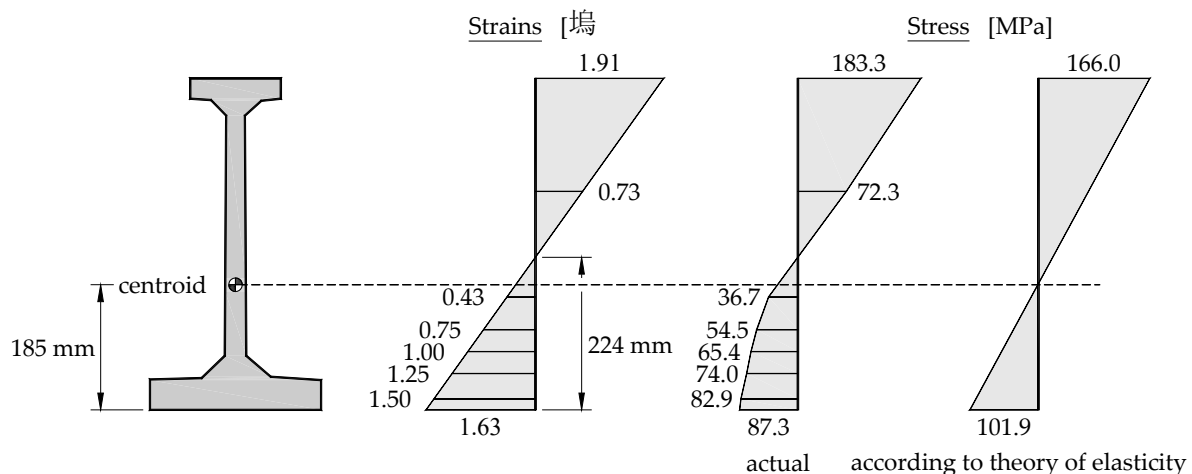
1.9 and 2.1‰ (on the compressed side). Figure 16 shows the distribution of strain and corresponding stress in the cross-section of the girder at the ultimate force. At the bottom edge ultimate strain of 1.63‰ was recorded, while in the extreme compressed fibre it was 1.91‰. The deformations were determined by assuming the “Euler–Bernoulli” beam theory and then, by using stress–strain relationship (see Figure 13) stress distribution at the girder section was calculated. The middle part of the section maintained in the elastic range, whereas the extreme fibers were already in the range of the non-linear dependence of σ – ϵ . The point of zeroing the stresses was located above the centre of gravity of the cross-section, which results from exceeding the range of elastic deformations of the material.

Figure 16. Strains and corresponding stress in the section of the tested cast-iron girder.

It is also important that the tensile strength of the material was not reached at the failure ($\sigma_{max} = 87.3 \text{ MPa} < R_t = 128 \text{ MPa}$). The stress achieved were only about 68% of the strength obtained in the tensile test. This fact can be explained by inhomogeneity of cast-iron, because on the surface of the girders numerous defects due to the imperfections of the casting process (inclusions and voids) were noticed—see Figure 17.

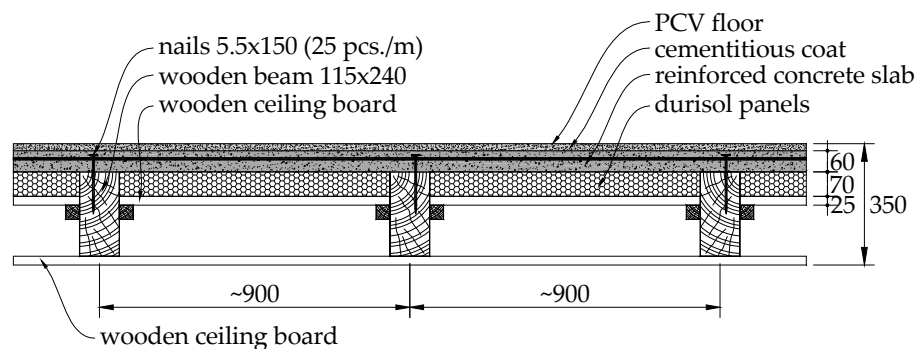
with durisol panels, on which a 60 mm reinforced concrete slab was then casted. The connections of the slab with the existing wooden beams were made with steel nails—see Figure 19.

Figure 19. Composite timber and concrete ceiling.

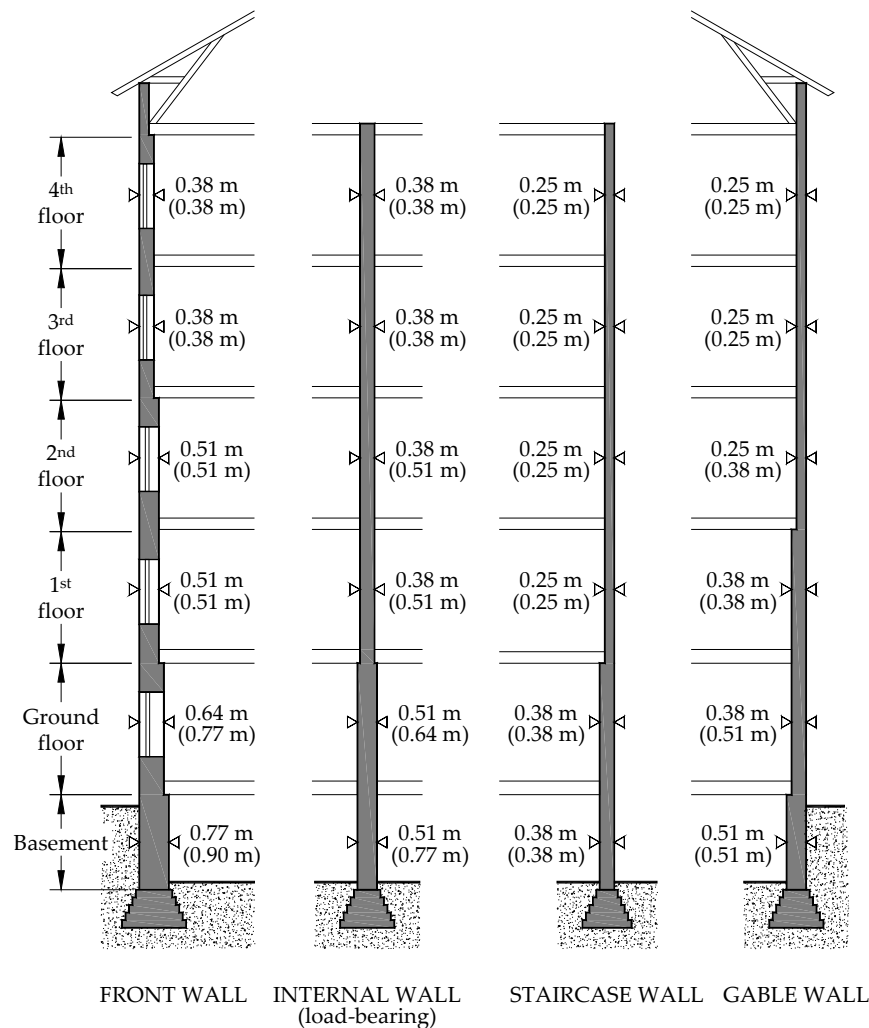
walls from the second half of the 19th century, and the turn of the 19th and 20th centuries, were made of ceramic bricks with an average strength of 5–6 MPa and were bound with lime mortars with a relatively low strength of less than 1 MPa.

Figure 23. Regulations from 1897 concerning required wall thickness in multi-storey buildings, introduced by Berlin authorities (according to [12], values in parentheses apply for factory facilities).

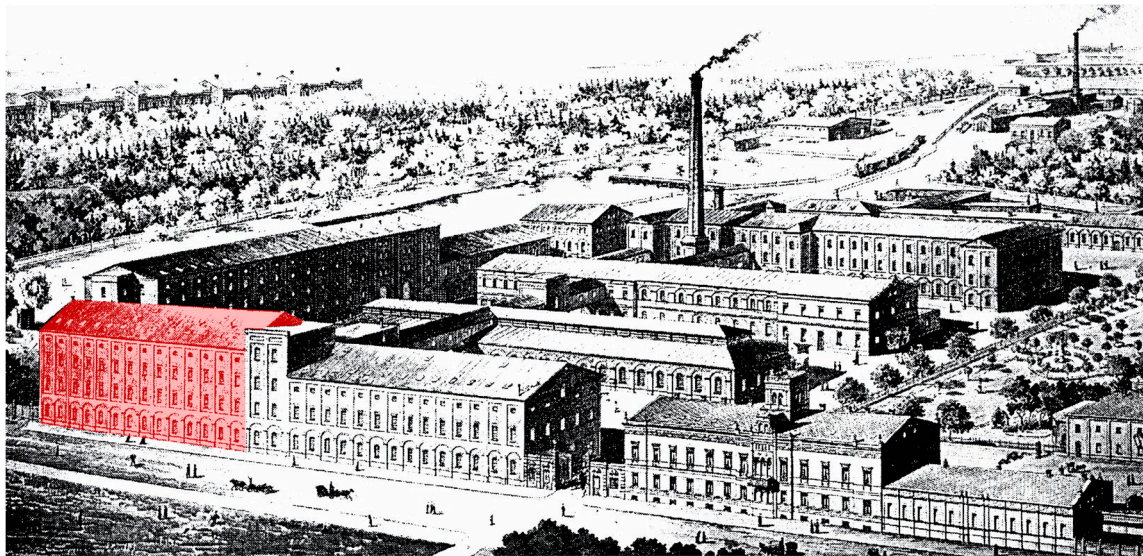
Figure 26. A general view of the K. Scheibler factory at “Wodny Rynek” at the end of the 19th century.

In May 2005, works were carried out inside the building to replace the windows in the southern wall on the ground floor level and cleaning works from the outside of this wall. Heavy equipment (loaders) was used to load the elements remaining after the demolition of the partition walls. The loader operator picked up rubbish while driving perpendicular to the wall. During the works the machine operator was warned about some cracks in the masonry piers between the windows. The works were continued despite the appearance of additional vertical cracks, which were noted by the workers. Soon after, the southern wall collapsed on the section of 5 window openings. Together with the wall, all of the inter-story ceilings collapsed. As a result of the structural failure, two people died, and a dozen were injured. The view of the partially collapsed building is shown in Figure 27.

that the walls of the building erected in the second half of the 19th century were in poor technical condition and did not meet contemporary requirements regarding the load-carrying capacity. The assessment of the wall elements after the disaster showed that the bricks were characterized by a significant change in shape (dimensions). The way the walls were made also left a lot to be desired (see Figure 24a). Laboratory tests showed that the average strength of the bricks was about 5.5 MPa (with a coefficient of variation of 14%), which is a very low value compared to the contemporary ceramic bricks (usually 10–20 MPa). Additionally, the strength of the lime mortar of 0.2–0.8 MPa was significantly lower than the lowest mortar class currently predicted by the standards $f_m = 1$ MPa (for M1 class).

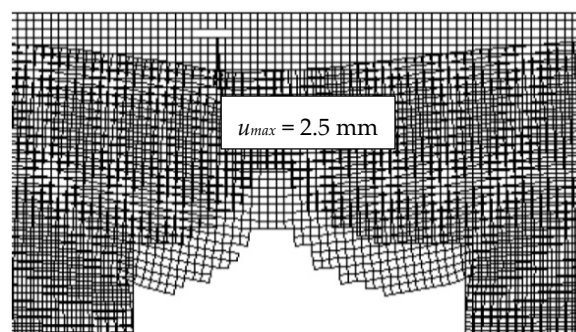
Figure 30. Results of the nonlinear FEM analysis.

The aforementioned effect prevented the wall collapse in the former boiler house of the “Grohman’s” factory complex in Łódź [15]. As part of the reconstruction works, an opening with dimensions of 3.3 × 4.0 m was made in the load-bearing wall. Two lintel beams of I240-section were introduced as a strengthening element—see Figure 29a. However, the works were carried out extremely carelessly, as the sections were loosely mounted in the wall sockets, which did not protect them against rotation (no anti-torsional stiffening). During the inspection, many loose bricks were found above the steel beams. Several of them became detached, injuring a passing person. Such an accident was, however, inevitable, taking into account the ineffectiveness of steel lintels, high deformability, and very low tensile strength of the wall. In the literature some analytical procedures can be found [16,17], which allow for designing the lintels with including contribution of the masonry wall. In the case under consideration, however, a non-linear analysis was performed. In the Figure 30, the results of the nonlinear analysis for a wall fragment were presented. In the calculations, fracture elements were used, assuming tensile stress above 0.04 MPa as the failure criterion. The formation of a secondary structural system, resembling a vault, is visible, but almost all the elements between the supports failed (detached).

In the presented case, it was decided [15] to strengthen the lintel by making a reinforced concrete portal, joined with the masonry structure—see Figure 29b,c. Despite the difficulties with pouring concrete (due to the limited access to the wall on one side), the work was successfully completed, and it was possible to continue safely use of the building.
