# Failure Investigation of Under Construction Prestressed Concrete Bridge in Chitwan, Nepal

**Abstract:** On 6 April 2021, a 200 m-long under-construction prestressed concrete bridge failed in the Chitwan District in central Nepal. Two of the four bridge spans collapsed without any notable evidence of dynamic force application. Under-construction bridge failures are sometimes reported and can have a significant impact on the future construction adjustments. Thus, a detailed study of failure mechanisms will be insightful for the structural engineering community. Aiming to document the failure modes and exemplify lessons for improvement, this paper reports the detailed component level failure mechanisms of the bridge using visual inspection, site measurements, finite element modeling, and some forms of non-destructive testing. The chronological failure mechanisms are presented based on the field evidence and juxtaposed with the results of analytical modeling. The sum of findings highlights that the dead load failure, triggered by the settlement of falseworks, is the most critically governing factor that initiated and aggravated the damage scenario.

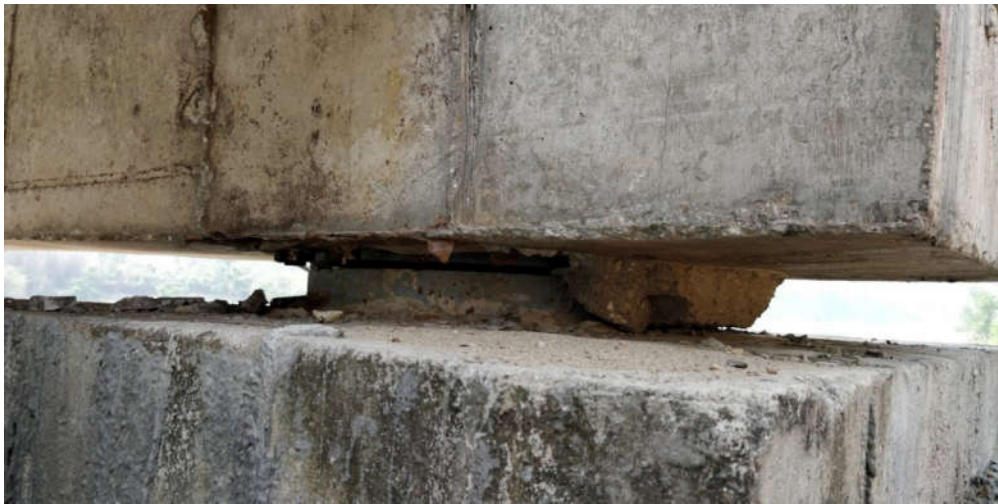
Bearing damage was attributed mostly to the horizontal movement of girders. A pot bearing system was used in the bridge, as shown in Figure 13. Bearing damage was observed in Abutment-1, Pier-1, and Pier-2, as shown in Figures 14, 15, 16, and 17, respectively.

**Figure 13.** Pot bearing system above Abutment-2 (Undamaged).
