Failure Investigation of under Construction Prestressed Concrete Bridge in Chitwan, Nepal

Abstract: On 6 April 2021, a 200 m-long under-construction prestressed concrete bridge failed in the Chitwan District in central Nepal. Two of the four bridge spans collapsed without any notable evidence of dynamic force application. Under-construction bridge failures are sometimes reported and can have a significant impact on the future construction adjustments. Thus, a detailed study of failure mechanisms will be insightful for the structural engineering community. Aiming to document the failure modes and exemplify lessons for improvement, this paper reports the detailed component level failure mechanisms of the bridge using visual inspection, site measurements, finite element modeling, and some forms of non-destructive testing. The chronological failure mechanisms are presented based on the field evidence and juxtaposed with the results of analytical modeling. The sum of findings highlights that the dead load failure, triggered by the settlement of falseworks, is the most critically governing factor that initiated and aggravated the damage scenario.

Keywords: prestressed concrete bridge;

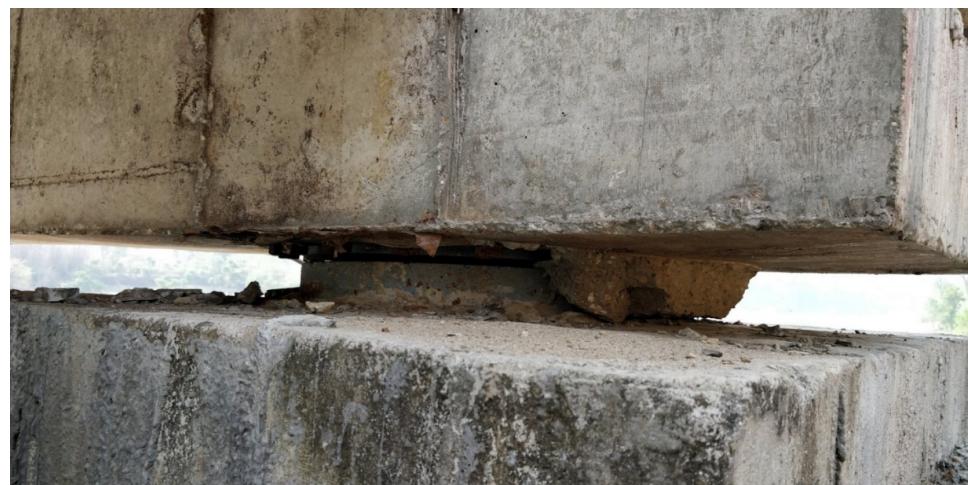
Bearing damage was attributed mostly to the horizontal movement of girders. A pot bearing system was used in the bridge, as shown in Figure 13. Bearing damage was observed in Abutment-1, Pier-1, and Pier-2, as shown in Figure 14, Figure 15, Figure 16, and Figure 17, respectively.

Figure 13. Pot bearing system above Abutment-2 (Undamaged).
