The Impact of Pollution on Cultural Heritage in the Historic Centre of Porto, Portugal

This investigation aims to study how these factors directly affect the built heritage associated with the Central Portuguese Way to Santiago based on three case studies: Carmelitas Church, São João Novo Church, and Vitória Church.

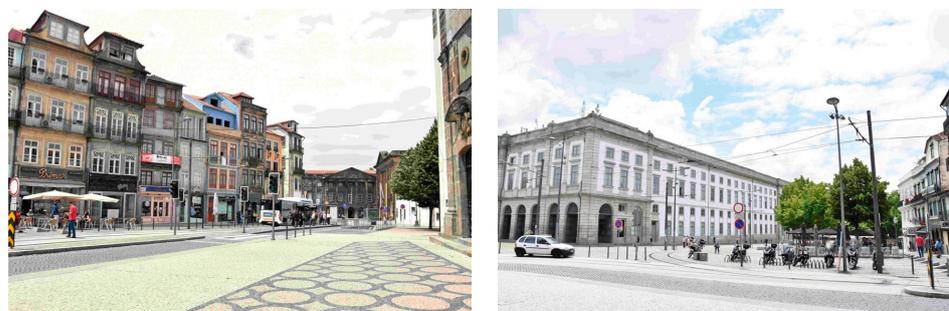
Figure 9. View of Carmo and Carlos Alberto Square, Porto. Source: Author.

The high level of car traffic in this area may explain the degradation of the granite stone and tiles that cover the façade. As there are no buildings or vegetation to protect the façade, it is more susceptible to external agents, such as rainwater and the water–wind combination.
