Design and Construction of CFRP Rod Panel Retrofit for Impacted RC Bridge Girders

Abheetha Peiris ^{1,*} and Issam Harik ²

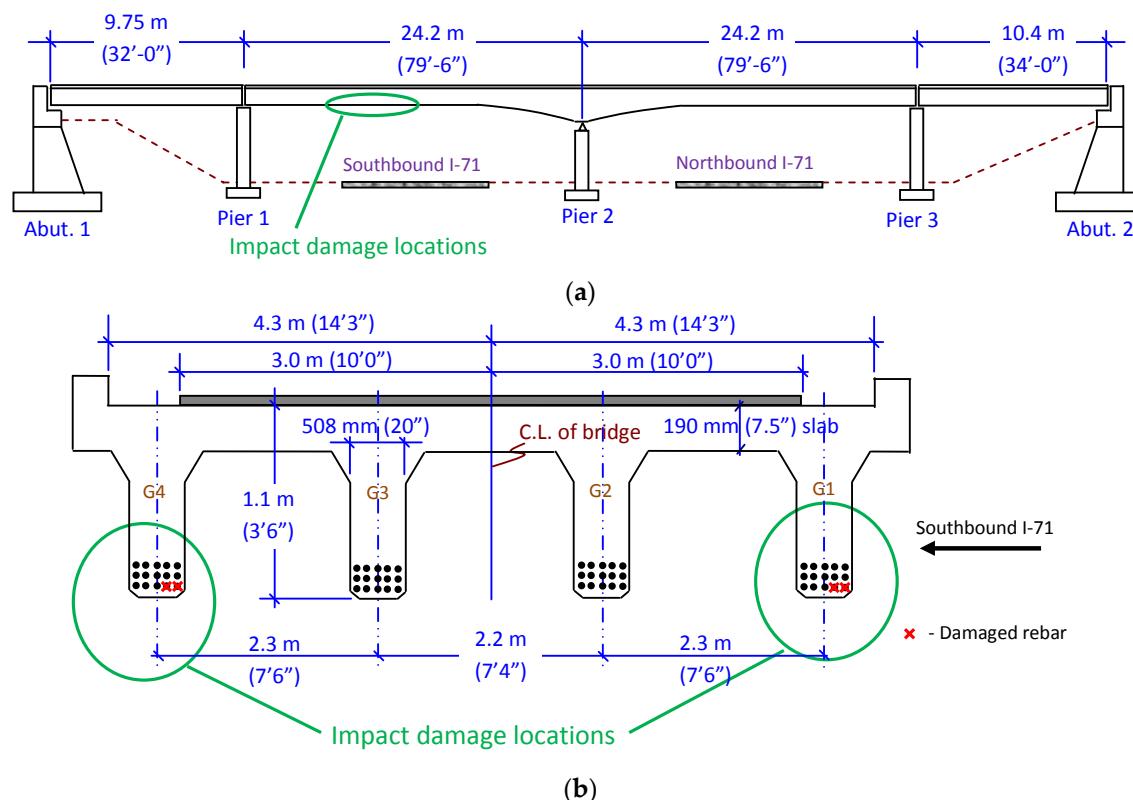
Figure 2. (a) General layout of the bridge; (b) Cross section of the bridge at impact location.

Both exterior girders (G1, G4) over the right lane were impacted, producing spalled concrete and bent reinforcing bars. At the point of impact, the bottom rebar mat of both RC girders consisted of five rebars, each 35.8 mm (1.41 in) in diameter, of which two were bent and yielded (Figure 3). The damaged reinforcement represented 13.3% of the total reinforcing steel available to resist positive bending. Several stirrups for shear reinforcement were also severed during the impact. On both girders, concrete damage to the impacted side appeared minimal, but there was significant concrete cracking and spalling on the girders' back sides. Girder 4 had the most damage, with the concrete spalling spread across approximately 3.7 m (12 ft).

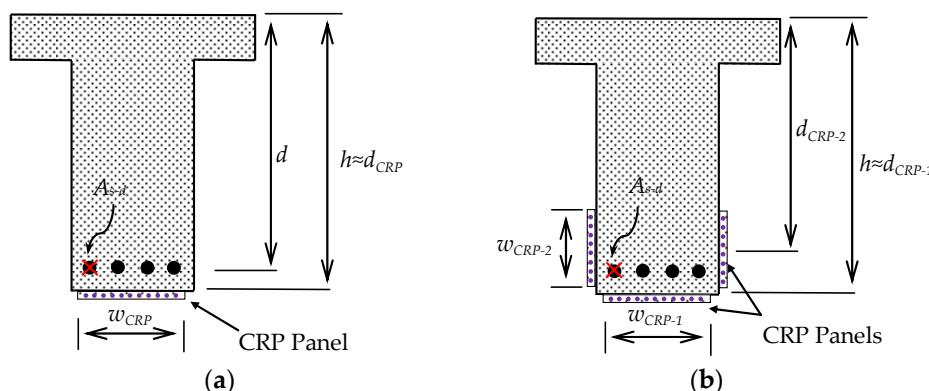
Figure 5. CRP application (a) On bottom surface; (b) On bottom surface and sides.

For the two CRP panels shown in Table 1, CRP 070 and CRP 195, the required widths to replace the two damaged rebars in each of the two impacted RC girders were 1700 mm (67 in) and 660 mm (26 in) respectively. As shown in Figure 2, the width of the impact damaged RC girder was 508 mm (20 in), but the width available for applying the CRP on the bottom face was less than that when accounting for the girder's chamfered edges. Based on the results, it was clear that even when using the larger capacity CRP 195, the panels would also need to be placed along the vertical faces of the girder (Figure 5b) to achieve the desired strengthening. While a single panel on the side of the damaged rebars can be applied, it is advantageous to apply the same sized panels on either side of the beam to maintain symmetry of the retrofit (Figure 5b). As the strain on the CRPs away from the bottom surface would be less than the debonding strain, the required panel widths were estimated using Equation (6). It is practical to use the same size CFRP rods for both the bottom surface and sides (i.e., $A_{r-1} =$

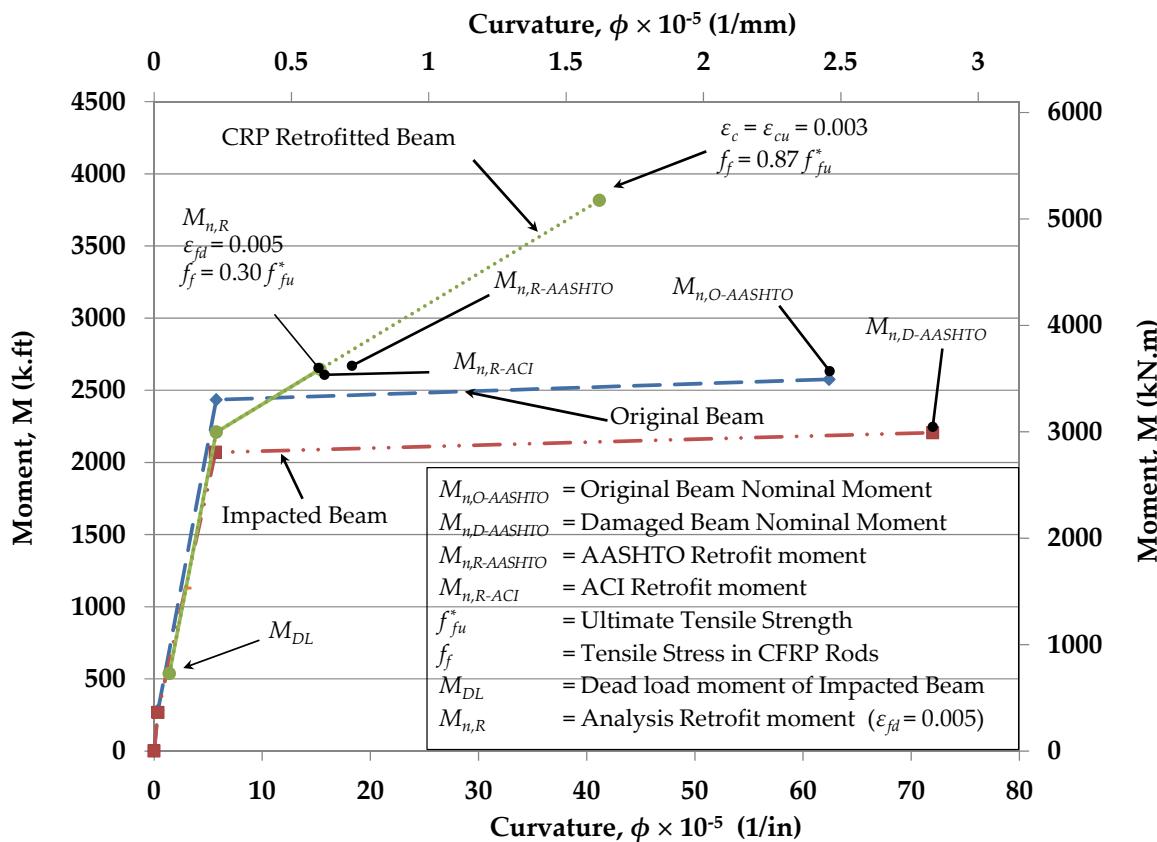
Figure 8. Moment-Curvature response of undamaged, damaged and retrofitted cross-sections.

For the retrofitted girder, analysis was initiated from the location where the damaged girder was subjected to just dead loads. The last point of analysis for the retrofitted girder was at crushing of concrete, where a concrete strain (ϵ_c) of 0.003 mm/mm (in/in) was reached, at which point the CRP reached 87% of its ultimate strength of 2200 MPa (320 ksi). Note that this point is purely theoretical as the strain at the CRP-concrete interface was 0.0143 mm/mm (in/in), almost three times the design limit for EB-CFRP. While CRPs should have higher debonding strains than externally bonded CFRP laminates [30], they are expected to be less than the debonding strains for NSM CFRP. While current AASHTO guidelines [9] do not address NSM CFRP, ACI [8] specifies a design debonding strain limit of $0.7\epsilon_{fu}$. Given the debonding strain limits for NSM CFRP and based on the material properties of the CFRP rods, this results in a debonding strain of 0.0098 mm/mm (in/in). The location where the strain at the CRP-concrete interface was 0.005 mm/mm (in/in), based on AASHTO debonding strain limits for EB-CFRP, is highlighted in Figure 8 as the location of the retrofit moment ($M_{n,R}$).

The nominal moments (Table 2) for the undamaged ($M_{n,O-AASHTO}$) and damaged ($M_{n,D-AASHTO}$) girder, as well as the flexural capacity of the CRP-retrofitted girder based on both AASHTO [9] and ACI [8], are plotted in Figure 8. The calculated values are in good agreement with the analysis curves. The results indicated that the CRP increased the moment capacity of the damaged girders beyond the original beam moment capacity.
