Article Surface Mechanical Effects of Wildfires on Rocks in Climbing Areas

Keywords: wildfires; rock weathering; hazards; risk perception; rock hardness; ultrasound pulse velocity; sport climbing

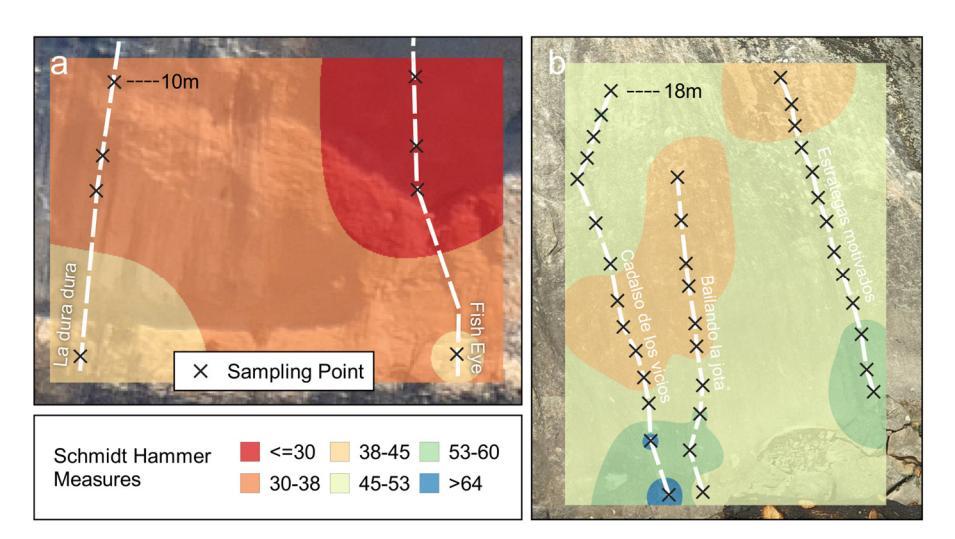
Figure 12. Spatial distribution of the SH measurements in: (a) "La Dura Dura" (Oliana) and (b) three routes in Site 6 of Cadalso de los Vidrios.

As referenced in the methodology, the iconic route of "La Dura Dura" in Oliana was selected for a detailed SH and UPV survey (Figures 12a and 13a). As this route was only partially affected by the fire, the results do not show the same large gradation as Cadalso. Figures 12b and 13b show SH and UPV maps from the three studied routes in Cadalso de los Vidrios and show a gradation of values: lower SH and UPV at the bottom, and lower SH and UPV to the top right. This gradation is coherent with the results obtained from the random grid measurements (Figure 11), in which the areas with detached spalling show higher SH and UPV values than those areas showing reddening. This is because reddened areas with non-detached spalling have more microcracks than those in which the surface affected by fire has detached and, therefore, a "new" surface not affected by the fire is

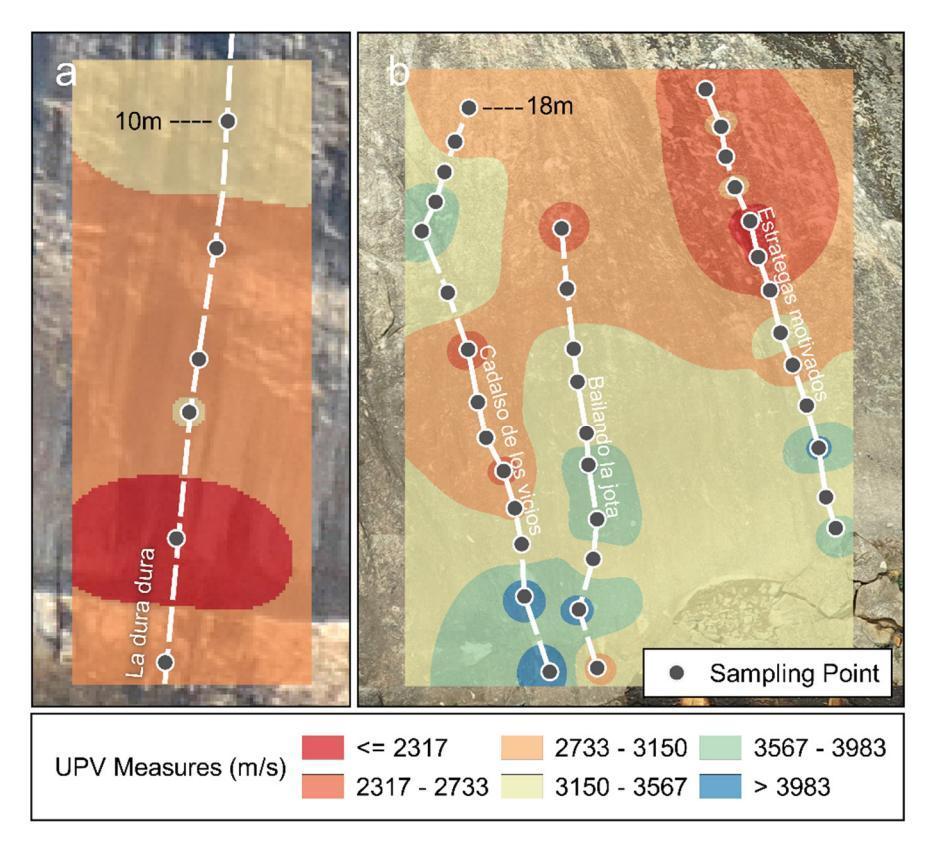
Figure 13. Spatial distribution of UPV measurements in: (a) "La Dura Dura" (Oliana) and (b) three routes in Site 6 of Cadalso de los Vidrios.

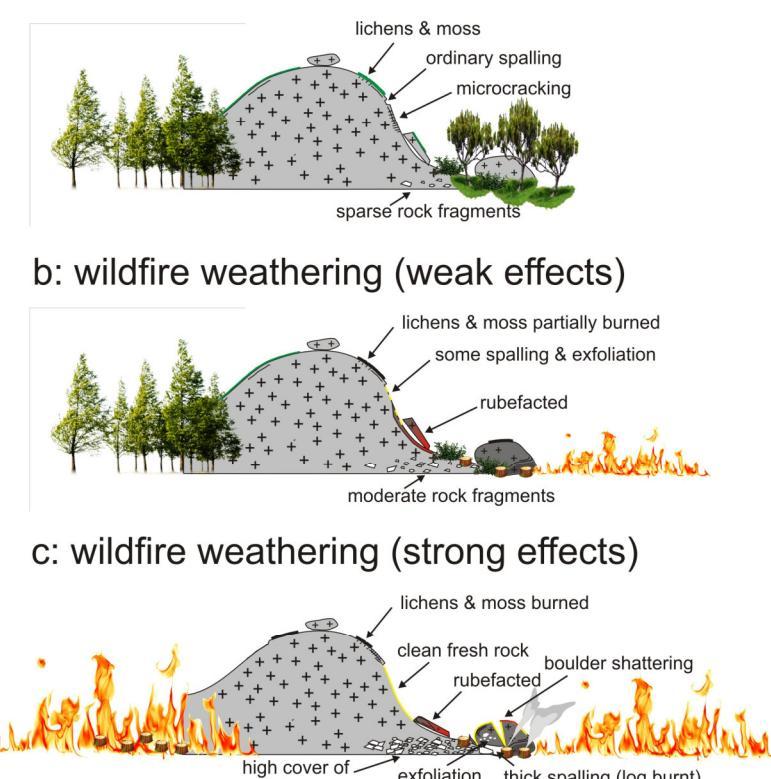
Wildfire weathering (Figure 15) has been noted as an important erosive agent, with changes in soil stoniness of up to 90% in the most damaged areas of Oliana. In Mediterranean areas, this effect has been demonstrated [46] by means of intense spalling. Both in Oliana and Cadalso, we noted the degree of spalling as a result of an increase in fire intensity and resulting sudden thermal shock. This effect is one of the most critical for sport climbing.

Figure 15. Surface mechanical effects of wildfires on rocks in the climbing areas: (**a**) ordinary situation with current weathering; (**b**) changes in bedrock by weak wildfire partially affecting an area; (**c**) strong effects of a wildfire on a bedrock wall.
