# Full-Scale Blast Tests on a Conventionally Designed Three-Story Steel Braced Frame with Composite Floor Slabs

**Abstract:** This paper summarizes the findings of two full-scale blast tests on a steel braced frame structure with composite floor slabs, which are representative of a typical office building. The aim of this research study was to experimentally characterize the behavior of conventionally designed steel braced frames to blast loads when enclosed with conventional and blast-resistant façade. The two tests involved a three-story, steel braced frame with concentric steel braces, which are designed to resist typical gravity and wind loads without design provisions for blast or earthquake loads. During the first blast test, the structure was enclosed with a typical, non-blast-resistant, curtainwall façade, and the steel frame sustained minimal damage. For the second blast test, the structure was enclosed with a blast-resistant façade, which resulted in higher damage levels with some brace connections rupturing, but the building did not collapse. Observations from the test program indicate the appreciable reserved capacity of steel brace frame structures to resist blast loa

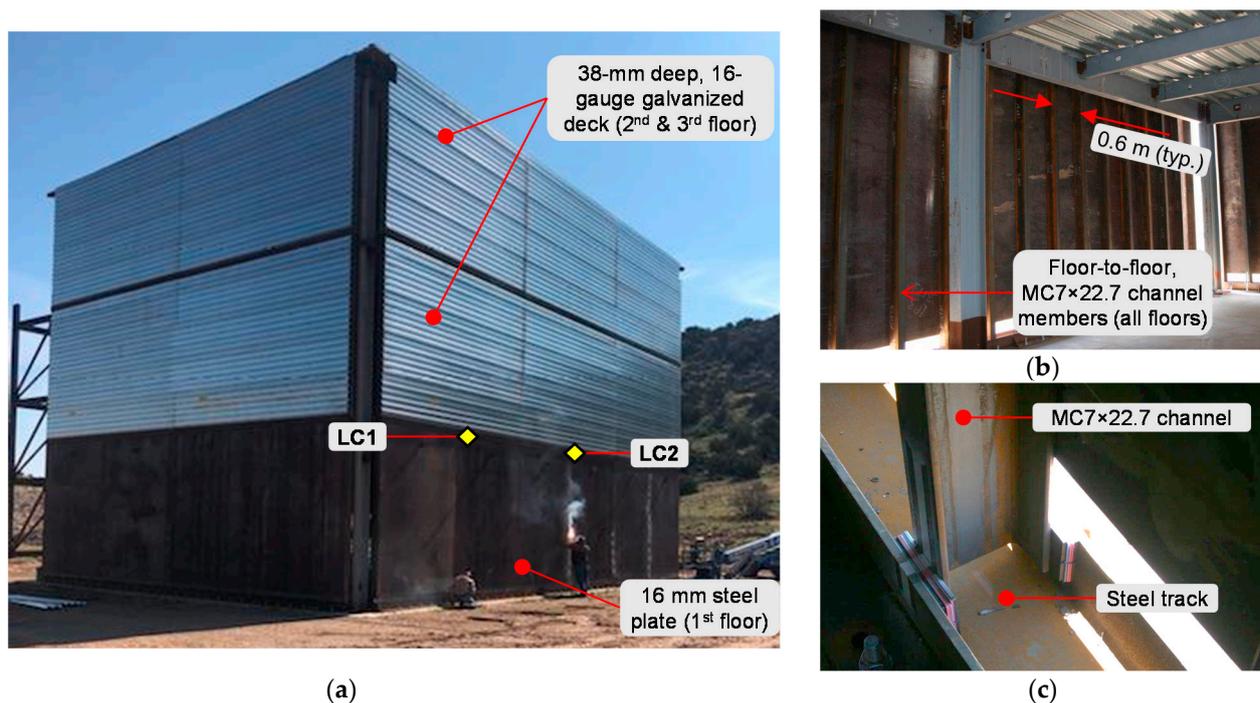
**Figure 5.** View of the test structure with blast-resistant steel façade for Test 2: (a) Southwest elevation view (LC = load cell, refer to Figure 9b); (b) View from the inside on the 1st floor (same channel configuration on all floors); (c) Close-up view of bottom end connection of  $MC7 \times 22.7$  façade channels to allow sliding for in-plane motion and resist load for out-of-plane motion.

Most of the façade connections at the second-floor level failed where the façade channels slipped out of the track during the rebound (Figure 5c). The connections at this level failed due to the higher dynamic reactions caused by the composite action of the 16 mm thick steel plate that was welded to the first-floor vertical façade channels (Figure 5b). Specifically, some bolts that connected the vertical channels to the frame ruptured in direct shear during the inbound response. During the negative phase of the airblast, the façade ends were not positively connected to the structure anymore, causing a zipper-type failure mode with the façade detaching from the frame. This connection failure did not affect the inbound blast load that was transferred to the steel frame. During the inbound response and as bolts ruptured, the façade channels transferred the blast load to the structure through direct bearing action with the edge of the concrete slab, since the

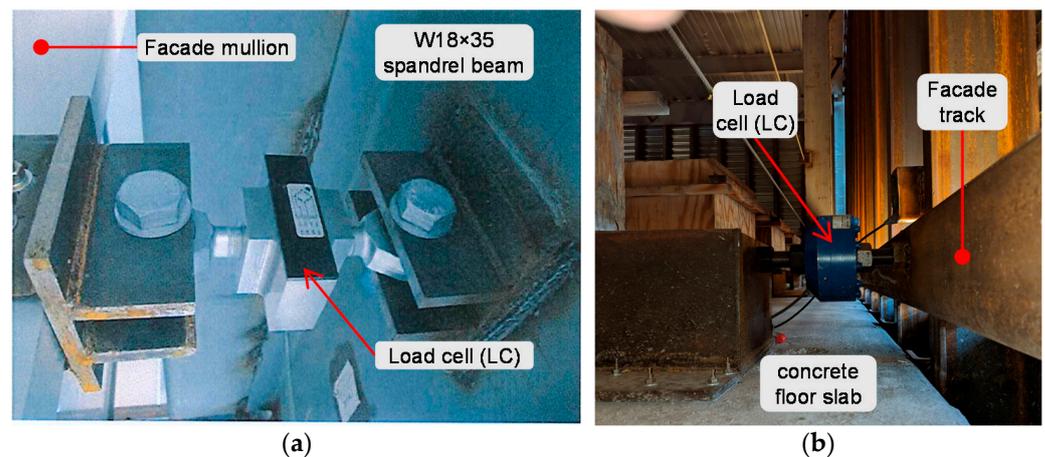
**Figure 9.** Close-up views of load cell configuration to measure the dynamic reaction loads transferred from the façade to the steel frame: (a) Test 1 LC connecting the mullion-to-spandrel beam web; (b) Test 2 LC connecting façade track-to-slab (refer to Figures 4a and 5a for LC locations).

gap between the slab edge to the façade channels was less than 50 mm, as can be seen in Figure 9b.

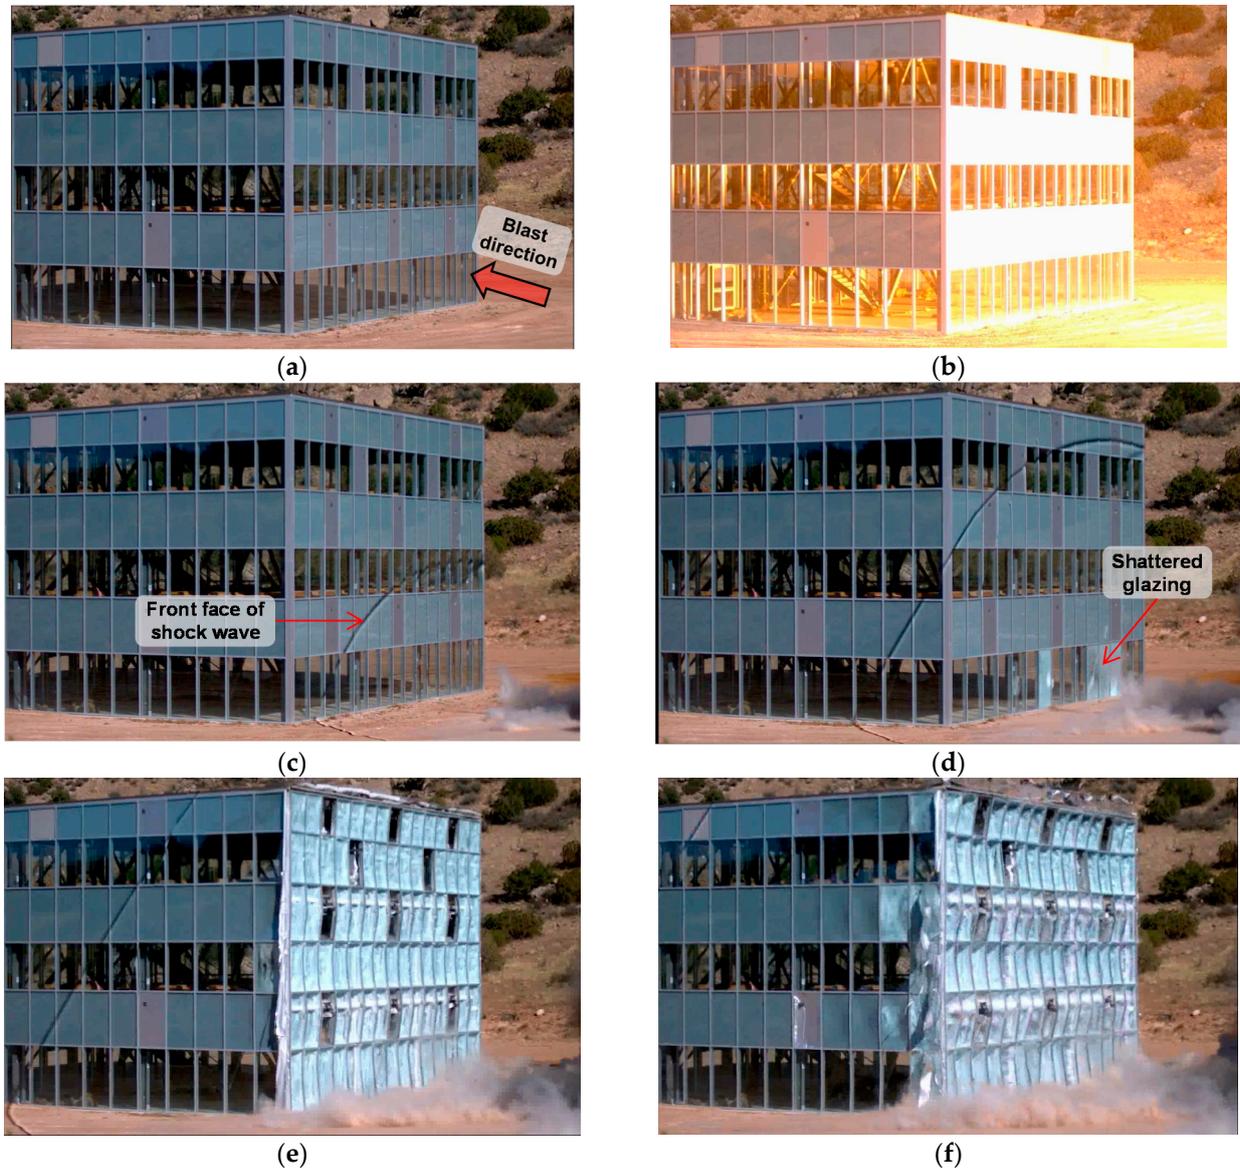
For the first test, the structure was enclosed with a conventional, non-blast-resistant, glazed curtainwall façade (Figure 4). Figure 12 shows a series of snapshots from highspeed video footage following the detonation of the explosive charge (Figure 12b) as the airblast shock wave propagated to the test structure. The airblast wave direction was from the south to the north (Figure 10) and first arrived on the south (front) elevation of the structure. The front face of the shock wave can be clearly seen on Figure 12c. Almost concurrently with the arrival of the shock wave, the first few glazed units shattered on the first floor, as indicated in Figure 12d. The glazing damage rapidly propagated to the entire front

elevation of the building, as shown in Figure 12e,f. Eventually, the exterior curtain wall façade failed almost instantaneously as the blast wave loaded the structure. Views of the post-test condition of the structure can be seen in Figure 13. Specifically, all front and rear elevation glazing completely shattered, and the aluminum mullions were severely damaged. Only a few glazed units remained intact at the side elevations of the building.

**Figure 12.** Test 1—Snapshots from high-speed video footage during test: (a) Prior to detonation; (b) Explosive charge detonation; (c) Arrival of shock wave; (d) Initial glazing failure on first floor; (e) Completely shattered glazing on front elevation; (f) Façade damage propagates to side façade.

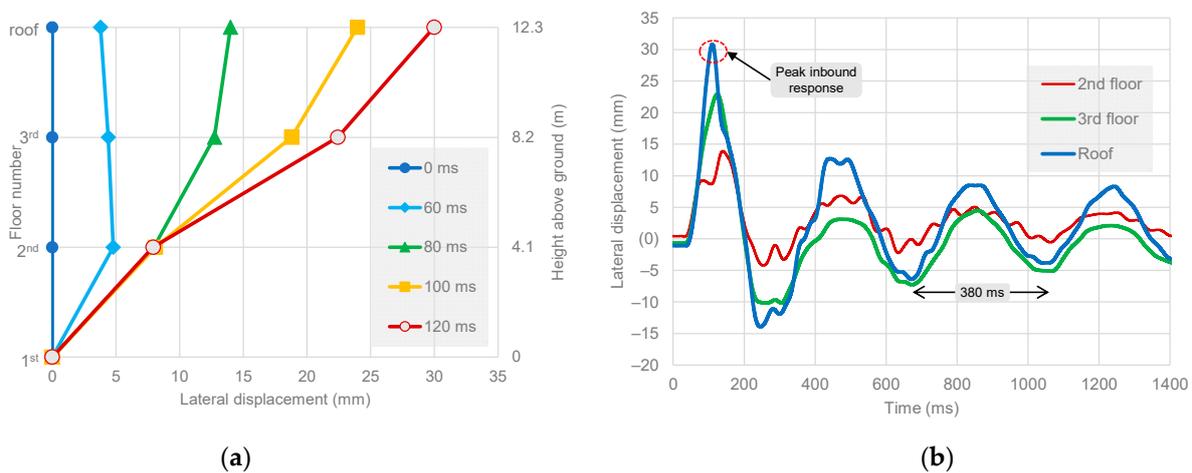
The deflected shape of the structure at different stages between time of detonation (0 ms) up to the time of peak inbound response (120 ms) is shown in Figure 14a. In addition, Figure 14b shows the recorded deflection histories at each floor level, as measured from DG4, DG5, and DG6 for the 2nd, 3rd, and roof respectively. Following the peak inbound response, there was a free vibration stage after about 200 ms from which the fundamental period of the frame was estimated to be ≈380 ms.

**Figure 14.** Test 1—Lateral response of structure: (a) Deflected shape at different times; (b) Lateral deflection history and estimation of natural period, data from DG4, DG5, and DG6.

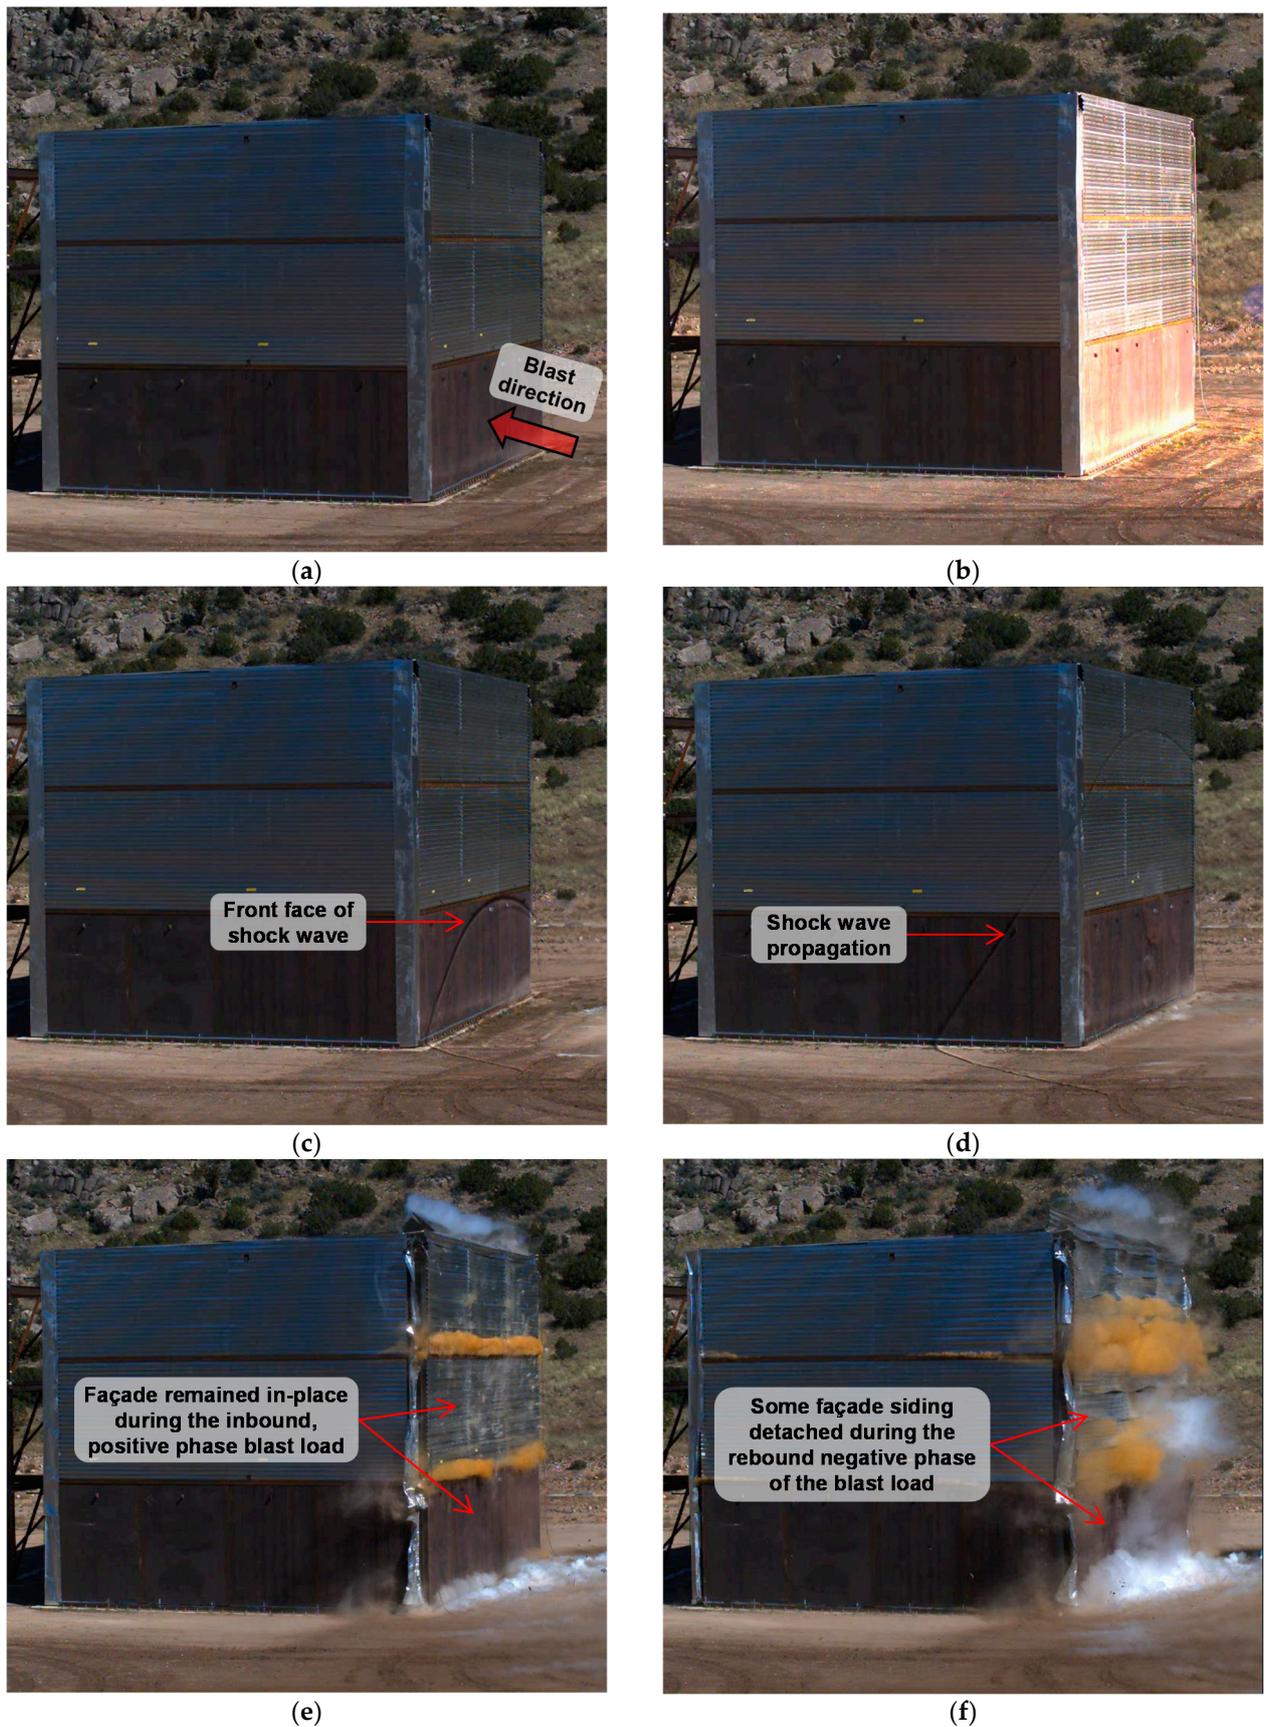
Following the completion of the first blast test, the damaged glazed façade was removed and replaced with the steel, blast-resistant façade (Figure 5). Figure 15 shows a series of snapshots from high-speed video footage following the detonation as the pressure wave propagated through the structure. The explosive charge weight and position were the same as for the first test (Figure 10). Figure 15c,d indicate the propagation of the front face of the pressure wave on the structure. A few milliseconds later, the front façade started responding to the applied load, as shown in Figure 15e. At this stage, the façade was still loaded with the inbound positive pressure from the airblast, which is reflected on the deformed shape of the corrugated deck siding on the second and third floors. The first-floor siding, which was comprised of a 16 mm thick steel plate (Figure 5a), remained practically elastic with minimal inbound deformation. As the pressure wave propagated, the negative phase of the airblast wave arrived, which is reflected in Figure 15f where some of the corrugated deck siding started to detach from the supporting channel members (Figure 5b).

**Figure 15.** Test 2—Snapshots from high-speed video footage during test: (a) Prior to detonation; (b) Explosive charge detonation; (c) Arrival of shock wave; (d) Propagation of shock wave over the structure; (e) Inbound loading of the front face facade; (f) Rebound response of the front face facade.

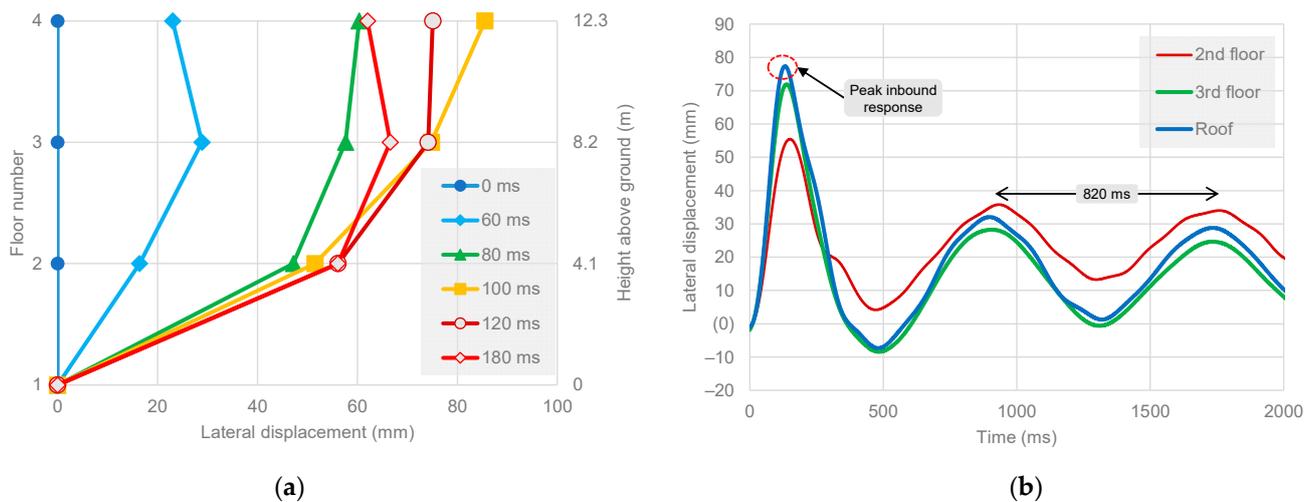
The deflected shape of the structure at different stages between the time of detonation (0 ms) and a few milliseconds past the peak inbound response (120 ms) is shown in Figure 20a. Figure 20b shows the lateral deflection histories at the three floor levels as recorded by DG4, DG5, and DG6 for the 2nd, 3rd, and roof, respectively. The natural period of the frame was estimated to be approximately 820 ms, which was more than twice as high as the estimated natural period of the frame during the first test that was  $\approx 380$  ms. The rupture of the two first-floor brace connections (Figures 17d and 18c) were the primary reason for the higher natural period. Basically, two out of the four brace members on the first floor were not participating in the LFRS; hence, the lateral stiffness of the frame dropped, which resulted in an increase in the natural period. A secondary reason for the increase in the natural period was due to the overall increase in the building mass due to the heavier blast-resistant façade (Figure 5) that the frame had during this test compared to the lighter conventional façade used for the first test (Figure 4).

**Figure 20.** Test 2—Lateral response of structure: (a) Deflected shape at different times; (b) Lateral deflection history and estimation of natural period, data from DG4, DG5, and DG6.
