# Architectural, Constructional and Structural Aspects of a Historic School in Greece. The Case of the Elementary School in Arnaia, Chalkidiki

Vasiliki Pachta <sup>1,\*</sup>, Vasiliki Terzi <sup>2,†</sup>

<sup>1</sup> Lab. of Building Materials, School of Civil Engineering, Aristotle University of Thessaloniki, 54124 Thessaloniki, Greece

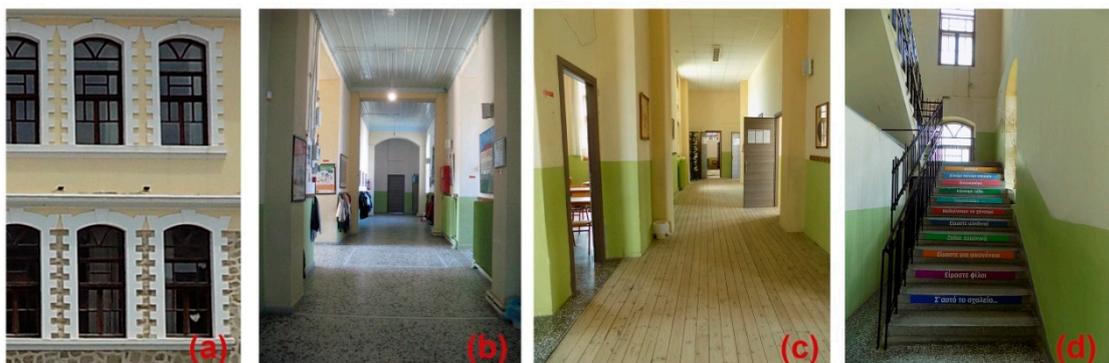
**Figure 6.** Constructional aspects of the stone school building: (a) Opening type; (b) pillars and concrete slab of the ground floor (corridor view); (c) pillars and wooden floor of the 1st floor (corridor view); (d) inner staircase.

On the northern (external) and central (inner) elongated wall, as depicted in Figure 5, there are pillars (thickness 55–68 cm) that were put alongside the building at almost equal distances (6.5–7.0 m). They extend from the basement to the 1st floor, supporting the beams (Figure 6b,c). On the southern part of the building the beams are supported in the external and internal walls.

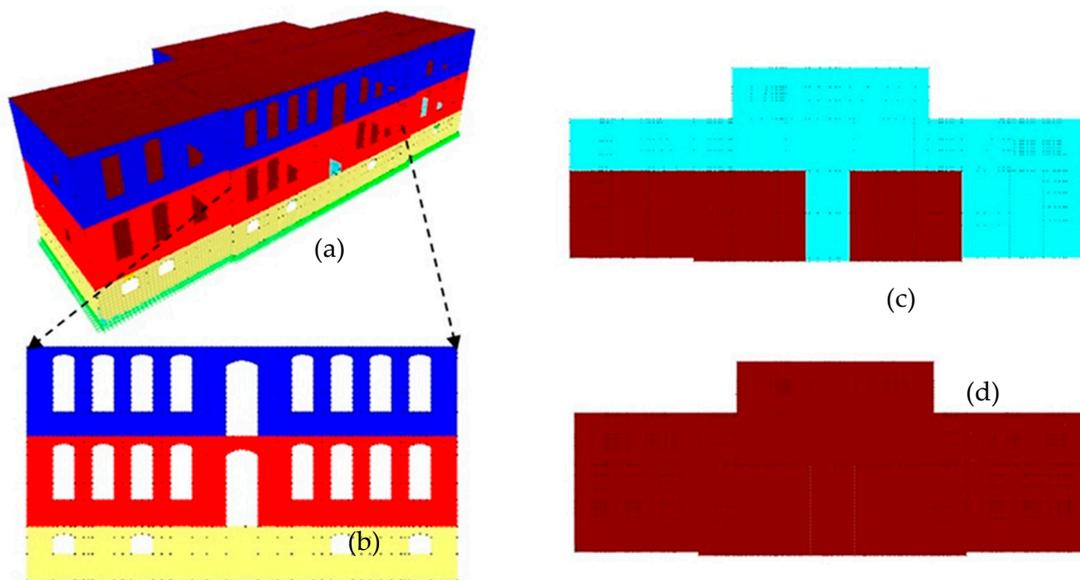
**Figure 9.** Finite element of the masonry structure [41]: (a) 3D view; (b) detailed representation of the openings; (c) horizontal elements of different materials (wooden and R/C plates); (d) wooden horizontal elements.
