# Towers on the Earthen Foundation: New Insights by the Excavation and Boring Survey at the Bayon Temple

Ichita Shimoda

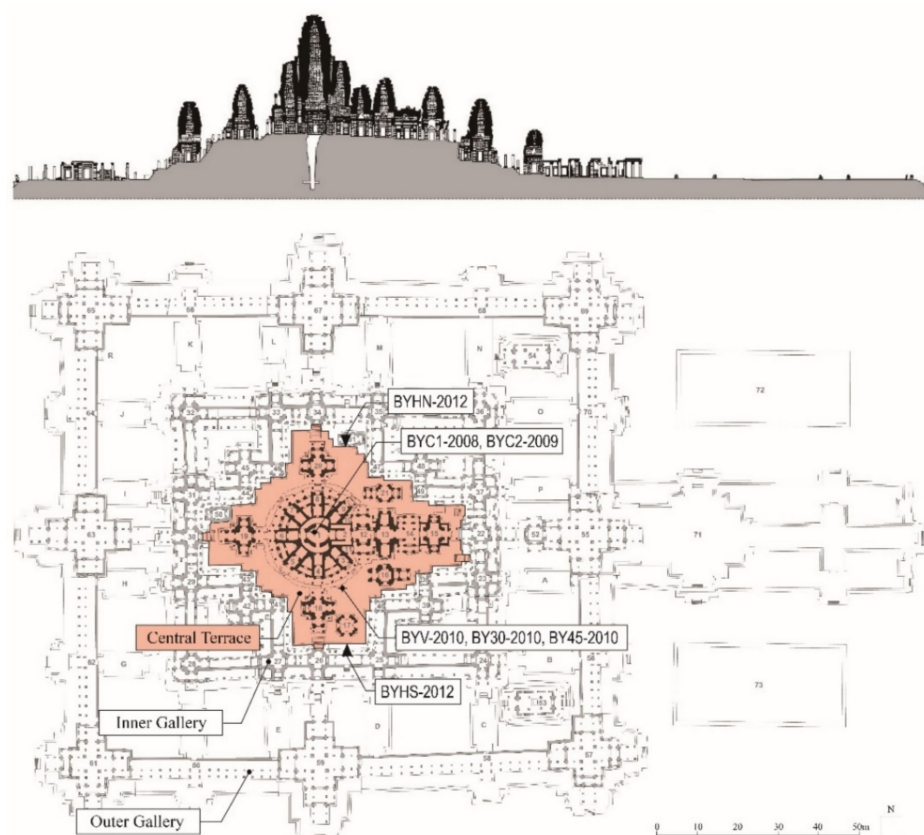
**Figure 2.** West–east section of the central axis line of Bayon temple (above) and a plan with the location of boring surveys (below) (after Dumarçay [8]).

From the bottommost level of the excavation work in the central tower, a preliminary boring test was conducted using a manual drilling tool, a hand auger (BYC1-2008) (Figure 2). A hole was drilled down to a depth of 8.41 m from the floor surface, and compacted soil was sampled from each level to analyze the water content ratio and grain size distribution. In 2009, a machine boring test was conducted in the same spot (BYC2-2009). A hole was drilled down to a depth of 19.5 m from the floor level, and compacted soil was sampled from each level to analyze the water content ratio and grain size distribution. A standard penetration test was also performed.
