Forensic Geology Applied to Decipher the Landslide Dam Collapse and Outburst Flood of the Santa Cruz River (12 November 2005), San Juan, Argentina

Abstract: A well-known landslide dam that collapsed and generated a large outburst flood is used to show the importance of forensic geology analysis, which is the on-site multidisciplinary study of geohazards carries out as soon as possible after their occurrence; this study is focused on understanding the complete spectrum of all mechanisms that caused the disaster. Diagnostic elements of all natural processes fade with time, allowing for progressively divergent interpretations that may impact the appropriateness of potential mitigation actions, as we demonstrate. The multidisciplinary field control of the abrupt rupture of a natural dam on the Santa Cruz River on 12 November 2005, that released c. 37 million m³ of water and sediment, can radically change the interpretation of how this dam collapsed. In situ sedimentological, geomorphological and topographical analyses of the remains of the collapsed natural dam suggest it was built in two mass-wasting episodes instead of one, as previously interpreted, involving different slide materi

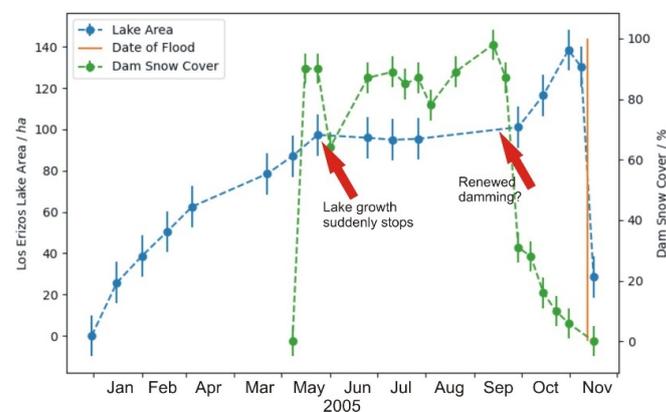
Figure 3. Los Erizos Lake area development showing the two-step lake growth, according to LANDSAT satellite images with visible lake perimeter. The percentage of snow cover over the dam complex is added (c. 20 Has), showing the coincidence of the maximum snow coverage and the second stage of lake growth.

The conditions of an extensive and heavy snow cover that promoted Flow 2 also helped to mask it in available 30 m-resolution satellite images, in which it was undetectable. Indirect evidence of a taller dam is the lake level marks above the height of Flow 1 deposit, and the two-step growth of the lake area (Figures 3 and 6). Since the dam is difficult to identify in satellite images contrary to the lake, remote sensing monitoring systems would

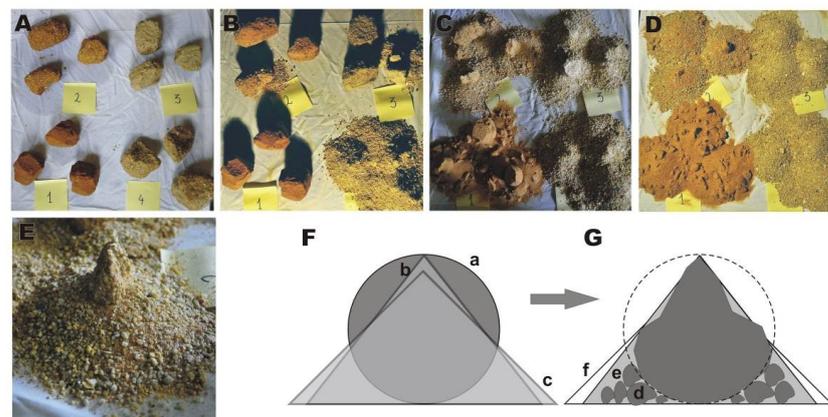
(c) Source: in addition to the angular rock fragments of all sizes up to a maximum of three meters in diameter, some molards were recognized (Figure 7), which imply a minor contribution from ice-cemented permafrost [20,21]. In some cases, these ice-cemented blocks were formed almost directly with the fragmented rocky substrate, so their disintegration did not generate the typical conical molards but were observed as groups of disaggregated rocks that protrude from the deposit.

Figure 6. Formation of molards. (A–D) Evolution of ~8 cm large frozen ground blocks of different composition (1—fine sand; 2—fine, medium and coarse sand; 3–4—granule-rich medium-coarse sand), taken at about 6 h intervals. (E) Detail of a molard after 24 h. (F–G) Schematic evolution of an isometric ice-cemented conglomeratic boulder whilst defrosting; the initial sphere (a) would degrade into a cone of 51.9° (b), but will adopt the maximum repose angle of 45° (c). On the right, the intermediate molard is shown. Initially chaotic fragments are released (d), that end by forming a high-sloping talus (e), that will evolve into a less-sloping talus (f). The original boulder (dark grey) might be exposed for a short time until it degrades to form the cone apex. Modified from Milana [20].
