# Weld Seam Failure Analysis of a Natural Gas Pipeline Reducer: Implications for Oil and Gas Transportation Safety

Ensuring the integrity of weld seams in pipeline components is critical for the safe and reliable transportation of oil and natural gas. This paper presents a systematic failure investigation of a cracked weld in a reducer located at a natural gas transmission station in Western China, aiming to identify the failure mechanism and assess its implications for pipeline safety management. A comprehensive analysis was conducted using macroscopic examination, chemical composition analysis, mechanical property testing, metallographic observation, and microscopic fracture characterization. The results reveal that the heat-affected zone (HAZ) exhibited abnormally high hardness (up to 588 HV0.1), indicating insufficient toughness that made it susceptible to cracking. The base metal showed a high carbon equivalent (CEV), placing it in the “difficult-to-weld” category and increasing its sensitivity to improper welding thermal cycles. On-site investigation further identified significant deficiencies in welding process control, including inadequate preheating, improper interpass te

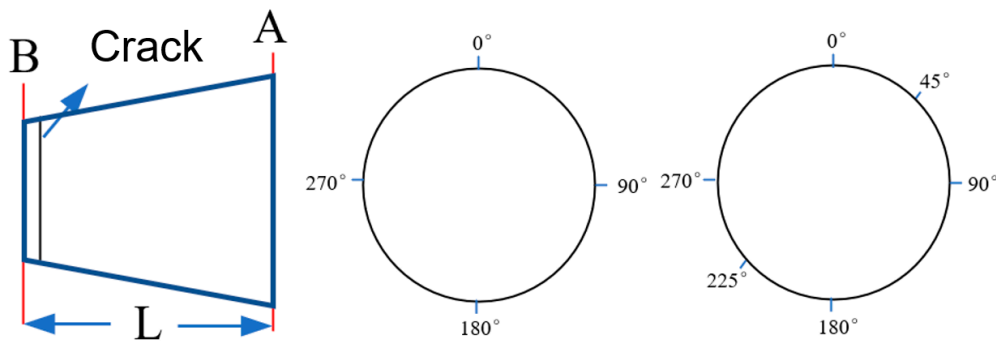
Figure 4. Schematic diagram of the measurement position for large and small heads.

The outer diameter and wall thickness of the reducer were measured using vernier calipers and a thickness gauge. The measurement locations are shown in Figure 4, and

the measurement results are shown in Table 1. The measurement results show that the geometric dimensions of the reducer conform to the requirements of “Steel buttwelding pipe fittings—Types and parameter”.

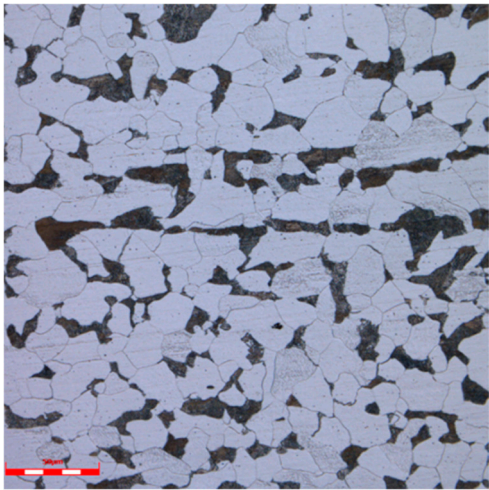
Figure 6. Straight tube microstructure (50 μm).

Metallographic samples were taken from the straight pipe, reducer, and circumferential weld, totaling six samples. According to “Inspection methods of microstructure for metals”, “Determination of ferrite grain size for cold rolled low carbon steel sheets”, and “Standard Test Methods for Determining the Inclusion Content of Steel”, the samples were analyzed for microstructure, grain size, and non-metallic inclusions using a MeF3A metallographic microscope and an OLS 4100 laser confocal microscope. The results are shown in Tables 5 and 6, and the metallographic structures are shown in Figures 6–9. The results show that the reducer’s metallographic structure is tempered sorbite with a grain size of 9.5; the straight pipe’s metallographic structure is ferrite and pearlite with a grain size of 7.5; and the circumferential weld exhibits a combination of acicular ferrite and polygonal ferrite. Observation of the cross-sectional sample of the crack revealed two cracks located in the heat-affected zone, extending from the inner wall to the outer wall, exhibiting predominantly transgranular morphology, with fewer secondary cracks and bifurcations, as shown in Figures 10 and 11. The long crack originated from the inner wall, penetrated the wall thickness, and displayed a distinct folded morphology; the short crack also originated from the inner wall, with a thicker root and a thinner tip.

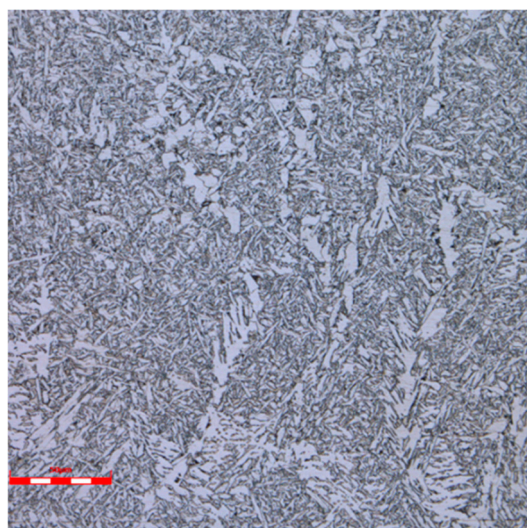
**Figure 9.** Weld structure of the reducer weld (50  $\mu\text{m}$ ).

| Sample | Structure |
|---|---|
| Circumferential weld | IAF + PF |

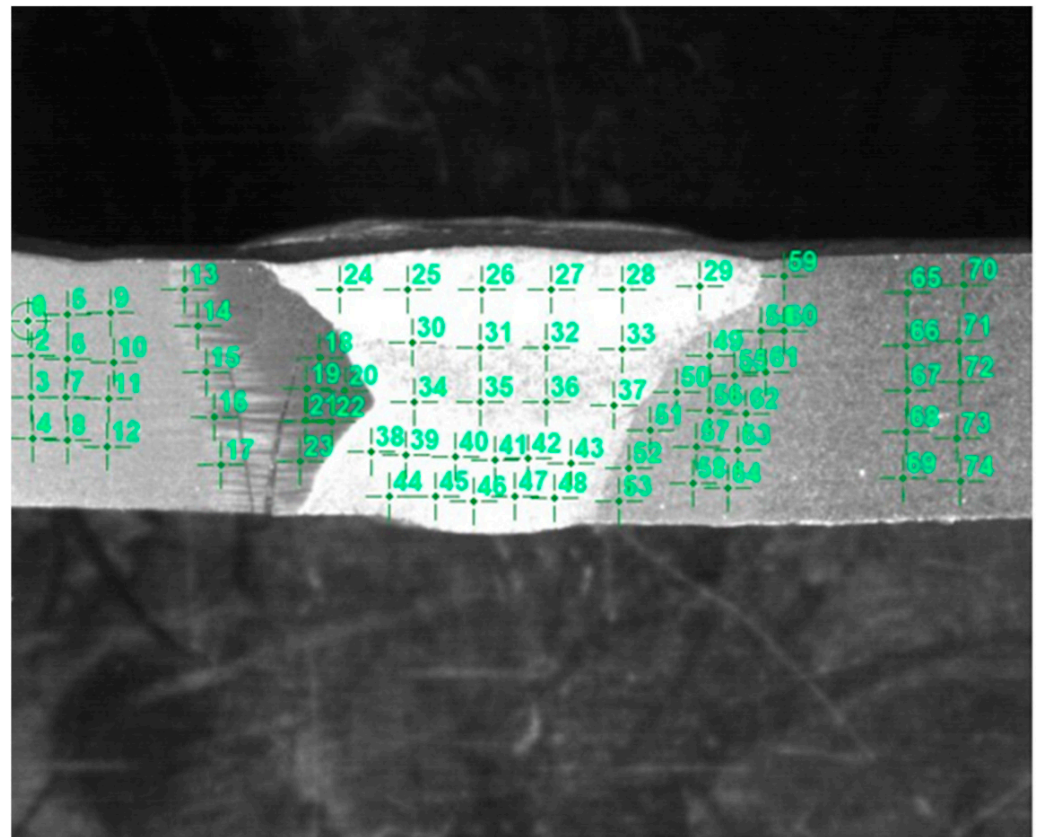
Figure 12. Microhardness test location.

Longitudinal cross-section specimens were taken from the crack. According to “Metallic materials—Vickers hardness test—Part 1: Test method”, a DuraScan 70G5 micro Vickers hardness tester was used. 74 hardness test points were established on the reducer and taper, as shown in Figure 12. The test results are shown in Table 8. The highest hardness in the heat-affected zone on the left side of the reducer reached 588 HV0.1, which does not comply with the hardness requirement of SY/T 4083-2012 “Technical specification for electric heat method of eliminating pipeline welding residual stress”: “The hardness value of carbon steel welds and heat-affected zones should not exceed 1.2 times the hardness of the base metal.” The macroscopic Vickers hardness of the specimens was used as a supplementary
