# Analysis of the Failure of the Rotating Support Girder of a Spreader Bridge <sup>†</sup>

This paper describes an example of a failure of the rotating support girder of a spreader bridge. The root cause of the damage was buckling of one of the girder's plates. This caused plastic deformation, which made the continued safe operation of the machine impossible. An FEM analysis was performed to determine the probable cause of the failure. Conclusions and recommendations are also presented in the paper to prevent similar failures in the future.

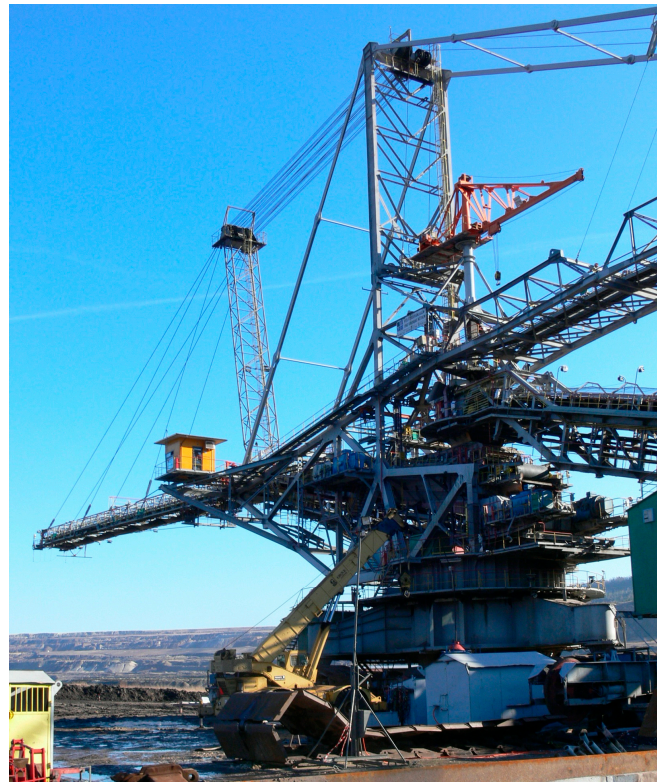
**Figure 2.** A2RsB 12.500 spreader.

The analyzed technical object was originally delivered by a German company in the 1980s. Since then, it has remained in operation. The machine type is A2RsB 12.500. During its operation, it underwent modifications and necessary overhauls. In Figure 2, the entire technical object is presented, including the spreader and bridge.

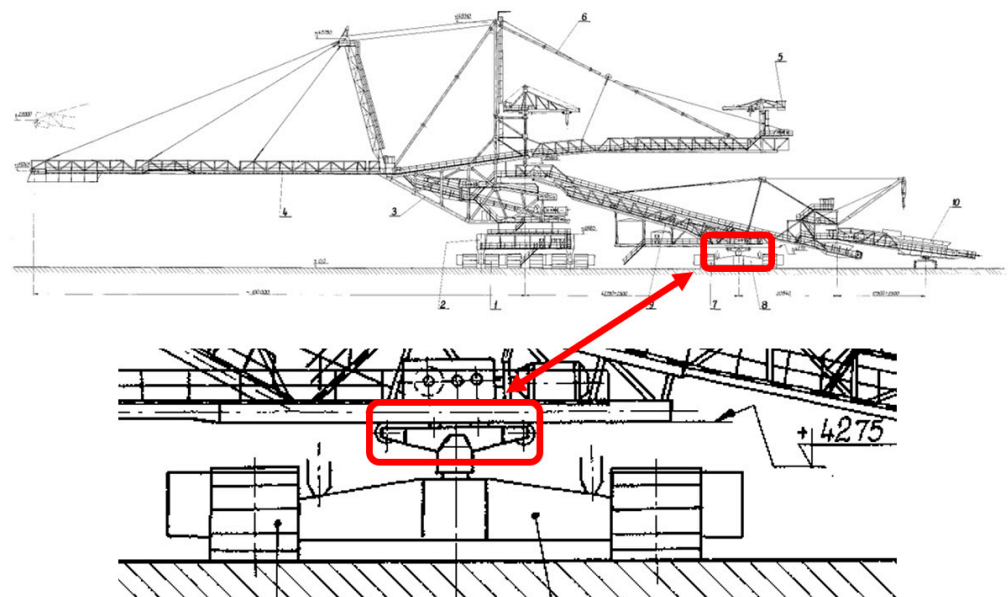
**Figure 3.** Rotating support girder location in relation to the entire machine.

The failure described in the article concerns a relatively small part of the entire machine. The damaged component is part of the support system of the loading bridge. Its location in relation to the entire machine is shown in Figure 3. The rotating support girder is an element that connects the substructure of the bridge to its main carrying structure. It allows for the relative movement of the substructure and superstructure in the following directions: translation along the machine axis, rotation around the substructure, and inclination to compensate for height differences in the stacker substructure. It is important, from the point of view of further work, to note that the support system prevents rotation along the axis of the entire machine.

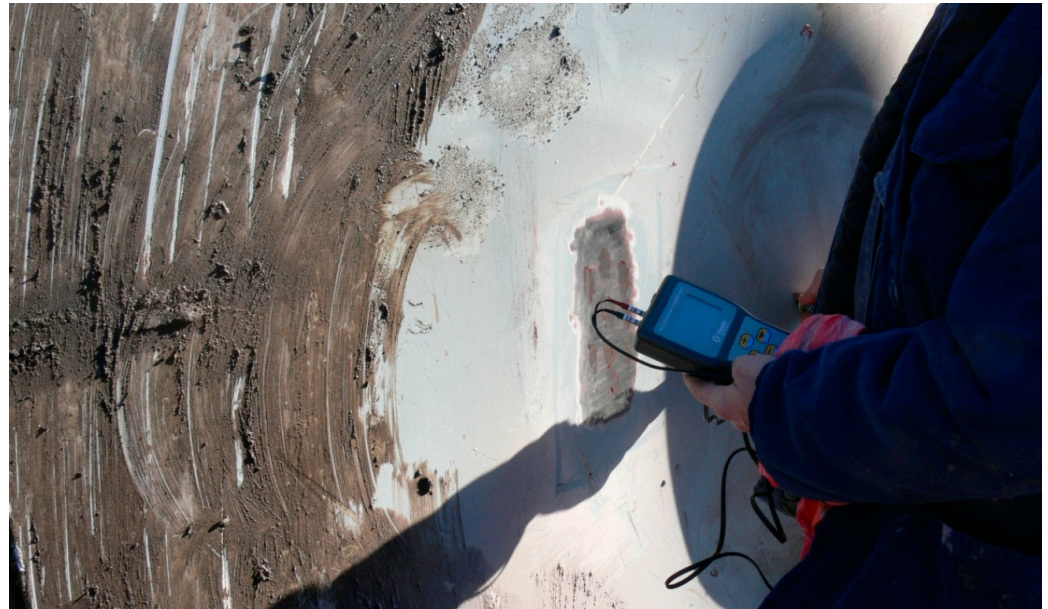
**Figure 4.** TIEDE TM-11 thickness gauge used for rotating support girder measurements.

damaged element. The magnetic particle method was used for this purpose. It did not reveal any defects that could cause the described failure. The second issue concerned the correctness of the design and the corrosion phenomenon. For this purpose, thickness gauge measurements (Figure 4) of all components of the rotating support girder were provided. As was the case for the magnetic particle method, no problems were found—all dimensions were in accordance with the available technical documentation.

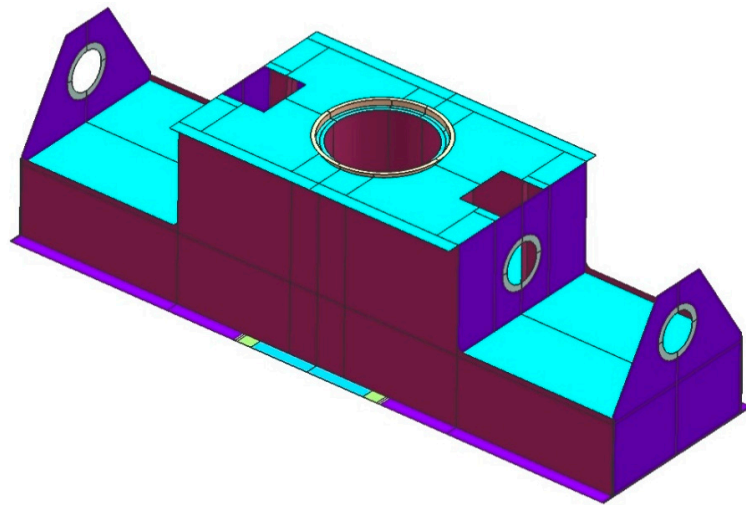
**Figure 7.** Geometrical model of the rotating support girder.

Numerical calculations were carried out in order to identify the causes of the buckling phenomenon. For this purpose, we created a geometric model of the analyzed object: the rotating support girder. The model was made using the surface technique. In Figure 7, the geometric model is shown. It was created according to the available technical documentation. Based on the geometric model, a discrete model was developed. It consisted of the following types of finite elements: shell, beam, and rigid. In total, 40,412 finite elements were used to build the model. Structural steel with a yield strength of  $R_e = 355$  MPa was adopted as the material model. The calculations were performed based on the Polish standard used in this type of machine. It is marked with the symbol PN-G-47000-2 [12] and is similar to the DIN 22261-2:1997 standard [13], which is widely used in this industry.
