# CT Scans of Asbestos Cement Pipes to Support the Development of Better Condition Assessments <sup>†</sup>

Karel van Laarhoven \* and Claudia Quintiliani

KWR Water Research Institute, Groningenhaven 7, 3433 PE Nieuwegein, The Netherlands;

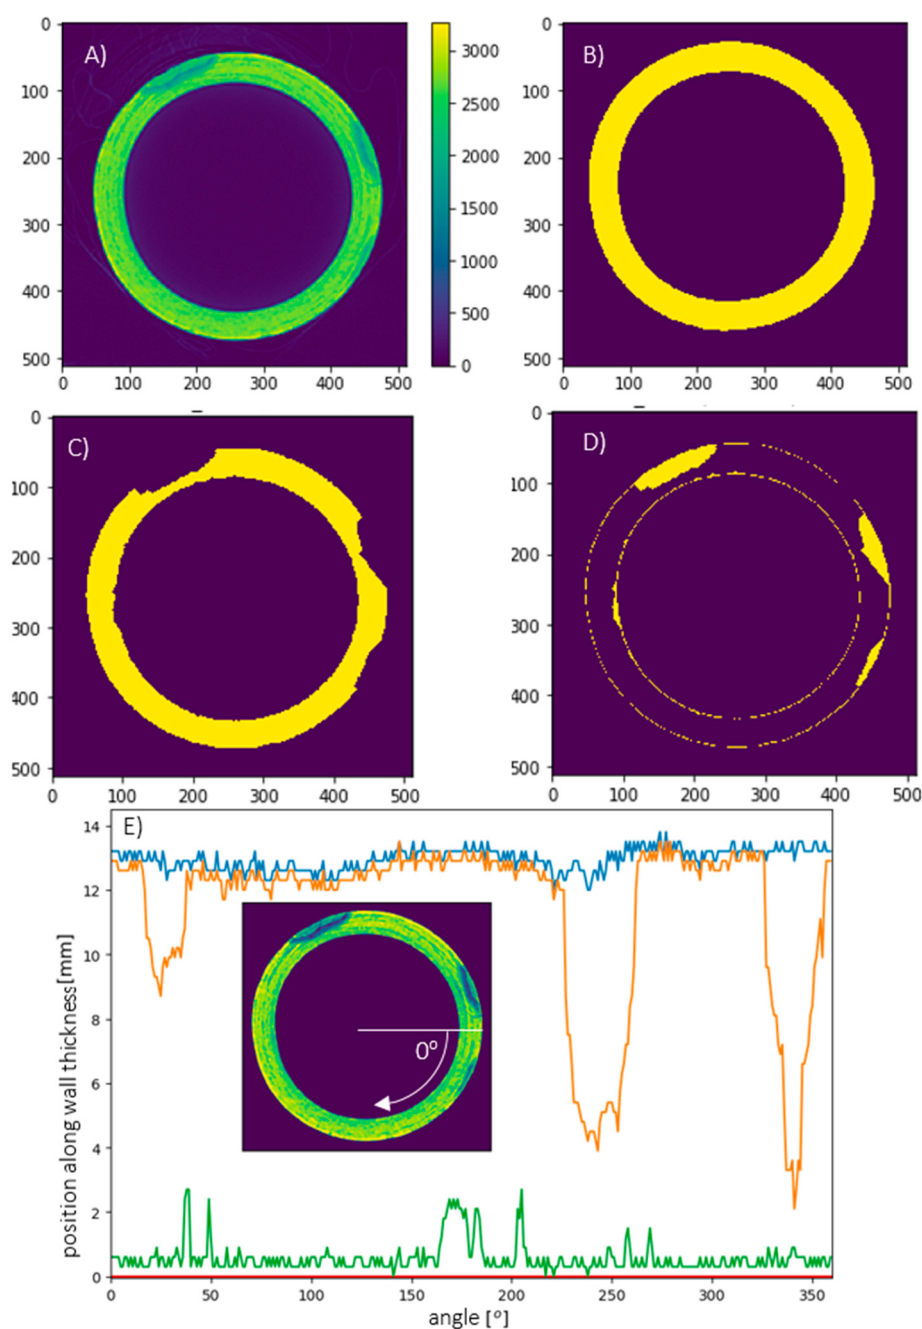
- (a) The algorithm starts with the original slice, shown in Figure 1A, with the color scale from the blue to yellow indicating low to high pixel grey values, corresponding to low and high radio densities, respectively;

- (b) The silhouette of the pipe material is collected, from the pixels with a value above 1500 (Figure 1B);
- (c) The silhouette of the undegraded pipe material was collected by finding pixels with a value between 1500 and 2400 (Figure 1C);

- (d) The silhouette of the degraded material is constructed, obtained by subtracting c from b (Figure 1D);
- (e) Profiles of the original wall thickness are determined from b (Figure 1E, blue) and the interfaces between the degraded and undegraded material are determined from d for internal degradation (Figure 1E, green) and external degradation (Figure 1E, orange). The arrow illustrates the relation between the angles on the x axis and the position in the original slice image.

**Figure 1.** Basic steps of the computed tomography (CT) image-processing algorithm.
