Seismic Performance Evaluation and Comparative Study of Reinforced Concrete Building on a Sloped Terrain with Regular Building by Considering the Effect of URM Infill Walls

Keywords: hilly slope; step-back building; infill wall; non-linear analysis

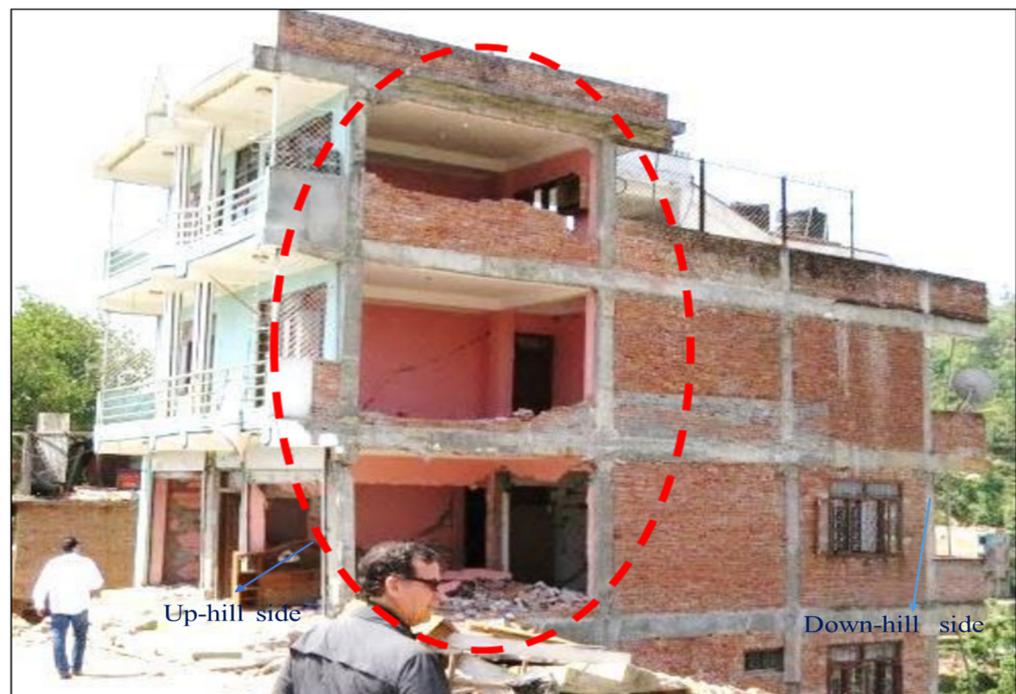
Figure 1. Damaged RC building resting on sloped terrain affected by the 2015 Nepal earthquake [5].

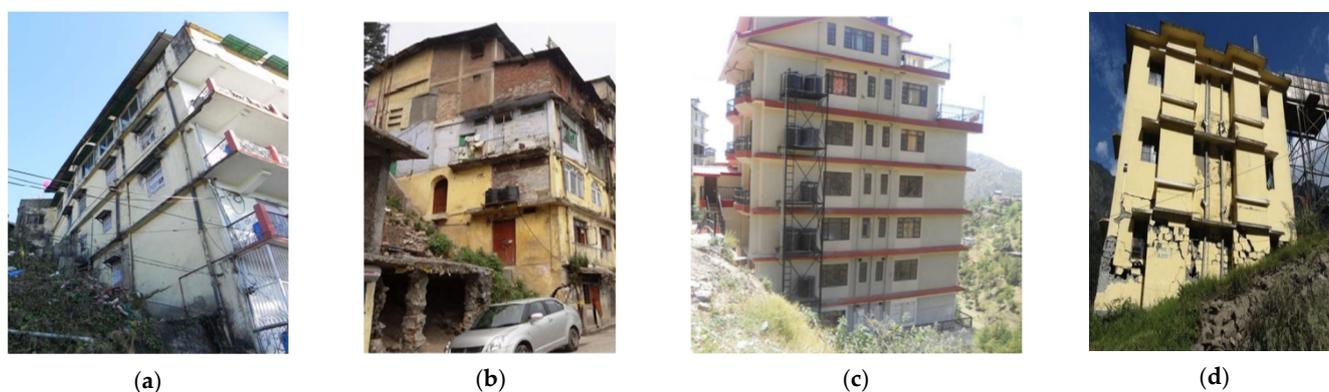
Figure 2. RC buildings situated in hilly regions of India. (a) [4], (b) [17], (c) [18], (d) [19].

Welsh-Huggins et al. [16] analysed buildings with stepped configurations in Mizoram and Aizawl. The researchers found that most buildings in Aizawl were designed without considering material degradation and soil–structure interaction. They observed a specific failure pattern, characterized by a zippering failure of the base column and a shearing failure in the storeys above it, particularly the second and third storeys. The study concluded that increasing the size of the columns and using larger transverse reinforcements could shift the failure mechanism from weak storey failure to side-way failure. This shift in design approach is illustrated in Figure 2, which depicts RC buildings situated in the hilly, sloped regions of India.

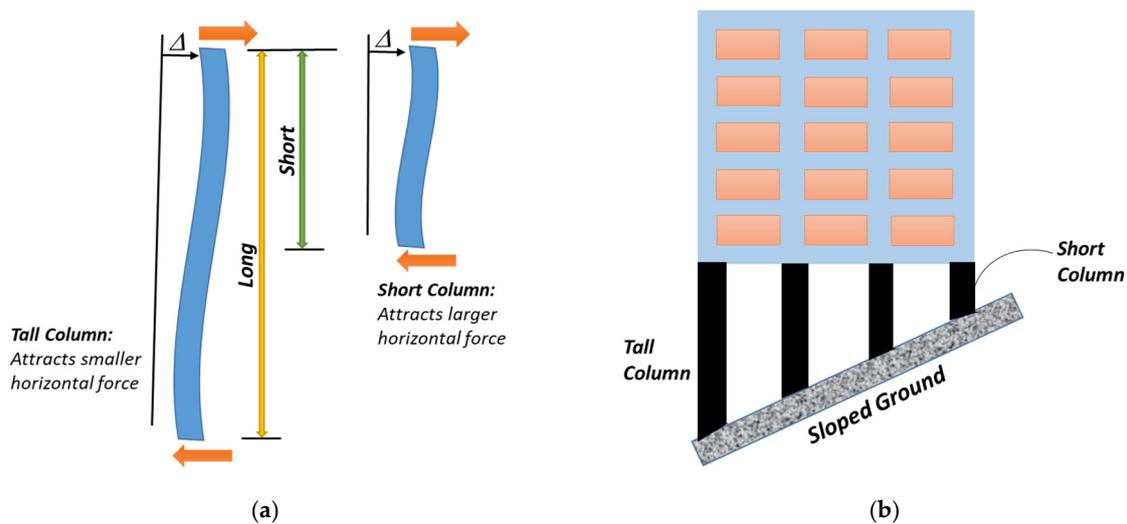
Figure 4. (a) Difference between short and long columns. (b) Representation of a building in a hilly region with a short column.

Generally, in hilly slope regions, the height of the columns varies due to the sloped terrain. As the height of the columns varies, both long and short columns come into action, as shown in Figure 4b. Columns with effective lengths (lesser lateral dimension) of less than 12 are categorised as short columns [21]. When the structure is designed without any proper consideration of large forces, the column fails. Short columns are stiffer than long

columns and require more force to displace, which invariably results in short columns attracting more force, as shown in Figure 4a. Short columns have higher resistance to lateral loads compared to long columns and attract more force during earthquakes. From past research [21–24], it is found that the cracking pattern is diagonal in nature before the failure of short columns. It is technically not possible to avoid short columns due to various reasons; hence, special care in the designing of short columns has to be incorporated. IS 13920:1993 [25] recommends the usage of confining reinforcement throughout the height of the short column.

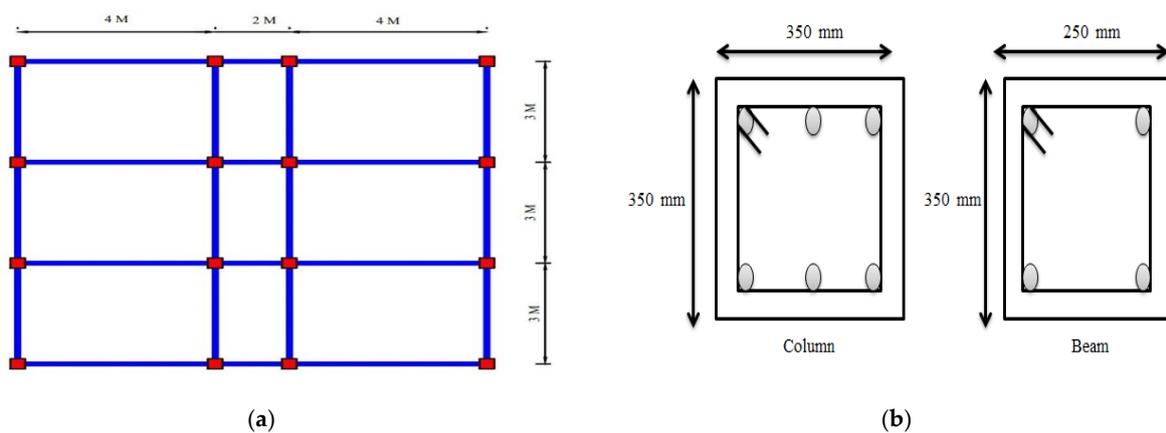
Figure 5. (a) Plan view; (b) cross-section of column and beam.

regular buildings are considered as reference buildings. The step-back building is modelled as three storeys on the uphill side and six storeys on the downhill side. All three buildings have a rectangular plan, and each building plan is $10\text{ m} \times 9\text{ m}$. The details of the plan are in Figure 5a, and Figure 5b shows the sizes of beams and columns. The step-back building with and without infill walls is shown in Figure 6a–c. Regular buildings of three and six storeys with and without infill walls are shown in Figure 6d–i. The dimensions of beams and columns considered in the models are $250\text{ mm} \times 350\text{ mm}$ and $350\text{ mm} \times 350\text{ mm}$, respectively. Both roof and floor slabs have a thickness of 125 mm . Sections are designed for a compressive strength of 20 MPa , and the yield strength of steel is 415 MPa . The live loads at the roof and floor are considered as 1.5 kN/m^2 and 3 kN/m^2 ; the roof floor finish as 1 kN/m^2 . An infill wall with a thickness of 125 mm is considered for the study. All the above dimensions were determined based on the literature review. The dimensions of sections used with reinforcement are shown in Figure 5b. The dimensions considered for the study building align with most of the real buildings situated in the region of Nepal and northeast India. While designing, slabs were assumed to be rigid diaphragms, whereas 3D space frames were designed using two-node beam elements. At every nodal point, six degrees of freedom (three rotational and three translational) were assigned. The properties of the crack section were determined as per IS 1893:2016 Part 1 [20]. The current model of the building was designed in accordance with Indian standards [20,32]. In order to introduce non-linear behaviour, two plastic hinges were assigned at both ends of all the frame elements. This method is called lumped plasticity. Similarly, assignment of flexural hinges was performed on both ends of the beam. At each end of the column, hinges were assigned for axial force moment interaction (P-M-M). Hinge properties were determined according to ASCE/SEI 41-06 (2013) [33]. The modelling of the infill wall was conducted using the strut modelling procedure. Details on the modelling procedures for the strut, along with its boundary conditions, are provided in Section 6.1. Furthermore, a single-strut model was used for pushover analysis and is shown in Figure 6b,e,h. However, a cross-strut model was used for time history analysis and is shown in Figure 6c,f,i. To simulate the effect of an infill wall, axial plastic hinges were assigned at the mid-span of the strut models. All three models were designed and analysed by using non-linear analysis with the software SAP2000 v20.2.0 [8]. In such analysis, the Takeda hysteresis model is adopted to simulate hysteretic behaviour in time history analysis for all the buildings. The analysis was conducted assuming the base of the building to be fixed.

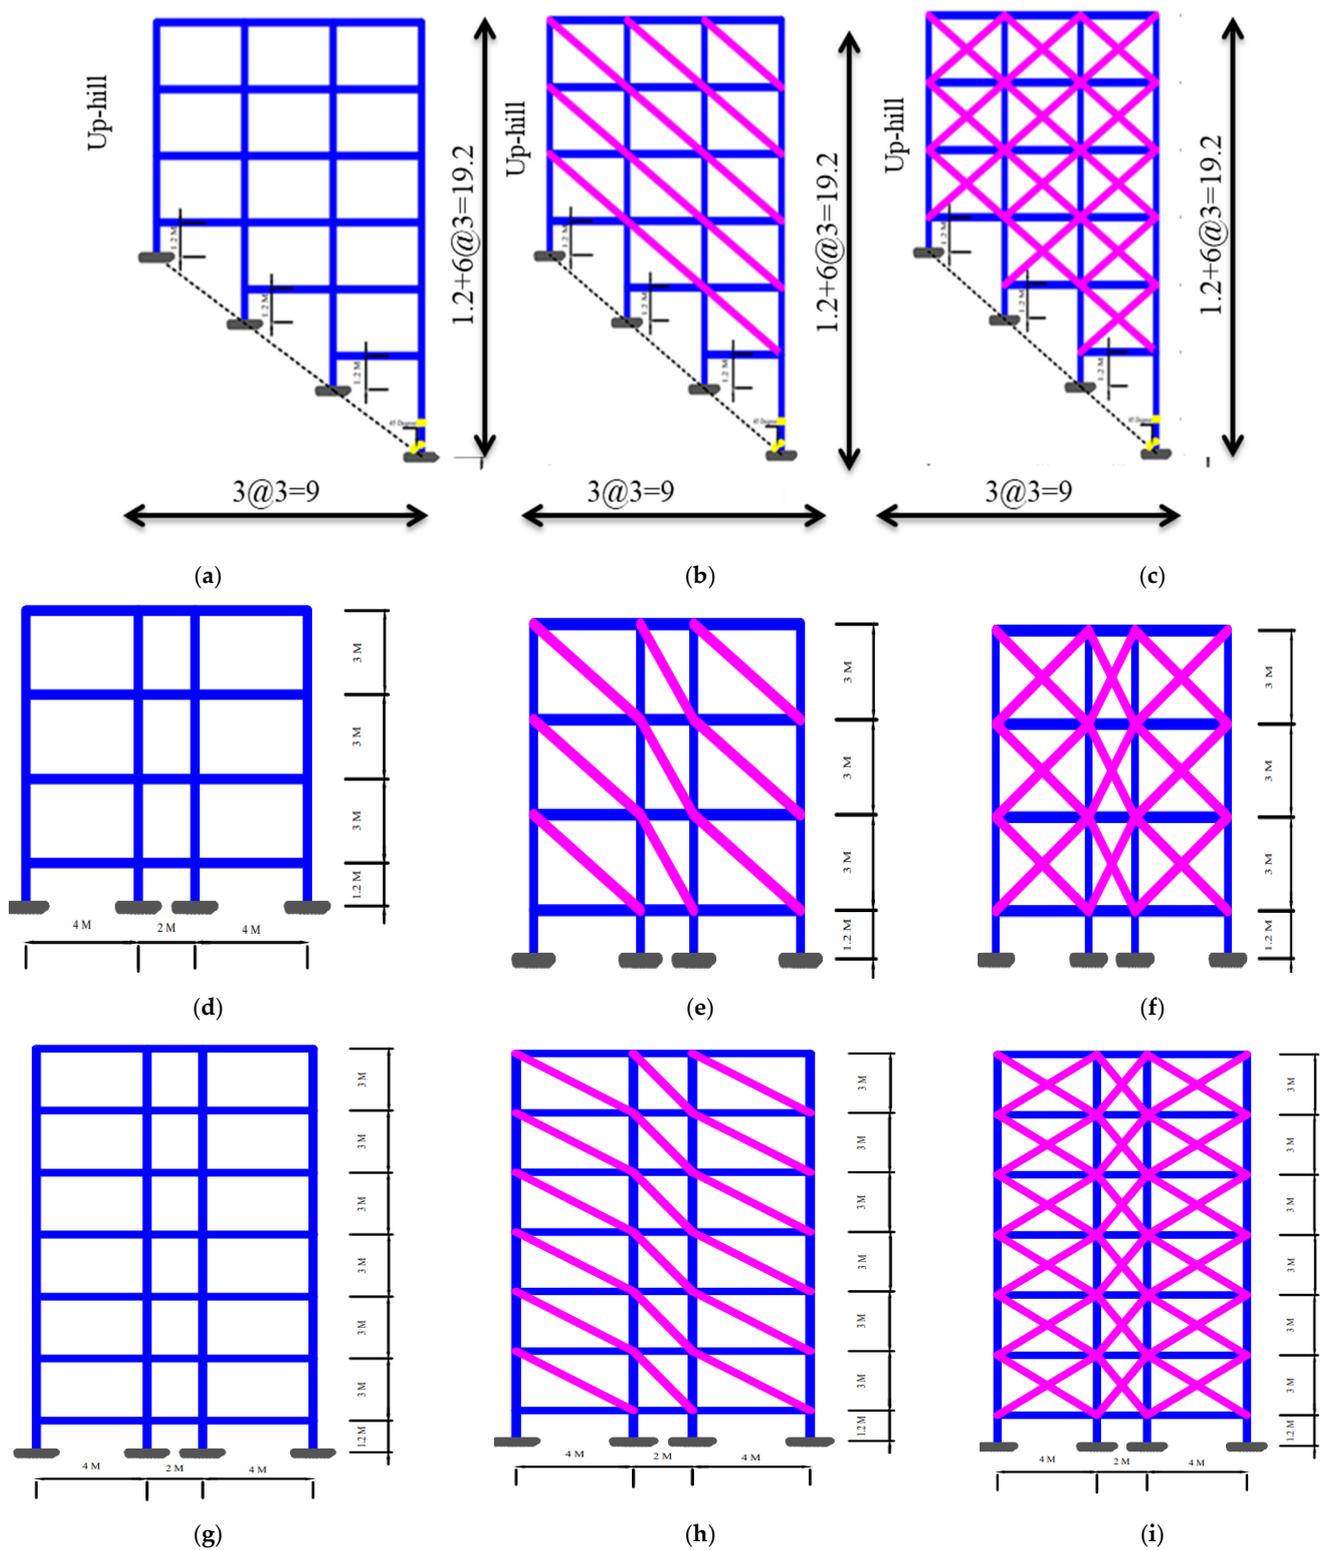
Figure 6. (a) Step-back building; (b) step-back building with single-strut infill; (c) step-back building with infill; (d) 3-storey regular building; (e) 3-storey regular building with single-strut infill; (f) 3-storey regular building with infill; (g) 6-storey regular building; (h) 6-storey regular building with single-strut infill; (i) 6-storey regular building with infill.

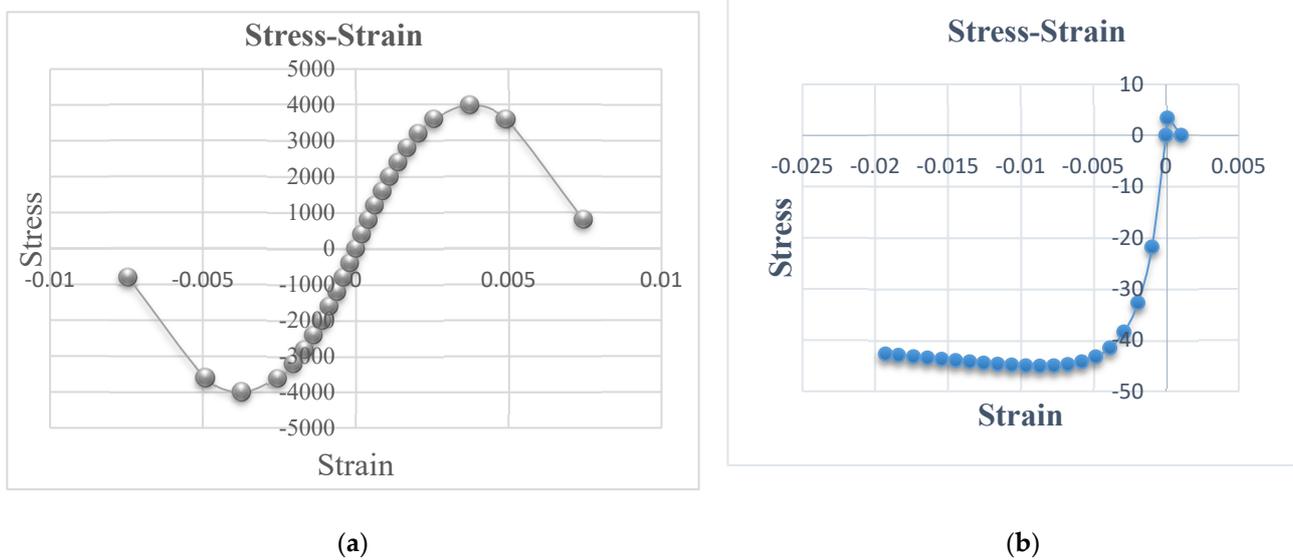
Figure 7. (a) Idealized stress–strain curve, (b) Mander confined concrete.

where f_m , f_b , f_{mo} , and E_{me} represent the compressive strength of the masonry prism, the compressive strength of the brick unit, the compressive strength of mortar, and the modulus of elasticity of brick, respectively. All the units are in Mpa. Generally, in the northeast regions, second-class bricks are used for the construction of buildings, and the compressive strengths of mortar and masonry bricks were considered in accordance with IS 1077:1992 [34]. The mortar mix ratio of cement to sand was considered to be 1:4. To simulate the stress and strain behaviour of concrete, Mander's confined concrete model was used and is shown in Figure 7b. Similarly, for steel, the elastoplastic law was adopted [35]. To include the non-linear behaviour of masonry, an idealised stress–strain curve formatted by Kaushik et al. [27] was used and is shown in Figure 7a. In this study, an infill wall of a thickness of 125 mm was considered.

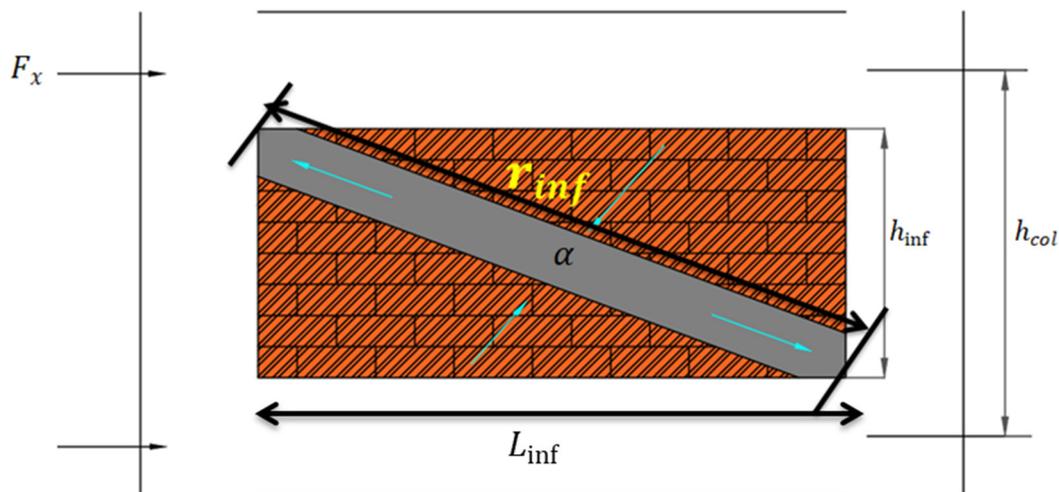
Figure 8. Equivalent diagonal strut of URM infill wall.

Diagonal struts were used to demonstrate the action of infill walls, which was done by calculating the effective width of the diagonal strut, and this is shown in Figure 8. The effective width (a) was adopted from ASCE 41 [33] and is given in Equation (3). A similar procedure is carried out in the Indian code IS 1893:2016 [20], as well as in other seismic codes of different countries.

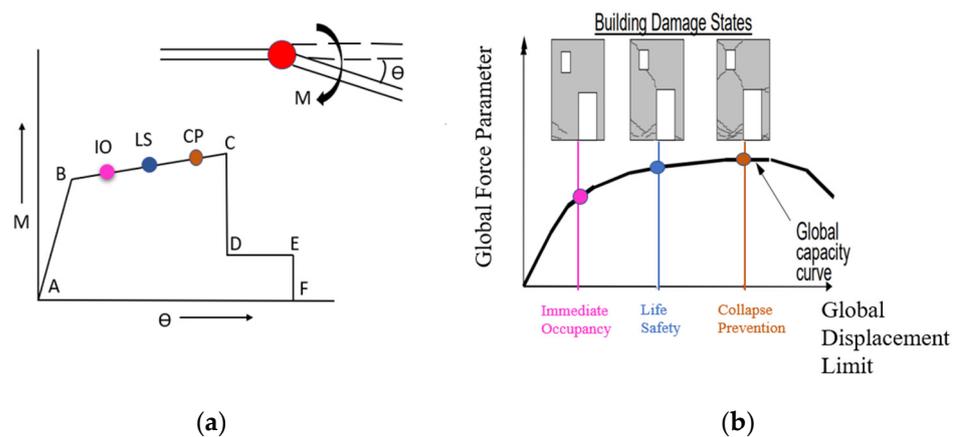
Figure 9. (a) Common flexural hinge features, (b) global capacity curve.

Maximum Considered Earthquake (MCE) were determined. According to IS 1893:2016 [20], Maximum Considered Earthquake (MCE) peak ground acceleration (PGA) for Zone V is 0.36 g, and DBE acceleration is 0.18 g, during the structure's service life [39]. Levels of damage, as shown in Figure 9a, such as immediate occupancy (IO), life safety (LS), and collapse prevention (CP), are defined according to ASCE 41-06 (2007) [33]. At the IO level, minor fractures are seen in non-structural parts of the building. Together with residual stiffness and strength in all storeys, a permanent drift is included into the structural design at the level of LS. At the level of CP, the buildings are barely stable, although the walls and columns are still functional. At this point, the building's non-structural components are severely compromised, and it is dangerously close to collapse [40]. Figure 9b highlights the various levels of damage in an RC building.

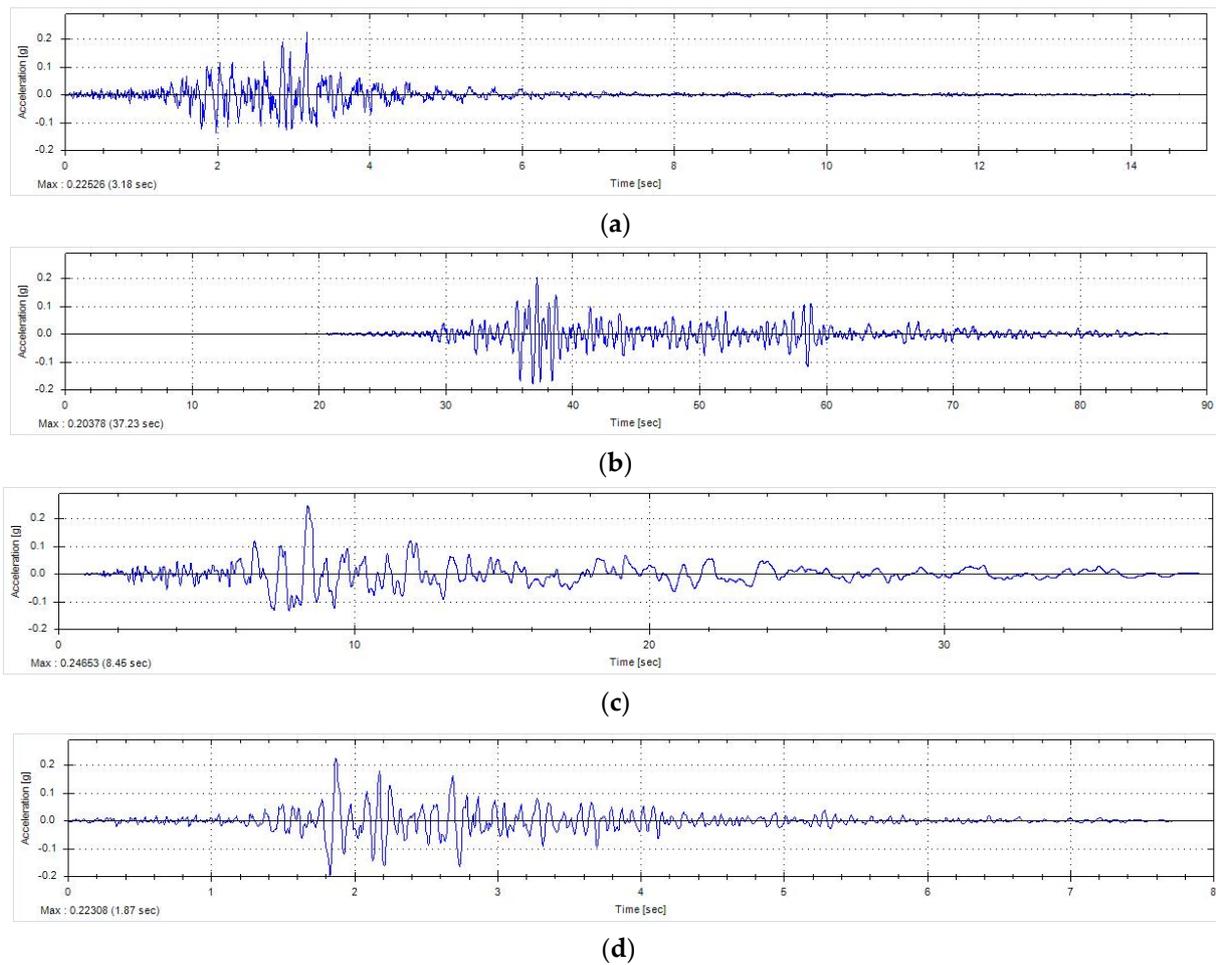
Figure 10. (a) Big Bear, (b) Chi-Chi, (c) Loma Prieta, (d) North Ridge.

For the present study, a non-linear time history analysis was performed to understand the dynamic behaviour of RC buildings. A set of four far-field ground motions were used and are shown in Figure 10a–d. The earthquakes used in the study are the 1992 Big Bear earthquake (M_w 6.5), 1999 Chi-Chi earthquake (M_w 7.7), 1989 Loma Prieta earthquake (M_w 6.9), and 1994 North Ridge earthquake (M_w 6.7). These ground motion data were scaled up with the peak ground accelerations (PGAs) of 0.18 g and 0.36 g to generate the results of storey displacement and storey drift ratio. The corresponding peak ground accelerations obtained from the scale factor are given below:

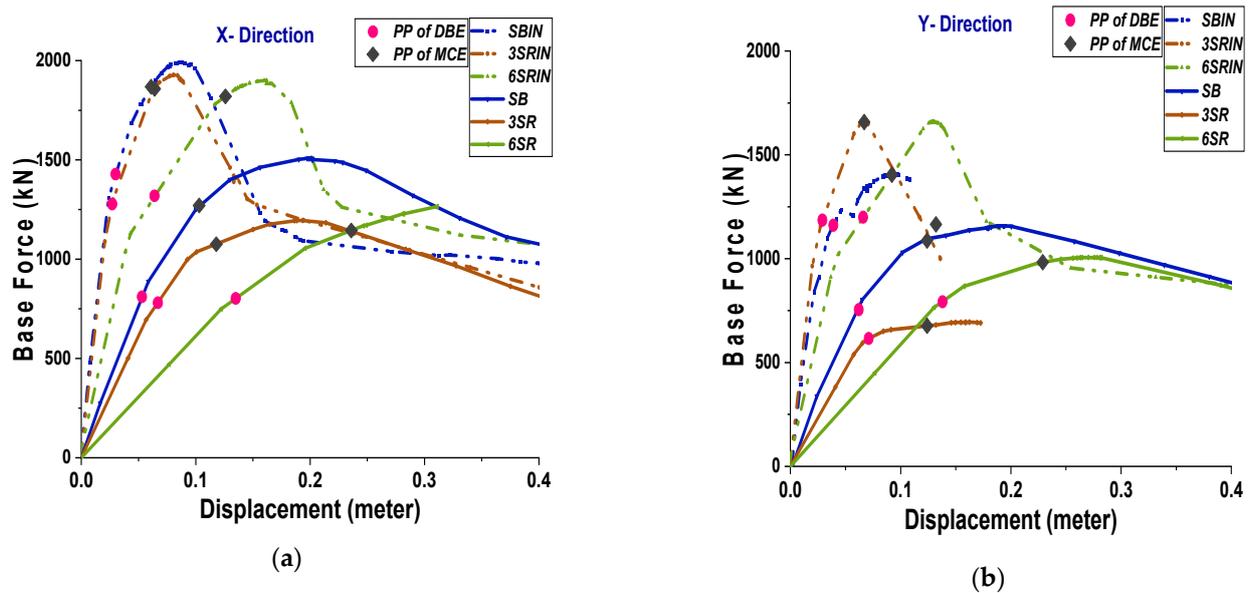
Figure 11. Capacity curves of buildings with and without infill walls in the (a) X and (b) Y directions.

This research analysed building stability through the lens of capacity curves, which graph a building's sway against its base resistance. The curves, particularly for top-floor nodes in the X and Y directions, are illustrated in Figure 11a,b. Structures with infill walls, represented by dotted lines, show greater peak base forces: 25% for step-back buildings (SBIN), 20% for three-storey (3SRIN), and 30% for six-storey (6SRIN) regular buildings compared to those without infill (SB, 3SR, and 6SR). The integration of infill walls significantly increases rigidity, enhancing lateral force resistance while reducing flexibility.

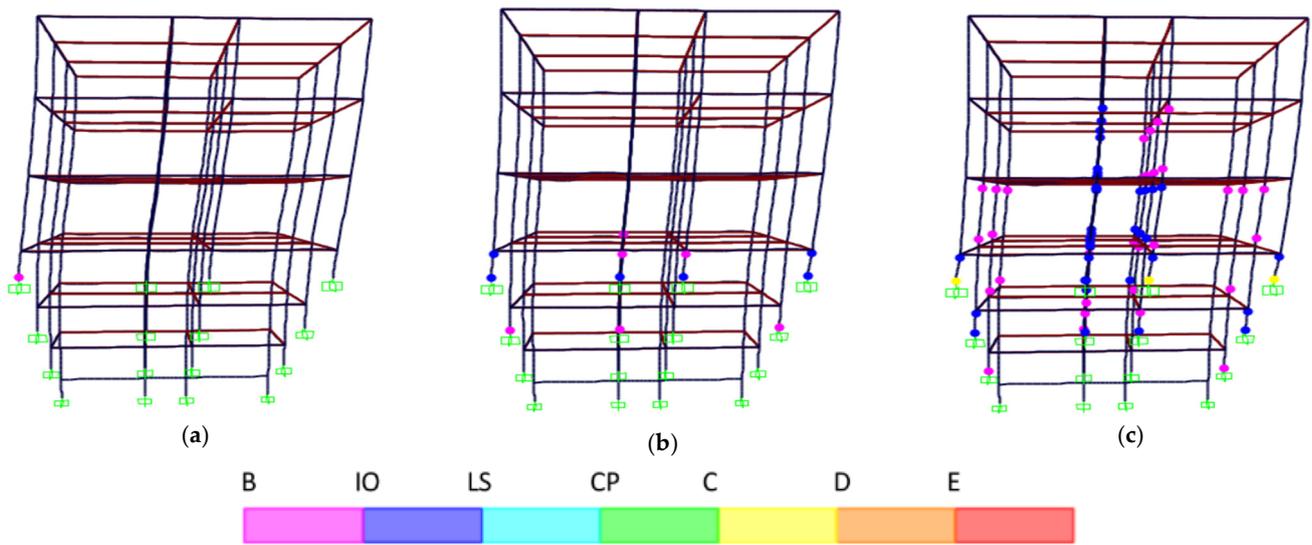
Figure 12. Hinge pattern of step-back building: pushover analysis in X direction; (a) first hinge; (b) performance point at DBE; (c) performance point at MCE.

Figure 12 shows the hinge pattern of a step-back building in the X direction. It can be observed that the first hinge is formed in the short column because the short column attracts a large force. Further, at the DBE performance point, a total of 12 hinges are formed; this is shown in Figure 12b. Table 3a gives the details of hinge formation along the step-back building for each interval. The structural components in the uphill side of the building fall in the range of IO to LS. Hence, it is seen that the uphill side of the building is more vulnerable at the DBE level. However, at the MCE performance point, 77 hinges were formed, and are shown in Figure 12c. From Table 3a it can be seen that some of the hinges on the uphill side columns fall in the region of C to D, which concludes with the total collapse of the frame. Also, the maximum number of hinges were formed in the uphill side of the step-back building, which shows the vulnerability of step-back buildings.

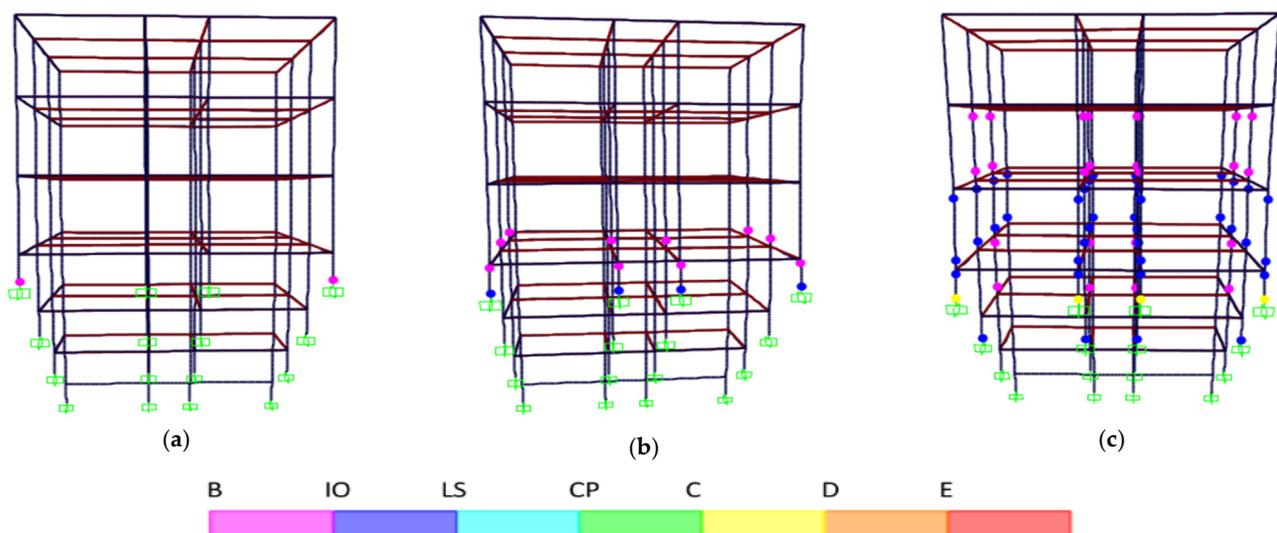
Figure 13. Hinge pattern of step-back building: pushover analysis in Y direction; (a) first hinge; (b) performance point at DBE; (c) performance point at MCE.

Figure 13 shows the hinge pattern of a step-back building in the Y direction. Here also it is observed that the first hinge was formed in the short column due to the attraction of a large force. Further, at the DBE performance point, a total of 15 hinges were formed and are shown in Figure 13b. Table 3b gives the details of hinge formation along the step-back building for each interval. Structural components in the uphill side of the building fall in the range of IO to LS. Hence, at the MCE performance point, a total of 73 hinges were formed and are shown in Figure 13c. From Table 3b it can be seen that some of the hinges at the uphill side columns fall in the range of C to D, which concludes with the total collapse of the frame. Also, the maximum number of hinges were formed at the uphill side of the step-back building, which shows the vulnerability of step-back buildings.

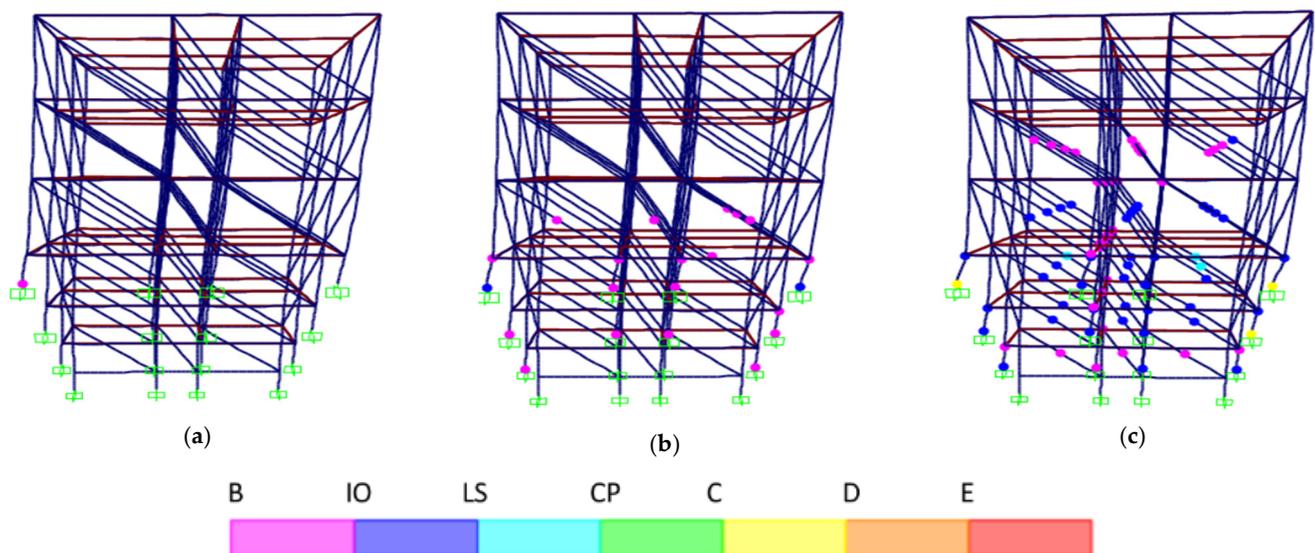
Figure 14. Hinge pattern of step-back building with infill: pushover analysis in X direction; (a) first hinge; (b) performance point at DBE; (c) performance point at MCE.

Figure 14 illustrates the hinge pattern in a step-back building with infill in the X direction. It has been observed that the first hinge forms in the short column, which attracts a large force. Additionally, at the Design Basis Earthquake (DBE) performance point, a

total of 21 hinges were formed, as depicted in Figure 14b. Table 4a provides detailed information about the formation of hinges along the step-back building with infill at each interval. Structural components of the uphill side of the building fall in the range of IO to LS, and the rest of the hinges formed in the infill of the building. Hence, at the DBE performance point, the uphill-side-storeys' infill walls underwent little damage that can undergo retrofitting. However, at the MCE performance point, 79 hinges were formed and are shown in Figure 14c. From Table 4a, it can be seen that some of the hinges fall in the range of LS to CP and some of them fall in the range of C to D on the uphill side of the short column. We conclude that the building underwent severe damage that cannot be retrofitted. Also, in the uphill side of the step-back building with infill, most of the infill walls underwent complete collapse.

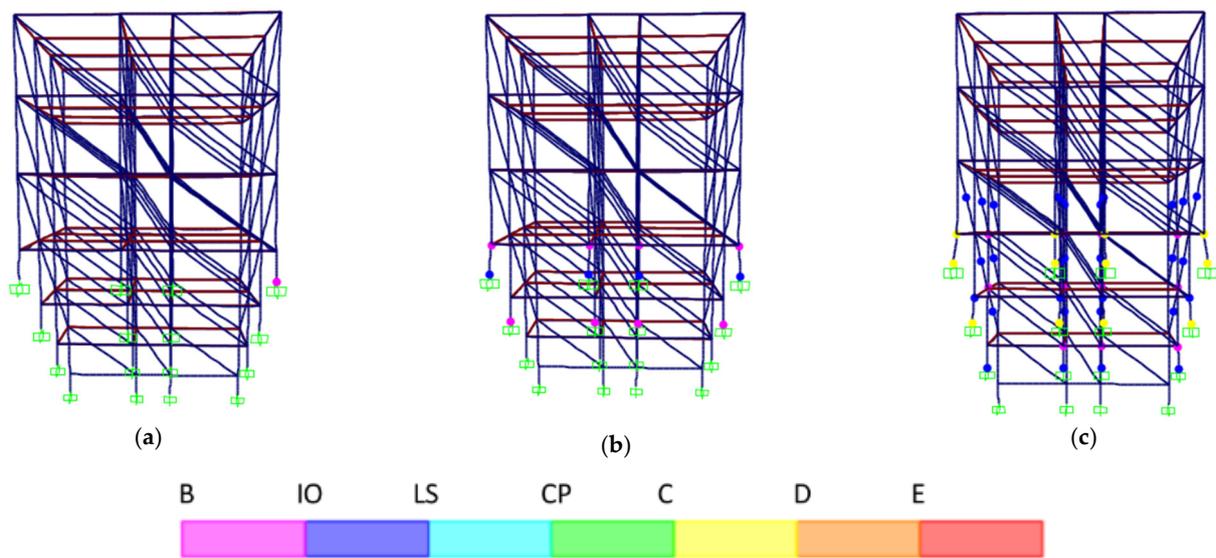
Figure 15. Hinge pattern of step-back building with infill: pushover analysis in Y direction; (a) first hinge; (b) performance point at DBE; (c) performance point at MCE.

Figure 15 shows the hinge pattern of a step-back building with infill in the Y direction. It can be observed that the first hinge was formed in the short column because the short column attracts a large force. Furthermore, at the DBE performance point, a total of 12 hinges were formed and are shown in Figure 15b. Table 4b gives the details of hinge formation along the step-back building without infill for each interval. Structural components in the uphill side of the building fall in the range of IO to LS, and the rest of the hinges fall in the infill of the building. Hence, at the DBE level, only short columns underwent deformation, and no damage was observed in infill walls. However, at the MCE performance point, 76 hinges were formed and are shown in Figure 15c. From Table 4b, it can be seen that the hinges were formed at infill walls in the range of the IO to LS levels, and some of the hinges on short columns fall in the range of C to D, from which we conclude that the step-building with infill underwent severe damage at the MCE performance point.

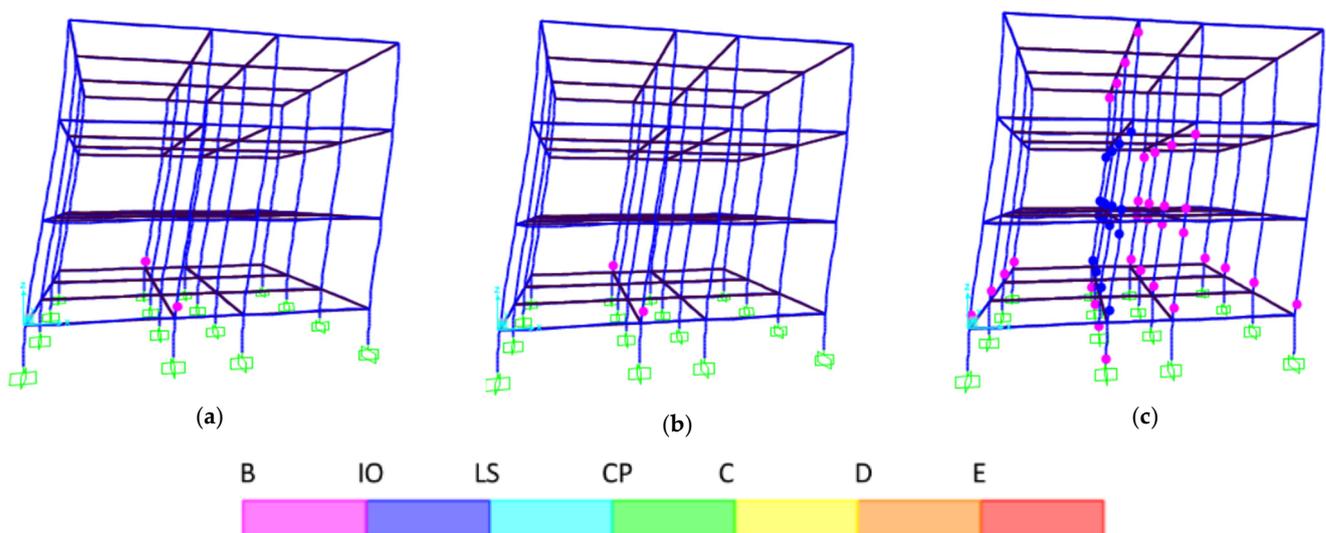
Figure 16. Hinge pattern of 3-storey regular building: pushover analysis in X direction; (a) first hinge; (b) performance point at DBE; (c) performance point at MCE.

Figure 16 shows the hinge pattern of a three-storey regular building in the X direction. It can be observed that the first hinge was formed at an intermediate column of the building. Further, at the DBE performance point, a total of two hinges were formed and are shown in Figure 16b. Table 5a gives the details of hinge formation along the three-storey regular building for each interval. Structural components in the intermediate column of the building fall in the range of B to IO. Hence, it can be seen that a three-storey regular building does not undergo deformation. However, at the MCE performance point, 48 hinges were formed and are shown in Figure 16c. From Table 5a, it can be seen that few hinges on intermediate columns fall in the range of IO to LS, from which we conclude that the three-storey regular building shows moderate damage and can be retrofitted.

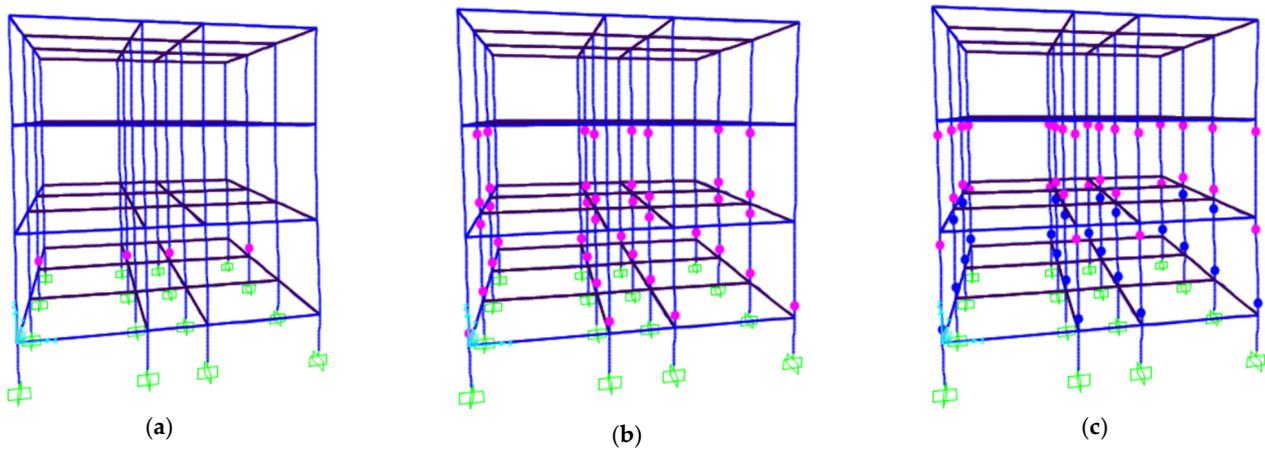
Figure 17 shows the hinge pattern of a three-storey regular building in the Y direction. It can be observed that the first hinge was formed at the intermediate column of the building. Furthermore, at the DBE performance point, a total of 40 hinges were formed and are shown in Figure 17b. Table 5b gives the details of hinge formation along the three-storey regular building for each interval. Structural components at the first and second storeys of the building fall in the range of B to IO. Hence, it can be seen that a three-storey regular building does not undergo deformation. However, at the MCE performance point, 56 hinges were formed and are shown in Figure 17c. From Table 5b, it can be seen that some of the hinges at the first storey of the building fall in the range of IO to LS, from which

we conclude that the three-storey regular building shows moderate damage and can be retrofitted.

Figure 17. Hinge pattern of 3-storey regular building: pushover analysis in Y direction; (a) first hinge; (b) performance point at DBE; (c) performance point at MCE.

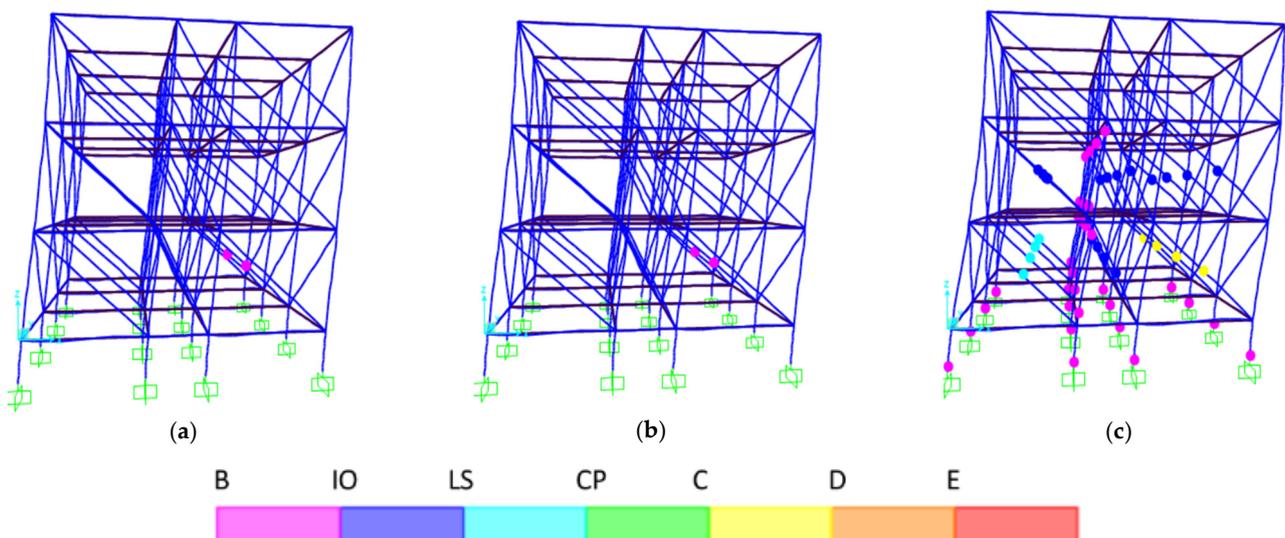
Figure 18 shows the hinge pattern of a three-storey regular building with infill in the X direction. It can be observed that the first hinge was formed at intermediate infill walls of the building. Furthermore, at the DBE performance point, a total of two hinges were formed and are shown in Figure 18b. Table 6a gives the details of hinge formation along the three-storey regular building with infill for each interval. Structural components in infill walls of the building fall in the range of B to IO. Hence, it can be seen that a three-storey regular building with infill does not undergo deformation. However, at the MCE performance point, 55 hinges were formed and are shown in Figure 18c. From Table 6a, it can be seen that in infill walls of the building, some hinges fall in the range of LS to CP and some fall in the range of C to D, from which we conclude that there was a total collapse of infill walls at the first storey of the building.

Figure 18. Hinge pattern of 3-storey regular building with infill: pushover analysis in X direction; (a) first hinge; (b) performance point at DBE; (c) performance point at MCE.

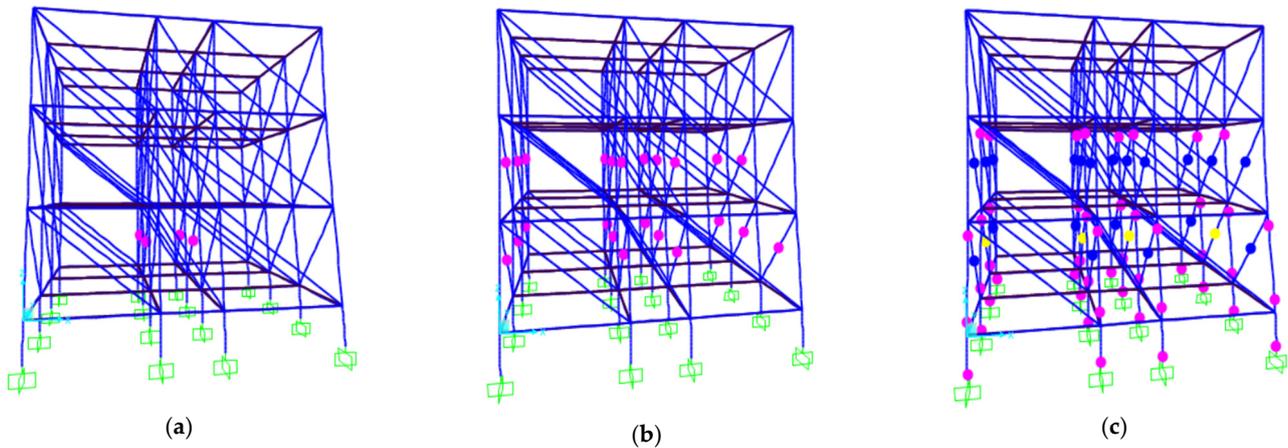
Figure 19 shows the hinge pattern of a three-storey regular building with infill in the Y direction. It can be observed that the first hinge was formed at the intermediate infill walls of the building. Furthermore, at the DBE performance point, a total of 23 hinges were formed and are shown in Figure 19b. Table 6b gives the details of hinge formation along the three-storey regular building with infill for each interval. Structural components in the outer infill walls of the first and second storeys of the building fall in the range of B to IO. Hence, it can be seen that a three-storey regular building with infill does not undergo

deformation. However, at the MCE performance point, 69 hinges were formed in the first and second storeys of the building, which is shown in Figure 19c. From Table 6b, it can be seen that in the infill walls of the building, some hinges fall in the range of LS to CP and some fall in the range of C to D, from which we conclude that there was a collapse of infill walls at the first storey of the building.

Figure 19. Hinge pattern of 3-storey regular building with infill: pushover analysis in Y direction; (a) first hinge; (b) performance point at DBE; (c) performance point at MCE.

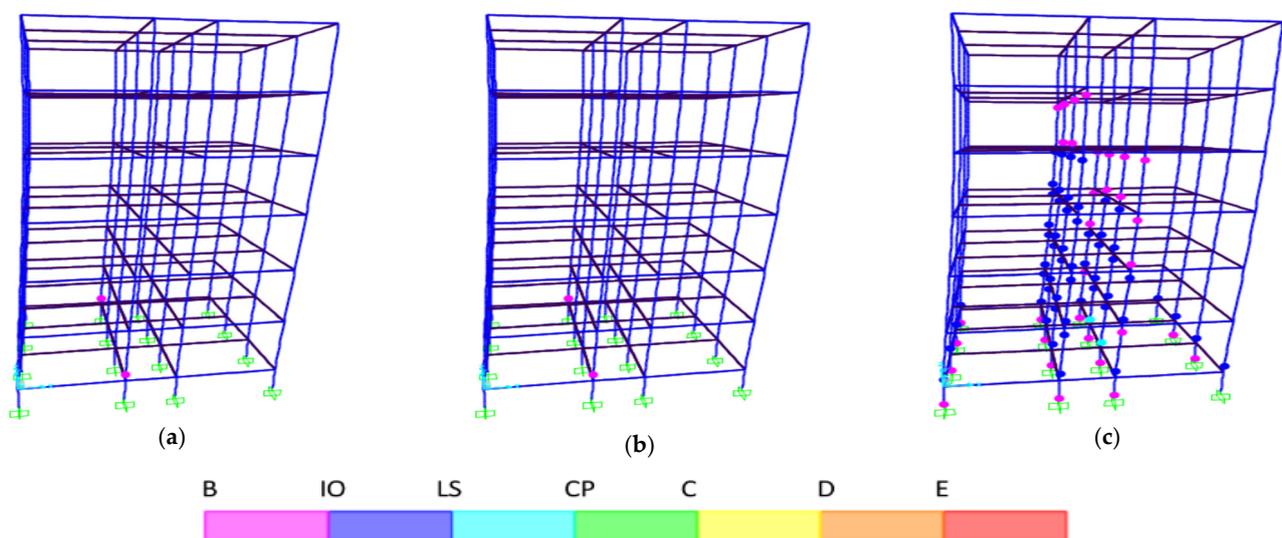
Figure 20 shows the hinge pattern of a six-storey regular building in the X direction. It can be observed that the first hinge was formed at an intermediate column of the building. Furthermore, at the DBE performance point, a total of two hinges were formed and are shown in Figure 20b. Table 7a gives the details of hinge formation along the six-storey regular building for each interval. Structural components in the intermediate columns of the building fall in the range of B to IO. Hence, it can be seen that six-storey regular buildings do not undergo deformation. However, at the MCE performance point, 90 hinges were formed and are shown in Figure 20c. From Table 7a, it can be seen that few hinges on intermediate columns fall in the range of IO to LS, and two hinges fall in the range of LS to CP of the first storey of the building, from which we conclude that there was severe damage to the column where hinges fall in the range of LS to CP, and that the rest of the columns can be retrofitted.

Figure 20. Hinge pattern of 6-storey regular building: pushover analysis in X direction; (a) first hinge; (b) performance point at DBE; (c) performance point at MCE.

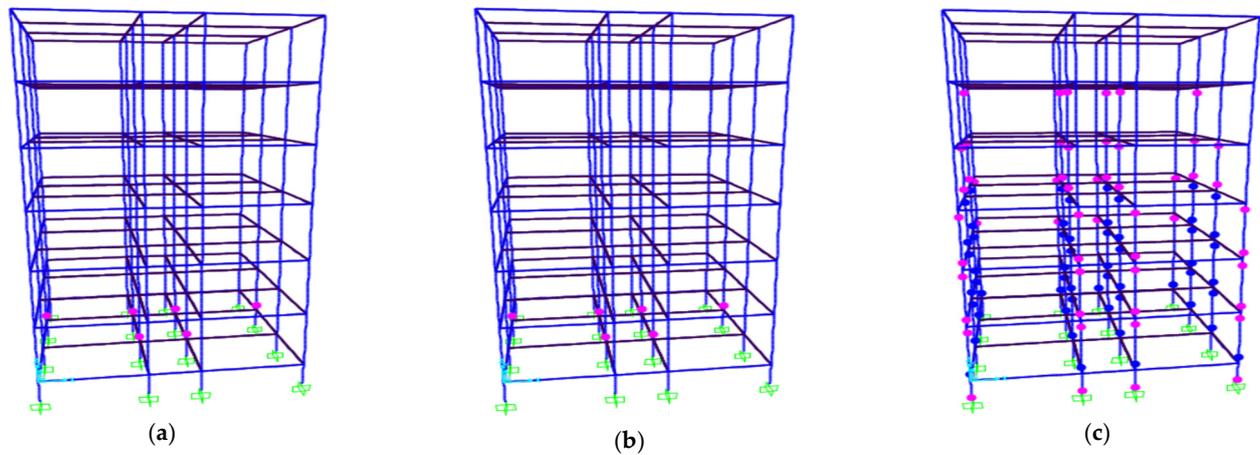
Figure 21 shows the hinge pattern of a six-storey regular building in the Y direction. It can be observed that the first hinge was formed at an intermediate column of the building. Furthermore, at the DBE performance point, a total of six hinges were formed and are shown in Figure 21b. Table 7b gives the details of hinge formation along the six-storey regular building for each interval. Structural components of the building fall in the range of B to IO. Hence, it can be seen that a six-storey regular building does not undergo deformation. However, at the MCE performance point, 110 hinges were formed and are shown in Figure 21c.

From Table 7b, it can be seen that some of the hinges from the first storey to the fourth storey of the building fall in the range of IO to LS, from which we conclude that the six-storey regular building shows moderate damage and can be retrofitted.

Figure 21. Hinge pattern of 6-storey regular building: pushover analysis in Y direction; (a) first hinge; (b) performance point at DBE; (c) performance point at MCE.

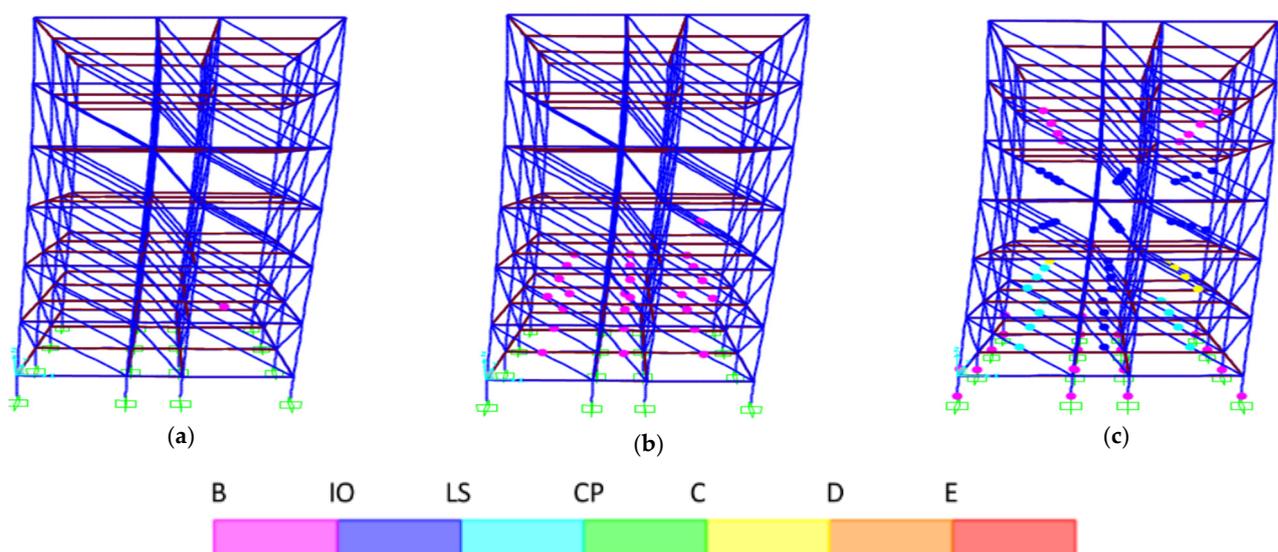
Figure 22 shows the hinge pattern of a six-storey regular building with infill in the X direction. It can be observed that the first hinge was formed at the intermediate infill walls of the building. Furthermore, at the DBE performance point, a total of 25 hinges were formed and are shown in Figure 22b. Table 8a gives the details of hinge formation along the six-storey regular building with infill for each interval. Structural components in the infill walls of the building fall in the range of B to IO. Hence, it can be seen that a six-storey regular building with infill does not undergo deformation. However, at the MCE performance point, 77 hinges were formed and are shown in Figure 22c. From Table 8a it can be seen that at the third storey and fourth storey of the building, hinges fall in the range of IO to LS, while at the first storey and second storey of the building, hinges fall in the range of LS to CP, and in infill walls, some hinges fall in the range of C to D, from which we conclude that the infill walls of the first and second storeys of the building show severe damage.

Figure 22. Hinge pattern of 6-storey regular building with infill: pushover analysis in X direction; (a) first hinge; (b) performance point at DBE; (c) performance point at MCE.

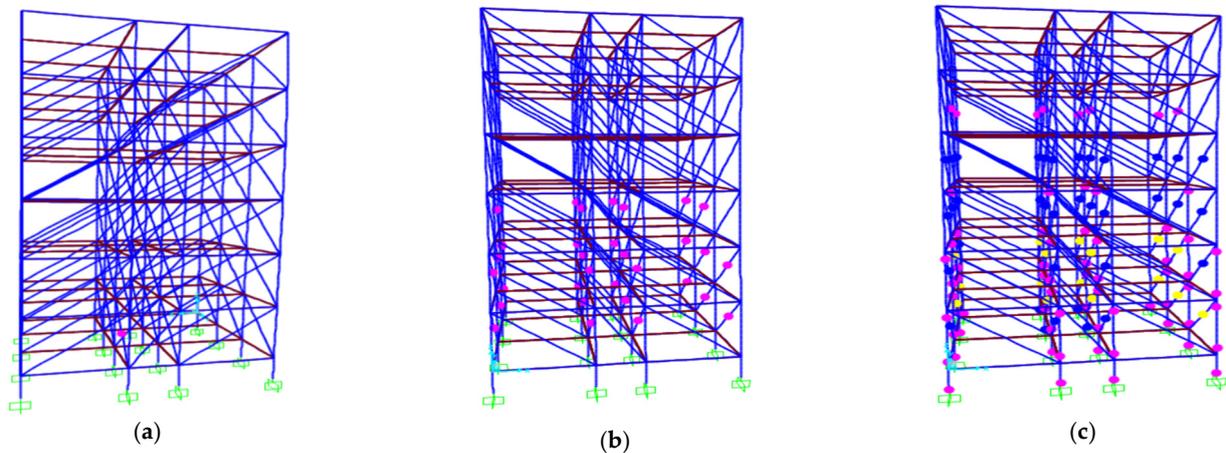
Figure 23 shows the hinge pattern of a six-storey regular building with infill in the Y direction. It can be observed that the first hinge was formed at the intermediate infill walls of the building. Furthermore, at the DBE performance point, a total of 31 hinges were formed and are shown in Figure 23b. Table 8b gives the details of hinge formation along the six-storey regular building with infill for each interval. Structural components in the infill walls of the building fall in the range of B to IO. Hence, it can be seen that a

six-storey regular building with infill does not undergo deformation. However, at the MCE performance point, 126 hinges were formed and are shown in Figure 23c. From Table 8b, it can be seen that, in infill walls of the first storey and second storey of the building, some of hinges fall in the range of C to D, from which we conclude that there is severe damage in the infill walls of the first and second storeys of the building.

Figure 23. Hinge pattern of 6-storey regular building with infill: pushover analysis in Y direction; (a) first hinge; (b) performance point at DBE; (c) performance point at MCE.
