Seismic Performance Evaluation and Comparative Study of Reinforced Concrete Building on a Sloped Terrain with Regular Building by Considering the Effect of URM Infill Walls

Keywords: hilly slope; step-back building; infill wall; non-linear analysis

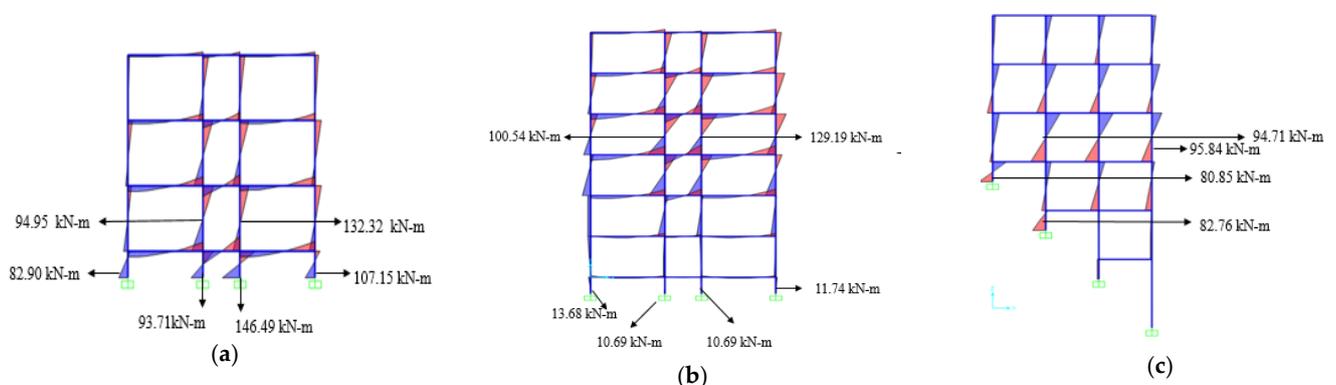
Columns with greater bending moments are more vulnerable during seismic activities. The maximum bending moment of a column can be found for a better understanding of a building's response. As a result, the maximum bending moment of each column was calculated at the third-storey level of the step-back buildings (which is also known as the uphill side of the step-back buildings). The buildings have 16 columns per storey. Due to seismic excitation, the most vulnerable column of the storey was discovered, and that column's maximum bending moment was compared to the three-storey regular and six-storey regular buildings. From Figure 24a, it can be observed that the uphill-side short column is the most affected column. Furthermore, the downhill-side columns in intermediate third and fourth storeys are the most affected, as seen in Figure 24b. Furthermore, the third and fourth storeys from the downhill side again fall in the uphill side of the building. Along the elevation, as shown in Figure 24c, the third storey lies in line with the uphill side of the building. Figure 24c shows the variation in bending moment along the slope for a step-back building, and it can be seen that the short column at the top of the hill attracts larger bending moments than that of the downhill-side-slope column.

Figure 24. Bending moments of step-back building; (a) uphill side of step-back building; (b) downhill side of step-back building; (c) along the slope.

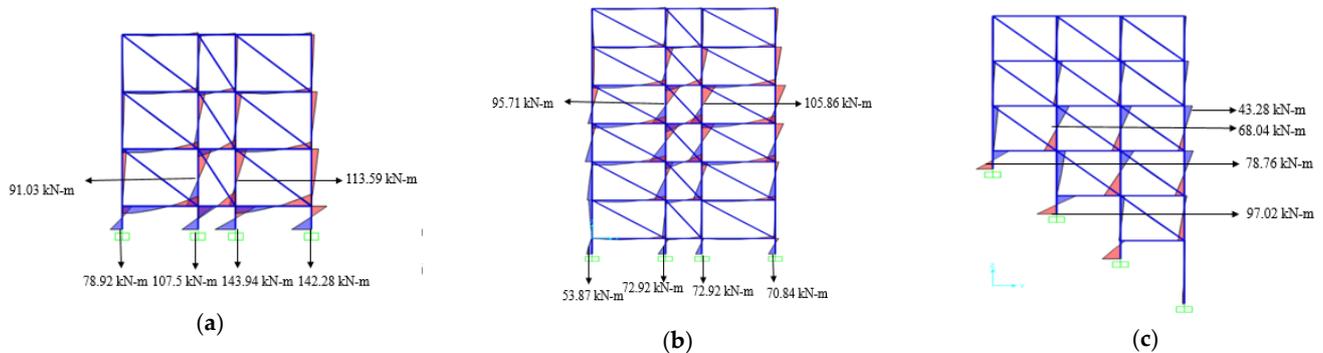
A similar pattern can be seen in the set-back building with infill walls. From Figure 25a, it can be seen that along the uphill side, the maximum bending moment is in the short column. In contrast, the maximum bending moment in the downhill side is in the column belonging to the fourth storey, which is considered to be a part of the uphill side, as shown in Figure 25b.

Figure 25. Bending moments of step-back building with infill; (a) uphill side of step-back building; (b) downhill side of step-back building; (c) along the slope.

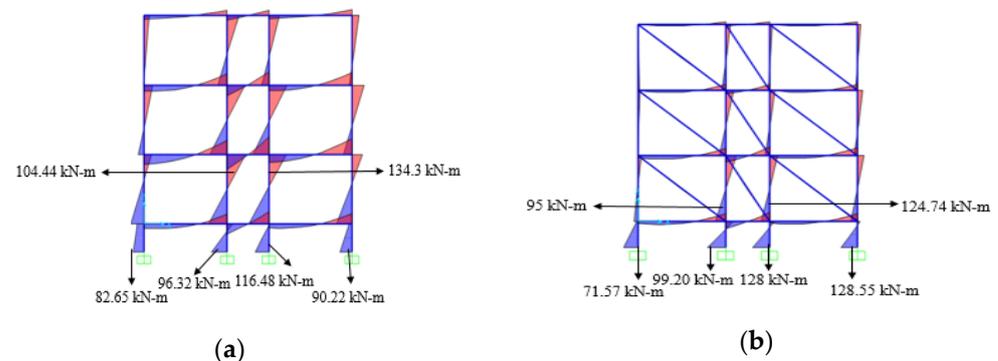
In a three-storey regular building without infill, the maximum bending moment is in the first-storey intermediate column, as shown in Figure 26a. The maximum bending moment formed in the same building with infill walls is in the short columns, as shown in Figure 26b.

Figure 26. Bending moments of 3-storey regular building (a) without and (b) with infill.

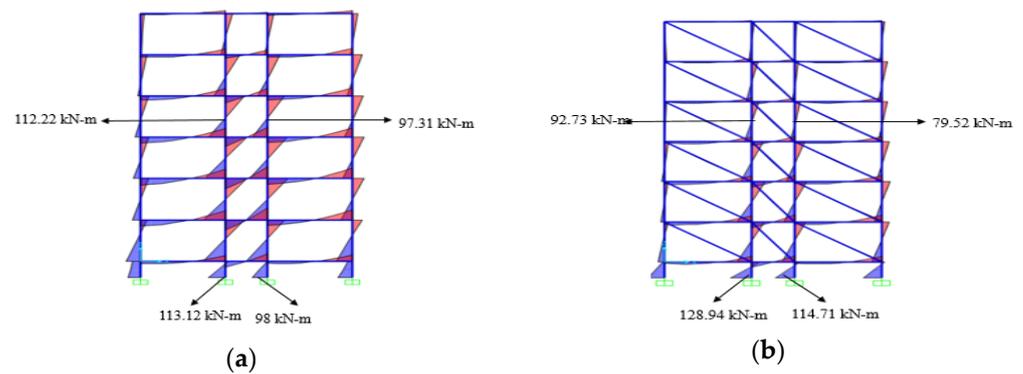
The maximum bending moment in the six-storey regular building with and without infill walls was found to be in the shortest column on the fourth floor of the intermediate columns, as shown in Figure 27a,b.

Figure 27. Bending moments of 6-storey regular building (a) without and (b) with infill.

The study of variation in bending moments for all the study buildings showed that there is a large variation in bending moments in columns along the step-back building when compared with regular buildings. When compared with the three-storey regular building (to represent the uphill side), the bending moment was greater in the step-back building. The downhill side was compared to a six-storey regular building. It was inferred that without infill walls, the maximum bending moment was found in the third and fourth storeys. Analysis of a six-storey regular building showed that the bending moment in the columns gradually decreases with respect to storey height. Further, by incorporating the infill walls in the step-back building, the bending moment was drastically reduced. Hence, the usage of infill walls reduces the bending moment.

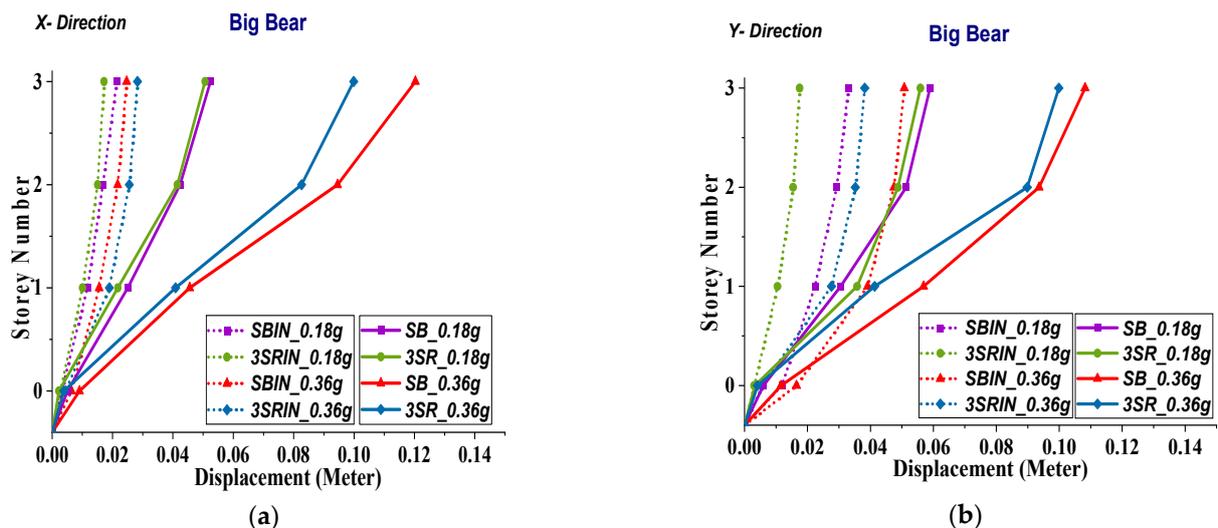
Figure 28. Comparison of storey displacement between the uphill side of step-back building and 3-storey regular building for Big Bear earthquake in (a) X and (b) Y directions.

Seismic evaluation at the global level can be accurately estimated by obtaining storey displacement. In the present study, Figures 28–32 represent the displacements of the uphill sides of the step-back buildings with and without infill walls compared to three-storey regular buildings with and without infill walls for all the considered ground motions. Figures 33–37 represent the displacements of the downhill sides of the step-back buildings with and without infill walls compared to the six-storey regular buildings with and without infill walls for all the considered ground motions. The graphs are plots of storey number vs. storey displacement at PGA levels of 0.18 g and 0.36 g. The dotted line represents the graph for a structure with infill walls, while the straight line indicates the graph for a structure without infill walls. So, for a better understanding of the variations in the results, the means of the ground motions were obtained and plotted in the graphs.

The inferences that can be drawn from Figures 28–37, given in Table 10a–d, reveal significant insights into how design features influence building resilience under seismic stress.

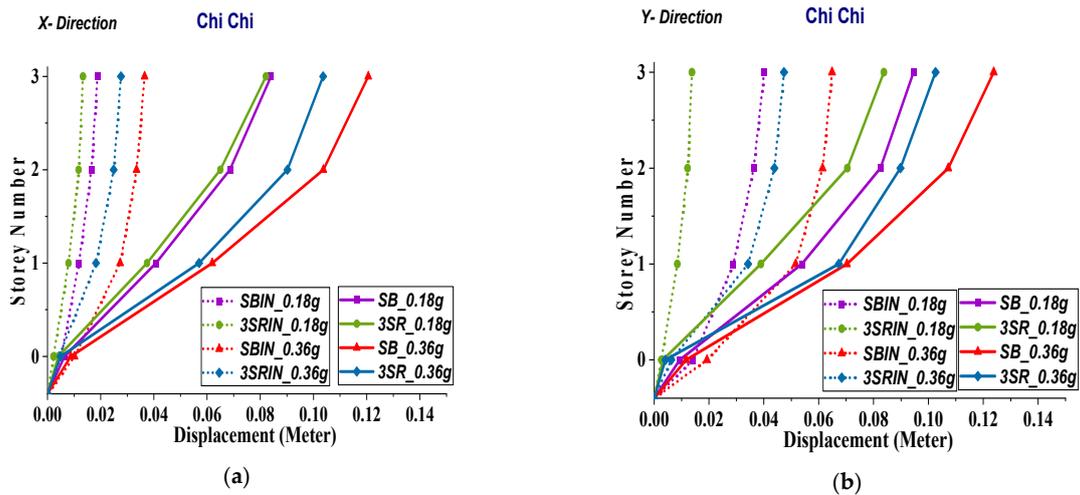
Figure 29. Comparison of storey displacement between the uphill side of step-back building and 3-storey regular building for Chi-Chi earthquake in (a) X and (b) Y directions.

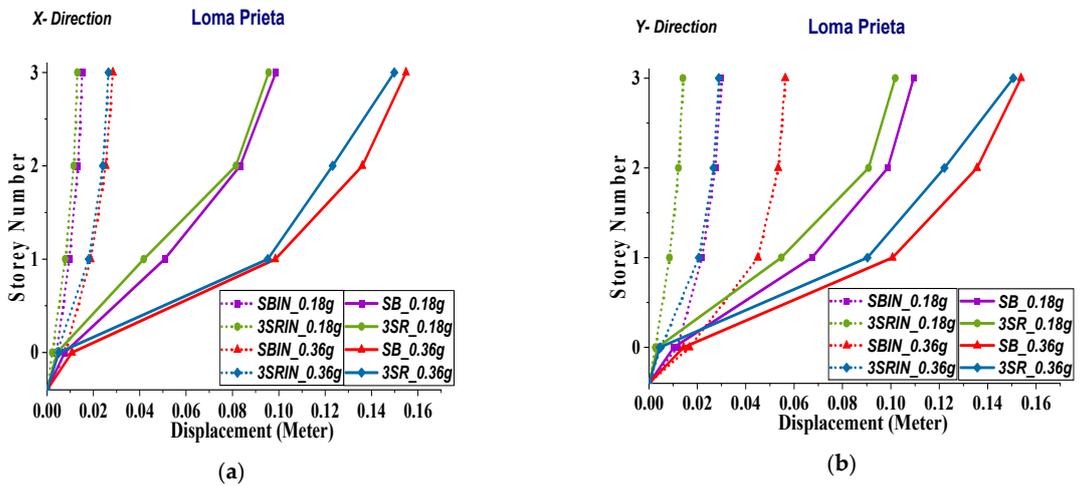
Figure 30. Comparison of storey displacement between the uphill side of step-back building and 3-storey regular building for Loma Prieta earthquake in (a) X and (b) Y directions.

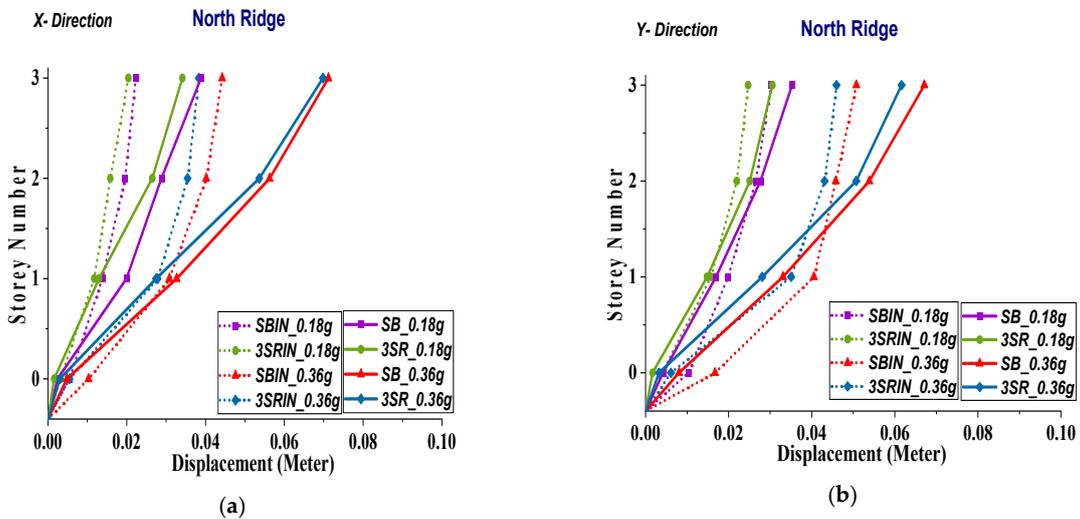
Figure 31. Comparison of storey displacement between the uphill side of step-back building and 3-storey regular building for North Ridge earthquake in (a) X and (b) Y directions.

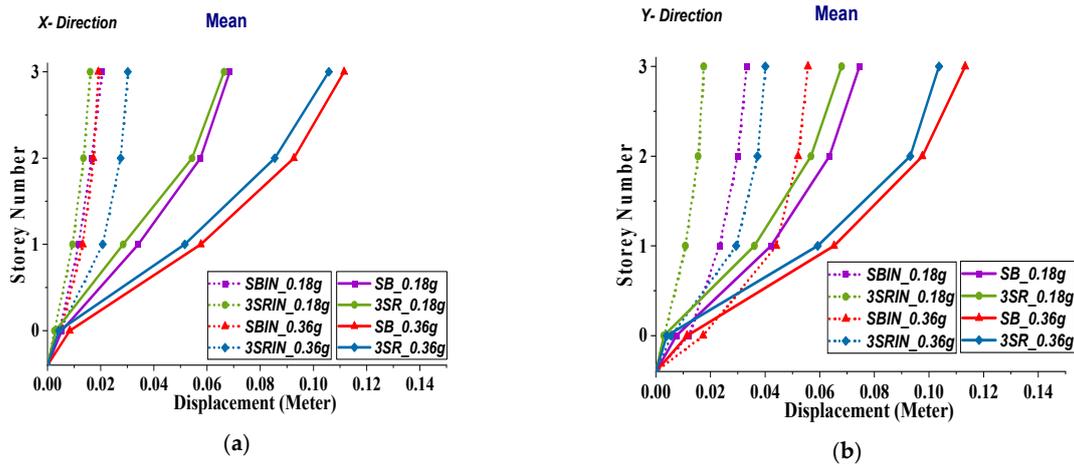
Figure 32. Comparison of storey displacement between the uphill side of step-back building and 3-storey regular building with the help of mean of the earthquakes in (a) X and (b) Y directions.

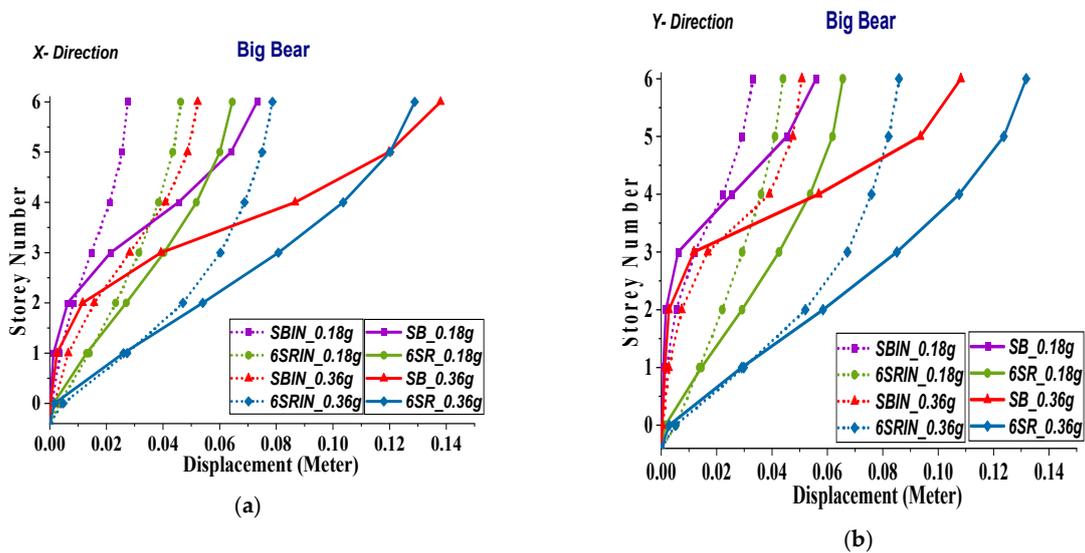
Figure 33. Comparison of storey displacement between the downhill side of step-back building and 6-storey regular building for Big Bear earthquake in (a) X and (b) Y directions.

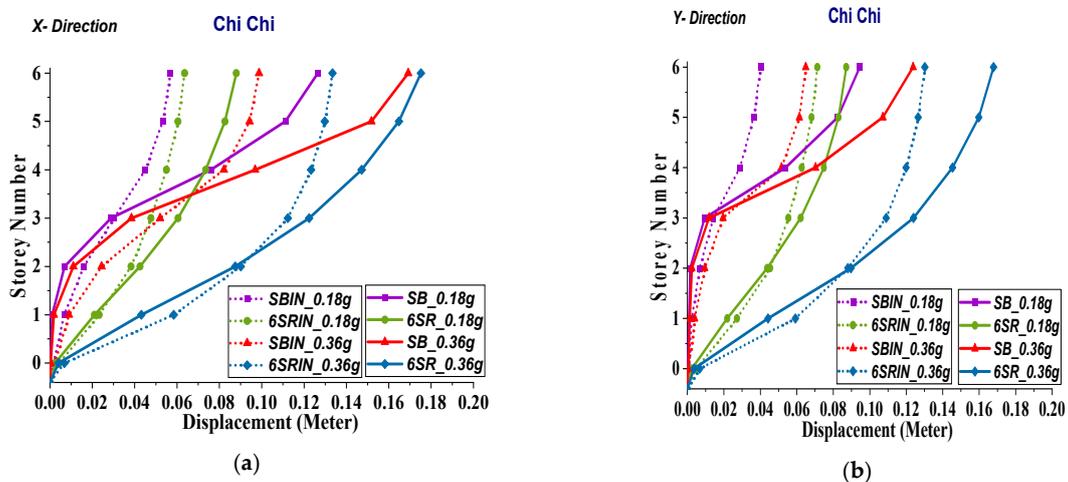
Figure 34. Comparison of storey displacement between the downhill side of step-back building and 6-storey regular building for Chi-Chi earthquake in (a) X and (b) Y directions.

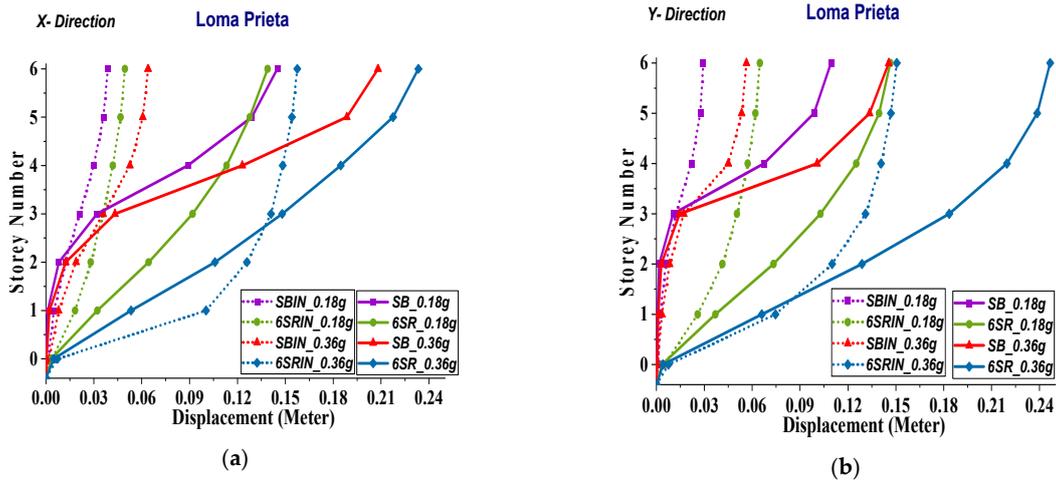
Figure 35. Comparison of storey displacement between the downhill side of step-back building and 6-storey regular building for Loma Prieta earthquake in (a) X and (b) Y directions.

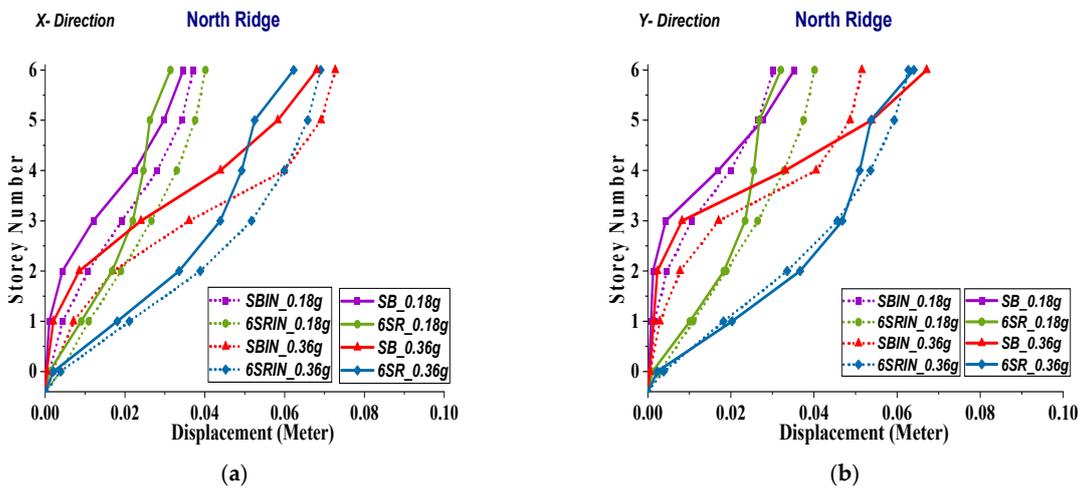
Figure 36. Comparison of storey displacement between the downhill side of step-back building and 6-storey regular building for North Ridge earthquake in (a) X and (b) Y directions.

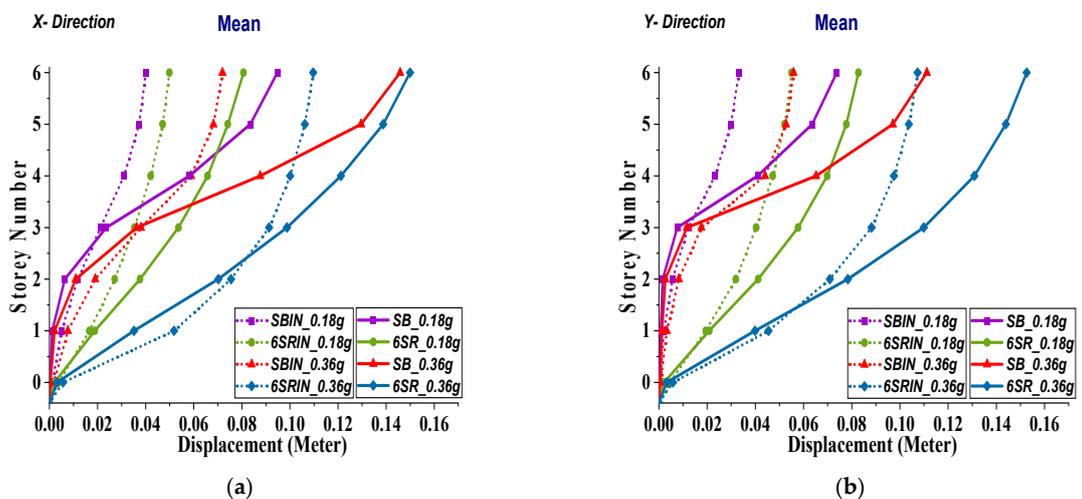
Figure 37. Comparison of storey displacement between the downhill side of step-back building and 6-storey regular building with the mean of the earthquakes in (a) X and (b) Y directions.

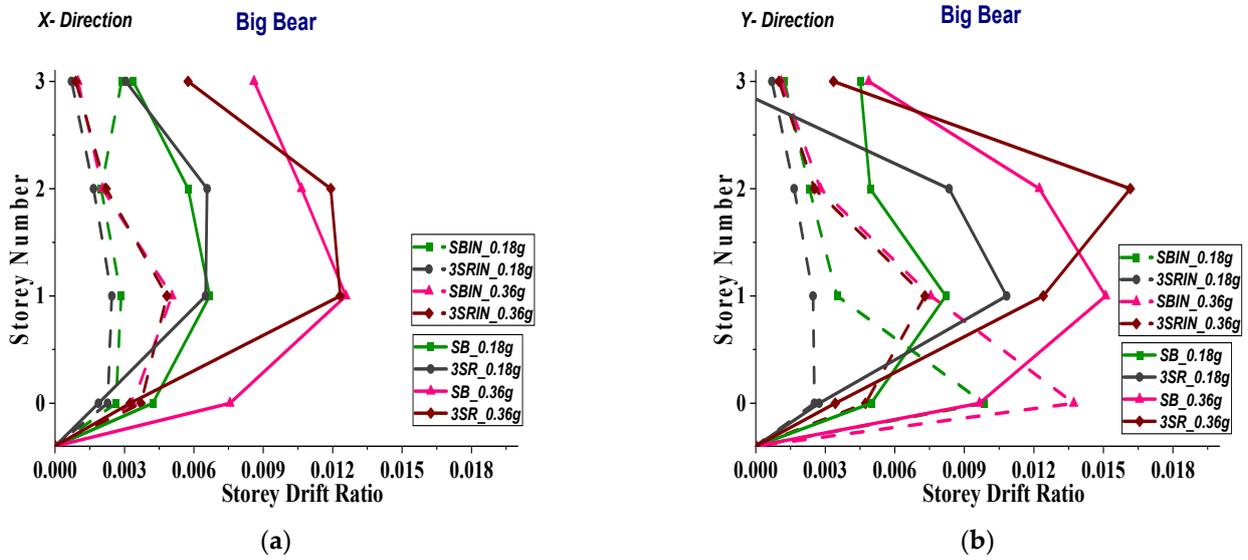
Figure 38. Comparison of storey drift ratio between the uphill side of step-back building and 3-storey regular building for Big Bear ground motion in (a) X and (b) Y directions.

The storey drift ratio is the relative translational displacement between two consecutive floors divided by the storey height. It is a critical engineering response quantity and structural performance indicator. Several aspects of structural engineering would benefit greatly from accurate storey drift ratio measurements, particularly for structures subjected to inelastic deformations [41]. The storey drift ratios of step-back, three-storey regular, and six-storey regular buildings with and without infills are illustrated in Figures 38–47. The storey drift ratio graphs are drawn in the same manner as the storey displacement graphs, at PGAs of 0.18 g and 0.36 g. Figures 38–42 represent the storey drift ratio of the uphill side of step-back buildings with and without infill walls to three-storey regular buildings with and without infill walls for all the considered ground motions. Figures 43–47 represent the storey drift ratios of the downhill sides of the step-back buildings with and without infill walls to the six-storey regular buildings with and without infill walls for all the considered ground motions. The graphs are plots of storey number vs. storey drift ratio at PGA levels of 0.18 g and 0.36 g. The dotted line represents the graph for a structure with infill walls,

while the straight line indicates the graph for a structure without infill walls. So, for a better understanding of the variations in results, the mean of the earthquakes graph is plotted.

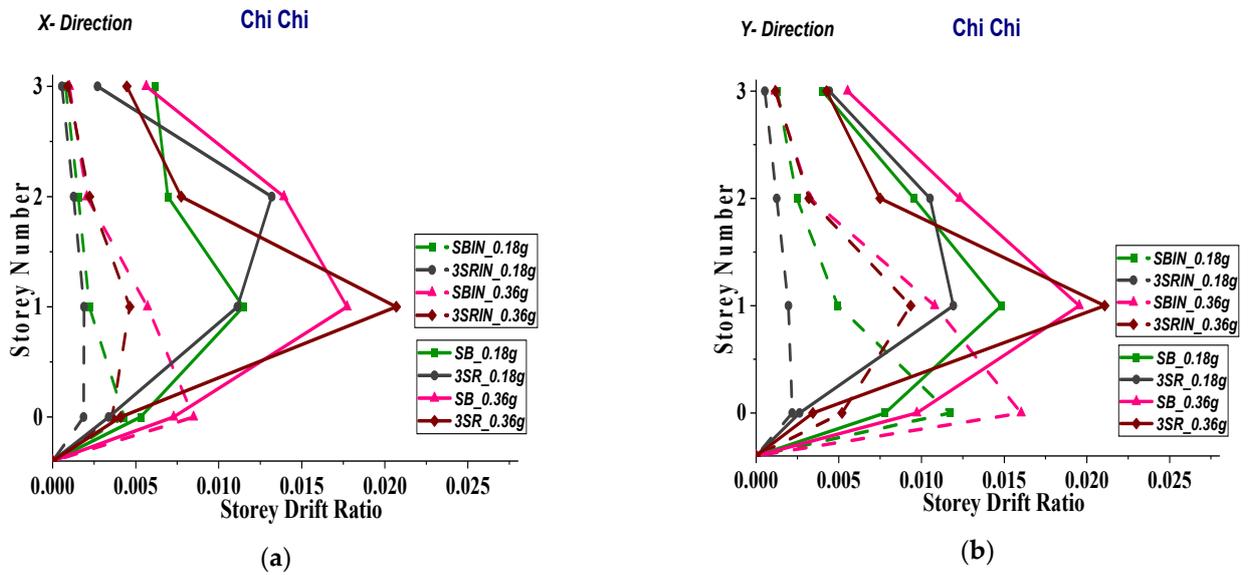
Figure 39. Comparison of storey drift ratio between the uphill side of the step-back building and 3-storey regular building for Chi-Chi ground motion in (a) X and (b) Y directions.

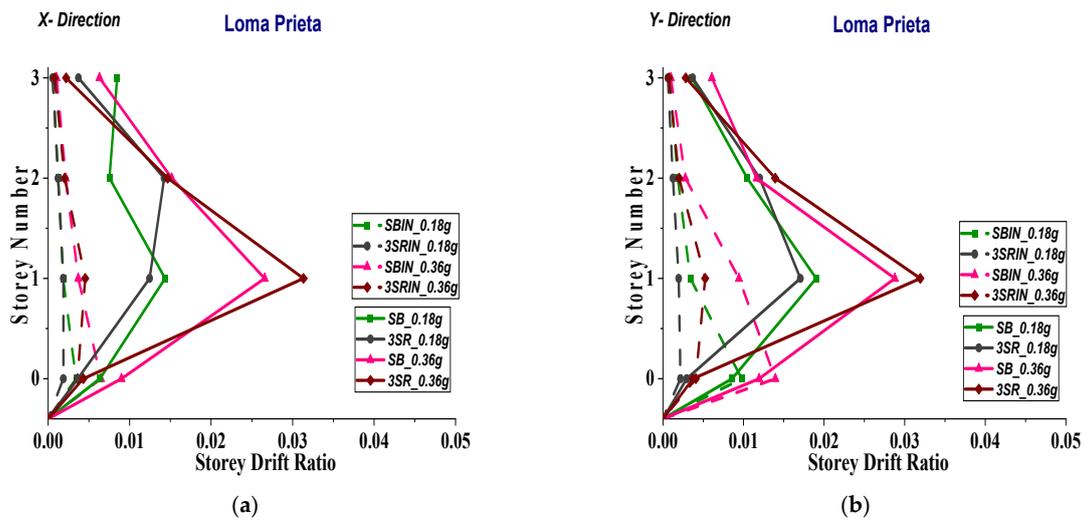
Figure 40. Comparison of storey drift ratio between the uphill side of step-back building and 3-storey regular building for Loma Prieta ground motion in (a) X and (b) Y directions.

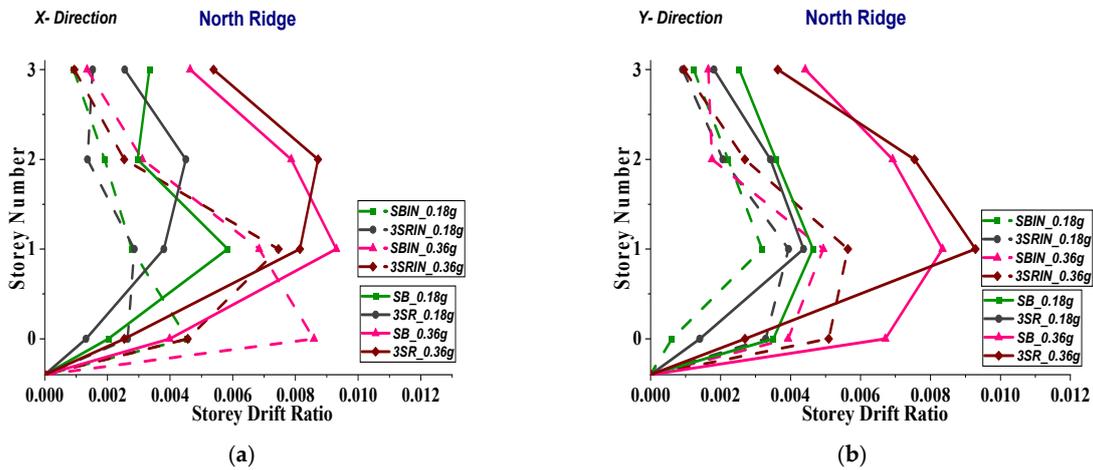
Figure 41. Comparison of storey drift ratio between the uphill side of step-back building and 3-storey regular building for North Ridge ground motion in (a) X and (b) Y directions.

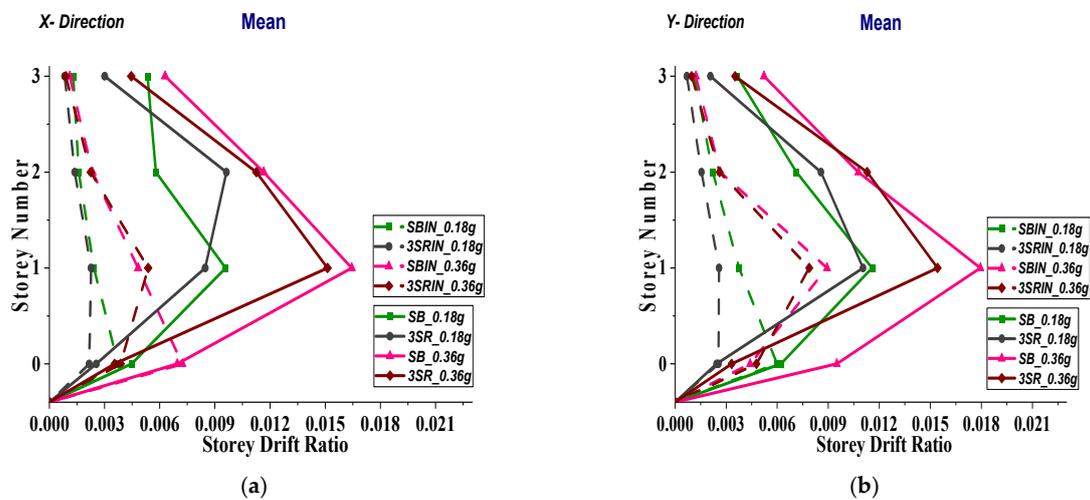
Figure 42. Comparison of storey drift ratio between the uphill side of step-back building and 3-storey regular building with the mean of the ground motions in (a) X and (b) Y directions.

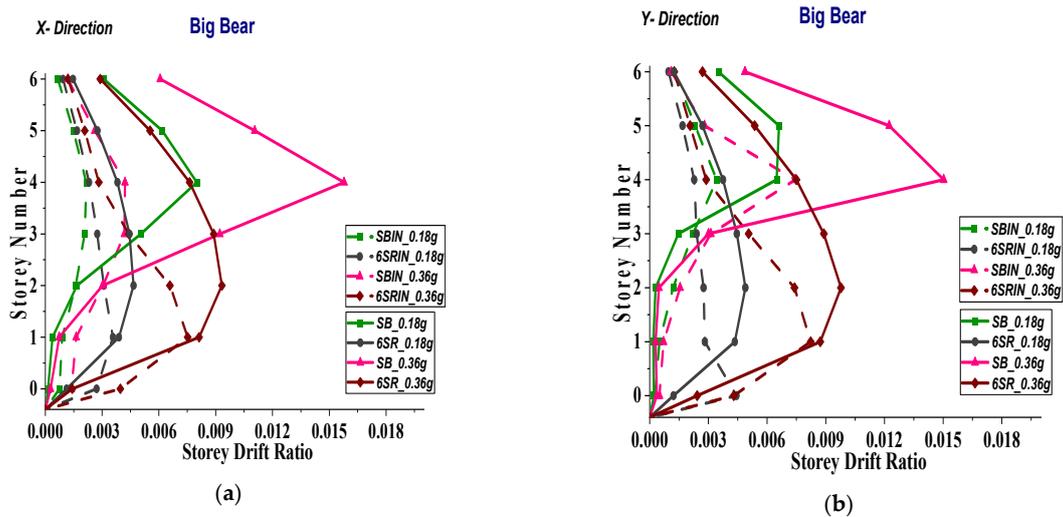
Figure 43. Comparison of storey drift ratio between the downhill side of step-back building and 6-storey regular building for Big Bear ground motion in (a) X and (b) Y directions.

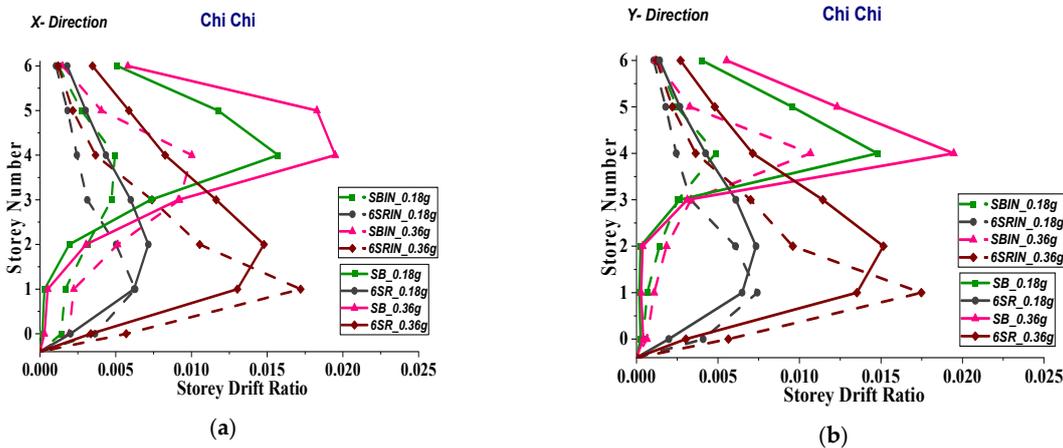
Figure 44. Comparison of storey drift ratio between the downhill side of step-back building and 6-storey regular building for Chi-Chi ground motion in (a) X and (b) Y directions.

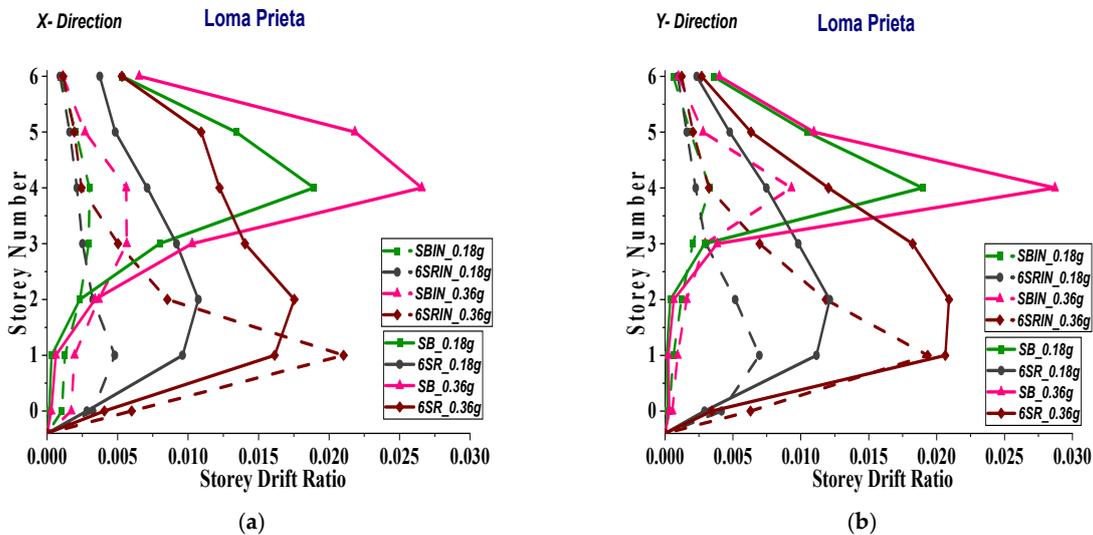
Figure 45. Comparison of storey drift ratio between the downhill side of step-back building and 6-storey regular building for Loma Prieta ground motion in (a) X and (b) Y directions.

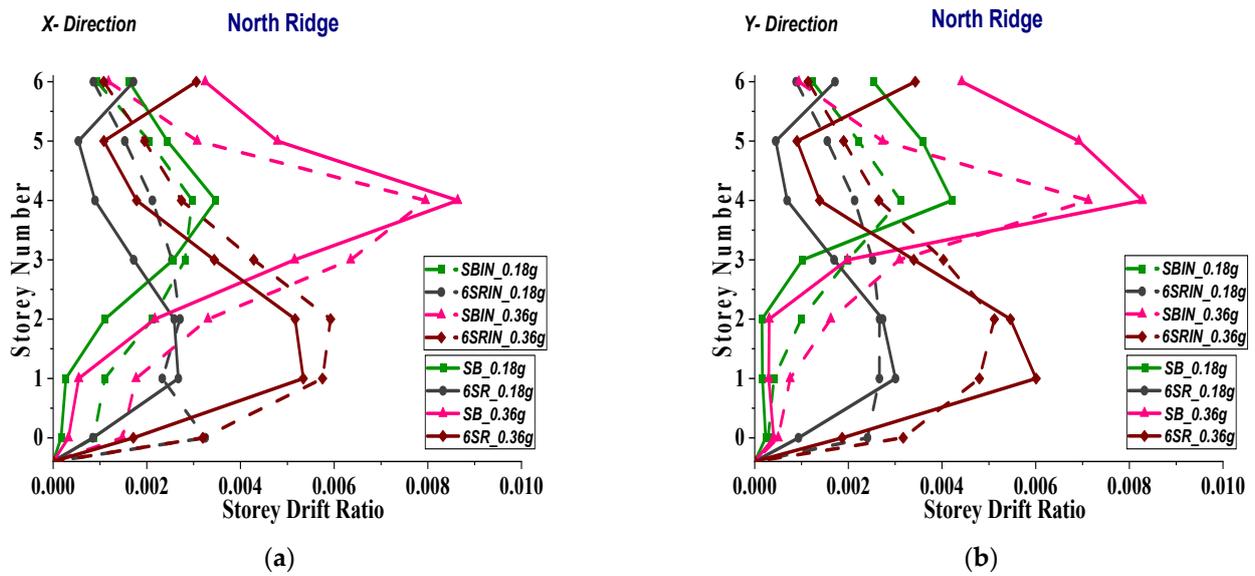
Figure 46. Comparison of storey drift ratio between the downhill side of step-back building and 6-storey regular building for North Ridge ground motion in (a) X and (b) Y directions.

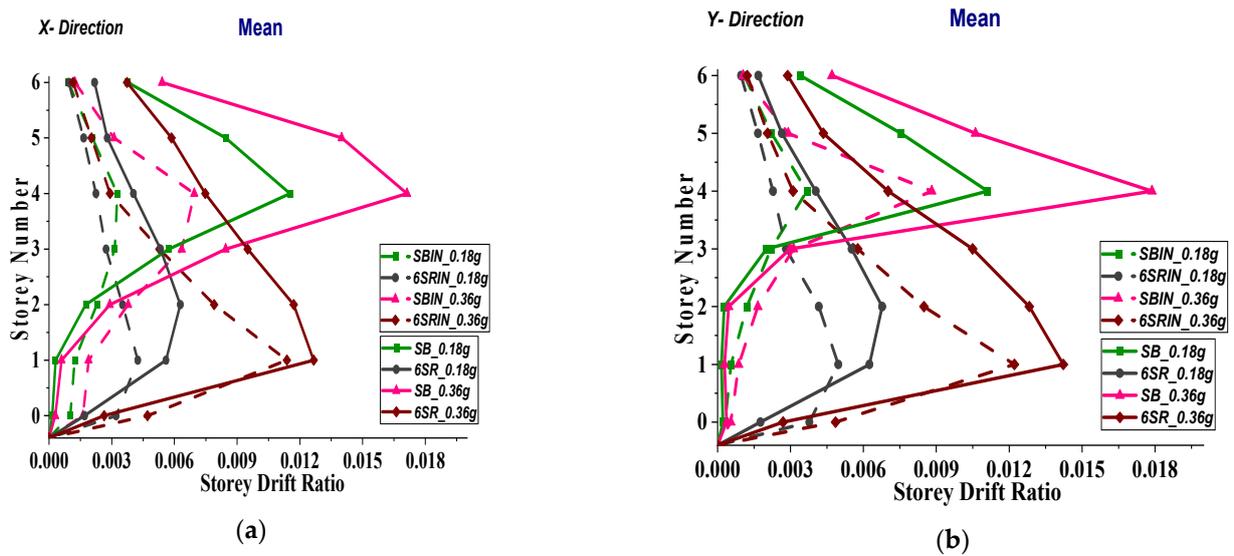
Figure 47. Comparison of storey drift ratio between the downhill side of step-back building and 6-storey regular building with the mean of the ground motions in (a) X and (b) Y directions.

- Storey drift ratio analysis indicates that step-back buildings without infill have higher drift ratios than those with infill. The first storey on the uphill side and the fourth storey on the downhill side of step-back buildings are particularly vulnerable to seismic activity, suggesting severe damage on the uphill side.
