Tensile Fracture Behavior and Characterization of Ceramic Matrix Composites

Jeongguk Kim

Advanced Railroad Vehicle Division, Korea Railroad Research Institute, Uiwang 16105, Korea; jkim@krii.re.kr; Tel.: +82-31-460-5518

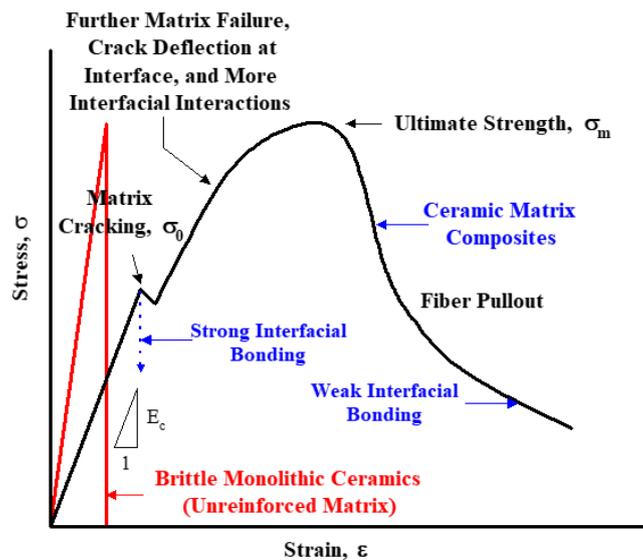
The main advantages of ceramic matrix composites as compared to monolithic ceramics are shown in Figure 1. In the stress-strain behavior, monolithic ceramics show only elastic regions, and exhibit tensile properties in the form of brittle fracture without any plastic deformation. However, in the case of ceramic matrix composites reinforced with continuous fibers, at the beginning of the uniaxial tensile test, they exhibit an elastic region like monolithic ceramics, and then reach an ultimate tensile strength (UTS) through a proportional limit, followed by the so-called graceful period similar to the plastic deformation of the metallic materials, and subsequently to the final fracture [1,3,5–8].

Figure 1. The stress–strain behavior in ceramic matrix composites as compared with monolithic ceramics.

Although there is no plastic deformation in ceramic matrix composites in practice, the reason for the similar properties of deformation in the stress–strain behavior is due to the influence of the continuous fibers present in the ceramic matrix materials. In general, the following process is possible; when the matrix is broken first (matrix cracking), then the crack propagates to the inside ceramic matrix, and when the crack tip meets the continuous fibers, debonding between the fiber and the matrix is occurred followed by extensive fiber pullouts. Finally, as the ceramic fibers take time for the final failure and improve the fracture toughness, thereby obtaining a stress–strain behavior similar to the plastic deformation in metallic materials. As a result, in the case of the ceramic composite materials reinforced with continuous fibers, it is observed that the fracture toughness can be improved [1,5,8].

As mentioned in Figure 1, there is a difference between monolithic ceramics and ceramic composites for uniaxial tensile testing. In general, monolithic ceramics that are not reinforced with fibers or other particles do not exhibit plastic zones, but show typical brittle fracture behavior leading to fracture immediately after passing through the elastic zones. On the other hand, ceramic matrix composites reinforced with continuous ceramic fibers show the same elastic deformation as monolithic ceramics until the first matrix cracking occurs. Afterwards, it shows the shape of the plastic zone that can be seen in the metallic materials through further processes such as further matrix failure, crack deflection at interface, and more interfacial interactions. This is not a plastic deformation actually occurring, but rather the fracture toughness is increased due to the behavior that increases the time to fracture in the processes of the formation of cracks and fiber pullout, showing the deformation behavior of this type. After continuing to reach UTS, they undergo a process such as fiber pullout, indicating so-called graceful failure, and finally the failure occurs.

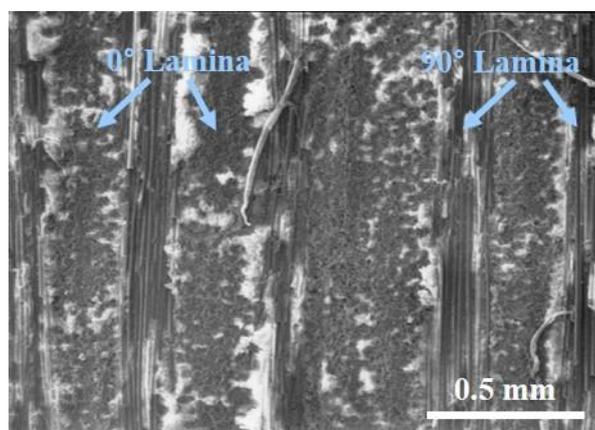
The materials used in this study are Nicalon ceramic fiber reinforced ceramic matrix composites with calcium aluminosilicate (CAS, $\text{CaAl}_2\text{Si}_2\text{O}_8$) glass ceramic matrix. Nicalon fiber (Nippon Carbon Co., Ltd., Tokyo, Japan) is a ceramic fiber composed mainly of SiC, and has a diameter of about 10 to 15 μm . Nicalon/CAS composites were manufactured by the hot-pressing method, and $[0/90]_{4S}$ cross-ply composite panel was used in this investigation. The microstructure of the Nicalon/CAS specimen is shown in Figure 2.

Figure 2. The microstructure of the cross-sectional view of $[0/90]_{4S}$ in Nicalon/CAS composites.

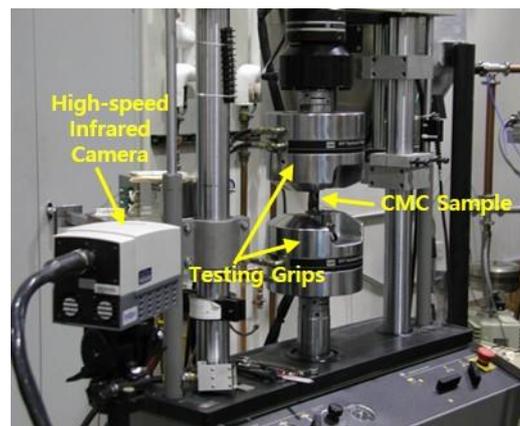
In this study, the speed of the high-speed infrared camera was 7 Hz. The testing setup for the tensile test with a high-speed infrared camera is shown in Figure 3. After the tensile test, the fractured specimens were subjected to microstructural analysis using SEM (S-360, Cambridge Instruments, Cambridge, UK). Through the observation of these microstructures, the inferences were made about the correlation between the IR camera monitoring results and the mechanical property data obtained in the tensile test.

Figure 3. The testing setup for tensile testing with a high-speed infrared camera.

The dog-bone type tensile specimens were prepared from $[0/90]_{4S}$ cross-ply Nicalon/CAS panel for the uniaxial tensile test, and the tensile test was performed using a servohydraulic testing machine (MTS 810, MTS, Eden Prairie, USA). Tensile tests were carried out in displacement control mode at room temperature with a cross-head speed of 0.3 mm per minute with the ASTM code [16]. In order to understand the relationship between changes in mechanical properties and temperature during the tensile test, a high-speed infrared camera (A8300, FLIR, Santa Barbara, USA) was used to monitor the entire tensile test. The use of an infrared camera makes it possible to monitor the temperature change of the specimen during the tensile test, and to observe the temperature change of the specimen based on the final fracture point.

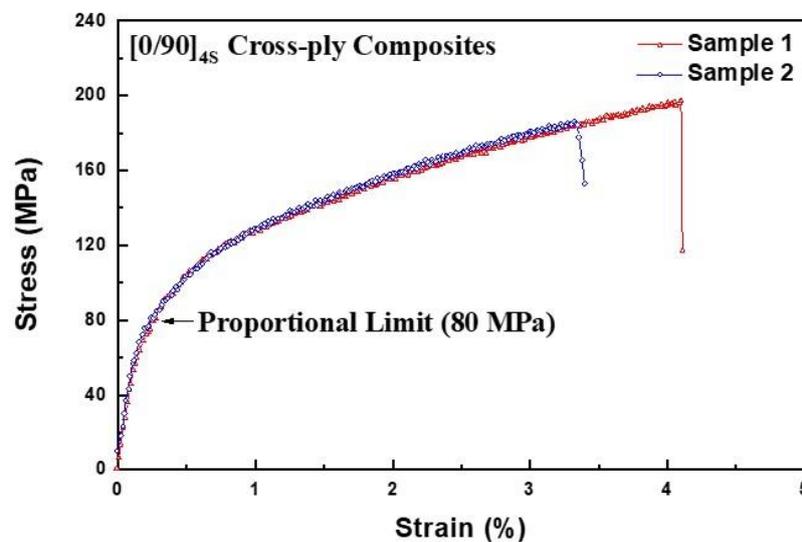
Figure 4 shows the tensile test results obtained in this study. As shown in the general tensile fracture behavior of ceramic matrix composites in Figure 1, the stress variation is similar. For both samples (sample 1 and 2), almost similar tensile failure behavior was obtained. However, the final failure occurred immediately after the UTS. Overall, the proportional limit was determined at about 80 MPa and the maximum tensile strengths were about 180 and 195 MPa, respectively.

Figure 4. The stress–strain behavior of cross-ply Nicalon/CAS composites.

Figure 6 combines Figures 4 and 5 to show stress-time and temperature change-time simultaneously. These results can be directly seen by comparing the relationship between stress change and temperature change during the tensile test. The results of the tensile test show that the final fracture occurred instantly after reaching the UTS, which is similar in the temperature change data. That is, a sudden temperature peak is observed just before the final break, and it can be assumed that the final failure was induced by a momentary and continuous fiber breakage. Since the speed of the high-speed infrared camera was 7 Hz , the final breakdown occurred suddenly within 1 second (7 data points representing 1 s). Since one temperature datapoint means about 0.143 s , it can be seen that the mode of final fracture was in the form of fiber pullout and failure in an instant. At this time, it can be seen that the thermal energy is generated due to the pullout energy between the matrix and the fiber and the final fiber breakage, indicating a temperature rise with an instantaneous temperature peak.

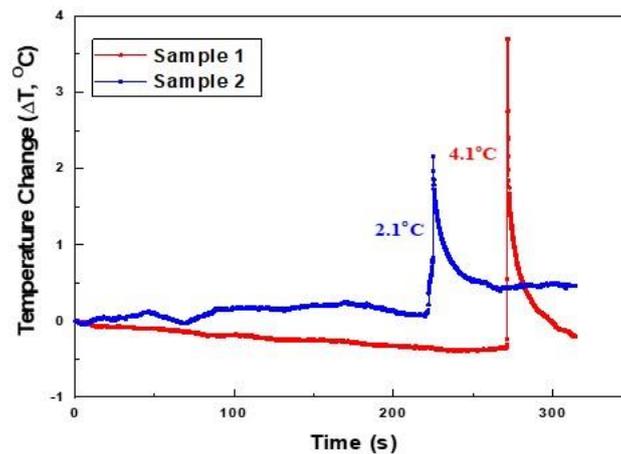
Figure 5 shows the temperature changes of the cross-ply Nicalon/CAS composites monitored during the tensile test. The characteristics of the temperature changes are that fluctuation or gradual degradation is observed around $0.5\text{ }^{\circ}\text{C}$, but overall, both samples show no significant temperature change during the tensile test. However, a sharp temperature peak was observed at the time of break, and the instantaneous temperature rise was $2.1\text{ }^{\circ}\text{C}$ and $4.1\text{ }^{\circ}\text{C}$, respectively. From these results, no significant temperature change is observed during the tensile test, but it is possible to infer whether it is accompanied by abrupt fracture behavior in the final failure stage, for example, extensive fiber pullout and massive matrix cracking.

Figure 5. The temperature variation during tensile testing in cross-ply Nicalon/CAS composites.

Therefore, inferring from the results of Figure 7, the 0° fibers composed of the matrix were broken first with matrix cracking and completely separated in the stress loading direction. Subsequently, it can be seen that the 90° fibers withstand the breakage relatively and finally break with the increase in stress. Therefore, the SEM image analysis proved that the final temperature peaks and temperature rises described in Figures 5 and 6 were made by the breakage and pullout of these 90° fibers.

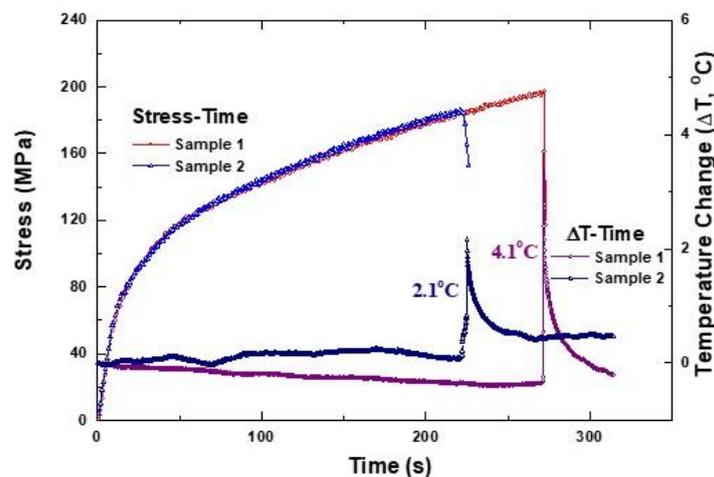
Figure 6. The stress–strain behavior vs. temperature variation during tensile testing in cross-ply Nicalon/CAS composites.

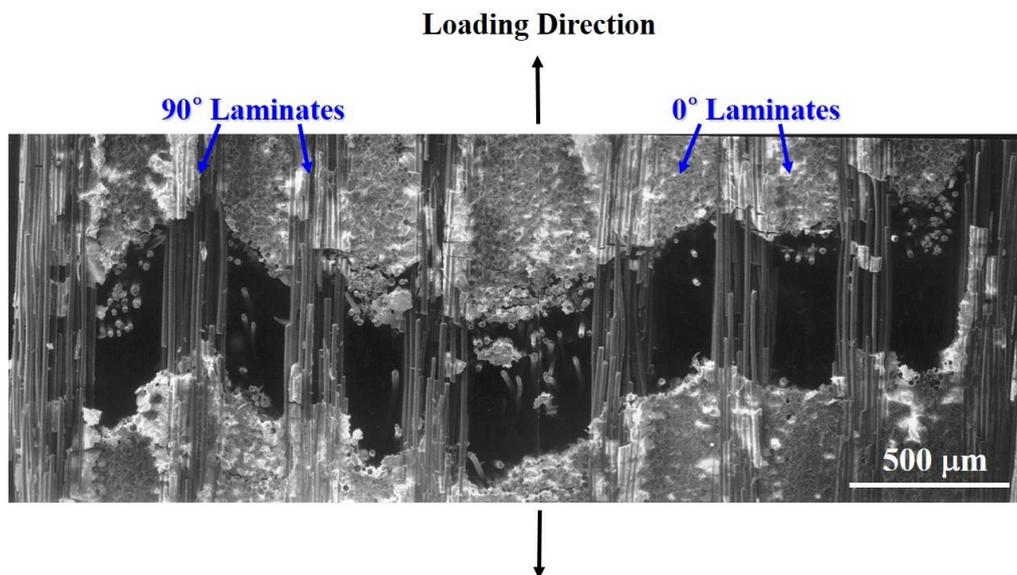
Finally, microstructural analysis was performed using SEM to analyze the failure mode or failure mechanism of Nicalon/CAS composites. Figure 7 shows the cross section of the final fracture surface of a Nicalon/CAS composite. Figure 7 shows that the fibers in the 90° laminate are still connected to each other and the fibers in the 0° laminate are completely split up and down.

Figure 7. SEM image of the overall fracture cross section in cross-ply Nicalon/CAS composite.

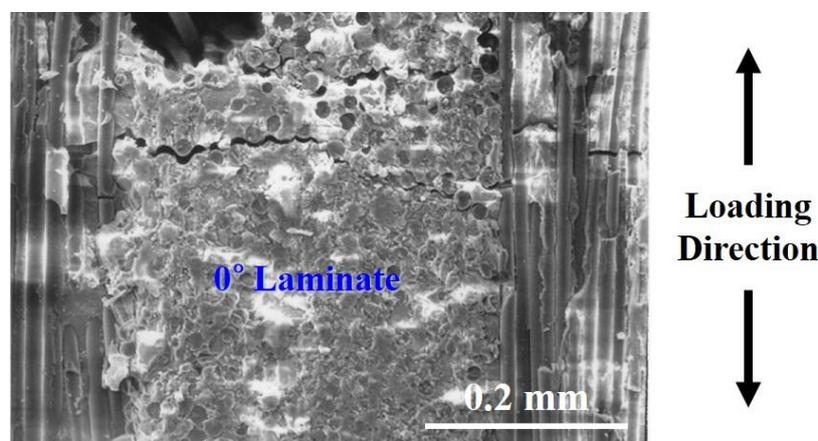
Figure 8 shows the failure image of SEM in 0° laminate of cross-ply Nicalon/CAS composite. It shows the interfacial debonding between fiber and matrix in 0° laminate. Through Figure 8, the initial crack was initiated in a 0° laminate, followed by interfacial debonding and the propagation of the crack by the applied load, and the crack encounters a 90° fiber. It can be inferred that the final breakdown is completed by breaking the fibers in the 90° direction.

Figure 8. The failure image of SEM in 0° laminate of cross-ply Nicalon/CAS composite.

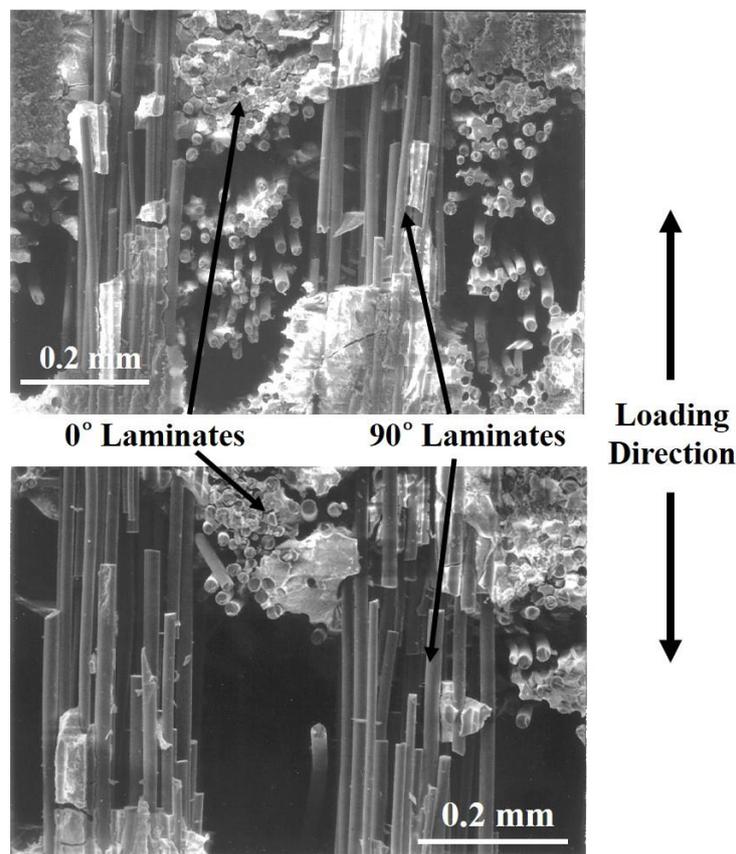
Figure 9 shows the final failure SEM images of cross-ply Nicalon/CAS composites with extensive fiber pullout. Figure 9 shows the final cues in more detail. It can be understood that following the break of the 0° laminate, the crack propagates to the 90° laminate so that the final failure is followed by multiple matrix cracking and interfacial debonding around the 90° fiber bundle followed by the final fiber pullout and fiber break. As such, the overall failure mode can be explained. It can also be seen that the temperature peaks and temperature rise immediately before breakdown were due to the final fiber pullout and fiber breakage.

Figure 9. The final failure SEM images of cross-ply Nicalon/CAS composites with extensive fiber pullout.

Inferring the above results, it becomes possible to explain the overall failure mode or failure mechanism as follows (1) matrix cracking in 0° laminate, (2) debonding between the fiber and matrix at 0° laminate, (3) further crack propagation in the 0° laminate, (4) delamination between 0° and 90° laminates, (5) fiber debonding and pullout in the 90° laminate, and (6) final rupture with extensive fiber pullout.
