Article

Microstructure and Mechanical Properties of 34CrNiMo6 Steel Repaired by Friction Stir Processing

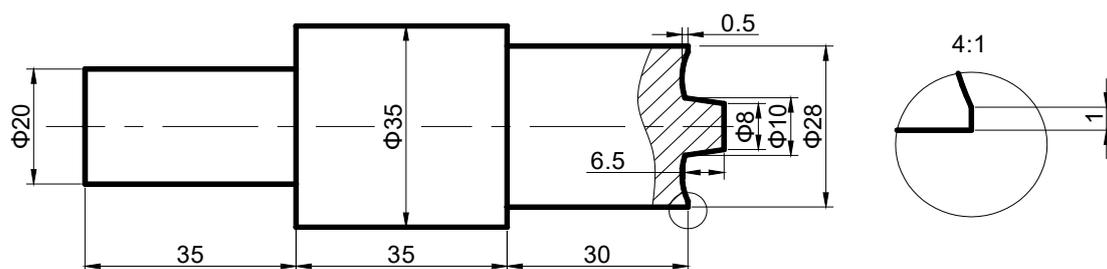
Figure 1. Photograph showing the dimensions of the tool.

The experiments were performed on an FSP equipment self-modified from a X53K vertical milling machine (Nantong Machine Tool Co., Ltd., Nantong, China), which consisted of a 1600 mm long and 400 mm wide movable worktable (traverse speed from 23.5 mm/min to 1180 mm/min) and a rotating shaft with adjustable rotation speed (from 37.5 rpm to 1500 rpm). Additionally, the tilt angle of the rotating shaft could be adjusted. Argon gas was applied to prevent the weld zone from oxidization and contamination during FSP. When welding high melting point metal, the tool with a screw pin was easy to plug up [17]. Therefore, a tool with a screw-free pin was used in this experiment. The size of the tool is shown in Figure 1, and the friction stir process is shown in Figure 2. As shown in Figure 2, because of argon protection, the metal was silver-white after welding, the tool was at a high temperature, and the toe flash on the advancing side (AS) was less than the on the retreating side (RS). The dimension of the unrepaired sample is shown in Figure 3. The filling block acquired from 34CrNiMo6 forgings corresponding to the trapezoidal groove size was machined to repair the samples. The substrate and the filling block surface were ground with SiC paper and cleaned with acetone prior to FSP repair. The filling block was fixed to the substrate by means of electron beam welding. The chemical composition (wt %) of 34CrNiMo6 steel is reported in Table 1. The welding point position is shown in Figure 3. The processing parameters are listed in Table 2.

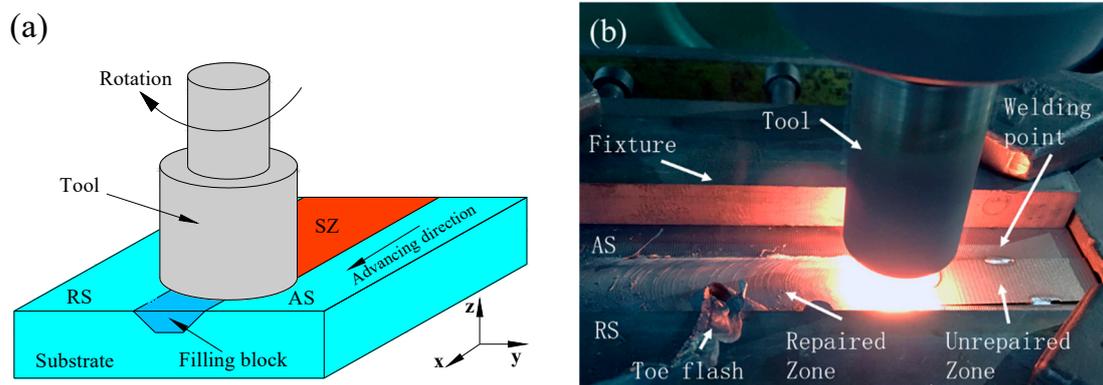
Figure 2. Schematic image of friction stir processing (FSP) repair: (a) schematic image, (b) actual process. RS, retreating side, AS, advancing side, SZ, stirred zone.

However, for some medium-carbon low-alloy steel, these consumable materials are not available or are expensive. To solve this problem, a new repair method based on the friction stir processing (FSP) was studied in this paper. The block which can be obtained from the waste produced by machining was used as repair material. This method, which is derived from FSP, can be widely used in repair fields. Friction stir welding (FSW) is an advanced welding process developed by TWI in 1991 [13] and has attracted great attention because of its advantages over conventional fusion welding techniques. These include higher joint efficiency, low distortion, and low residual stress [14,15]. FSP is a solid-state joining process derived from conventional friction welding, in which a non-consumable rotating pin tool is plunged into the filling metal block and the substrate. Frictional heat generated from the tool shoulder and the tool pin completely softens the filling blocks and partially softens the substrates being joined, which are then deformed around the tool [16]. In order to confirm the feasibility of this method, the microstructure, microhardness, and mechanical properties of repaired 34CrNiMo6 steel were analyzed in this study.

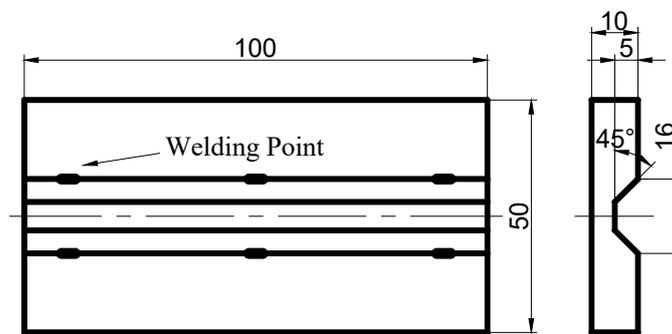
Figure 3. Geometric shape and size of the unrepaired plate.

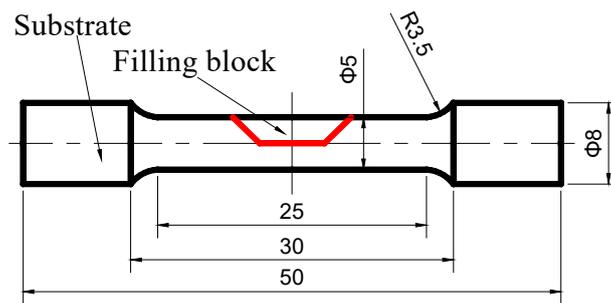
Figure 4. Geometric shape and size of the room-temperature tensile specimen.

An Omniscan MX2 phased array flaw detector manufactured by Olympus was used for flaw detection. Defect-free samples were machined for the standard bar tensile test. Considering the actual use of the repaired components, the tensile specimen contained a part of the substrate. The shape and the size of these samples are shown in Figure 4. The tensile test was carried out by an electronic universal tensile tester with a tensile rate of 0.5 mm/min. The microhardness of the cross section of the repaired specimen was measured by a Qness A10+ microhardness tester (Qness GmbH, Salzburg, Australia). The repaired samples for microstructure observation were machined through a wire electrolytic discharge machine (Jiangnan Wire Cutting Co., Ltd., Nanchang, China) and etched with a 4% nitric acid alcohol solution for 10 s. The microstructure and phase compositions of the repaired samples were examined with Nova Nano SEM450 FE SEM (FEI, Hillsboro, OR, USA) and Zeiss Axis Scope A1 (Zeiss, Jena, Germany). The fracture morphology was also examined with SEM. The XRD analysis was performed using a Bruker D8 advance A25 X-ray diffractometer (Bruker, Berlin, Germany) with monochromatic CuK α radiation operated at 40 KV and 40 mA. X-ray diffraction (XRD) analyses were carried out to confirm the phase structure of the stirred zone (SZ).

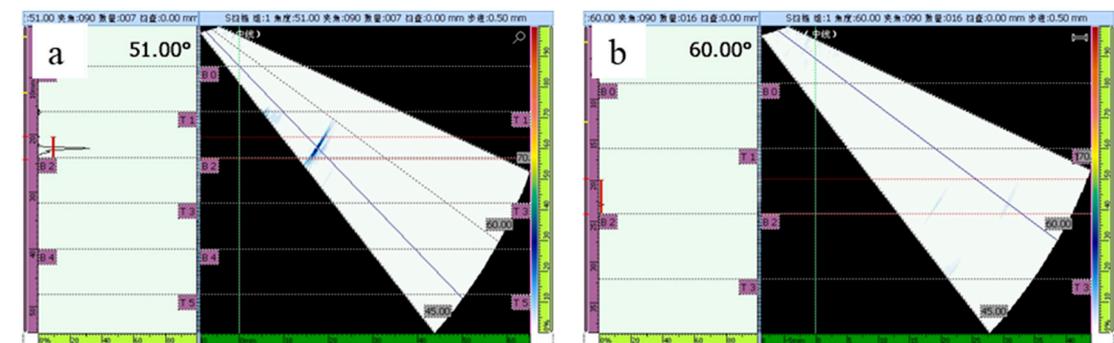
Figure 5. Results of ultrasonic phased array detection: (a) photo of the signal detected for a defect consisting of a 0.1ϕ hole, (b) photo of the signal detected for the repaired sample.

Figure 5 shows the results of ultrasonic phased array detection which used the C scan as the scan mode. The signal of a 0.1ϕ hole defect was defined as the standard and is shown in Figure 5a. Figure 5b shows the signal detected for the repaired sample, which was recorded at the back of the sample. Figure 6a shows the surface of the FSP-repaired sample. The surface of the repaired area was silver-white. The repaired zone was well protected from oxidation by an argon shield. Figure 2b shows the actual repair process. The color of the repair process was bright white. It can be concluded that the temperature was higher than $1000\text{ }^{\circ}\text{C}$ and less than that corresponding to the melting point in the repair process.

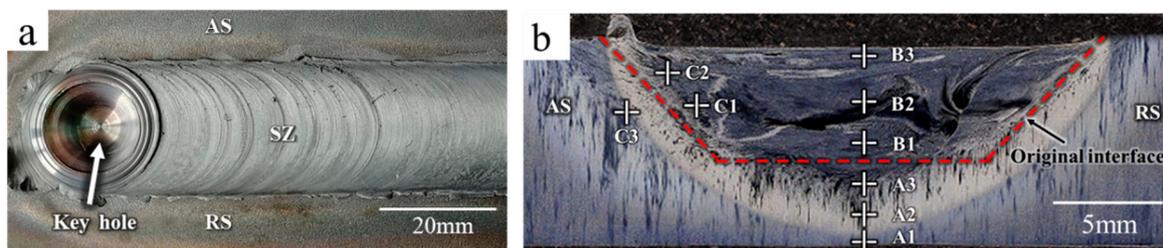
Figure 6. Surface and cross section features of the FSP-repaired samples: (a) photo of the repaired sample surface, (b) cross-sectional morphology of the repaired sample.

Figure 6b shows the cross-section features of the repaired sample, which contained the repair zone and the substrate. The repair zone included the SZ, the thermo-mechanically affected zone (TMAZ), and the heat-affected zone (HAZ). In order to describe the microstructure more clearly, the sample was divided into nine zones. Zones A1–A3 were at the bottom of the sample: A1 was the HAZ near the substrate, A2 was near the interface between the TMAZ and the HAZ, and A3 was the TMAZ at

the bottom of the sample; B1–B3 were the SZ: B1 was near the original interface (about 0.5 mm), and B3 was near the surface (about 0.1 mm); C1–C3 were at the upper left of the original interface: C1 was between the SZ and the TMAZ, C2 was in the TMAZ, and C3 was near the interface between the TMAZ and the HAZ.

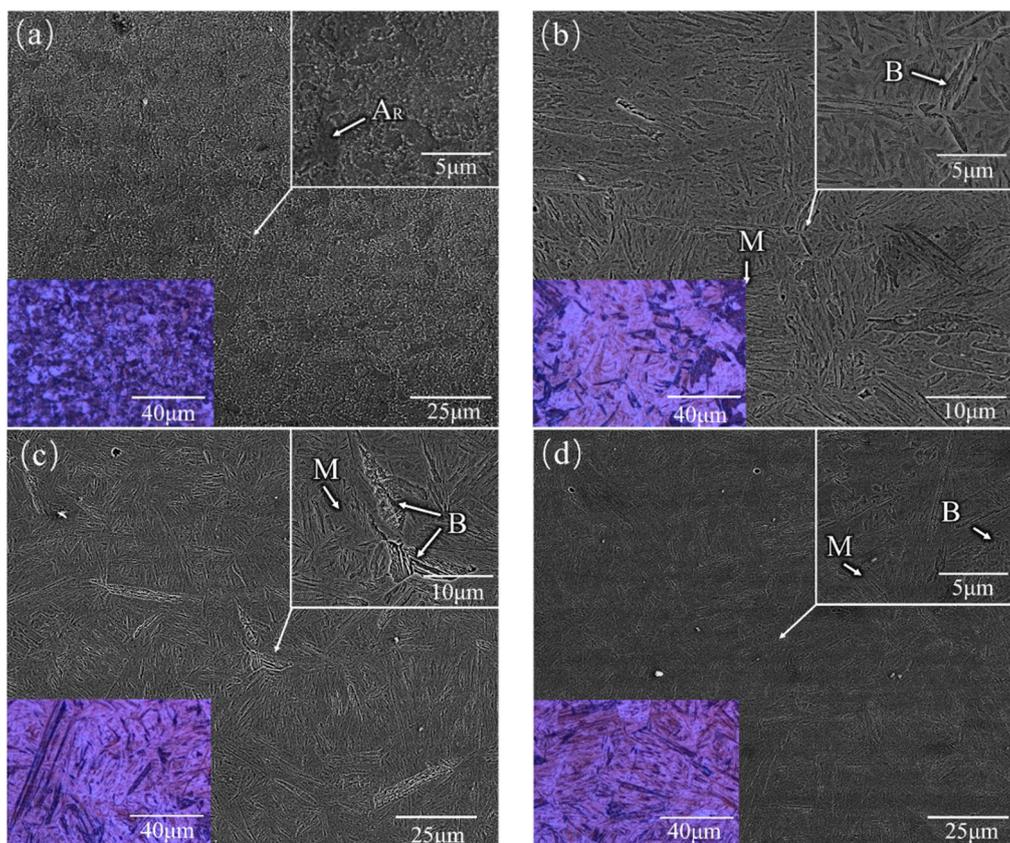
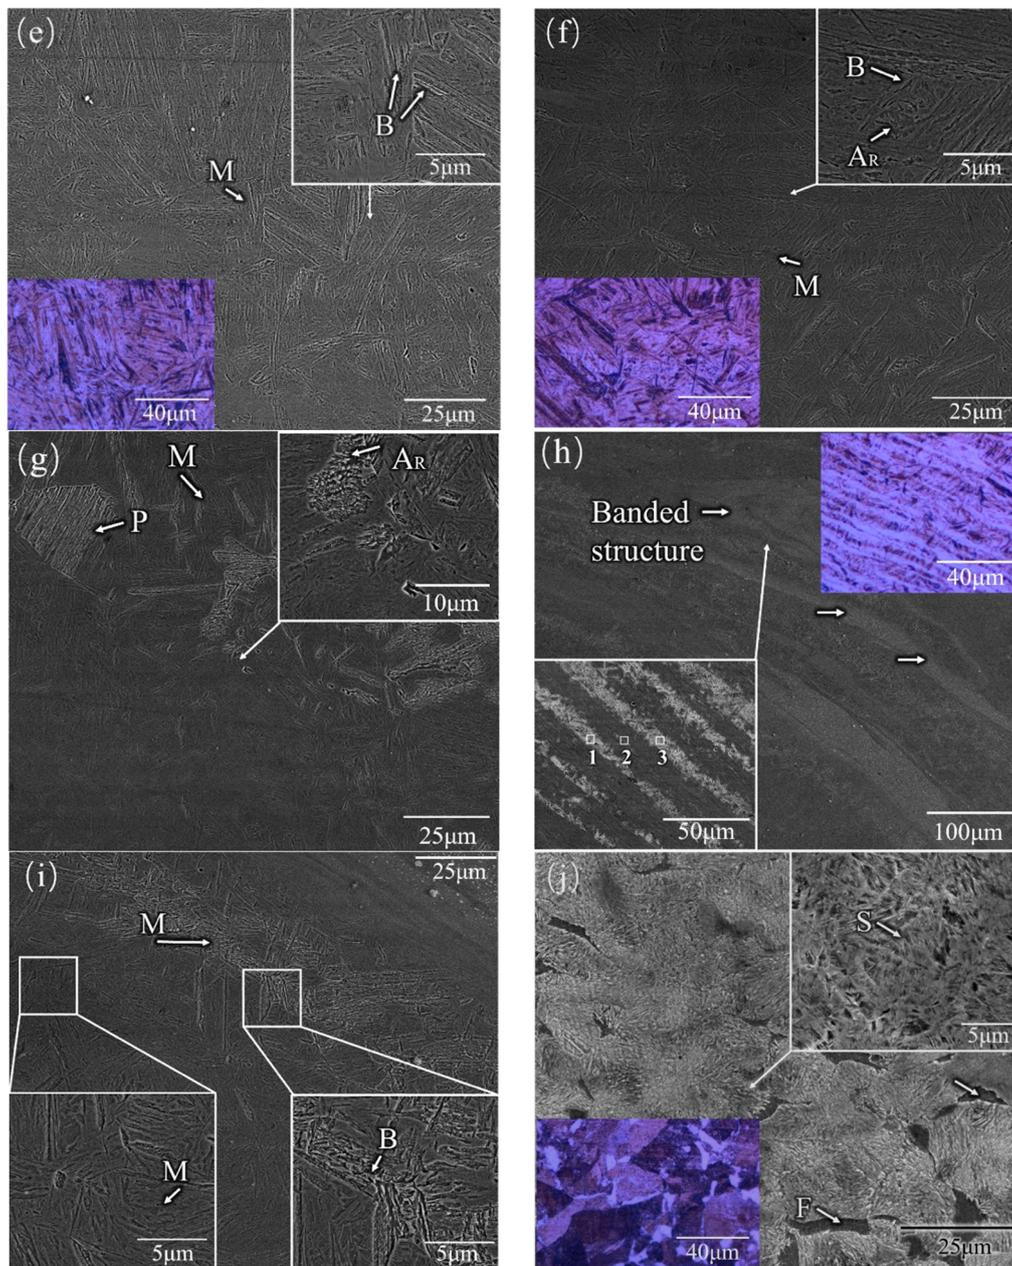
Figure 7. Typical SEM photos of FSP-repaired 34CrNiMo6 shown in Figure 5 (small box for partial enlargement): (a–c) zones A1–A3; (d–f) zones B1–B3; (g–i) zones C1–C3; (j) substrate. The color photos are optical microscope (OM) photos (A_R : Retained austenite; M: Martensite; B: Bainite; P: Pearlite).

As is shown in Figure 7d–f, a high-volume fraction of lath martensite, low bainite, and some retained austenite was found in the SZ. The size of the martensite was different in different positions of the SZ. Although no precise thermometer was used, the temperature of the stirring zone could be roughly determined by the color of the tool. As shown in Figure 2b, it can be speculated that the temperature of the SZ was much higher than the austenite transformation temperature (A_{c3}). This conclusion was also confirmed by the microstructure found in the zone. The heat input in the SZ came mainly from the friction between the pin tool and the workpiece, which was also the main source of heat for FSP. At the same time, because of the close distance to the shoulder affected zone, the top region of the SZ was subject to more heat generated by the friction between the shoulder and the workpiece surface. Under the combined action of temperature and deformation, austenite transformation occurred in the SZ. Because the SZ was the region with the largest heat accumulation and the cooling rate was relatively stable, the austenite had enough time to transform into martensite. When the austenite was subcooled to a temperature range below the pearlite transformation temperature and above the martensite transformation temperature, bainite transformation occurred from shear transformation to short-range diffusion. Bainite transformation was also affected by the heat input.

As shown in Figure 7a, a large number of retained austenite island (A_R) were found in the HAZ. As previously analyzed, deformation and heat input caused the phase transition. However, unlike the SZ, the heat dissipation rate at the bottom of the plate was faster, because the bottom of the plate was directly in contact with the clamp, and the austenite produced by deformation-induced transformation did not have enough time to transform. Comparing Figure 7b with Figure 7c, the sample in Figure 7b was found to contain a larger martensitic fraction, and no trace of retained austenite was observed. Figure 7b shows an area closer to the SZ than Figure 7c, where there was enough time for martensite transformation.

As shown in Figure 7g–i, the most complex microstructures were found in this area. In the upper part of the onion rings, there were bands at the junction between the SZ and the HAZ (Figure 6 C2). Table 3 shows the EDS analysis results of the banded structure of the SZ on the repaired sample. It was

Table 3. EDS analysis results of the banded structure of the SZ in the repaired sample (regions 1–3 are the region marked in Figure 7h) (wt %).

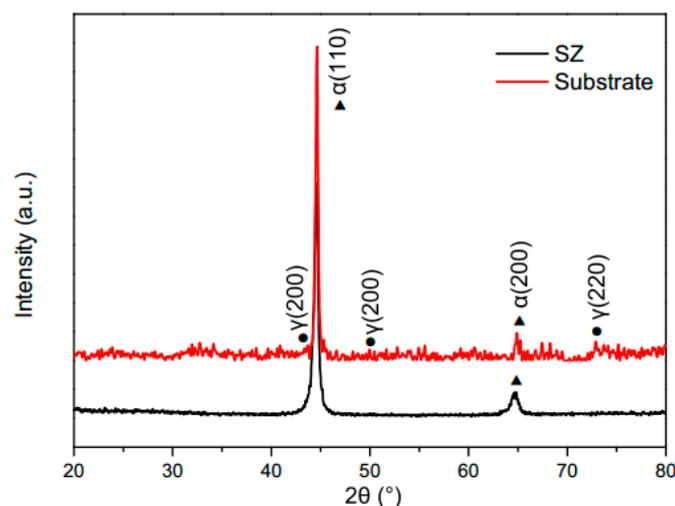
Figure 8. XRD patterns of the SZ of the FSP-repaired specimen.

In summary, the evolution of the microstructures was caused mainly by two factors. One of the factors was the heat input. During the processing, the microstructure of the SZ and TMAZ transformed into austenite due to the influence of the heat input [21]. As the tool pin moved, the repaired zone began to cool. Different cooling rates led to different microstructure transformations. The second factor was the deformation. The process caused a large deformation which promoted austenite transformation into ferrite. At the same time, the size of the martensite was also affected. In order to confirm the analysis of the microstructure, crystal phases of the SZ and the substrates were identified by XRD. The XRD patterns are presented in Figure 8, which shows α_M (α -Fe in martensite) arising from different hkl planes, with varying intensities. The bainite peaks are attributable to α (110) and α (200) in the SZ and the substrates [7]. The austenite reflections in the substrate sample derived from (111), (200), and (220). No austenite peaks were found in the SZ samples. Combining the results of XRD, SEM, and OM, it could be confirmed that the SZ was composed of martensite and bainite, without austenite.

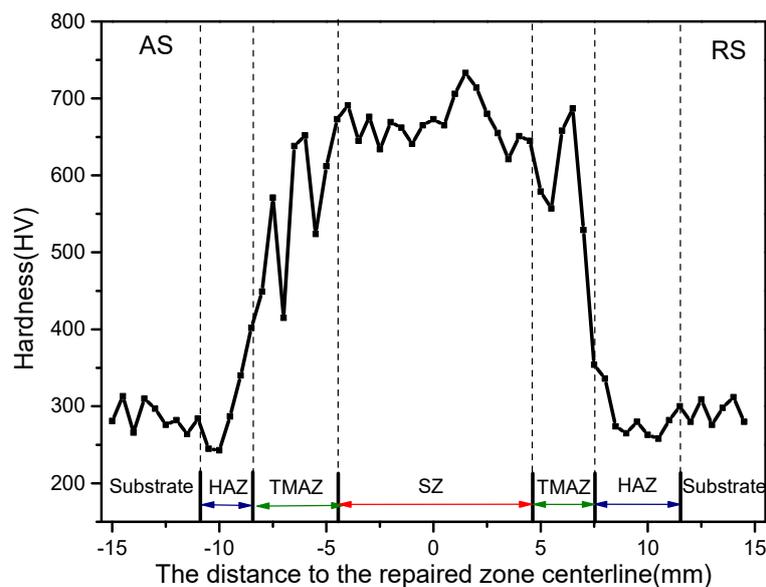
Figure 9. Microhardness distribution for FSP-repaired 34CrNiMo6. HAZ, heat-affected zone, TMAZ, thermo-mechanically affected zone.

Figure 9 shows the microhardness distribution for the repaired 34CrNiMo6 steel. The microhardness in the repaired zone was much higher than in the substrates. At the same time, the microhardness values showed differences in the retreating side and advancing side. The mean microhardness value in the SZ was about 650 HV. As analyzed in Section 3.1, a high-volume fraction of bainite and lath martensite was found in the SZ. At the same time, the stir zone had a refined grain size due to the effect of the tool pin. The microhardness in the TMAZ was 550–620 HV. It was found that the hardness value fluctuated greatly in the TMAZ. Big fluctuations of microhardness were found in the AS. The microstructure in the TMAZ was the most complex. Both quenched martensite and tempered martensite were found in the zone. The formation of pearlite could affect the microhardness of the zone. The tool pin showed a lower effect on the TMAZ than on the SZ, so grain refinement was better than in the SZ. At the same time, the grains were elongated. The microhardness of the HAZ was much lower than those of the SZ and TMAZ, whose value was about 360–420 HV. The microhardness showed a downward trend in the HAZ of the AS, while it fluctuated smoothly in the HAZ of the RS. The microhardness was only 7% lower than in the substrate, which was much better than the result obtained with the fusion repair method. The different heat input in the AS and RS could explain this phenomenon. The AS often generated more heat than the RS. Compared with the SZ and TMAZ, the HAZ was only affected by the heat input. The heat input of FSP is much lower than that of conventional fusion welding. Therefore, grain growth is not severe, and the HAZ is small.

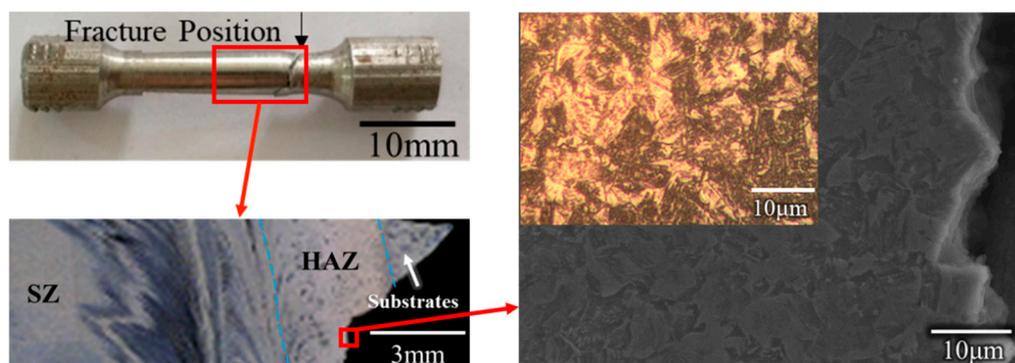
Figure 10. Image of the fracture position in the tensile specimens.

The room temperature tensile properties of the repaired specimens are listed in Table 4. It was found that the maximum ultimate strength (UTS) was 900 MPa and could reach 91.8% of that of the substrate (the maximum ultimate strength of the substrate was 980 MPa [22]). The mean ultimate strength was 883 MPa, which was about 90% of that of the substrate. Three tensile specimens were fractured in HAZ. The results of the microstructural analysis indicated that a high-volume fraction of lath martensite formed in the SZ. The results of the microhardness and the XRD results could also confirm the microstructure of the SZ. The high strength can be attributed to the microstructure of the high-volume fraction of lath martensite. The microhardness results of the retreating side indicated that the values of this side were the lowest, which could cause fracture in the specimen. To confirm the fracture position of the tensile specimen, a cross-sectional photo of the fractured tensile specimens

was analyzed (Figure 10). It was found that the fracture mainly crossed through the HAZ. The optical image and SEM image of the fractured tensile specimen were also used to analyze the microstructure. The microstructure of the HAZ was composed of ferrite and pearlite. In the former microstructure analysis, the SZ consisted of martensite and bainite, while the fracture position consisted of ferrite and pearlite. It is well known that martensite and bainite have high strength, while ferrite and pearlite have low strength. Therefore, the fracture occurred in the HAZ, which is in accordance with the results of microhardness. In order to better understand the fracture mechanism, the fracture morphology was analyzed. Figure 11 shows the SEM image of fracture morphology in specimen No. 2. It should be noted here that, as Figure 10 shows, a heavy necking took place during tensile loading. The most complex fracture morphology found is shown in Figure 11. The typical ductile ‘cup-and-cone’ fracture surface included three parts: the fiber region in the center, the outside smaller shear lip, and the larger radial region between the two [23]. Although the fracture morphology in Figure 11 does not conform to the typical ductile ‘cup-and-cone’ fracture surface, some ductile characteristics were found in the fracture morphology. Figure 11b shows some elongated shapes of voids, which may indicate that localized shear stresses also occurred, in addition to tensile stresses, during deformation. The results of the tensile tests were in accordance with the microstructure analysis. Both dimples and small steps were found in the fracture surface. The fracture mode of the tensile samples was ductile/brittle mixed fracture.

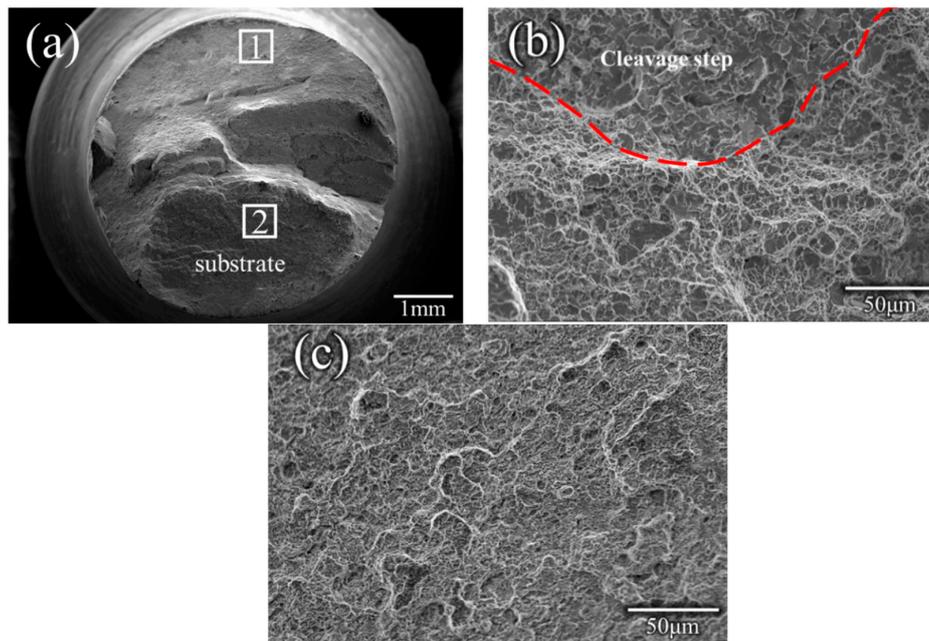
Figure 11. SEM image of the fracture morphology in a specimen, (a) Macroscopic appearance of the fracture (b,c) higher magnification SEM image of region 1 and region 2.
