Article

Deformation Field Analysis of Small-Scale Model Experiment on Overtopping Failure of Embankment Dams

Qiang Lu, Yanchang Gu *, Shijun Wang, Xiandong Liu and Hong Wang

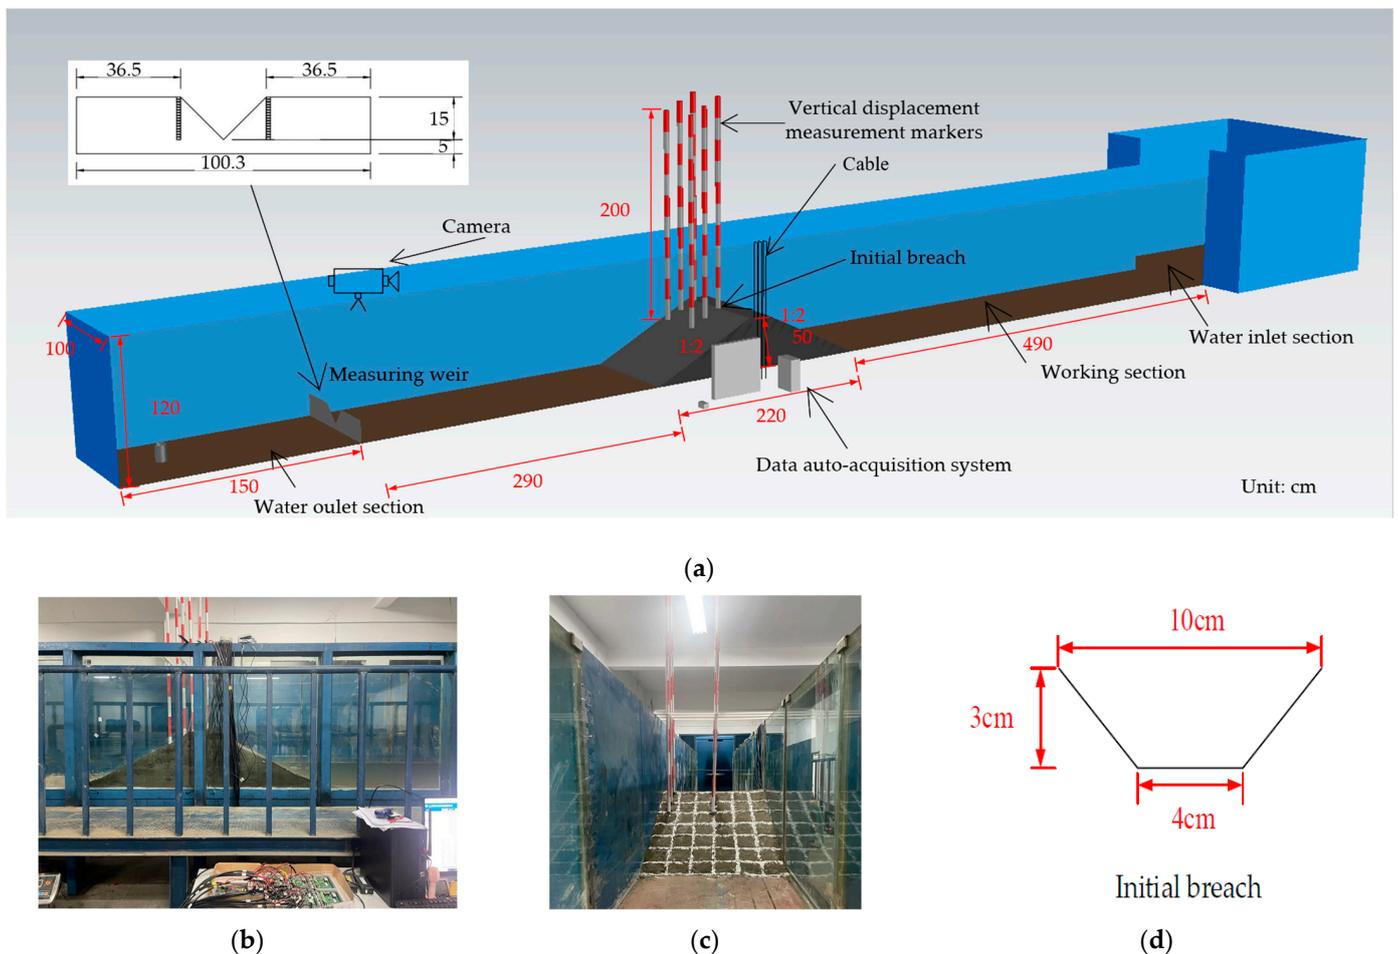
Figure 1. (a) Schematic diagram of the experimental model; (b) side view of the model; (c) downstream slope of the dam; (d) dimensions of the initial breach.

The model experiment of overtopping failure of homogeneous embankment dams was carried out in a glass flume at the Nanjing Hydraulic Research Institute experiment research base, and the glass flume is mainly based on the water inlet section, the working section, the water outlet section, and other components. The size of the water inlet section is 200 cm × 200 cm × 200 cm (*L* × *W* × *H*, the same as below); the working section is made of reinforced glass, with a size of 1000 cm × 100 cm × 120 cm; the water outlet section is equipped with a sedimentation reservoir and a plug-in tailgate, with a size of 150 cm × 100 cm × 120 cm. The experimental embankment dam is a homogeneous earth–rock dam with a height of 50 cm, a width of 20 cm at the dam crest, a length of 100 cm, and upstream and downstream dam slopes of 1:2. To facilitate the embedding of sensors inside the dam, the initial breach was preset at the mid-dam location [26], and the dimensions of the breach and the schematic diagram of the model are shown in Figure 1.

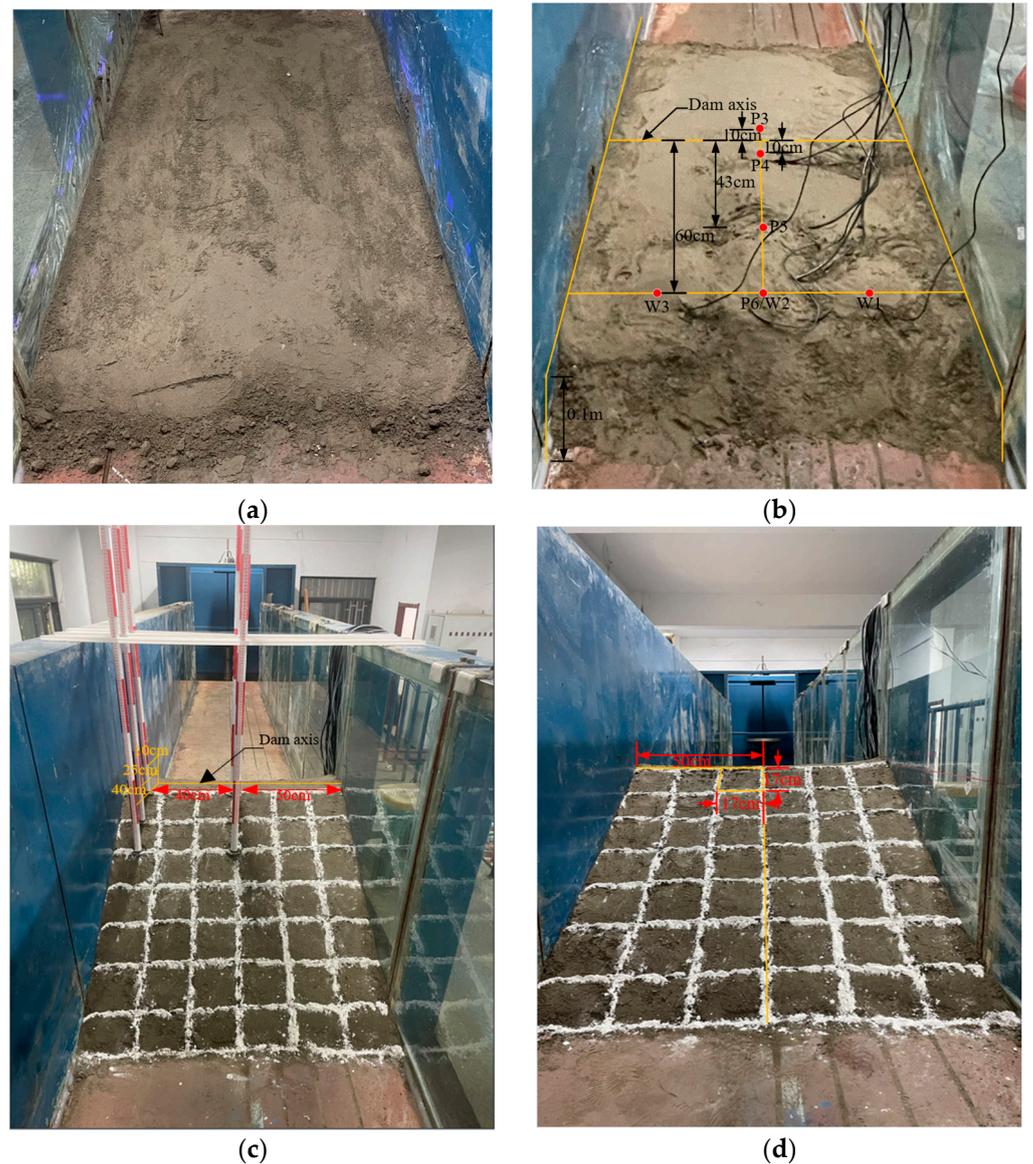
Figure 2. Filling process of the model dam: (a) dam compaction; (b) embedded sensors; (c) measurement benchmark installation; (d) division grids.

The flume sidewall faces immediately adjacent to the dam's sides were waterproofed with Vaseline prior to dam filling to attenuate the bounding effect of the flume sidewalls on the modeled dam. Vaseline not only reduces the confinement of the flume to the modeled dam but also prevents contact leakage at the interface. In order to ensure the homogeneity of the dam body and the reproducibility of the experiment, the dam body was filled in five layers, each with a thickness of 10 cm, and the mass of the required soil material was calculated based on the volume of each layer area. For more visualization of the dam failure process, the model dam was constructed by dividing a grid of approximately 17 cm × 17 cm on the downstream slope of the dam. Figure 2 shows the filling process of the model dam.

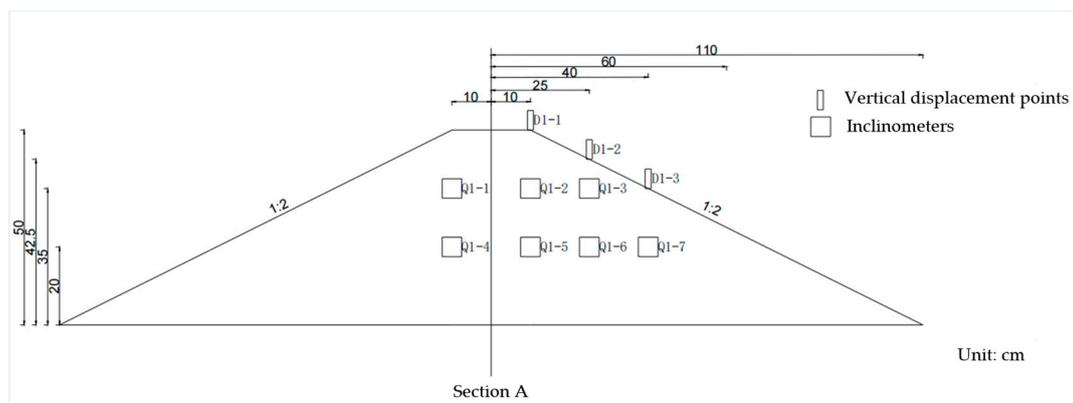
Figure 3. Detailed drawing of measurement point arrangement at section A.

The measurement program includes environmental variables and deformation, and the specific measurement point layout is detailed in Figures 3 and 4.

- (4) Internal deformation: Two internal deformation monitoring sections are set up in the dam body, respectively, in the center section of the dam (section A) and the corresponding position 40 cm to the right of the center section (section B). Among them, in section A, one inclinometer is set at each elevation of 35 cm and 20 cm above the dam foundation at axis distances of -10 cm, 10 cm, and 25 cm, respectively, and one inclinometer is set at an elevation of 20 cm above the dam foundation at an axis distance of 40 cm; in section B, one inclinometer is set at each elevation of 35 cm and 20 cm above the dam foundation at an axis distance of 10 cm. A total of nine inclinometers are used.

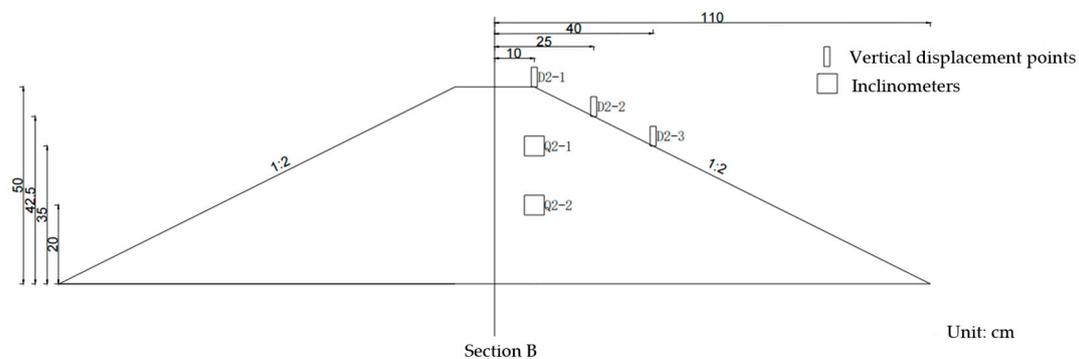
Figure 4. Detailed drawing of measurement point arrangement at section B.

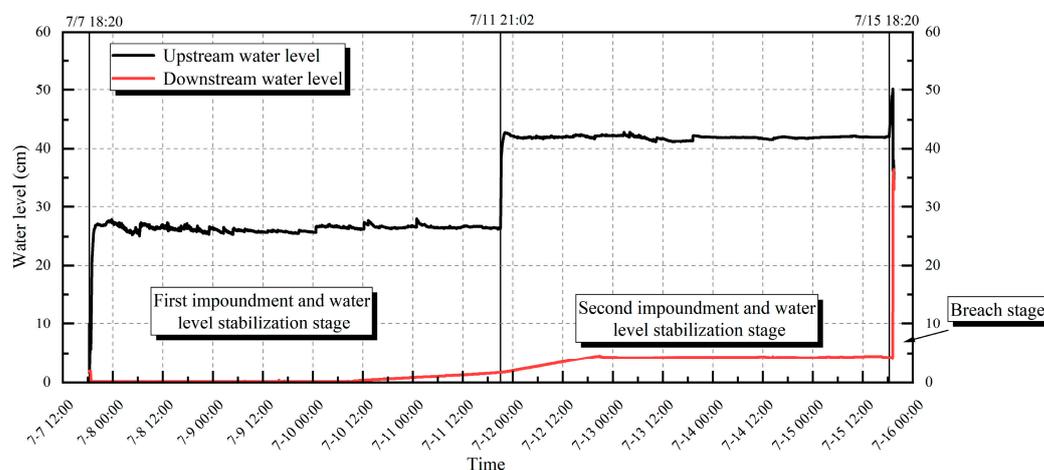
Figure 5. Process of upstream and downstream water level changes.

The experiment employs staged impoundment. The first impoundment started on 7 July at 18:20 and ended on 7 July at 19:23, lasting 1 h 3 min; the water level was stabilized for 97 h 39 min. The second impoundment started on 11 July at 21:02 and ended on 11 July at 21:30, lasting 28 min; the water level was stabilized for 92 h 50 min. The breaching period started on 15 July at 18:20 and ended on 15 July at 19:18, lasting 58 min. The reservoir water level rise to the dam crest lasted 48 min. Information tables for the first impoundment, the second impoundment, and the calendar time of the breach stage are detailed in Table 3 and Figure 5.

The upstream and downstream water level change processes are shown in Figure 5, and the upstream and downstream water level change processes during the dam failure period are shown in Figure 6.

The first impoundment period lasted 1 h 03 min, and the upstream water level increased from 00 cm to 26 cm; the upstream water level was maintained at 26 cm, and the length of the stabilization period was 97 h 39 min; the second impoundment period lasted 0 h 28 min, and the upstream water level increased from 26 cm to 42 cm; the upstream water level was maintained at 42 cm, and the length of the stabilization period was 92 h 50 min.

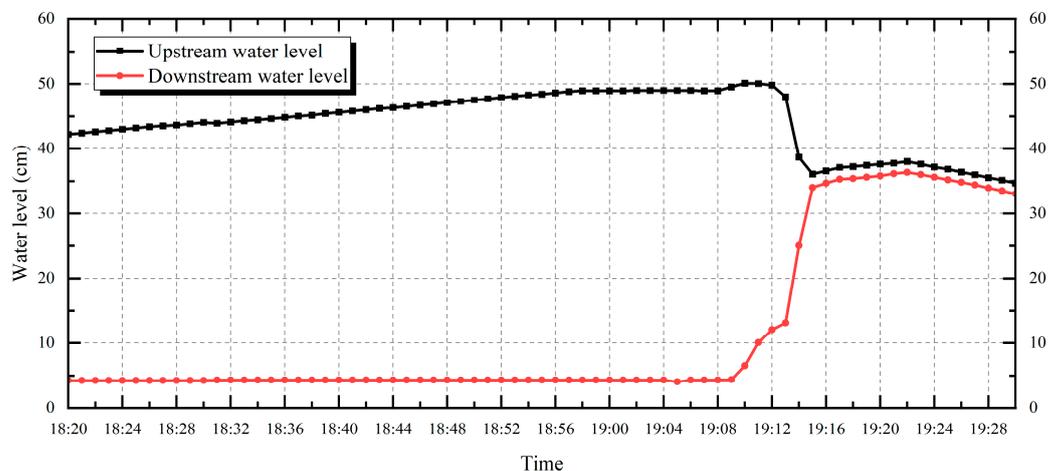
Figure 6. Process of upstream and downstream water level changes during the breaching stage.

During the breaching period, the water level increased from 42 cm to the dam crest for 48 min, after which the overtopping breaching damage began. Then, the water levels upstream and downstream were leveled off after 7 min, and the breaching ended.

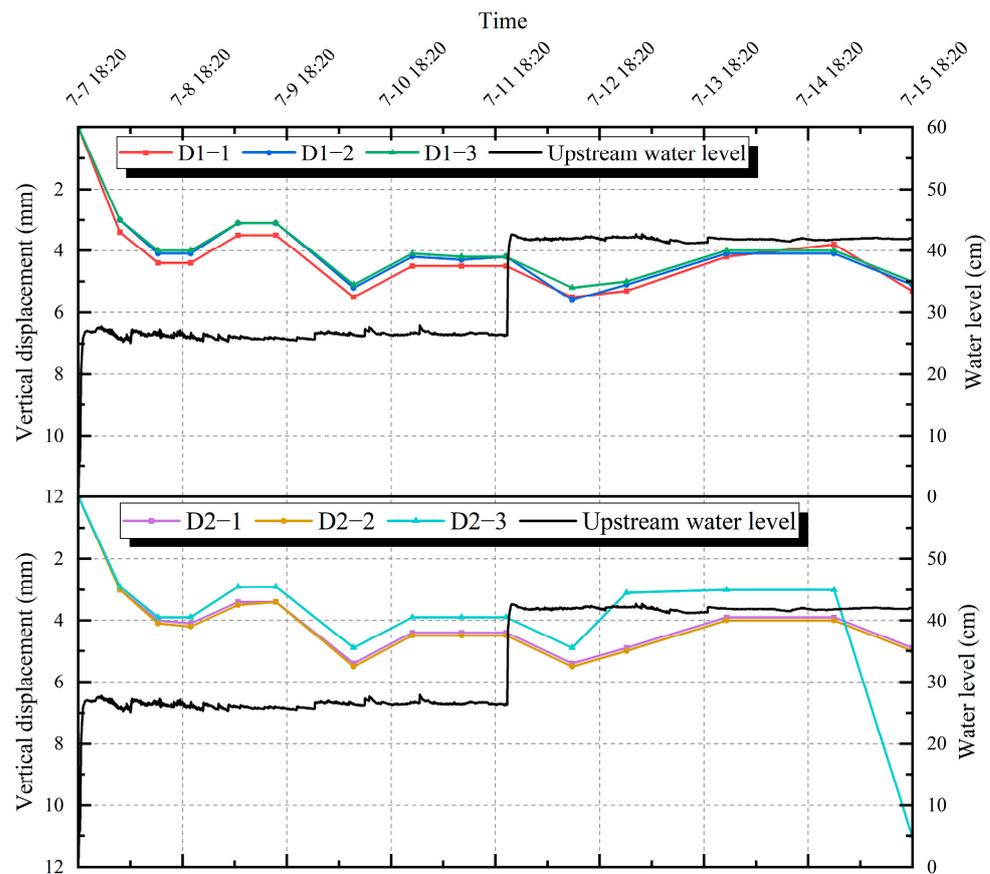
Figure 7. Change process of vertical displacement of the dam surface during the impoundment stage.

The change process of vertical displacement of the dam surface during the impoundment stage is shown in Figure 7, and the cumulative vertical displacement of the surface in each stage at each measurement point is shown in Table 4.

- (3) Nevertheless, the most considerable change in vertical displacement occurred at measurement point D2-3 in section B. According to the analysis, with the increase in the saturation line of the dam body, the soil of the downstream slope was saturated and the height of escape point increased, resulting in longitudinal cracks in the soil of the

- downstream slope and slight slippage to the downstream side, which led to the considerable vertical displacement measurement value of the D2-3 measurement point.
- (4) The vertical displacement of the dam body was well correlated with the impoundment process and had a certain lag. During the two impoundments and water level stabilization processes, the vertical displacement of the dam body showed a pattern of gradual increase and tended to stabilize.
 - (5) Combined with the whole impoundment process, the rate of change in vertical displacement during the first impoundment and water level stabilization was fast and in the rapid development stage, while the amount of change during the second impoundment and water level stabilization was not significant.

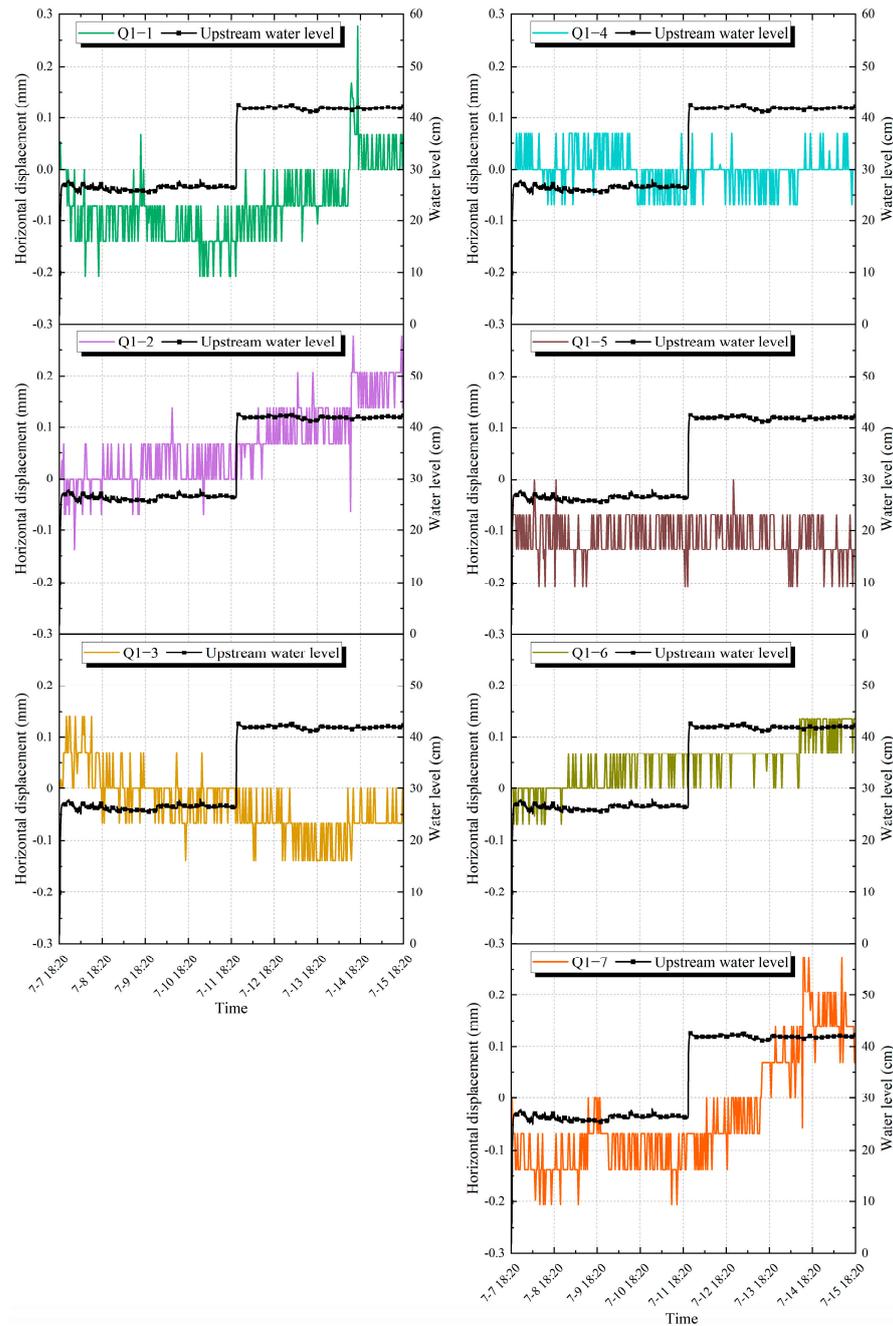
Figure 8. Change process in the left and right bank horizontal displacement (L&R HD) at each measurement point during the impoundment stage of section A.

The change process in the L&R HD at each measurement point (Q1-1, Q1-2, Q1-3, Q1-4, Q1-5, Q1-6, and Q1-7) during the impoundment stage of section A is shown in Figure 8, and the horizontal displacements of the left and right banks at each measurement point (Q2-1 and Q2-2) during the impoundment stage of section B are shown in Figure 9. The L&R HD at each measurement point in the water impoundment stage of section A shows a ladder-type jump, which is only an auxiliary reference for qualitative analysis.

- (1) The horizontal displacement of the two sections' left and right banks shows a general deformation trend to the left bank, and the displacement of section B is more significant than that of section A. In the water impoundment and water level stabilization stage, the dam body is subject to seepage pressure and soil wetting; the deformation gradually increases, and the L&R HD tends to tilt to the left bank. As the water level of the upstream reservoir increases, the measured value of the measuring point gradually increases, and the rate of change is faster in the second impoundment period compared with the first impoundment period. Comparing the measuring points with the same elevation and the same axis distance in two different sections, such as measuring point Q2-1 with 35 cm elevation in section B and measuring point Q1-2 in section A, it is found that the measured value of the measuring point in section B has an enormous variation, which indicates that the horizontal displacement of the right bank of the dam body changes more than the location of the middle of the dam.

- (2) Displacements at the measurement points near the dam crest and the dam toe are relatively more substantial. A comparative analysis of the most extensive displacement changes between the two sections in the storage stage found that the 35 cm elevation downstream side of the dam crest measurement points (Q1-2 and Q2-2) and the 20 cm elevation near the dam toe measurement point (Q1-7) measured larger value changes, so we should focus on the change in horizontal displacement on the left and right banks in this area.

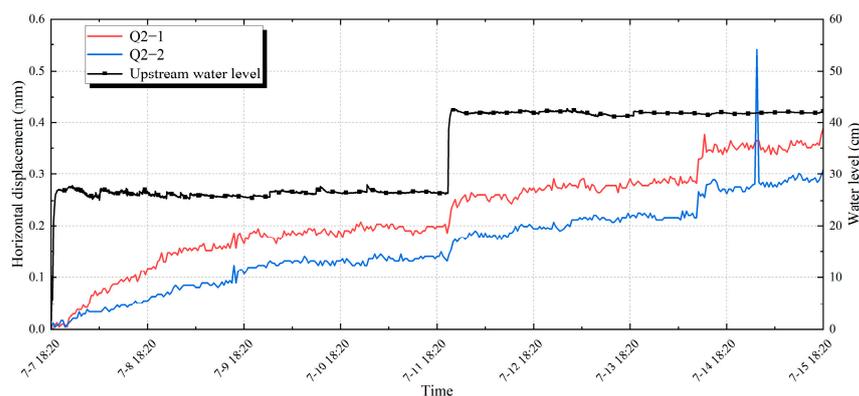
Figure 9. Change process in the L&R HD at each measurement point during the impoundment stage of section B.

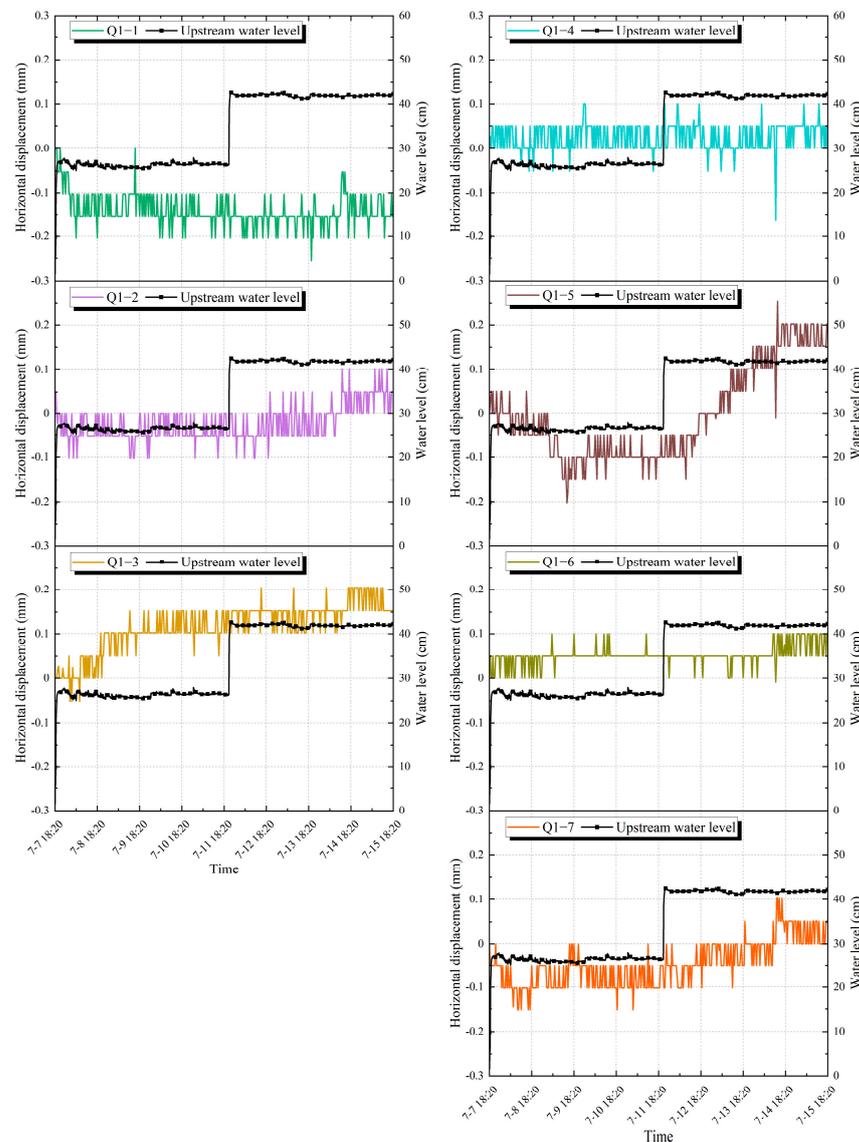
Figure 10. Change process in the upstream and downstream horizontal displacements (U&D HD) at each measurement point during the impoundment stage of section A.

The change process in U&D HD at each measurement point (Q1-1, Q1-2, Q1-3, Q1-4, Q1-5, Q1-6, and Q1-7) during the impoundment stage of section A is shown in Figure 10, and the changes in U&D HD at each measurement point (Q2-1 and Q2-2) during the impoundment stage of section B are shown in Figure 11. The U&D HD at each measurement point in the water impoundment stage of section A shows a ladder-type jump, which is only an auxiliary reference for qualitative analysis.

- (1) The magnitude of change in U&D HD is more significant in the later stages than in the earlier stages. The deformation of the dam body is gradually increased by seepage pressure and soil wetting during impoundment and water level stabilization, and the U&D HD generally shows an inclination to the downstream side. Compared with the first impoundment and water level stabilization period, the displacement change rate is faster in the second impoundment and water level stabilization period.

- (2) The displacement of the right dam section to the downstream side is greater than that of the middle section, and the displacement of the measurement points near the downstream dam slope location is relatively significant. While comparing the measuring points with the same elevation and axis distance in two different sections, it is found that the variation in the measured value of the measuring point of section B is more prominent (e.g., measurement points Q2-2 at 20 cm elevation in section B and Q1-5 at 20 cm elevation in section A), which indicates that the variation in U&D HD in the right dam section is more considerable than that of the middle position of the dam. In the comparative analysis of the displacement of the water impoundment stage at the most prominent points of the two sections, we found that the measurement points (Q1-5 and Q2-1) at 20 cm elevation downstream of the dam crest measured the most significant variation, so we should focus on the changes on U&D HD on the downstream side of the dam crest.

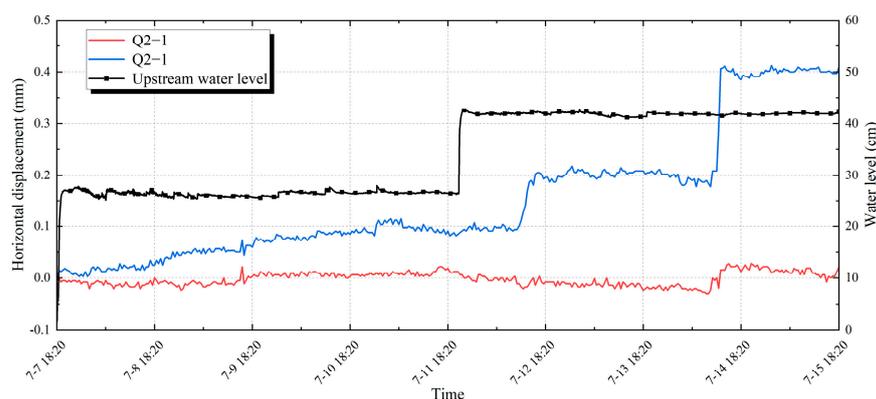
Figure 11. Change process in the U&D HD at each measurement point during the impoundment stage of section B.

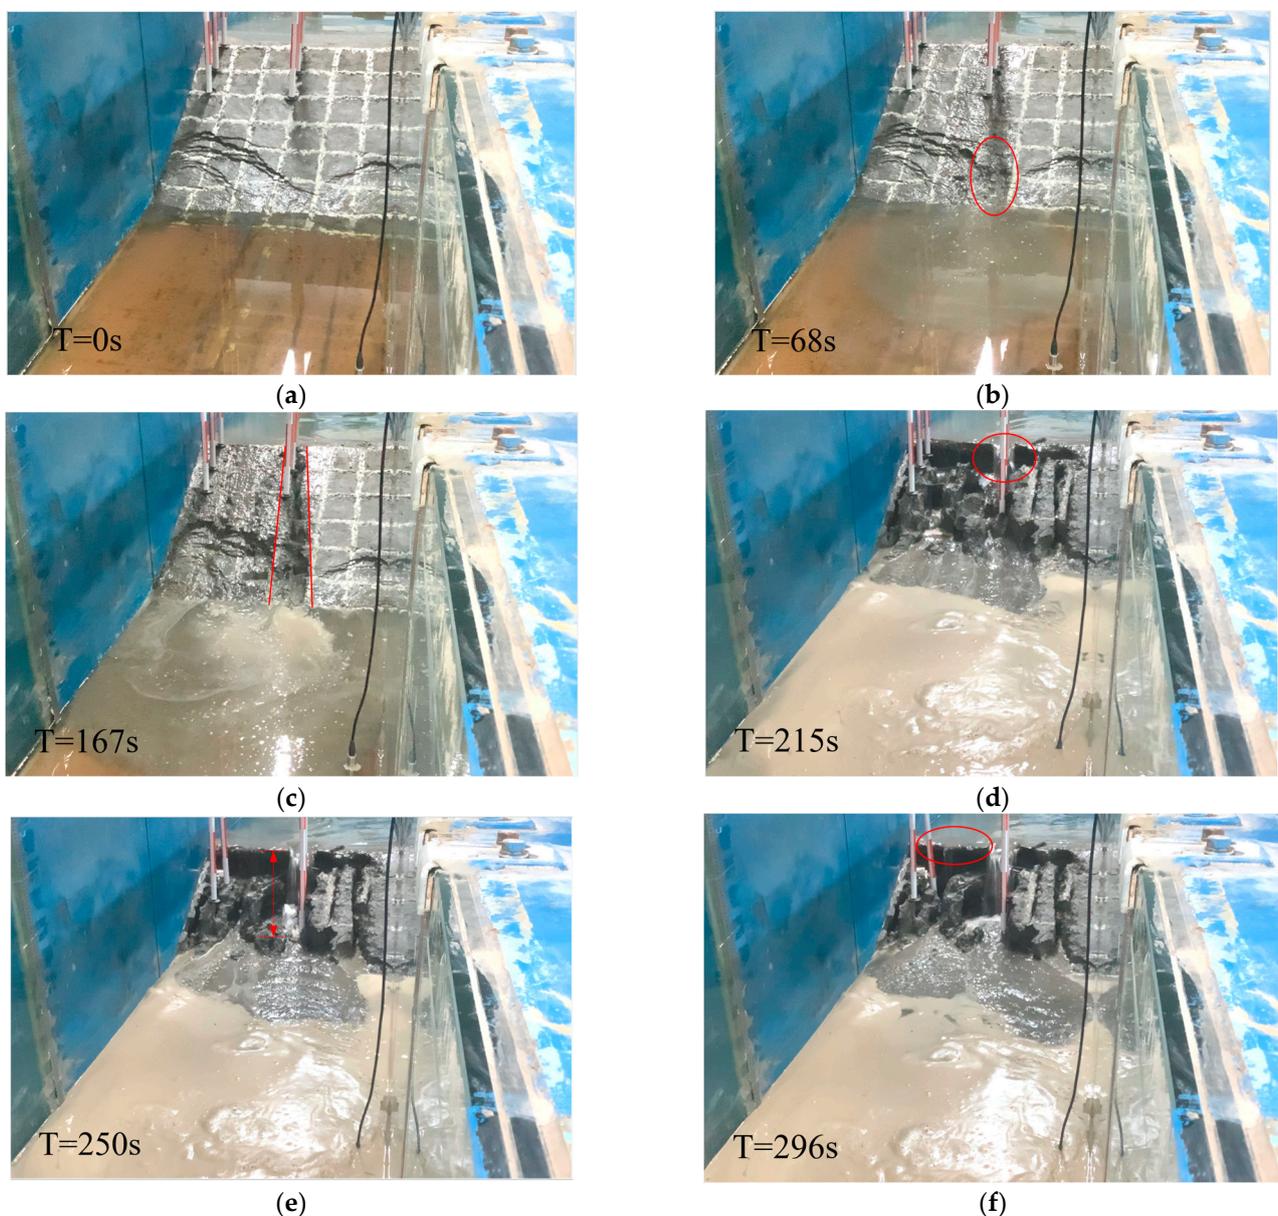
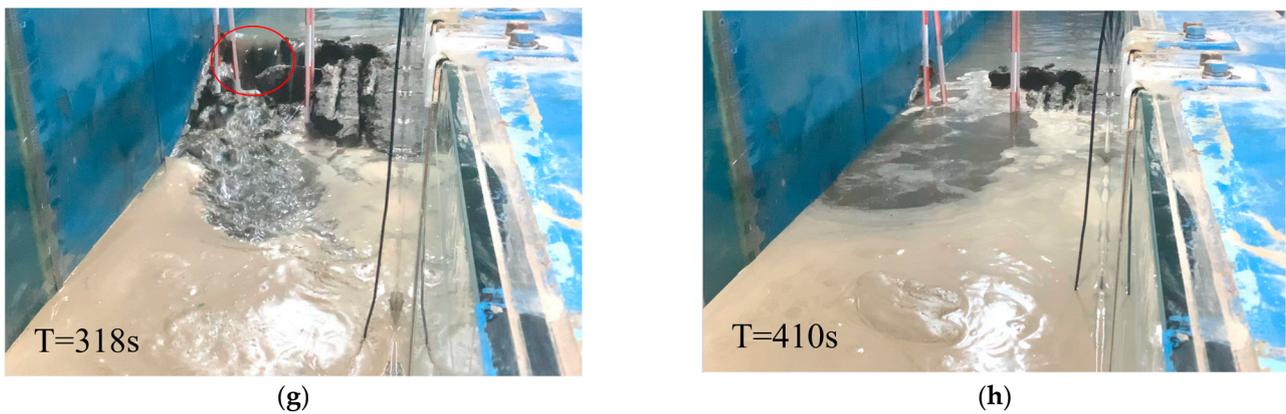
Figure 12. Evolution of the dam breaching process: (a) the upstream reservoir overtopped; (b) “head-cut” erosion began to form and developed from the downstream to the upstream side; (c) formation of multilevel headcut erosion; (d) the “headcuts” merged to form a “waterfall-like water flow”; (e) the water flow drop increased and the scouring capability further increased; (f) the soil on the upstream side of the dam crest in the right dam section was destabilized and collapsed due to gravity; (g) the breach continued expanding and gradually formed structural collapses; (h) the upstream and downstream water levels leveled off and the failure ended.

It should be especially pointed out that, due to the lack of seepage control measures for the dam body, a certain degree of infiltration damage occurred before the overtopping breach, which resulted in the collapse of the right bank of the dam body during the overtopping breach without the collapse of the upstream side of the center section of the original test design breach.

The evolution of the dam failure during the breaching period is shown in Figure 12.

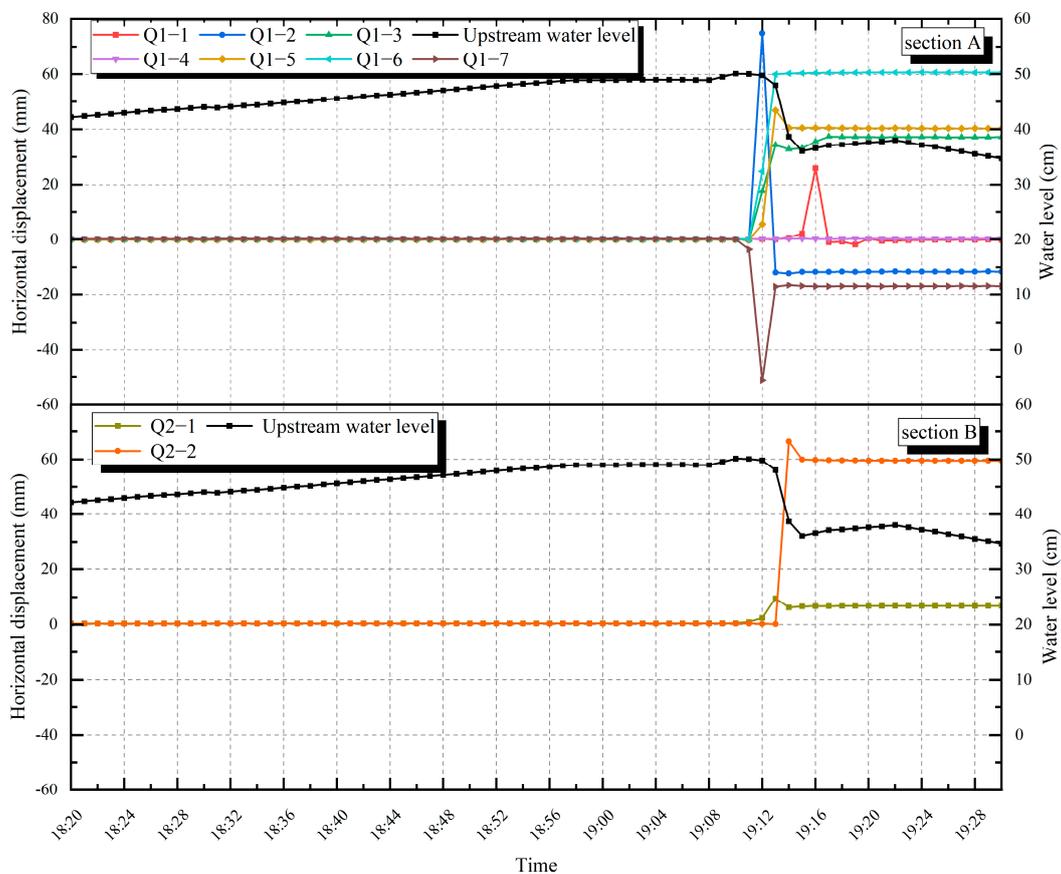
Figure 13. Change process of the L&R HD at each measurement point during the breach stage of sections A and B.

The variation process of internal L&R HD at each measurement point is shown in Figure 13, and the statistical situation of the variation in the measured values is shown in Table 5.

- (2) With the “multilevel headcut” continuing to erode back toward the dam and developing upstream, the “multilevel headcut” gradually merged into a larger “headcut”. Within 215 s after the breach formed, a “waterfall-like water flow” emerged at this point, signifying the dam body erosion damage had progressed to the dam crest. At the center section of the breach (the downstream side of the dam crest and downstream side measurement points Q1-2 and Q1-3 at 35 cm elevation and the downstream side measurement points Q1-6 and Q1-7 at 20 cm elevation), the measurement values for above measurement point suddenly changed at 19:12.

- (4) With the rapid erosion of the dam body by the “waterfall-like water flow”, after 296 s of upstream reservoir water overflowing over the dam crest, the right bank of the dam crest soil body collapsed due to gravitational instability, resulting in the formation of a new breach whose width increased rapidly. At this moment, the failure and collapse processes of the dam body were very intense, the water erosion ability was potent, the flow and flow velocity of the breach increased rapidly, and the water level of the upstream reservoir decreased rapidly. The dam body formed a structural collapse after 410 s, resulting in the upstream and downstream reservoirs being connected. The measurement value of Q2-2 at the downstream side of the dam crest at 20 cm

- (5) As shown in Table 5, the sudden change in measuring point Q1-2 on the downstream side of the dam crest at 35 cm elevation in section A was the most considerable, with an amplitude of 79.2 mm. Before the structural collapse of the dam body occurred, embankment dam failure mainly occurred on the downstream side of the dam body. The dam crest’s downstream side and the dam body’s downstream side in section A have considerable overall variation. When combined with the breaching process, it can be seen that the initial breaching mainly occurred in section A. Compared with the same location of measuring points in section A, the sudden change time of the measuring points in section B took place later, and the amount of sudden change was smaller (e.g., measuring point Q2-1 at the downstream side of the dam crest at the 35 cm elevation). Due to the formation of a new breach on the right bank of the dam body, the amount of sudden change on the downstream side of the dam crest measuring point Q2-2 at 20 cm elevation in section B was 66.26 mm, which is more extensive than that of the original breach center section at the same location. From the beginning to the end of the overtopping breach of the earth dam, there was no sudden change in the measurement point on the upstream side of the dam crest at the 20 cm elevation in section A.

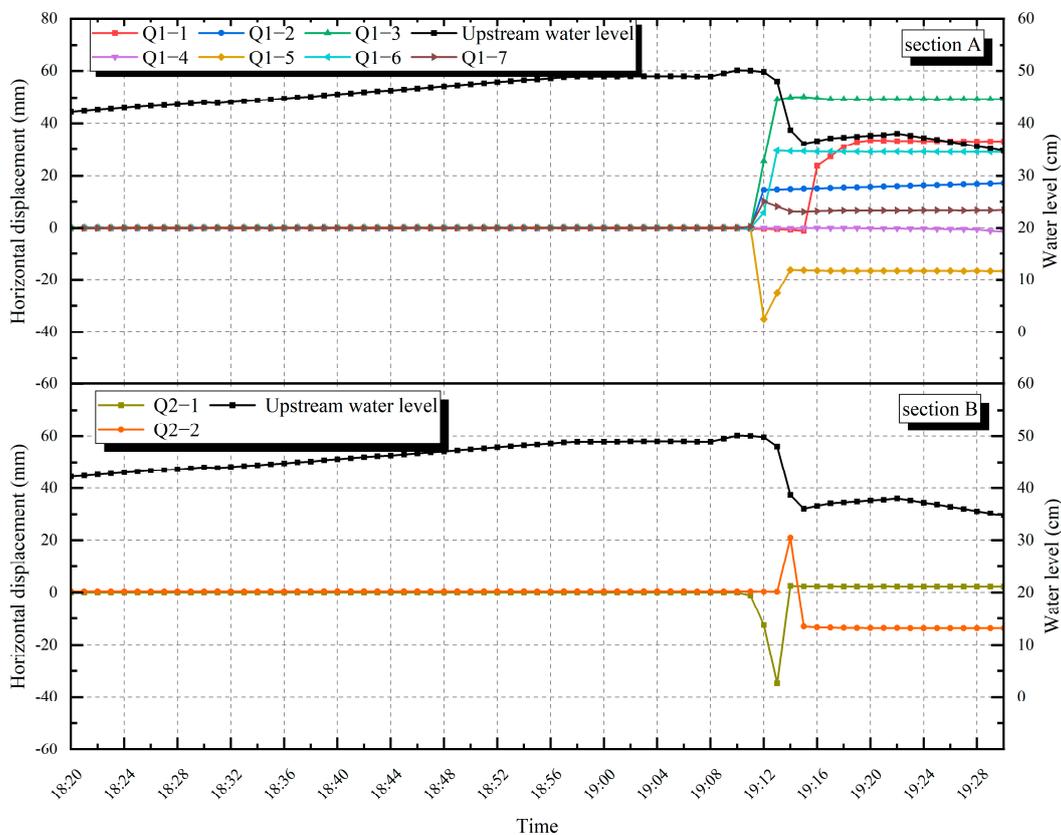
Figure 14. Change process of the U&D HD at each measurement point during the breach stage of sections A and B.

The variation process of internal U&D HD at each measurement point is shown in Figure 14, and the statistical situation of the variation in the measured values is shown in Table 6.

- (2) After the overtopping failure started, the closer to the downstream slope of the dam, the earlier the sudden change appeared, such as the 20 cm elevation Q1-7 measuring point in section A.

- (6) Before the dam body's structural collapse occurred, the measurement point on the upstream side had not caused any sudden changes.
