# Preliminary Risk Assessment of Dam Failure at the Location of the Cukaru Peki Deposit, Bor (Serbia)

**Abstract:** Industrial waste landfills, as evidenced by frequent accidents occurring in recent years, are regarded as one of the most hazardous facilities in the world. For the adequate management of a landfill, risk assessments of dam failures should be performed before operations begin. This paper deals with the preliminary risk assessment used for the tailings and pyrite concentrate storage facilities, as well as the drainage waters reservoir, which are currently at the development and construction stage in the Cukaru Peki deposit located in eastern Serbia. The research was conducted to establish the facts and level of risk at an early stage to allow for timely prevention of potential accidents and bring operational practice in line with design requirements. The annual failure probability was estimated using a semi-empirical method, based on the dam stability factor. While, the framework proposed by the New Zealand Society on Large Dams was applied to assess the consequences of potential failures. The risk was assessed as a function of accident probability and the severity of

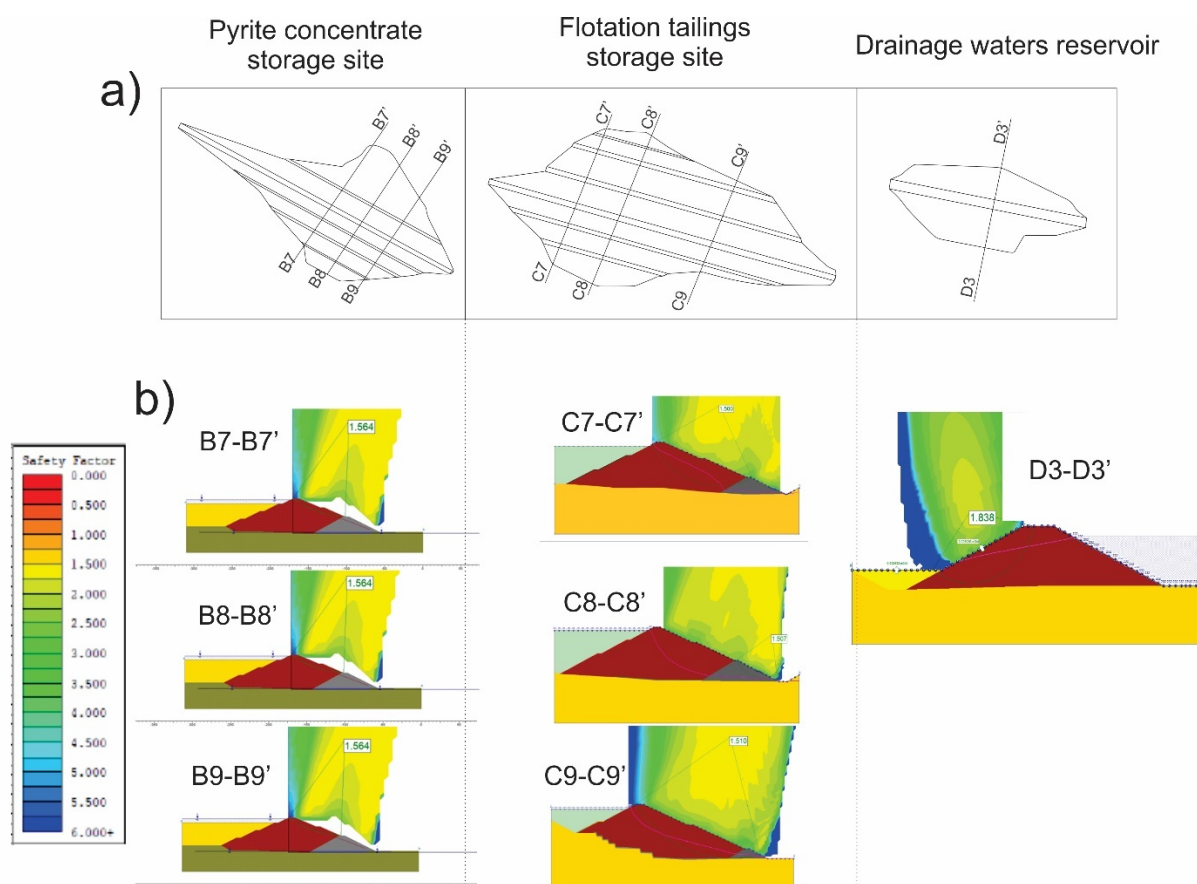
Figure 6 shows the profile and cross-section of all the dams used for stability calculations. Table 5 represents the obtained values of the static  $F_s$ . It may be noted that if we consider the recommended minimum values of  $F_s$  at static load, according to the local SRPS.U.C5.020 standard, all calculated factors are satisfactory.

**Figure 6.** Results of stability analysis: (a) Position of the profiles used for stability analysis and (b) cross-sections of the dams [20]. Reproduced with permission from author and publisher Mining and Metallurgy Institute Bor (MMI Bor), Serbia Zijin Mining doo Bor, Detailed Mining Design—Mineral Processing and Disposal of Tailings and Pyrite Concentrate from Cukaru Peki Deposit—Upper Zone, Bor, 2020.
