# A Study on Predicting the Movement of Columns in Hanok Architecture Using the UMAP and DBSCAN Algorithms

**Abstract:** A hanok is a traditional Korean house built with wood as the main structural material. It is constructed using cross- and unidirectional joint techniques without the use of steel. A hanok is composed of vertical and horizontal members, with columns being the most important vertical members and Daedeulbo being the most important horizontal member. As a cultural heritage structure, a hanok is often deformed due to damage to the wood over the years. In particular, the building beginning to lean is a typical example. Depending on the extent of damage, hanoks are repaired through partial or complete dismantling, but the same phenomenon recurs in many hanoks even after repair. In this study, 69 hanoks with well-documented records were selected to build a building column arrangement DB, column movement DB, and building attribute DB. The constructed DB was optimized in two dimensions by utilizing the features of each element with the UMAP algorithm and then clustered using the DBSCAN algorithm. Using this method, the movement of one column was analyzed individually, and

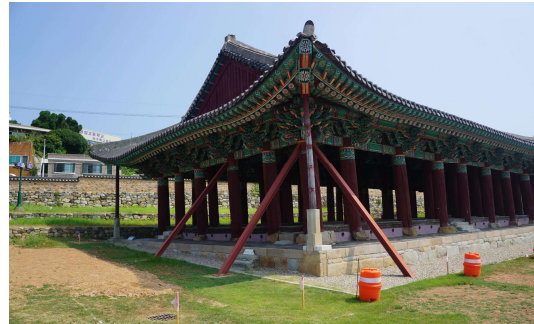
**Figure 1.** Steel supports to prevent the column leaning phenomenon. This hanok's columns were leaning outward, and steel supports were installed to prevent further leaning. As of 2016, the hanok has been completely dismantled and repaired. The cause is unknown. (National treasure: Yeosu Jinnamgwan).

However, the limitation of periodic inspections is that they consist of visual inspection indicators and do not have numerical evaluation indicators, so, by the time the column movement of a hanok is visually detected, the best time to rectify the issue has passed (Figures 1 and 2).

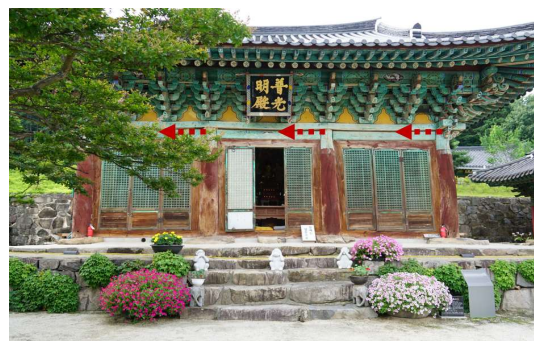
**Figure 2.** Columns leaning to the left. The upper part of the column is visibly leaning to the left. The cause remains unknown. (Treasure: Wanju Wibongsa Bogwangmyeongjeon, taken in 2018).

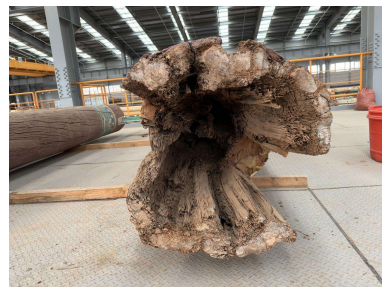
**Figure 6.** Damage to the lower part of a column. The lower part of the column was damaged by termites. (National treasure: Yeosu Jinnamgwan.).

While replacing the entire aging structure with new wood can provide a sense of structural stability, the Standard Specifications for Cultural Properties states that cultural heritage repairs should be based on the principle of maintaining the original. The original style, technique, and surrounding environment must also be preserved. Therefore, if there is a risk of collapse or damage, the existing structural materials can be reused. In the case of major structural materials with large cross-sections such as columns and Daedeulbo, it is not easy to find original materials in Korea. Therefore, the reuse rate is relatively high for structural materials with large cross-sections, and only the damaged parts are removed and repaired in the same form as the original (Figures 6 and 7).

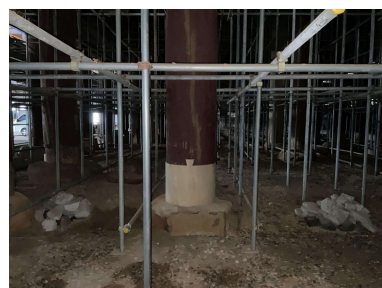
**Figure 7.** Repairing the lower part of a column. According to the principle of preserving the original, the whole column is not replaced, but only the damaged part is cut out, and a new one of the same shape is made. This is a common method for repairing a hanok. (National treasure: Yeosu Jinnamgwan.).

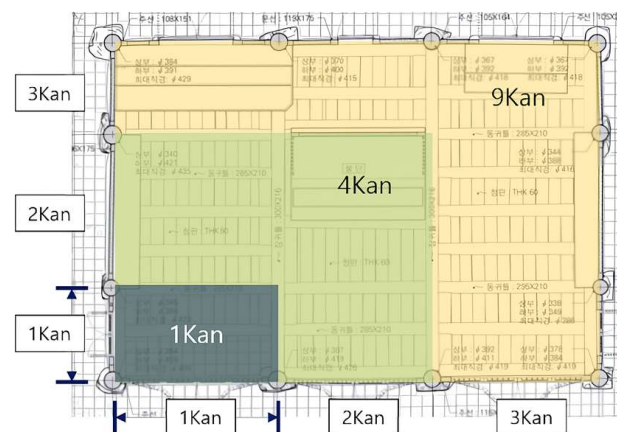
**Figure 12.** A 3 × 3 (9-kan) floor plan [16]. In the elevation of a hanok, a unit of 1 kan is used between columns. Additionally, 1 kan also means a unit of space. Therefore, this floor plan is 3 kan in the front and 3 kan on the side, or 9 kan in size.

A hanok is composed of vertical and horizontal members that are joined to each other to form a space. The spatial area of a hanok uses the unit of “kan”, and in the elevation, the space between a column and another column is 1 “kan”, and the space consisting of one column on the  $x$  axis and one column on the  $y$  axis is also 1 “kan”. The scale of Figure 12 is three columns in the front and three columns on the side, and the building size can be estimated using kan, even if the distance between columns is different.

Figures 12 and 13 are on the smaller side of the scale, as the horizontal and vertical ratio of the plane is closer to 1:1. Therefore, the data values for the ratio of the floor plan and kan according to the arrangement of the columns were extracted.

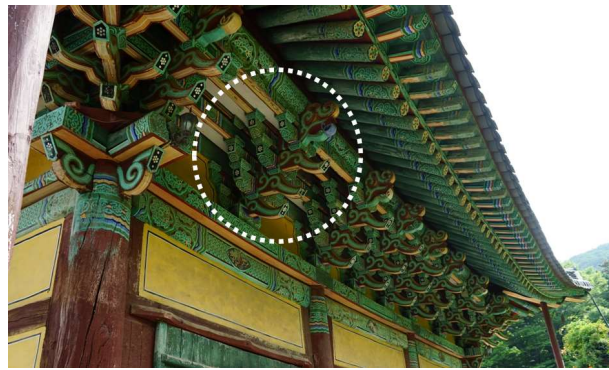
**Figure 20.** The style of Gongpo: Dapo. The Dapo style (white circle) is the most splendid. In the same form as Jusimpo, a Gongpo is added to the top of a horizontal member between columns. It is mainly found in palace and temple buildings.

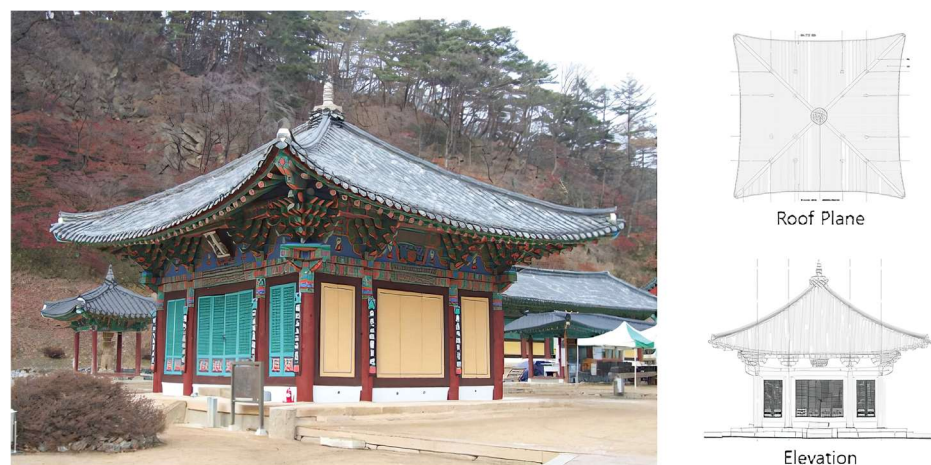
**Figure 21.** The Moim roof style [23].

The roof is the most proportional part of a hanok's elevation. Depending on the form of the roof, the appearance of the building changes, and the structure is also different. The styles of roofs are broadly categorized as Moim, Ujingak, Paljak, and Matbae. The Moim style is formed by gathering in the center of the plane, as shown in Figure 21, which can be seen on a plane that is close to a square. If the Moim roof becomes a long horizontal plane, a Ujingak roof such as that in Figure 22 is formed.

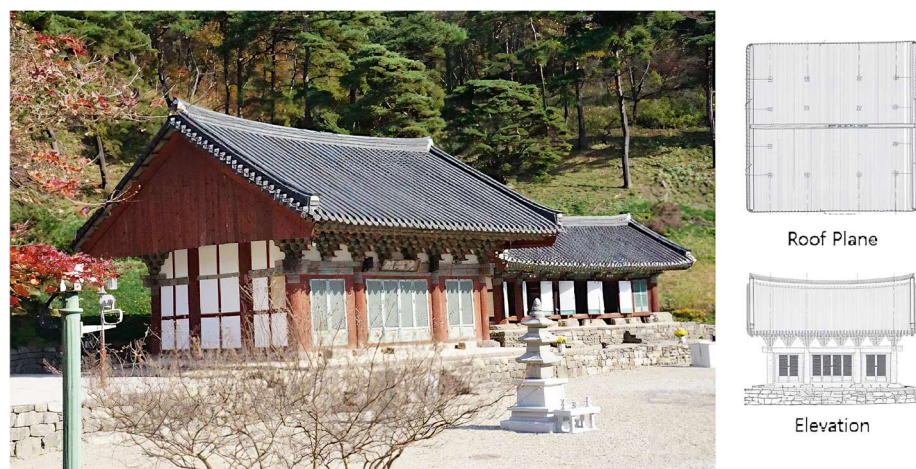
Figure 23. The Matbae roof style [25].

A Matbae roof is a form in which the front and back sides are symmetrically sloped, and the left and right sides are vertically lowered, as shown in Figure 23. A Paljak roof is a structure formed by mixing a Ujingak roof and Matbae roof, and it features one of the most beautiful curves in hanok architecture (Figure 24).

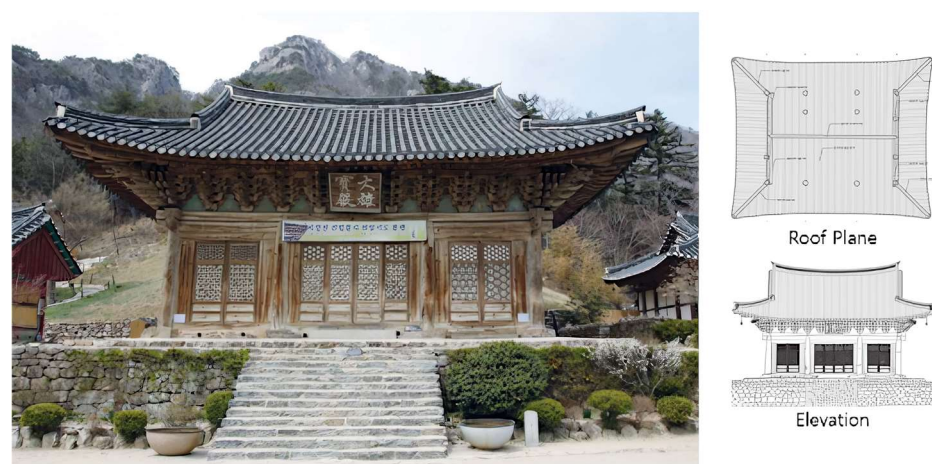
Figure 24. The Paljak roof style [26].

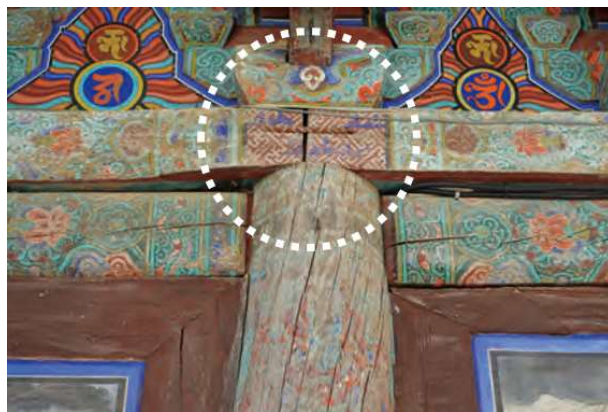
**Figure 59.** Pyeongbang. Pyeongbang is a horizontal member placed on an external column. This is an example of reinforcing the joints with “C”-shaped steel (white circle) to prevent the pyeongbangs from separating. (Treasure: Daegu pagyesa wontongjeon).

check the direction of movement for reinforcement. In addition, due to the characteristics of a hanok, not using steel is a major feature; however, inaccurately diagnosed exposed steel reinforcement seems to be heterogeneous, as well as being a factor that increases the variability in column movement (Figures 58 and 59).
