# Mass Timber Rocking Panel Retrofit of a Four-Story Soft-Story Building with Full-Scale Shake Table Validation

**Abstract:** Soft-story wood-frame buildings have been recognized as a disaster preparedness problem for decades. There are tens of thousands of these multi-family three- and four-story structures throughout California and other cities in the United States. The majority were constructed between 1920 and 1970, with many being prevalent in the San Francisco Bay Area in California. The NEES-Soft project was a five-university multi-industry effort that culminated in a series of full-scale soft-story wood-frame building tests to validate retrofit philosophies proposed by (1) the Federal Emergency Management Agency (FEMA) P-807 guidelines and (2) a performance-based seismic retrofit (PBSR) approach developed within the project. Four different retrofit designs were developed and validated at full-scale, each with specified performance objectives, which were typically not the same. This paper focuses on the retrofit design using cross laminated timber (CLT) rocking panels and presents the experimental results of the full-scale shake table test of a four-story 370 m<sup>2</sup>

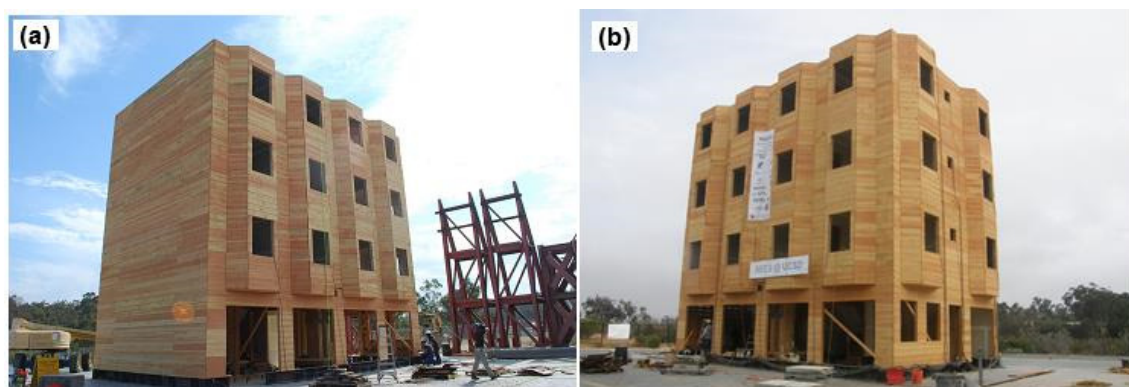
**Figure 3.** The test building designed as part of the NEES-Soft project: (a) Southwest view; and (b) Southeast view.

In order to investigate the performance of soft-story buildings subjected to seismic ground motion, a four-story building with a soft-story as its first story was designed and constructed on the top of the shake table at the University of California-San Diego's outdoor shake table laboratory (Figure 3). The building represented a corner building with two adjacent buildings on the North and West sides. The test building had four garage doors at the first story on its south side and two windows and a storage and an entrance door on its east side. The upper stories each had two two-bedroom units with bay-windows on the south and east sides. It can be seen that the large openings due to garage and storage doors reduce the available space for lateral load resisting systems, i.e., shear walls; thus, the building is soft and weak at the first floor. The details of the structural and architectural drawings of the building, existing vertical and lateral load resisting systems, and types of fasteners are presented in Bahmani et al. [14] and van de Lindt et al. [13] and hence are omitted here for brevity. Figure 3 shows photos of the NEES-Soft four-story test building built at the NEES@UCSD laboratory just prior to the installation of the CLT rocking walls. The shake table is a 7.6 m (25 ft) × 12.2 m (40 ft) outdoor

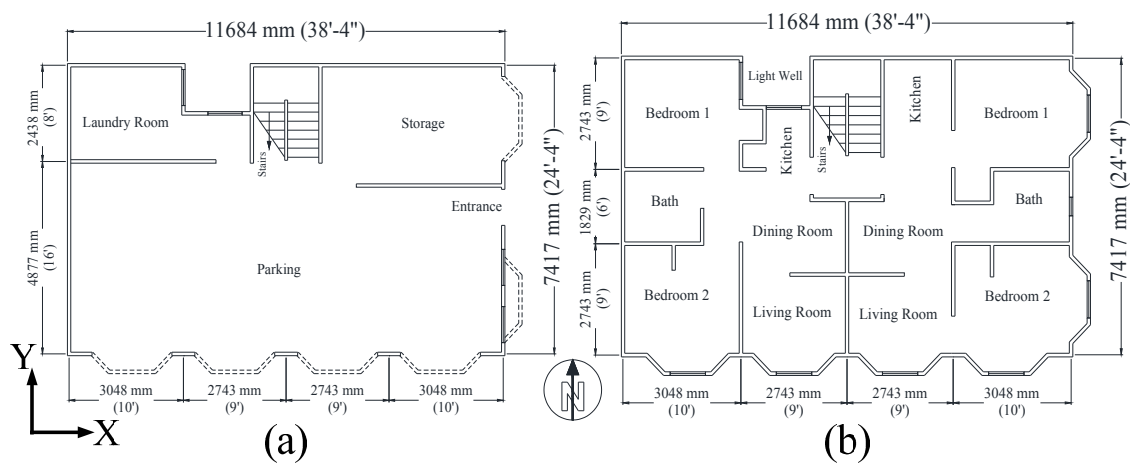
**Figure 4.** Floor Plans for the four-story test building: (a) First story; and (b) Upper stories.

Although the exterior architecture was important for the aspect ratio and determining the locations and number of openings at the soft and other stories, there were several other features of this particular building era that had to be identified, such as interior wall density, room size, nail schedules, floor diaphragm, and flooring details, and of particular note is the lack of hardware such as metal straps and plates, which were not available in this era. The test building plan dimensions were 7.3 m  $\times$  11.6 m (24 ft  $\times$  38 ft), and Figure 4 presents the architectural plan views of the first story and upper stories (floors 2–4 had the same floor plan).

As mentioned, certain features observed during site visits were included such as the light well that can be seen in Figure 4. However, some modifications to the archaic building materials were necessary to ensure that the test building could be repaired in a timely and financially manageable way since a number of tests were conducted at moderate to high amplitude. Table 1 provides a comparison between the features commonly found in these types of soft-story buildings and the NEES-Soft four-story test building. The effectiveness of the FEMA P-807 retrofit methodology was examined experimentally by conducting shake table tests in the summer of 2013 at the NEES@UCSD outdoor shake table facility.

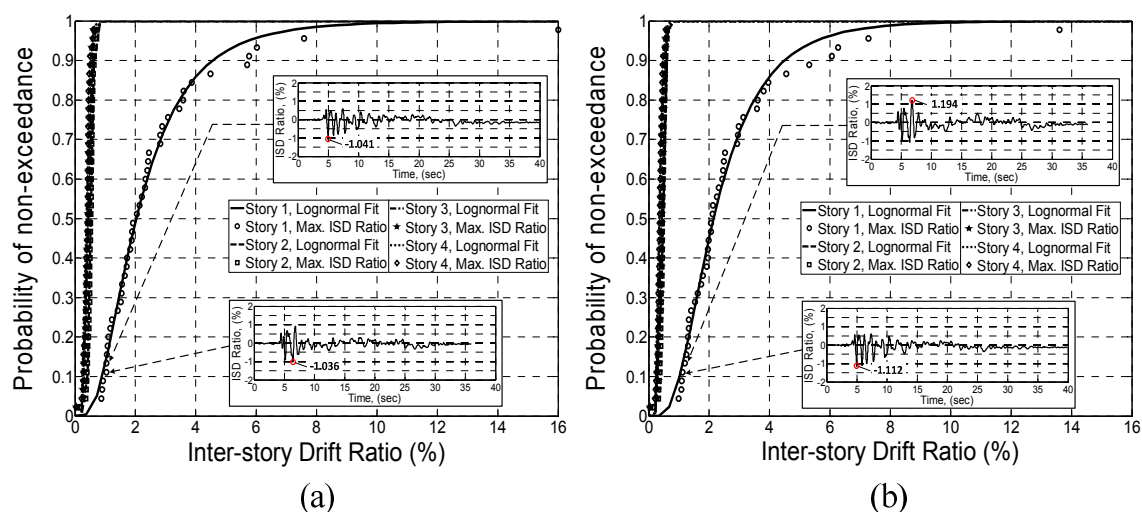
**Figure 5.** Probability of non-exceedance versus inter-story drift ratio of the four-story building retrofitted in accordance with P-807 guideline using CLT panels: (a) in the X-direction; and (b) in the Y-direction.

The design limit state for the FEMA P-807 retrofit was the following: retrofit for a 20% exceedance probability of the FEMA P-807 guidelines at the 50% MCE intensity. It should be noted that, for the generic site used within the NEES-Soft project, the MCE seismic intensity was assumed to be equal to a spectral acceleration of  $S_a = 1.8$  g. Thus a spectral acceleration of 0.9 g corresponded to a 50% intensity of the MCE. In order to verify the effectiveness of the retrofit design, the retrofitted building with CLT panels was analyzed using nonlinear time-history analysis (NLTHA) and was subjected to 44 uni-axial earthquake records (FEMA P695, [29]) scaled to a spectral acceleration of 0.9 g using the scaling approach outlined by ASCE7-10 [28]. The building was analyzed uni-axially in each direction independently using 44 ground motions since the FEMA P-807 guideline is based on evaluating the buildings in each direction separately. Figure 5 presents the rank ordered peak inter-story drift (ISD) ratios in the form of the probability of non-exceedance versus inter-story drift ratios when subjected to the 44 uni-axial far-field earthquake ground motions. It should be noted that the ISD ratios were limited to 16%, which is the upper limit of collapse range of wood-frame buildings based on the numerical study by Pang et al. [30]. It can be seen that the ISD ratios corresponding to a probability of non-exceedance (PNE) of 80% (i.e., probability of exceedance (POE) of 20%) is 3.8% in both the X- and Y-directions, which is below the 4% ISD ratio believed to be the onset of collapse as defined by the FEMA P-807 guideline. The CLT rocking panels in the Y-direction ensured that the retrofit design met the center of rigidity requirements.

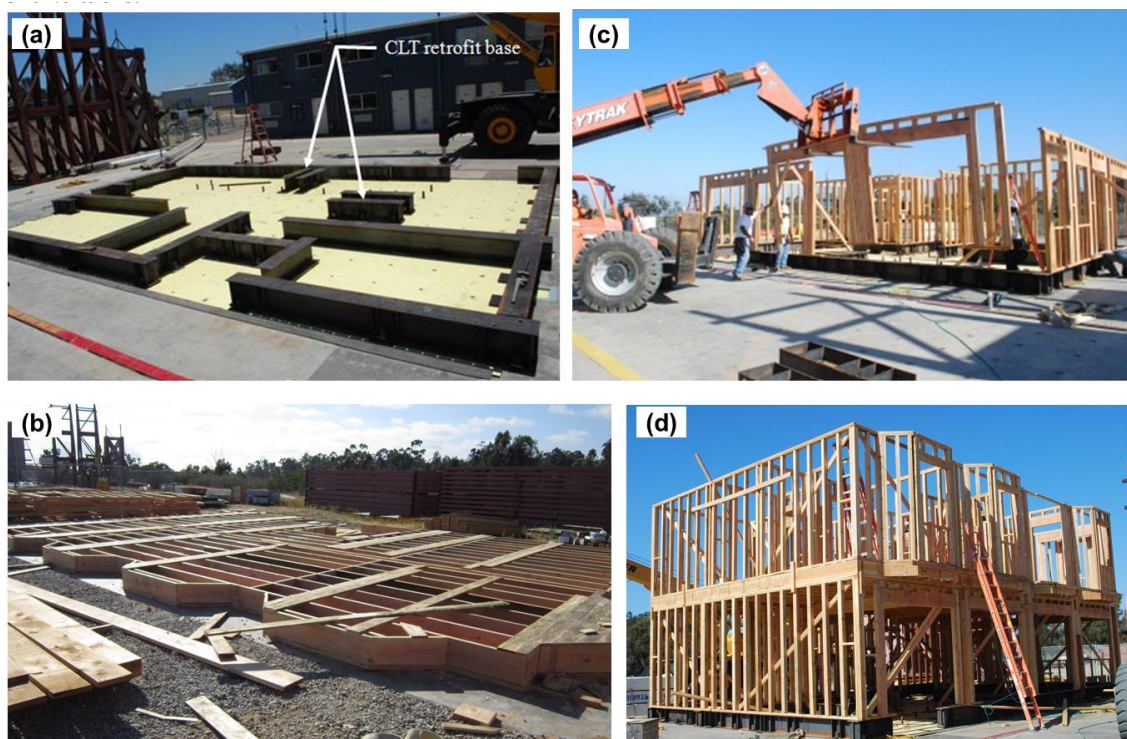
**Figure 6.** Construction of four-story building: (a) Installation of steel interface beams; (b) Prefabrication of floors and walls; (c) Erection of the first story with large openings; (d) Erection of the second story (stories 3 and 4 had the same floor plan as story 2).

Steel interface beams were designed and installed at the top of the shake table in order to anchor the four-story test building to the shake table and accommodate the installation of anchor bolts for each wall at the first story. W16  $\times$  61 interface beams were attached to the shake table prior to the construction of the building and the installation of retrofitting elements. It should be noted that, since the building was tested in four different testing phases, the interface beam segments were designed such that they could support all the retrofitting elements used in the four phases of testing in this study. Figure 6 presents photos of the construction of the four-story building on top of the shake table.

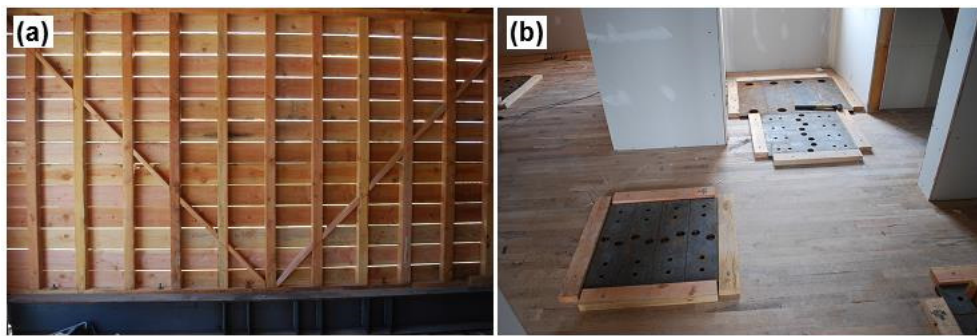
**Figure 7.** (a) Diagonal bracing at the west wall of the building at the first story; (b) steel plates attached to floor.

It should be noted that diagonal bracing was installed along the exterior walls of the west side of the building at the first story, which was a common construction practice during the construction of these types of buildings (Figure 7a). Additional mass was added to each floor of the building to represent the mass of the material not used in construction of the building such as tile flooring (Figure 7b). Horizontal wood siding was used for all the exterior walls of the building. Figure 8a presents one of the garage openings at the first floor, and Figure 8b shows the north-west view of the finished four-story building with horizontal wood siding installed on the exterior walls.

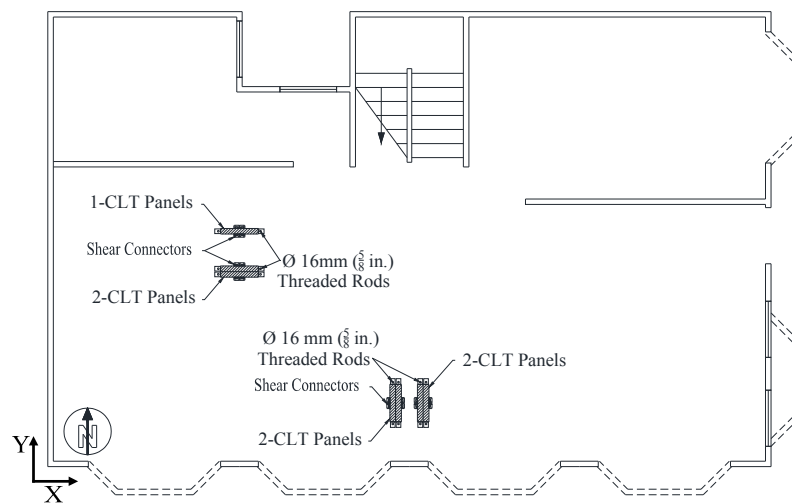
**Figure 9.** Location of cross laminated timber (CLT) panels in the ground story.

The CLT panels were placed based on basic constraints such as the need to park vehicles after the retrofit and still meet the guidelines of FEMA P-807. Three and four CLT panels were installed along the longitudinal (i.e., X-direction) and transverse directions (i.e., Y-direction) of the building, respectively, as shown in Figure 9. Since the shake table was uniaxial in the X-direction, the three panels rocking in the X-direction provided strength and stiffness, while the four panels in the Y-direction moved the center of rigidity closer to the center of mass, reducing torsion; recall that this is one goal within the FEMA P-807 retrofit guideline.

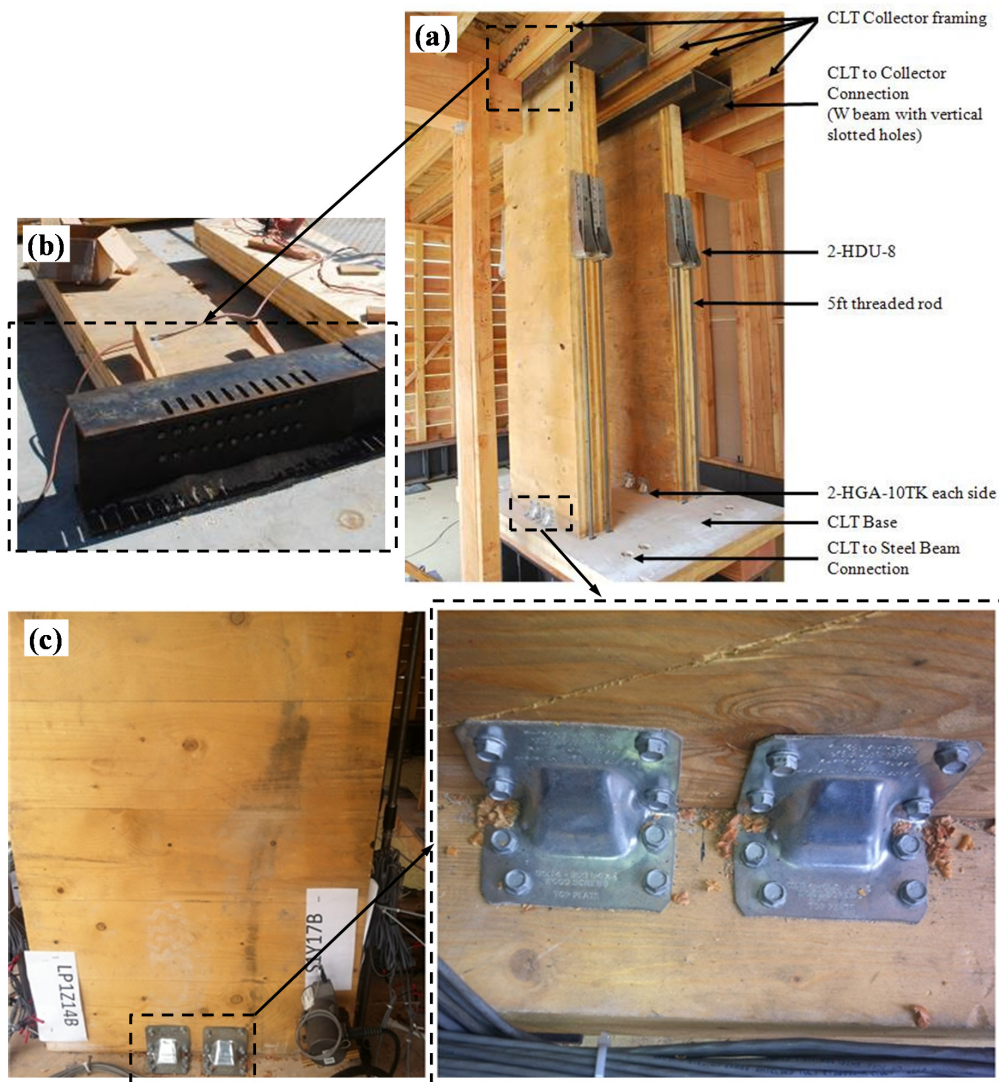
**Figure 10.** Cross Laminated Timber (CLT) panels: (a) Walls installed with all associated components; (b) Vertically slotted holes at the top shear transfer connection; (c) Shear connections to the base with self-tapping wood screws.

The details of the CLT rocking wall assemblies that were used to retrofit the ground story of the four-story building are presented in Figure 10. The panels were designed such that they could rock freely using vertically slotted holes at the top shear transfer connection. The 16 mm (5/8 in.) diameter threaded rods were used at each side of the CLT panels to resist the overturning moment, and the rods were designed such that they can yield, if needed, thereby dissipating energy from the earthquake and providing the necessary ductility to the assembly. Shear connectors were added to the CLT panels to transfer the shear force from the CLT panel to the base steel (i.e., foundation) using a metal connector and 6.5 mm (1/4 in.) diameter self-tapping wood screws.

Each CLT line of resistance consisted of two doubled CLT panels. The panels were installed over CLT bases, which were bolted to the steel framing. The transfer of shear forces was accomplished using four HGA-10 KT (Simpson Hurricane Gusset Angle) for each double panel. The transfer of uplift force was accomplished using HDU-8 hold-downs with 1.5 m (5 ft) long mild steel threaded rods designed to stretch and provide the required ductility during rocking. The top of each panel was connected to the floor framing above using a wide flange beam. The web of the beam was connected to the CLT panel using screws, and the flanges were bolted to the collectors through vertical slotted holes.

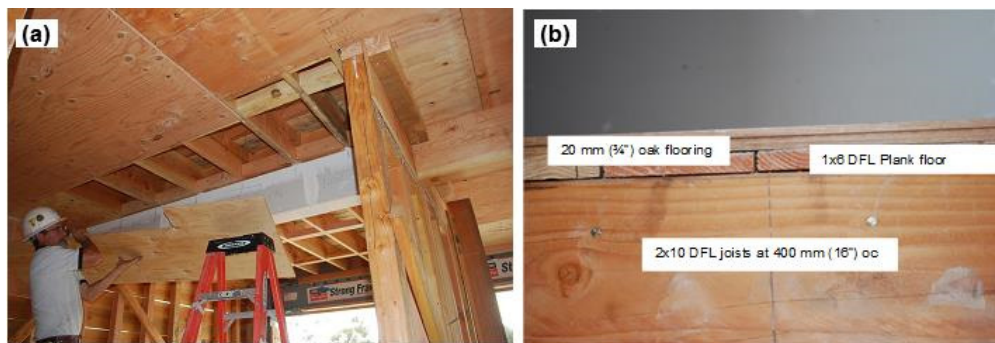
**Figure 11.** First story diaphragm reinforcement: (a) Installation of plywood panels; (b) Framing of the flooring system.

Collectors were provided by reinforcing existing second floor framing with additional framing members, blocking and strapping as needed to match the capacity of the CLT panels. Plywood panels were added to the underside of the second floor system to strengthen and stiffen the diaphragm and distribute the load to the collectors. A similar assembly was used for the transverse direction and a combination of strapping and blocking was used to develop the collector. The threaded rod length was selected to allow for the required deformation at the top of the CLT panel through rod elongation, since the observed behavior of CLT is that of a rigid body. Figure 11 presents the plywood panels at the ceiling of the first story and the framing of the flooring system of the building.

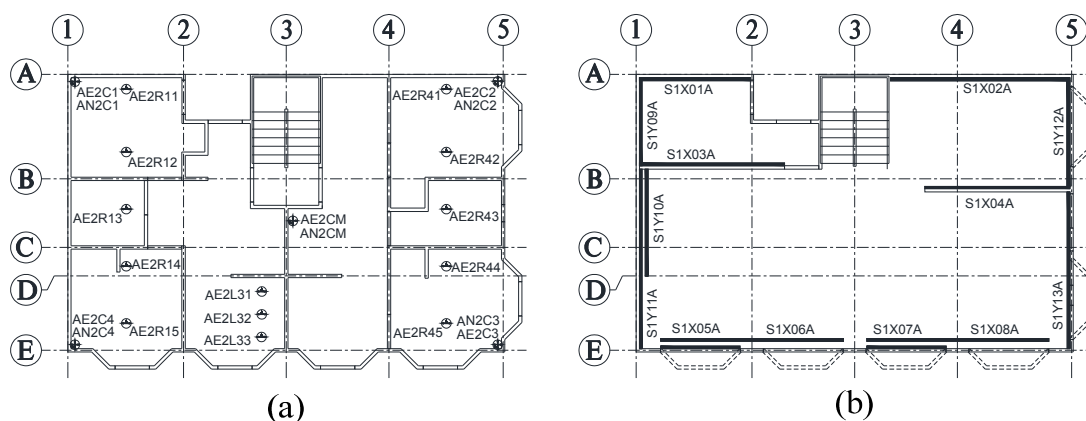
**Figure 12.** Location of sensors installed in the first story: (a) accelerometers; (b) string potentiometers.

The responses of the building to seismic excitation were recorded by approximately 400 sensors that were installed in different locations throughout the building. Two accelerometers were installed at every corner of each story and at the center of mass (CM) of each floor diaphragm to record the acceleration in both the X- and Y-directions. Two arrays of five accelerometers were installed at each of the two-bedroom units to record the accelerations and eventually to compute the displacement (via numerical integration over time) of the diaphragm during each seismic test. String potentiometers and linear potentiometers were installed in different locations to record the displacement of the shear walls due to shear and uplift forces. Strain gauges were installed on the threaded rods to record the strains and elongation on the rods. Twenty-two load cells were installed underneath the anchor bolts of the exterior and interior walls of the first story to record the uplift forces at each anchor bolt. Figure 12 presents the typical locations of the accelerometers and string potentiometers within the first story.

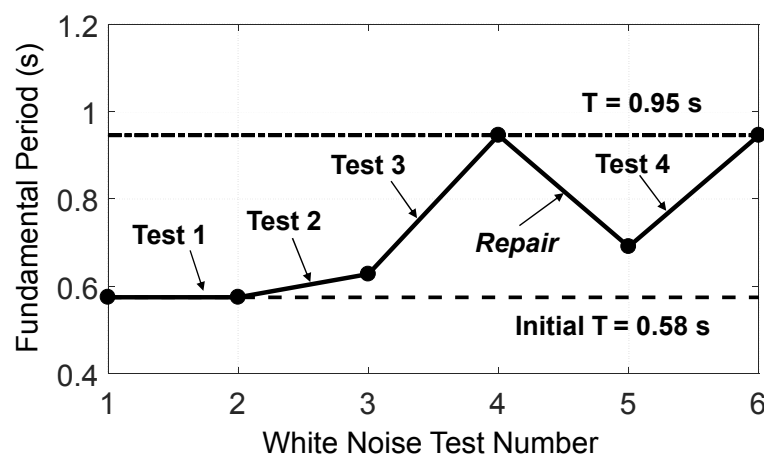
Figure 13. Fundamental period of the building after conducting seismic tests or repair.

In order to obtain the natural frequencies of the test building prior to and after each seismic test, a white noise test with a root-mean-square (RMS) acceleration amplitude of 0.05 g was conducted. Generally, after each seismic test the fundamental period of the building increased due to damage. Following repairs to the first story of the building, the fundamental period of the building decreased to approach the initial fundamental period of the test building at the undamaged state. Figure 13 presents the fundamental period of the building tracked during four tests.

The fundamental period of the building without any retrofit (i.e., the original condition) was approximately 1.0 s. The initial fundamental period of the building before applying any retrofit was 0.58 s. During repair and damage inspection, additional drywall screws were added to the drywall with loose connectors, and some drywalls were also replaced due to the observation of shear cracks and the significant lack of transferring shear force. The frequencies corresponding to the peaks obtained from the white noise test were utilized to know the intrinsic damping of the building using the half-power bandwidth method (Chopra, [33]). The 1.2% intrinsic damping obtained from the experimental test was close to the value of 1% assumed during the design of the building.

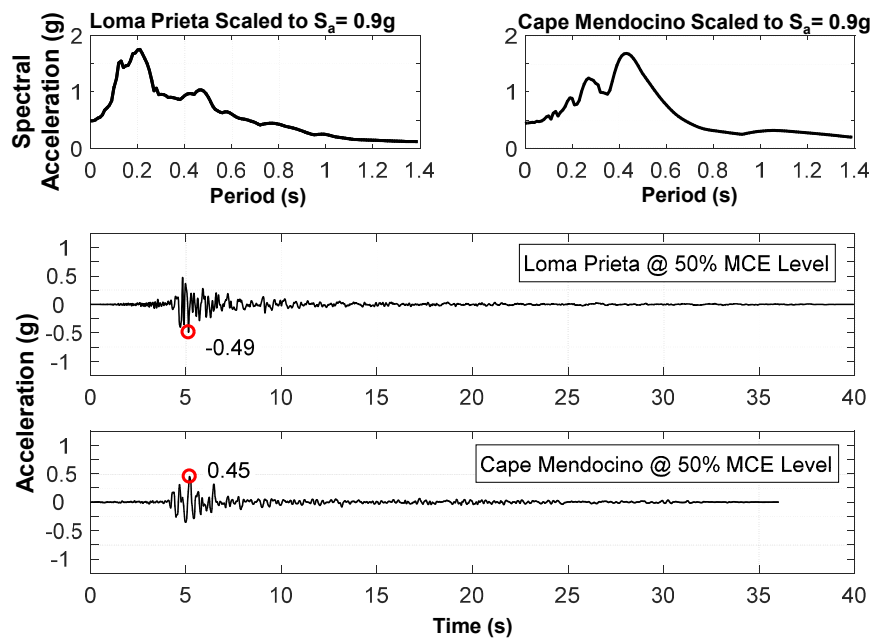
**Figure 14.** Ground motions used and spectral accelerations.

In order to verify the effectiveness of the retrofits under seismic loading, the building was subjected to two different ground motions. The 1989 Loma Prieta-Gilroy (component G03000) earthquake record and the 1992 Cape Mendocino-Rio (component RIO360) earthquake record were selected and scaled to different spectral accelerations for each phase of testing. Table 3 presents the ground motions and their corresponding peak ground accelerations (PGA) and spectral accelerations for each phase of the test program. Figure 14 presents the spectral accelerations for the Loma Prieta and Cape Mendocino ground motions scaled to  $S_a = 0.9$  g and the acceleration time histories of the ground motions scaled to the 50% MCE level (i.e.,  $S_a = 0.9$  g). For scaling the ground motions, 22 bi-axial far-field earthquake ground motion records of the FEMA P-695 [29] were used. Each ground motion consisted of a pair of horizontal ground motions in the X- and Y-directions. A SRSS (square root of the sum of the squares) spectrum was constructed by taking the SRSS of the five percent-damped response spectra of two components of each pair of the horizontal ground motion components. Each pair of ground motions was scaled such that, in the period range from 0.08 to 1.5 s, the average of the SRSS spectra of all pairs of components did not fall below the site design spectrum. This period range represented 0.2 times the period of the stiffest retrofitted building to 1.5 times the period of the un-retrofitted building based on the numerically predicted periods. For the generation of the design spectrum in the San Francisco Bay Area, the spectral response accelerations at short periods ( $S_s$ ) and at a period of 1.0 s ( $S_1$ ) were 1.8 g and 1.2 g, respectively. It should be noted that the building was retrofitted in both the X- and Y-directions to

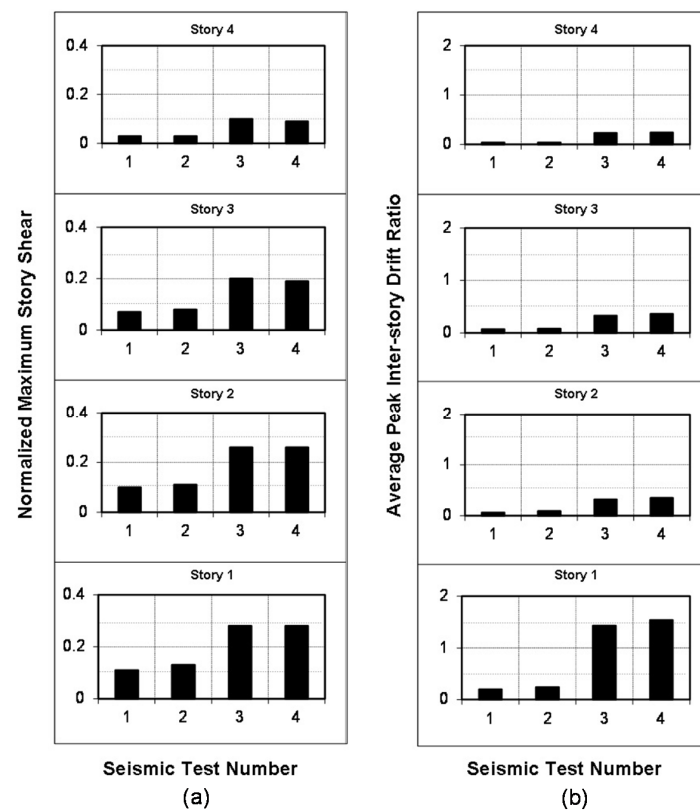
**Figure 15.** Behavior of the building over its height for each seismic test: (a) Normalized maximum story shear ratios; (b) Average peak inter-story drift ratios.

The normalized maximum story shear ratio was calculated for each story by dividing the story shear by the total weight of the building above the base steel, 467 kN (105 kips) (Figure 15a). It can be seen that the maximum story shear force at the first story was approximately 30% more than the maximum story shear at the 3rd story during Seismic Tests 3 and 4. It should be noted that these maximum shear forces do not occur at the same time.

In order to investigate the performance of the retrofitted building, the maximum inter-story drifts along the X-direction (i.e., parallel to the direction of shake table motion) were obtained by taking the average displacements recorded at the corner of each story (Figure 15b). An effective height of 2438 mm (96 in.) was used in calculating the inter-story drift ratios, which was equal to the clear height of each story. It can be seen from the bar chart that the peak inter-story drift occurs at the first story (the only story that was retrofitted per the FEMA P-807 guidelines). This is typical of a soft-story building response in which the upper stories behave essentially as a rigid body and thus experience little damage. No structural or non-structural damage was found in the upper stories, with the exception of minor hairline cracks near door and window corners on the second level. Table 3 presents the values of the average peak inter-story drift ratios and the normalized maximum story shear recorded at each seismic test. It should be noted that the maximum inter-story drift ratios recorded were less than 2%, which satisfied the performance criteria.

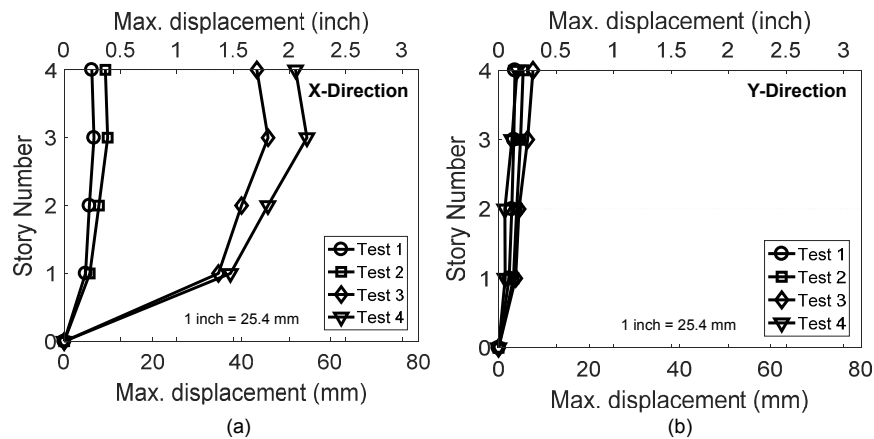
**Figure 16.** Building displacement profile in (a) the X-direction and (b) the Y-direction.

Figure 16 presents the displacement profile of the test building for all four seismic tests along the X- and Y-directions when the maximum displacement relative to the ground occurs at the roof level. It should be noted that the peak inter-story drift of single stories does not necessarily occur when the roof is at its peak displacement, i.e., this would only occur in a first mode response. It can be seen from Figure 16 that the first story experienced the maximum inter-story drift among all stories for the retrofits designed in accordance with the FEMA P-807 guidelines; the inter-story drifts of the first story remained less than the drift limit defined by the FEMA P-807 document. Of note is that the Y-direction had very small inter-story drifts, indicating that the torsion was indeed removed from the original building through placement of the four Y-direction CLT rocking walls.

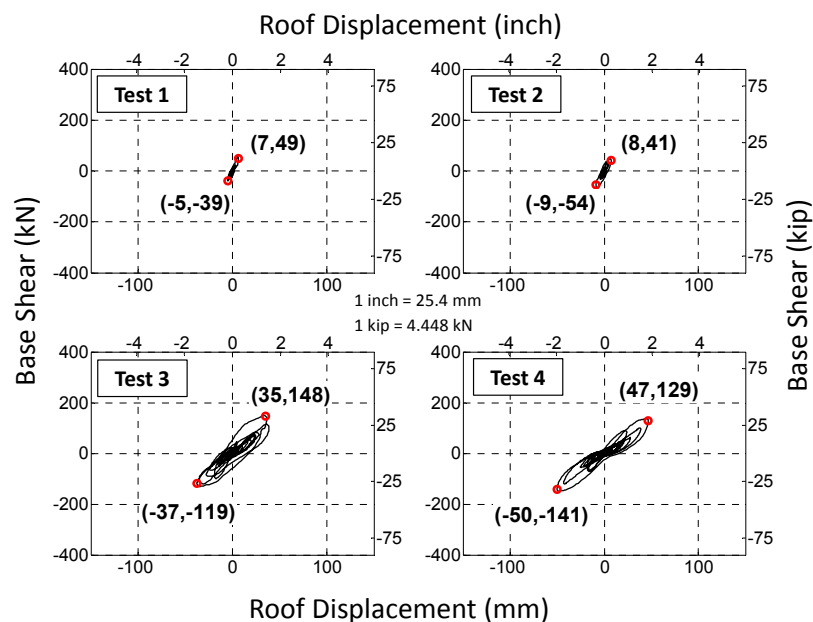
**Figure 17.** Global hysteresis of the building in the X-direction (numbers shown in brackets are in mm and kN).

The inertial force at each floor diaphragm was calculated by applying Newton's second law by using the spatial average of the acceleration time histories recorded at each corner of the stories and the mass associated with each story. The shear force at each story was then calculated for all seismic tests. Figure 17 presents the global hysteresis of the building, which is defined here as the roof displacement versus the shear force at the base of the building (i.e., base shear) for all four seismic tests. It should be noted that the global hysteresis are close to a diagonal line extending from the first to the third quarter and are relatively smooth (i.e., without spike). This behavior was expected since the FEMA P-807 retrofit tends to concentrate deformational response in the first (soft) story, thereby limiting the contribution of higher modes.

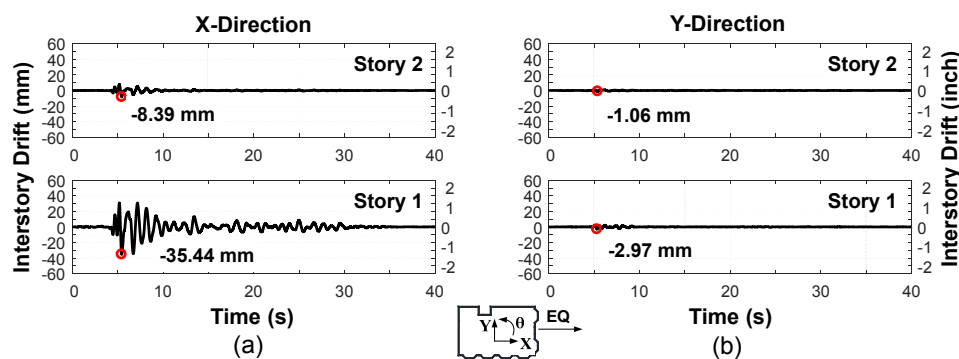
**Figure 18.** Translational response of the building retrofitted with CLT panels and subjected to Cape Mendocino-Rio ground motion with peak ground accelerations (PGA) = 0.45 g: (a) X-direction; (b) Y-Direction.

The response to Seismic Test 4 produced the maximum displacement profile of the building (Figure 16); therefore, the time-history response of the building subjected to the Cape Mendocino-Rio

record scaled to  $S_a = 0.9$  g is selected to show the behavior of the building retrofitted with CLT rocking panels. Figure 18 presents the translational response (inter-story drift time-histories) of the first and second stories of the building in both the X- and Y-directions. Figure 18a presents the average translational responses in the X-direction (i.e., parallel to the motion of the shake table). It can be seen that the inter-story drift recorded at the first story is approximately four times the inter-story drift recorded at the second story. Thus, the first story is still soft even though it has been retrofitted. This results in more damage in the first story than in the upper stories (the upper stories only had hairline cracks in the drywall). Figure 18b presents the average translational response of the first and second stories in the Y-direction (perpendicular to the direction of shake table motion). It can be seen that the response of the building in this direction was very small; thereby demonstrating that torsion response had been effectively eliminated.

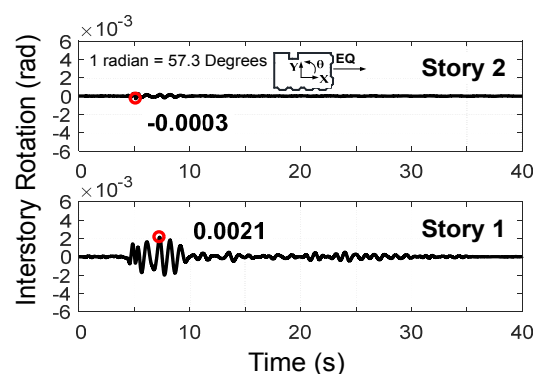
**Figure 19.** Inter-story rotational responses of the retrofitted building measured at the 1st and 2nd stories subjected to Cape Mendocino-Rio ground motion scaled to  $S_a = 0.9$  g.

As mentioned previously, soft-story buildings can be soft in both translation and torsion. The four-story test building was not only soft in both translational directions but also had very low torsional stiffness due to its high stiffness irregularity in the first story (i.e., location of garage doors, window openings, etc.). The FEMA P-807 guideline is intended to eliminate the torsional response of buildings by reducing eccentricities. The inter-story rotational responses of the test building at the first and second stories during Seismic Test 4 are shown in Figure 19. It can be seen that the absolute inter-story rotational responses of the building at the first and second stories were 0.0021 radians (0.12 degrees) and 0.0003 radians (0.017 degrees), respectively; which confirms the elimination of the torsional irregularities in the retrofitted building.

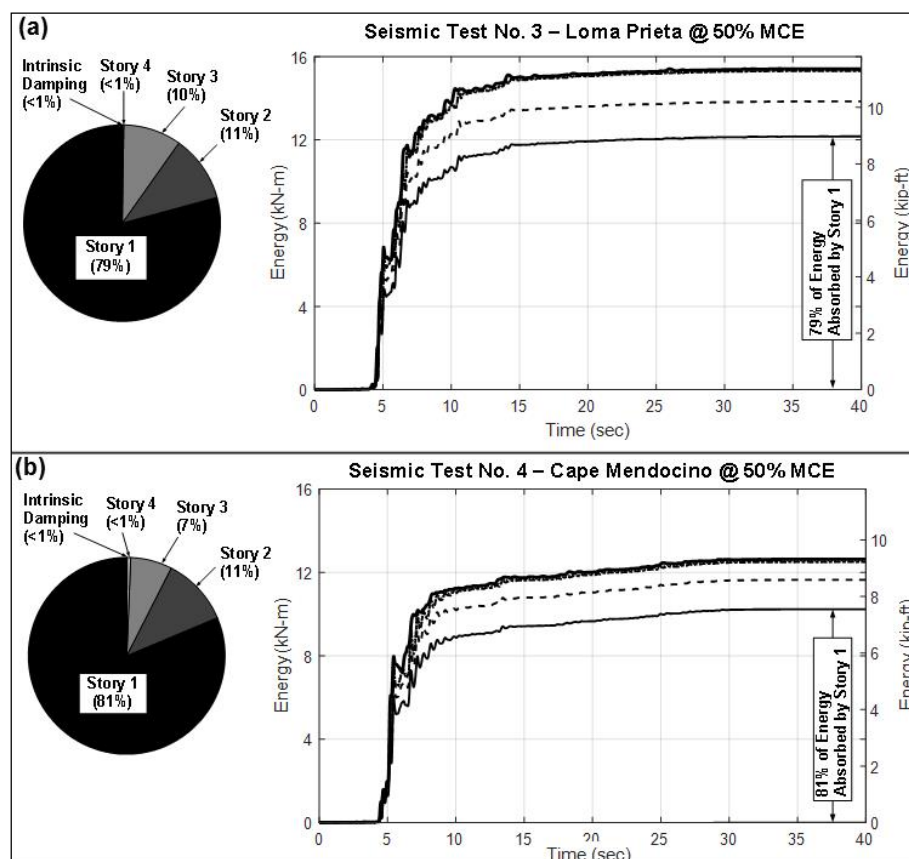
**Figure 20.** Distribution of ground motion energy dissipated at each story of the retrofitted building subjected to (a) Loma Prieta at  $S_a = 0.9$  g; (b) Cape Mendocino-Rio at  $S_a = 0.9$  g.

The performance of the building was evaluated with regard to the amount of earthquake energy dissipated at each story of the building. The larger the area enclosed by the hysteresis curves of the lateral resisting elements of a story, the more energy that story dissipates. The percentages of the energy dissipated at each story of the retrofitted building are shown in Figure 20. The detail of calculating dissipated energy by each story is presented in Bahmani [16]. It can be seen that about 80% of the ground motion energy was dissipated at the first story due its high displacement and nonlinear response. This confirms that the FEMA P-807 retrofit method requires the first story to absorb a significant portion of earthquake ground motion.

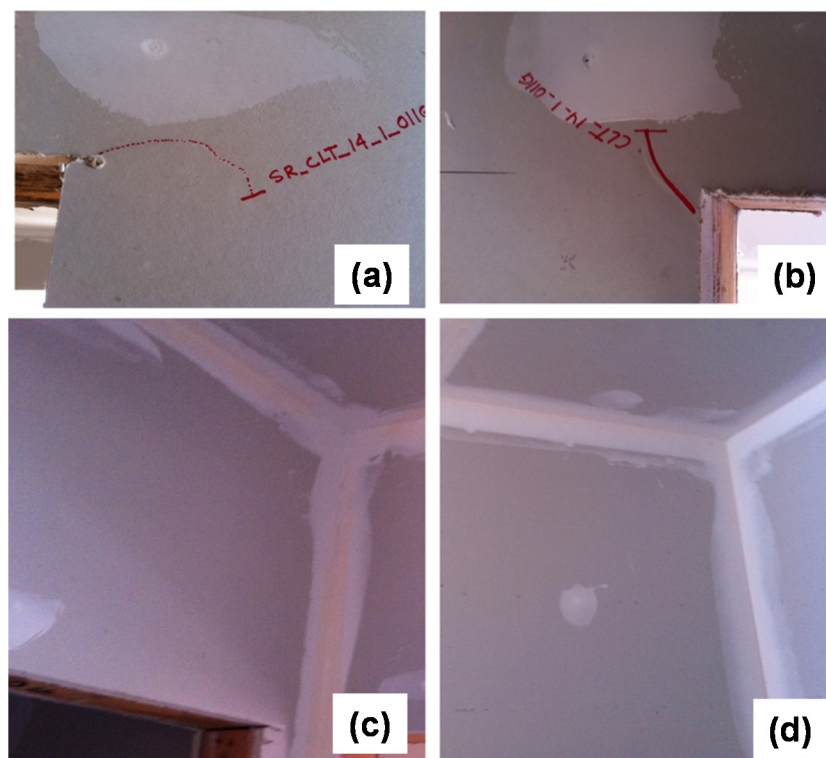
**Figure 21.** Typical damage observed in (a,b) diagonal cracks in the drywall at the first story; (c,d) no damage at upper stories (third story).

Figures 21 and 22 present photos of typical damage that occurred during tests. Figure 21a,b show significant damage at the first story (laundry room), but only a very small crack (hairline) was observed next to the corner of a window at the second story. Figure 21c,d present the damage incurred in the walls at the third story. It can be seen that the third story experienced no to very minor damages. This confirms that, for the FEMA P-807 retrofit methodology, the first story is expected to experience significant damage, while the upper stories do not experience significant damage because of their box-like rigid-body behavior during excitation.

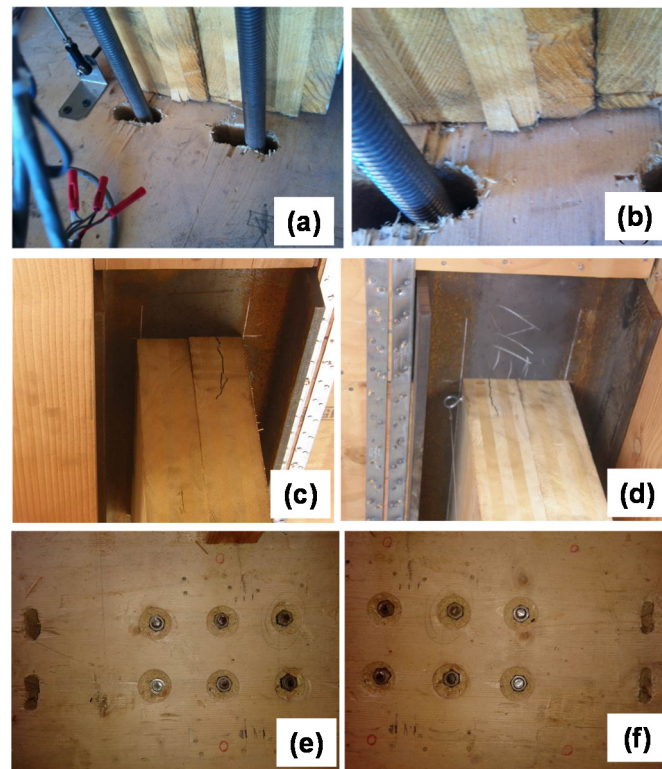
**Figure 22.** Damages at the CLT walls after tests: (a,b) minor splitting near the base; (c,d) cracks at the top of walls; (e,f) no damage to the bases.

Figure 22 shows that the CLT rocking panels (i.e., retrofit elements) exhibited minor signs of distress. One of the threaded bars had yielded during the test. There were small cracks and splitting

near the ends of a number of panels. The horizontal panels at the bases had small dents, indicating that the panels were engaged in rocking motions, as expected.
