Seismic Evaluation and Strengthening of an Existing Masonry Building in Sarajevo, B&H

Abstract: A significant number of old unreinforced load-bearing masonry (URM) buildings exist in many countries worldwide, but especially in Europe. In particular, Bosnia and Herzegovina has an important stock of masonry buildings constructed from the 1920s until the 1960s without application of any seismic code, due to their nonexistence at that time. With the 1963 Skopje earthquake, this class of buildings were shown to be rather vulnerable to seismic actions, which exhibited serious damage. This article assesses the seismic vulnerability of a typical multi-storey residential unreinforced load-bearing masonry building located in the heart of Sarajevo, which may be exposed to an earthquake of magnitude up to 6 by Richter's scale. The buildings of this kind make up to 6% of the entire housing stock in the urban region of Sarajevo, while in Slovenia this percentage is much higher (around 30%). The analysis of a typical building located in Sarajevo revealed its drawbacks and the need for some kind of strengthening intervention to be implemented. Additionally, many structures of this type are overst

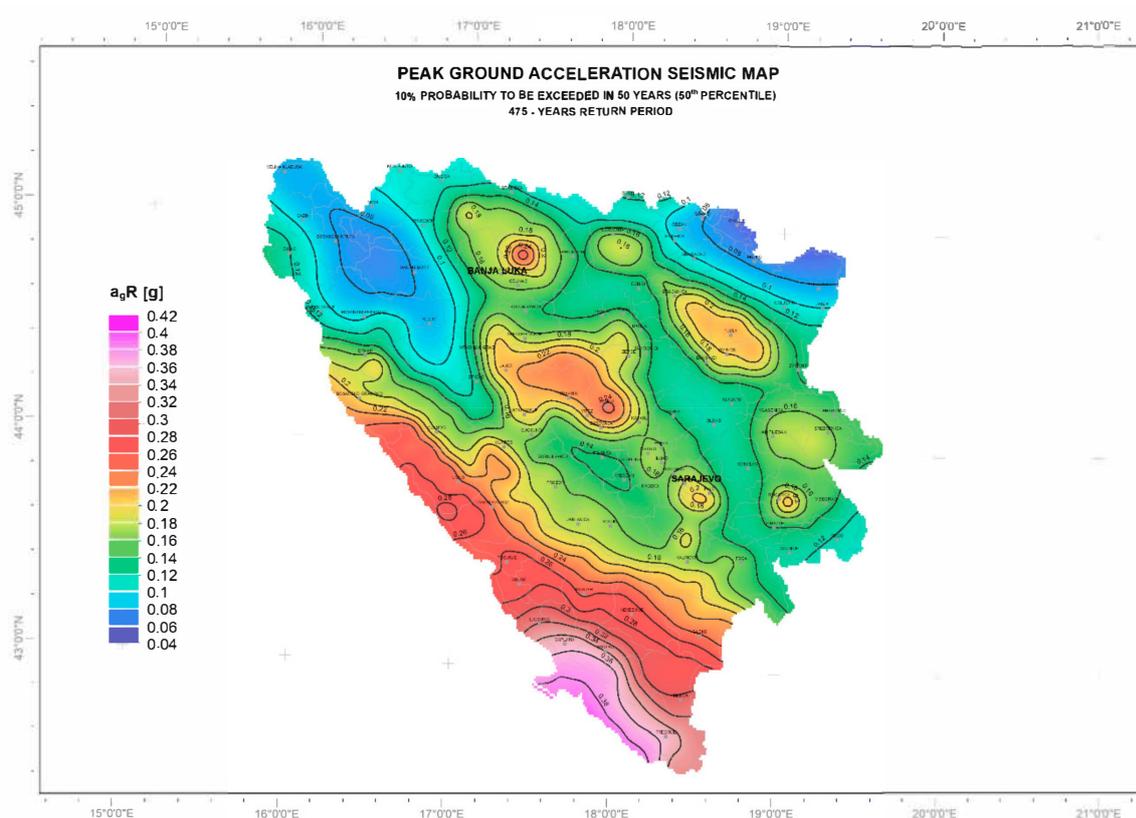
Figure 1. Seismic hazard map for Bosnia and Herzegovina in terms of peak ground acceleration (PGA) (475 years return period) [3].

According to the new seismic hazard code for Bosnia and Herzegovina, defined in terms of peak ground acceleration (PGA) with a return period of 475 years (Figure 1), Sarajevo can experience earthquakes with a peak ground acceleration of $0.18g$ [3]. Such conditions make this structure rather vulnerable as it was constructed without the application of any seismic measures.

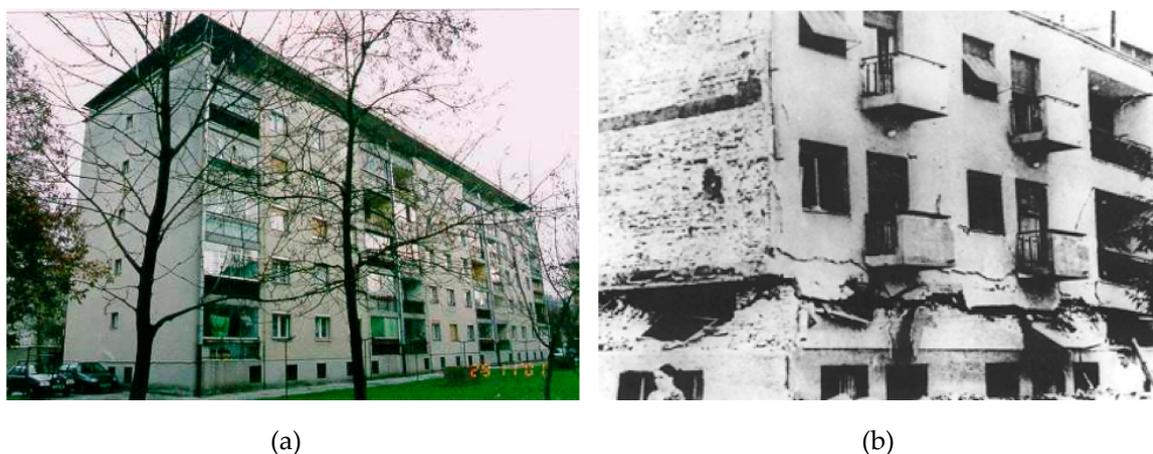
Figure 2. (a) Typical building in Slovenia; (b) devastation of a typical building after the 1963 Skopje earthquake [4].

In this paper, a building structure built in 1957 and typical of the Balkans region is elaborated. These type of buildings can be found in all towns in Slovenia (Figure 2a) and they make up to 30% of the entire housing stock in Slovenia [7]. According to the national census [8], the buildings of this type make up 6% of the housing in the urban part of the Sarajevo city center. This construction type was built from 1920 until 1963 in the entire region of ex-Yugoslavia, especially in the Republic of Macedonia, Montenegro, and Bosnia and Herzegovina, mainly in the urban areas. At that time, no seismic codes existed in this region, so these structures were constructed with no seismic regulations. The 1963 Skopje earthquake showed the drawbacks of this type of structures (Figure 2b), which were severely damaged due to inadequate wall concentration in the predominant earthquake direction, low resistance of the loadbearing system, high height of the unreinforced masonry structure (URM), etc. It is only after this catastrophic event that these type of structures were addressed in the first Temporary Seismic Code produced in 1964 and later upgraded after the 1969 Banja Luka earthquake (which had a focal depth of only 25 km, and a magnitude of 6.4 by Richter's scale). This was one of the most devastating earthquakes registered in this region. Due to the vast devastation caused by the Banja Luka earthquake, micro-zonation of the urban part of the city was done in 1972. According to that data, the expected average ground acceleration for Banja Luka is 0.18g [9]. Regardless of this fact, the area of Banja Luka in the seismological map of Bosnia and Herzegovina was defined as an area of maximum registered intensity of 9 by the Mercalli–Cancani–Sieberg intensity scale [10] for a return period of 500 years. More recently, Lee et al. [11] conducted the micro-zonation of Banja Luka in the light of performance-based earthquake-resistant design.

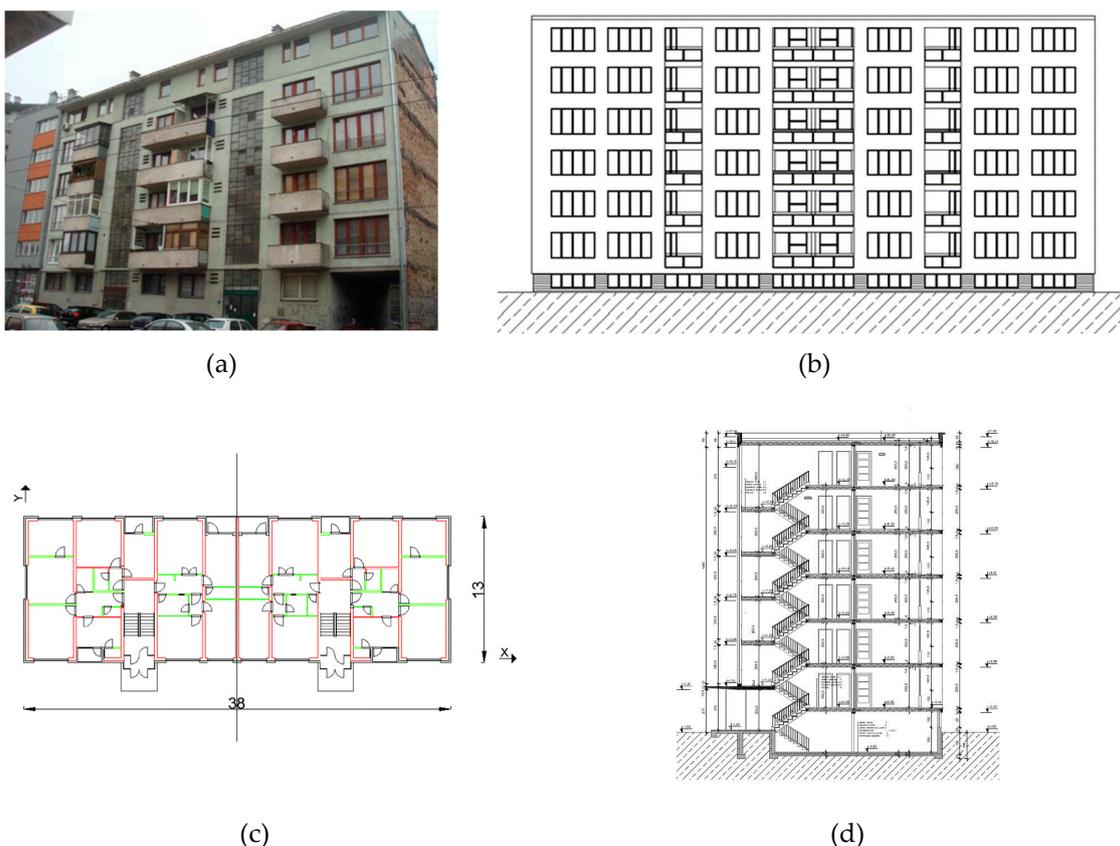
Figure 3. (a) Analyzed building located in Sarajevo; (b) east façade; (c) plan view of the typical floor and labeling of coordinates (X and Y); (d) typical cross section.

The analyzed building is located in the urban part of Sarajevo (Figure 3a,b) and it has a rectangular plan, with length $L = 38$ m and width $B = 13$ m (Figure 3c). The total height of the structure with the basement is 21 m (Figure 3d). The main load bearing walls are located in the Y direction, while the load bearing walls in the X direction are attenuated by many openings. The structure is composed of a basement made of reinforced concrete walls. Dimensions of the walls differ and the inner walls in the Y direction are 38 cm thick, while in the X direction the thickness of the outer walls is 30 cm and of two inner walls is 25 cm. The walls in both directions on all the floors are made of solid brick masonry (dimensions of bricks $250 \times 120 \times 65$ mm) and a façade part (non-load bearing) made of hollow bricks 125 mm thick. The slabs are made of semi-prefabricated “Herbst” concrete hollow elements, joists, and a concrete slab of 6 cm. The total thickness of the slab at the storey’s is 26.5 cm, and the same construction is kept for the roof with thickness increased to 43.5 cm. The structure is an unreinforced masonry building with prefabricated slabs, behaving as rigid diaphragms [5,6].

In order to obtain the necessary information regarding the physical and mechanical characteristics, several on-site and laboratory tests were done. Laser distancemeters and total stations were used for verification of the geometric data and as a result, drawings of the building were produced (Figure 3b–d). Brick units and concrete compressive strengths were determined on samples from the building (Figure 4a). Five series of two bricks were taken out from representative locations in the structure and their compressive strength was tested in accordance with the ex-Yugoslavian standards [13] (Figure 4b). Locations of the extracted brick samples are marked by numbers from 1 to 5 (Figure 4a). The mean value of brick compressive strength was 19.4 MPa, while the minimum value was 13.4 MPa putting it into a class of M15 (15 MPa), which fulfills the requirements for a load-bearing wall [13]. Compressive strength of concrete was determined using six cylindrical samples in accordance with the regulations defined in standard [14]. The mean value of concrete compressive strength was 25.1 MPa, while the minimum value was 22.8 MPa putting it into a class of MB25, which is equivalent to C20/25 in Eurocode 2 [15], and the reinforcement was $\varnothing = 14$ mm, type of steel GA240/360 (smooth bars with yield stress 240 MPa, and 360 MPa ultimate strength). Based on results from the experimental campaign, the calculated compressive strength of masonry according to Eurocode 6 [16] was 4.1 N/mm^2 , which was used as the basis for the calculation of other mechanical characteristics. The slabs were made out of concrete class C20/25 and a reinforcement $\varnothing = 8$ mm and the same type of steel was used as in the basement. All other characteristics were determined from the characteristic compressive strength of the concrete according to Eurocode 2 [15].

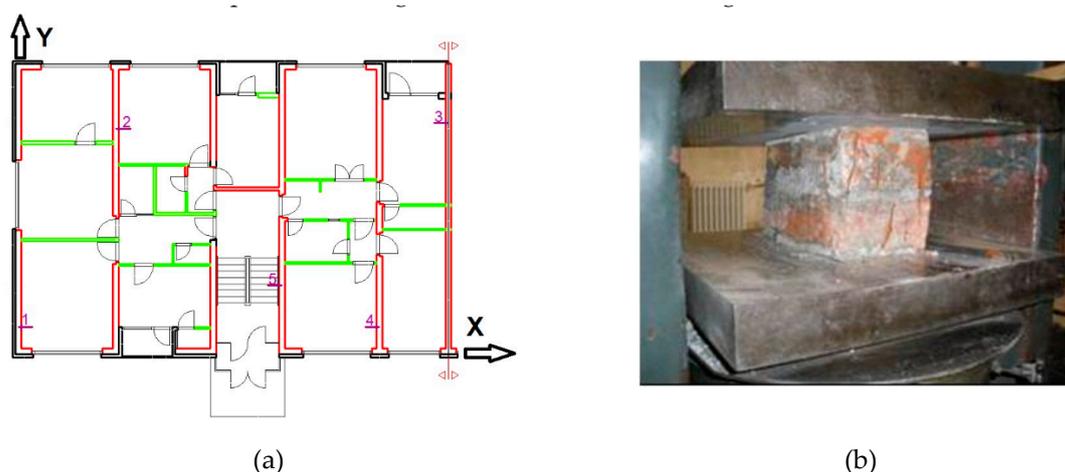
Figure 4. (a) Location of the samples for determination of the compressive strength of bricks; (b) tested sample.

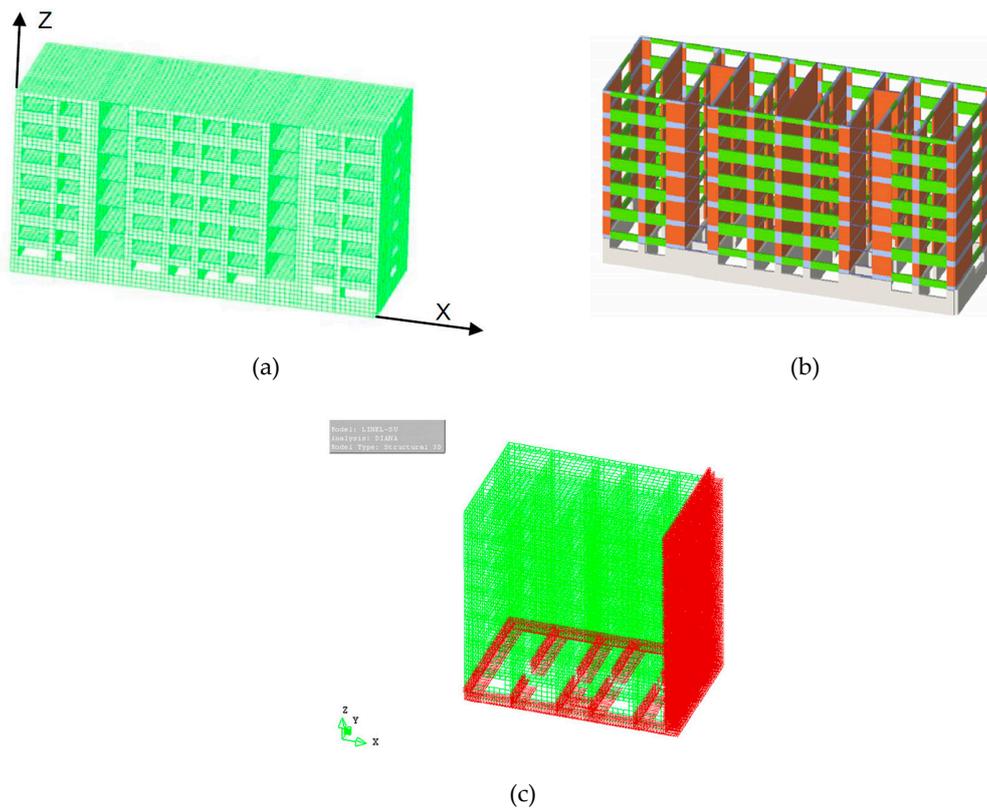
Figure 5. Models used for safety assessment: (a) Finite element model (FEM) in DIANA; (b) EFM in 3MURI; (c) FEM model in DIANA (only half is modelled to keep the computational effort acceptable).

The building, depicted in Figure 3a, was modelled using a finite element model (FEM) and the equivalent frame model (EFM), with the application of DIANA [17] (Figure 5a) and 3MURI [18] (Figure 5b), respectively. DIANA software [19–24], as well as 3Muri [24–30], have been widely applied to model masonry structures. The structure was modeled with a curved shell (quadrilateral element CQ40S type) element. In FEM an element size was 0.25 m having a total of 84,523 nodes and 28,522 elements, while in the EFM, the number of 3D nodes was 218, 34 2D nodes, and 506 elements for the entire structure (Figure 5a,b). In FEM only half of the structure was modeled and analyzed as the structure is symmetric, employing in total 15,759 CQ40S elements and 45,443 nodes (Figure 5c). The applied adequate boundary conditions are indicated in Table 2. Material nonlinearity properties of masonry [31] were taken into account with the application of the total strain fixed crack model, as defined in DIANA [17]. The post-cracked shear behavior was introduced by a very low shear retention factor. The physical and material characteristics taken in the analysis are given in Table 3.

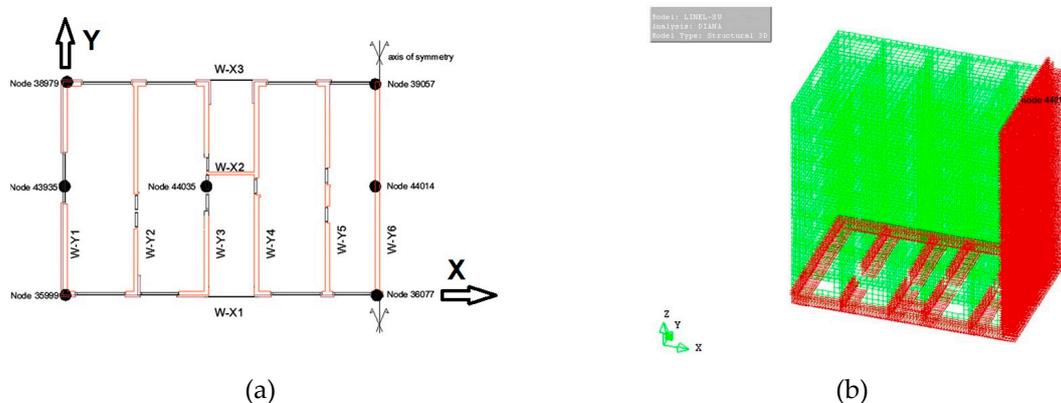
Figure 6. (a) Location of the nodes; wall labeling; (b) location of the control node 44014.

Figure 6a shows the labeling of the walls in the structure in the two directions as well as the numbers of the nodes on the top floor of the structure. The node used to monitor the top displacement is located at the axis of symmetry in the center of the structure (referred to as node 44014) (Figure 6b). For more details regarding the numerical model of the structure and material characteristics the reader is referred to references [5,6].

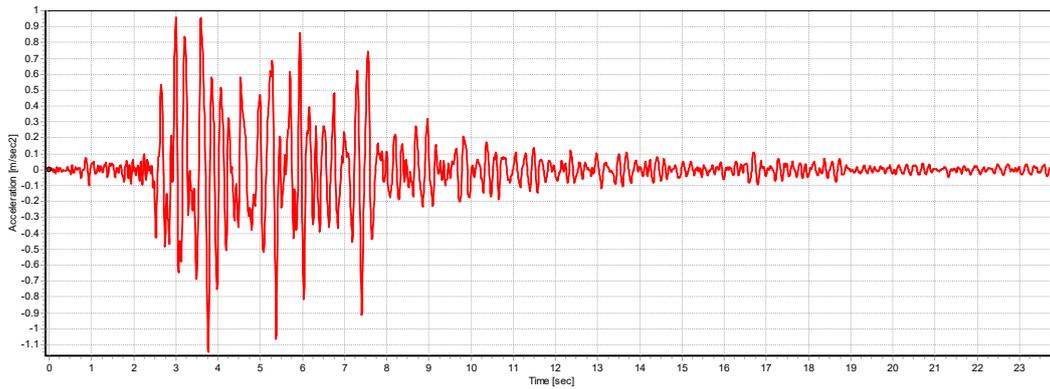
Figure 7. Petrovac earthquake acceleration scaled to 0.1 g [36].

In order to generate the response of the structure to various PGA values, the structure was exposed to the short-period 1979 Petrovac strong earthquake motion registered at Montenegro. This acceleration record is commonly used for seismic structural assessment throughout the region [34,35]. In order to take into account the ground motion in Sarajevo, according to the new seismic hazard map, the accelerogram from the Petrovac earthquake (with a PGA of 0.43 g) was scaled down to 0.1 g (Figure 7) and 0.2 g. Seismosignal software [36] was used for scaling and filtering the acceleration record. The code response spectrum used in the EFM model is presented in Figure 8 for 0.1 g.

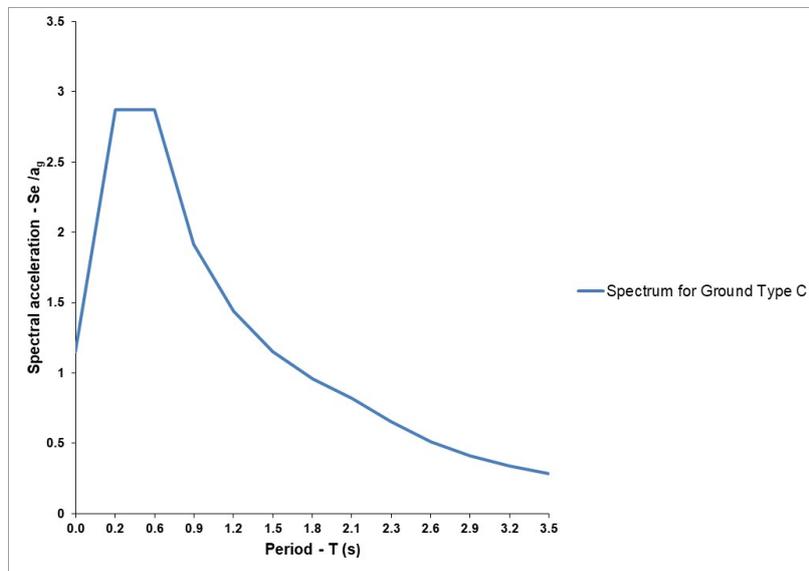
Figure 8. Elastic response spectra for Sarajevo according to Eurocode 8 for 0.1 g.

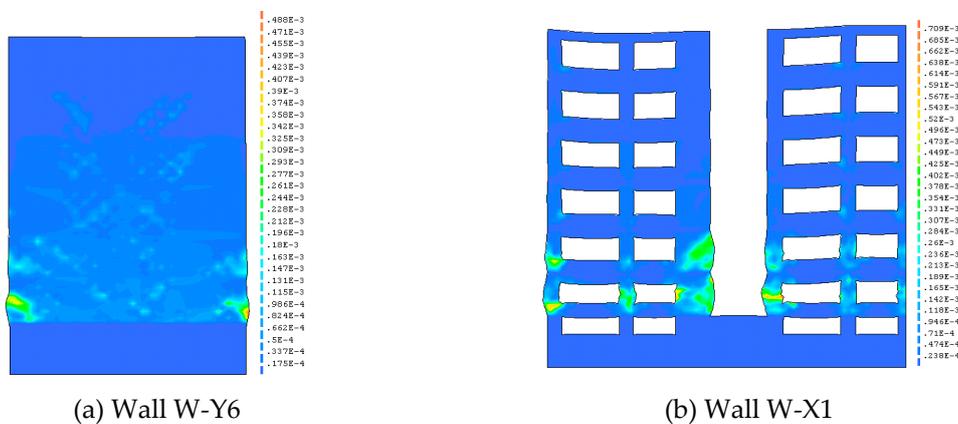
Figure 9. (a) Typical diagonal X-shaped crack due to shear in the perpendicular wall; (b) concentration of damage at the ground floor in the longitudinal wall (0.1g scaled accelerogram).

Due to the earthquake action of 0.1 g, in the Y direction, formation of typical diagonal cracks (Figure 9a) were noticed with concentration of the damage at the ground level (Figure 9b) (connection between the concrete basement and masonry structure) after 24 seconds.

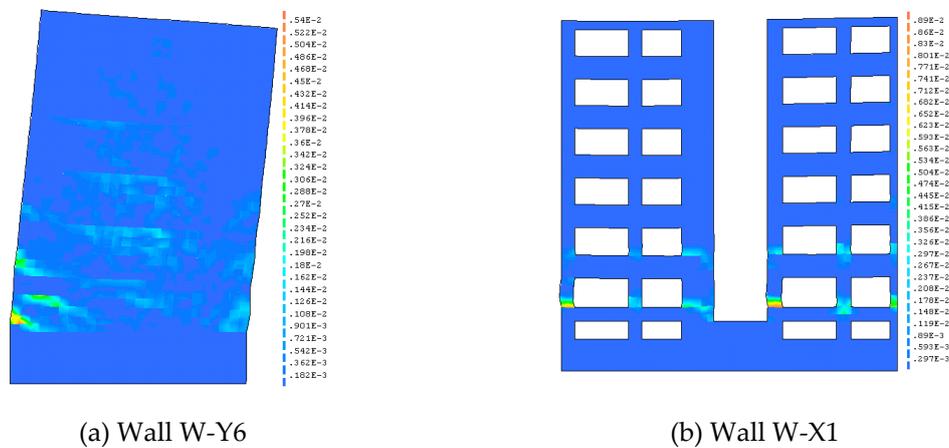
Figure 10. (a) Damage of the perpendicular wall; (b) longitudinal wall due to 0.2 g scaled accelerogram.

On the other hand, it was only after 3.89 seconds that the structure showed significant damage, which caused the collapse of the structure, when the structure was exposed to 0.2 g of the same earthquake (Figure 10a,b).

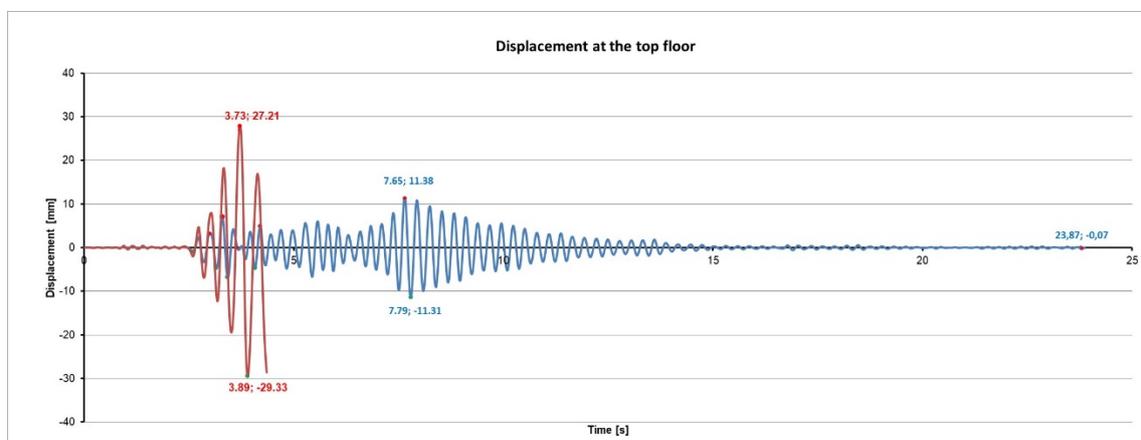
Figure 11. Displacement of the node 44014 at the top floor due to action of 0.1 g (indicated by a blue color) vs 0.2 g scaled accelerogram (indicated by the red color).

From Figure 11 it is evident that, once the structure is exposed to the Petrovac ground motion scaled to 0.2 g, it undergoes very large displacements with a maximum of 29.33 cm after only 3.89 s, which is 2.6 times larger than when the structure was exposed to a 0.1 g scaled accelerogram. It is evident that these types of structures are highly vulnerable to such seismic actions and strengthening measures should be proposed.

The maximum displacement in the case of 0.1 g is rather small and it amounts to 11.38 cm while for the case of higher seismic activity (0.2 g) the displacement increased to 29.33 cm, which is 2.6 times larger. The maximum inter-storey drift per each floor was calculated separately (as it does not happen simultaneously). The maximum value of inter-storey drift of each floor was identified, and an envelope of the inter-storey drift was created. Further, the maximum inter-storey drift (envelope) moved from 0.8 % to 5.8 % (Figure 12) as the PGA increased from 0.1 g to 0.2 g, making the structure more vulnerable, and showing that severe damage will occur if exposed to an earthquake of higher PGA (0.2 g).

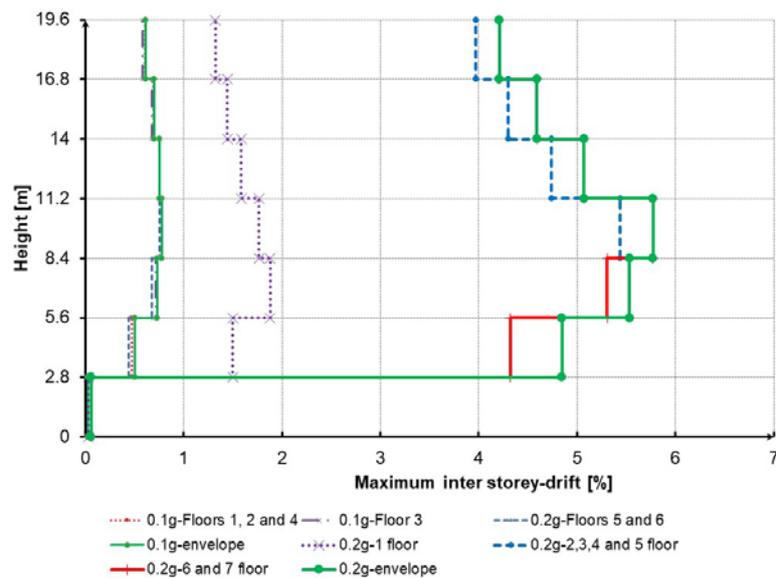
Figure 12. Maximum inter-storey drift for PGA 0.1g and PGA 0.2g scaled accelerograms.

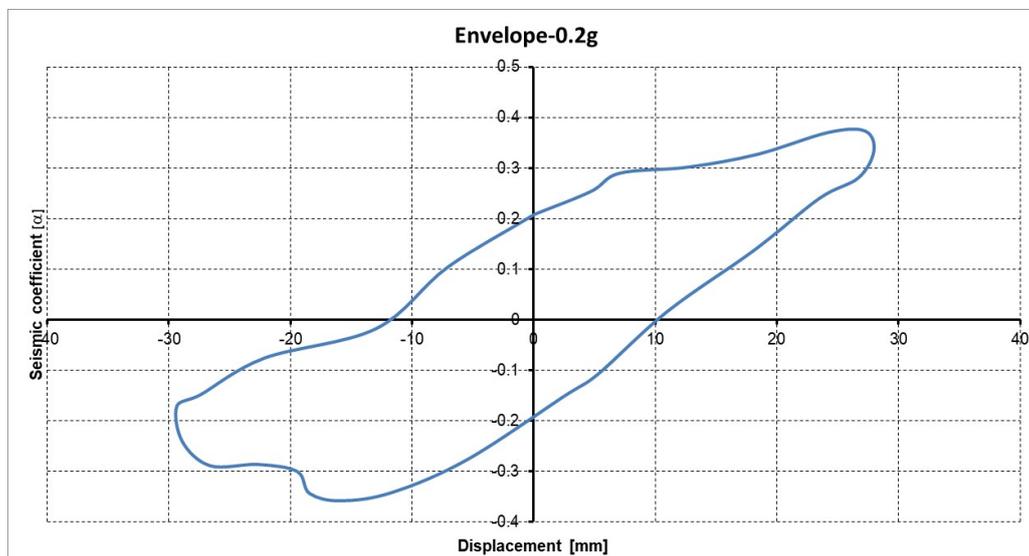
Figure 13. Envelope of the hysteresis curve in the transversal direction.

The hysteresis curve originated by the 0.2 g scaled accelerogram was determined for the control node 44014 and the relationship between the seismic coefficient (ratio between base shear and gravity forces) and displacement has been obtained as shown in Figure 13. The maximum seismic coefficient of 0.37 was reached while the maximum displacement was 29.3 mm. From Figure 13, energy dissipation was observed due to flexural and shear phenomena. However, in order to understand the behavior of a structure besides the amount of dissipated energy, it is important to know the equivalent viscous damping ratio and dissipated energy ratio.

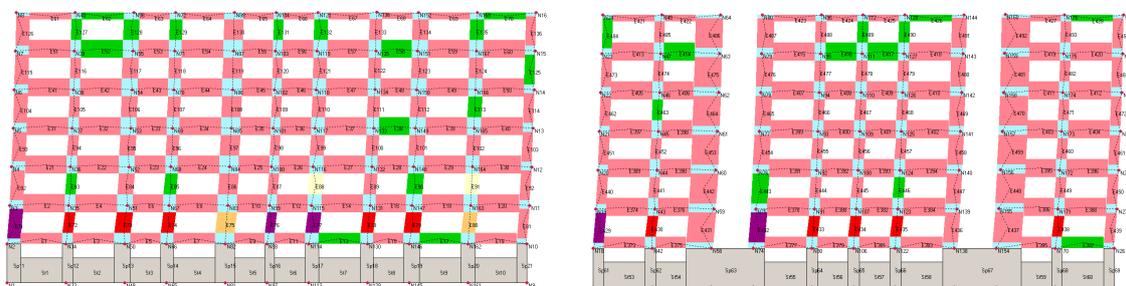
Figure 14. Façade walls damage of the original structure after exposure to $PGA = 0.1$ g.

The structural analysis of the case study was also performed with the EFM (additional information could be found in references [5,6,29]). Here, only the results in the X direction of the façade walls will be shown. Damage was again concentrated in the lower floor of the structure with bending and compression failure at the ground level of the structure (Figure 14). The observed damage shown in Figure 14 (damage in masonry piers) is consistent with the damage observed on the building after the Skopje earthquake (Figure 2b). As results obtained by both FEM and EFM approaches regarding the pushover analysis were in a very good agreement, it was decided not to report the respective results

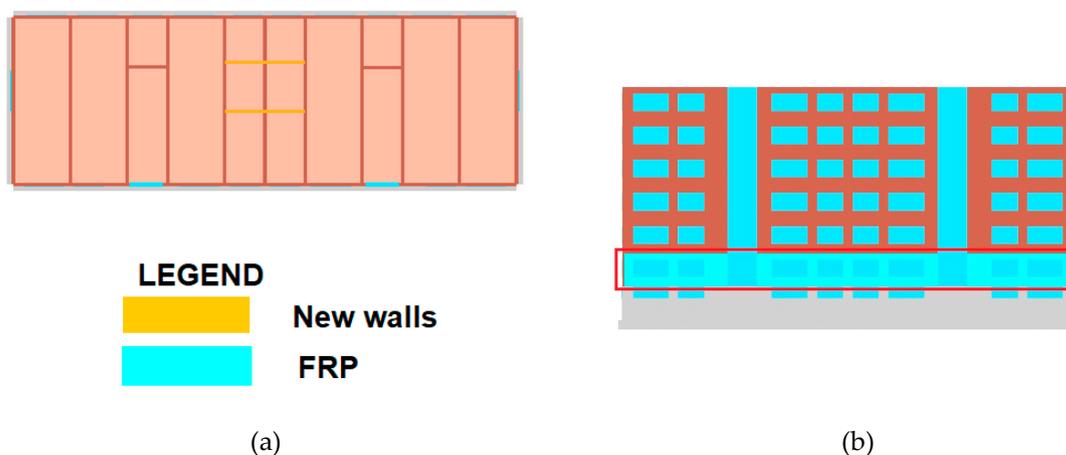
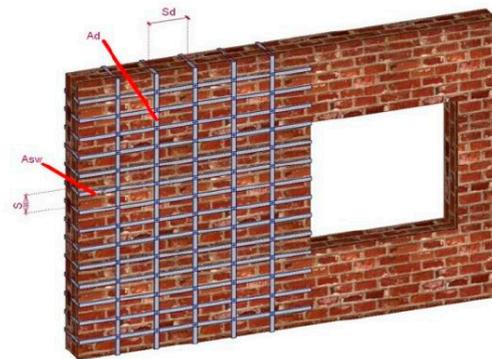
Figure 15. Strengthened structure (a) 4 additional walls; (b) FRP at the ground level; (c) FRP modeling in 3MURI [18].

The proposed strengthening method followed here is a combination of traditional and modern strengthening techniques. This envisaged solution includes the construction of four new walls (Figure 15a) and strengthening the ground floor with fiber reinforced polymers (FRP) where concentration of damage was observed, see Figure 14. In this way, the structure moved from inadequate to the adequate positioning of the structural walls in plan [32]. The walls were positioned in such a way as to keep the symmetry of the structure and in that way circumvent possible undesirable torsional effects. The new walls are made of solid clay bricks connected with lime mortar in order to be compatible with the existing walls. The four new structural walls were built in place of existing separation walls in order to not affect the serviceability of the structure, besides being the most convenient location. The walls are founded on new continuous wall footings connected to the existing foundation. The two longitudinal walls surrounded with a red rectangle in Figure 15b were reinforced at the ground floor with carbon FRP bidirectional strips, having thickness of 2 mm and a width of 200 mm and spaced every 0.5 m, see S_d in Figure 15c. The used FRP material has the following mechanical properties: $E = 240,000$ MPa (modulus of elasticity), $f_{td} = 3182$ MPa (tensile strength) and $\epsilon = 1.45\%$ (ultimate elongation), area of the corresponding strips is 2×200 mm².

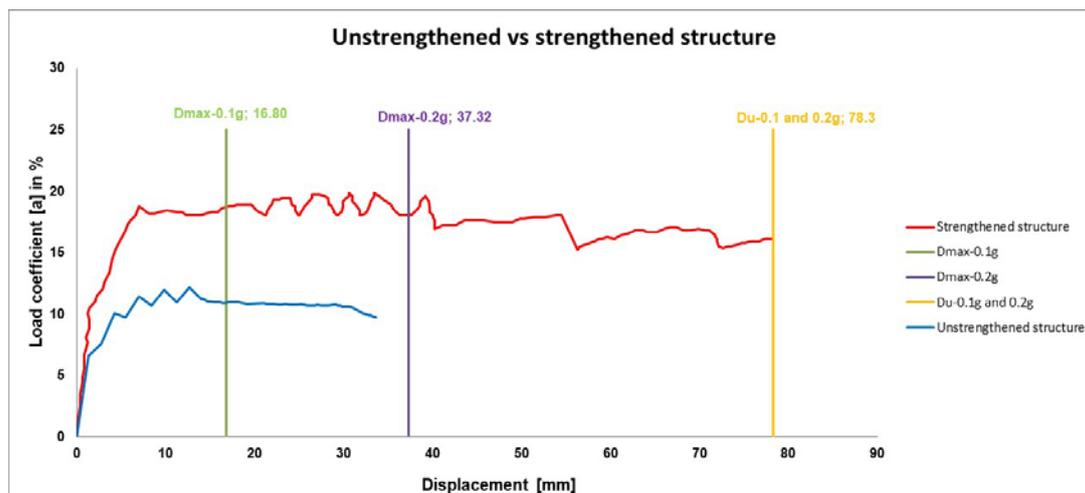
Figure 16. Pushover curves of the unstrengthen and strengthened structures, with performance points for PGA = 0.1 g and PGA = 0.2 g (D_{max} —demand displacement and D_u —ultimate capacity displacement).

The comparison of the performance of the unstrengthen and strengthened structure exposed to the elastic response spectra as defined in Eurocode 8 [37] for PGA equal to 0.1 g and 0.2 g and C soil type (Figure 16), shows that the strengthening procedure adopted could not overcome the problem of seismic vulnerability of this type of structures for larger earthquake motions. The structure has an adequate behavior if exposed to a smaller PGA, however bending failure occurs at the lower floors of the structure with the increase of PGA.

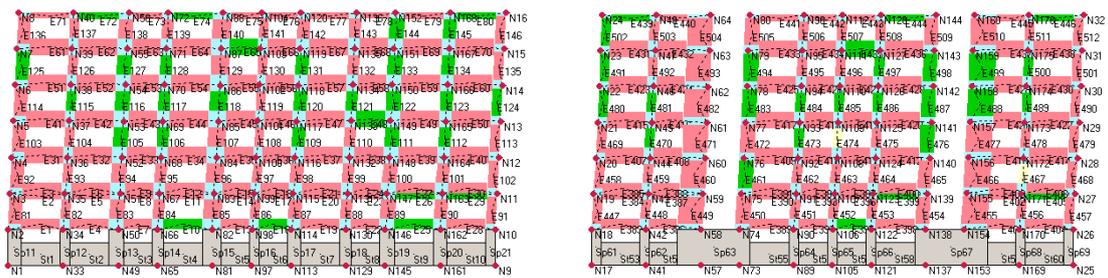
Figure 17. Wall damage after exposure to PGA = 0.1 g—satisfactory behavior of the structure.

Both analyses satisfied the Damage Limit State (DLS) check according to Eurocode 8 [37]. However, the structure exposed to the excitation of 0.2g did not pass the Ultimate Limit State (ULS) check, where the obtained value of q^* (the relationship between the elastic response force and the yield strength of the equivalent system) as defined in reference [38] was 4.90, which is larger than the maximum acceptable value of 3 [38], while in the case of 0.1g this value was equal to 2.45. The available ductility (the ratio between the ultimate displacement and the elastic limit displacement) was 16.78 for the two analyzed cases. If the structure is to be exposed to an earthquake with PGA of 0.1g this intervention would be acceptable (Figure 17). However, this cannot be stated for an earthquake of a higher magnitude, where the concentration of damage due to bending is seen on the lower levels of the strengthened building (Figure 18) causing major damage on the masonry spandrels.

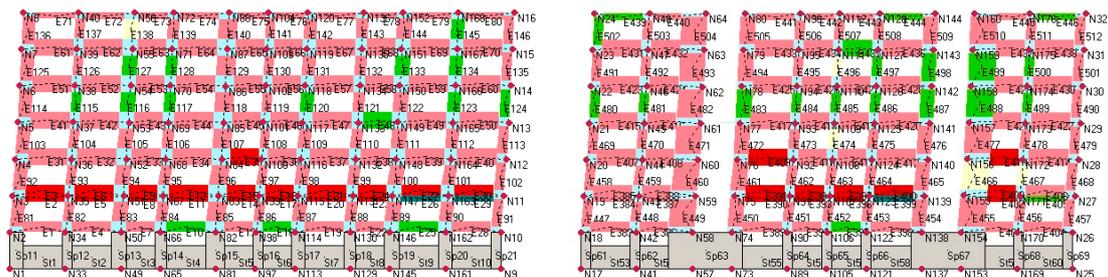
Figure 18. Wall damage after exposure to PGA = 0.2 g—inadequate behavior of the structure.
