Review

Coating Acetylated Wood

Roger Rowell ^{1,*} and Ferry Bongers ²

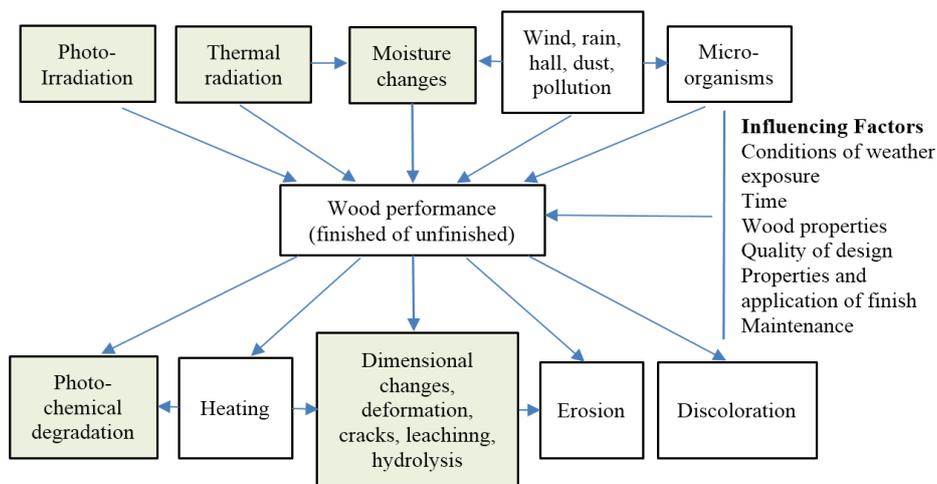
Figure 1. Elements in the weathering process.

Wood exposed outdoors undergoes a number of physical and chemical processes commonly called weathering [4]. This involves moisture, sunlight (UV), decay processes and temperature. Due to these, uncoated wood surfaces erode, roughen, discolor, check, crack and decay. An overview of the effect of various weathering processes is given in Figure 1. The three main ones are moisture, decay and ultraviolet (UV) energy.

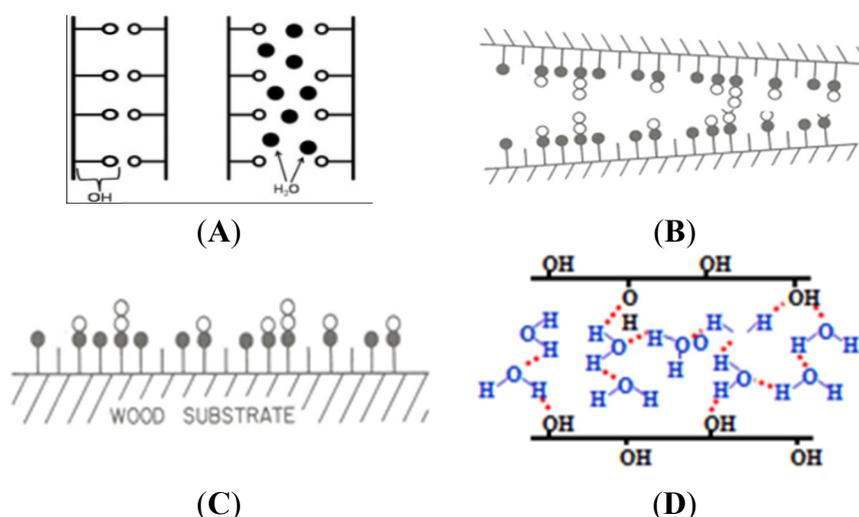
Figure 2. Models of water added to the wood cell wall. (A) Water molecules entering the wood cell wall; (B) water molecules unzipping hydrophilic polymer chains; (C) water bonding to the cell wall either as primary water ● or secondary water ○; (D) fully hydrated cell wall at the fiber saturation point.

Figure 2 shows the mechanism of water molecules adding to the wood cell wall. In Figure 2A, water molecules enter the cell wall and start hydrogen bonding with accessible hydroxyl groups. Figure 2B shows the “unzipping” of hydrophilic polymer chains, Figure 2C shows the sorption of primary water ● molecules and secondary water ○ molecules, and Figure 2D the fully hydrogen bonded water in the cell wall [5]. Hydrogen bonds between hydroxyl groups on and between hemicelluloses, cellulose and lignin are constantly changing.

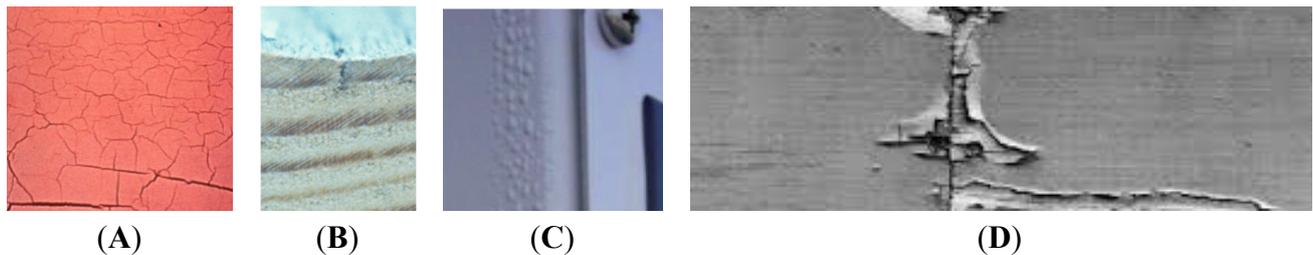
Figure 3. Cracking of surface coating due to differential swelling of the coating and wood (A); micro checks occur in the wood due to moisture evasion and swelling (B); water collecting under coated wood (C); and coating failure due to moisture build up in end grain (D).

As moisture is added to the cell wall, wood volume increases nearly proportionally to the volume of water added. Swelling of the wood continues until the cell matrix reaches the fiber saturation point (FSP) and water, beyond the FSP, is free water in the void structure and does not contribute to further swelling. This process is reversible, and wood shrinks as it loses moisture below the FSP. Sorption of moisture results in swelling/shrinking, cracking, coating failure, and surface degradation. Because the swelling of a coating is usually less than the swelling of the wood substrate, the differential swelling results in coating failure (Figure 3).

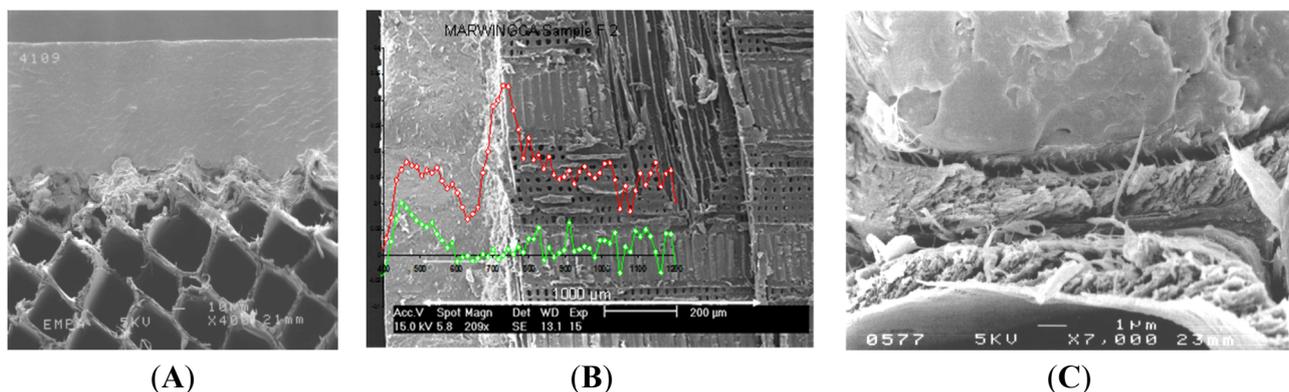
Figure 4. Coating on the surface of the wood (A); moisture gradient at the interface of the coating and the wood (B); and coating delamination (C).

Figure 4 shows the mechanism of coating failure due to moisture. As seen in Figure 4A, the coating is on the surface of the wood with little or no penetration into the wood. Figure 4B shows the buildup of moisture at the interface between the wood and the coating and Figure 4C shows the coating delaminating from the wood surfaced due to differential swelling of the coating as compared to the wood. Once the coating has failed, or the uncoated wood sorbs water, moisture spreads within the wood and the wet wood becomes a good substrate for fungal invasion and the decay process begins.

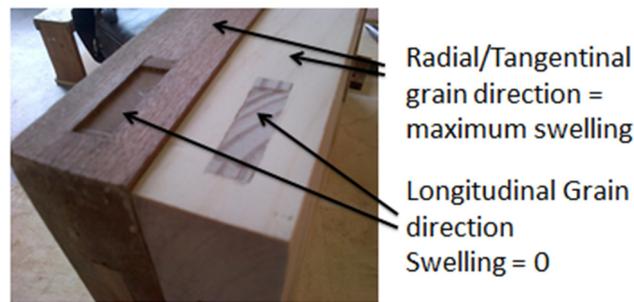
Figure 5. Stile and rail door part showing swelling of the control (left) and no swelling in the acetylated door (right). No longitudinal swelling in either control or acetylated wood but radial and tangential swelling in the control but not in the acetylated wood.

Since the moisture in the cell wall is greatly reduced in acetylated wood and the wood is stabilized to changing moisture content, acetylated wood expands and contracts very little during weathering cycles. This means the wood will move less than the coating in most cases. An example of the difference in wood swelling of control and acetylated wood can be seen in Figure 5.

Figure 5 shows the difference in swelling between control and acetylated wood in a stile and rail door after exposure to high humidity for a long period of time. Since there is essentially no longitudinal swelling in either control or acetylated wood, the swelling that will occur is in the radial and tangential directions. The control door on the left shows the swelling that has taken place in the radial and tangential directions while the acetylated door on the right shows no swelling in any direction [4].

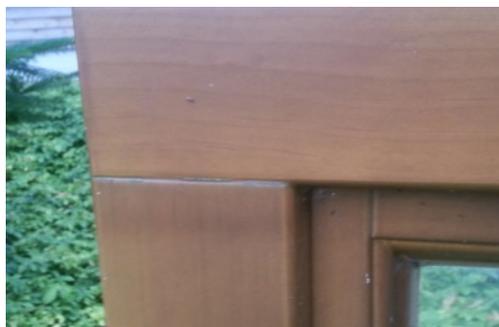
Figure 6. Corner window joint in an acetylated window.

Figure 6 shows a corner joint in an acetylated window. The color discoloration on the upper horizontal part of the joint is due to liquid water sorbed in the end grain of the horizontal member. Since the wood lumens are still open after acetylation, water can and does enter end grain by capillary action [4]. While water has entered the end grain, there is no swelling so any coating failure would be due to water and not differential swelling.

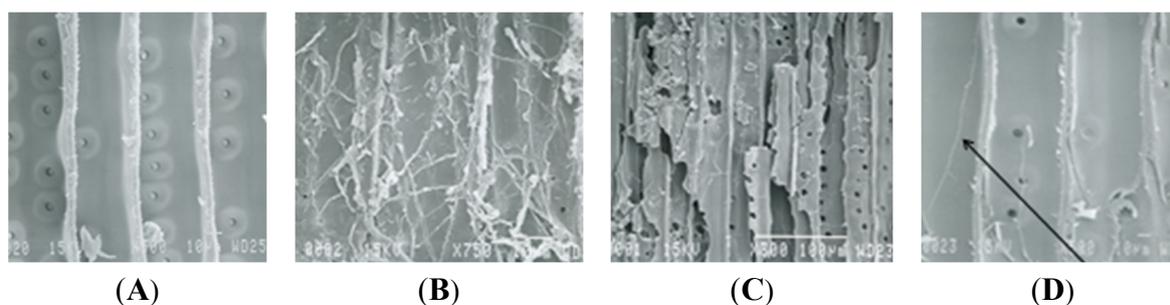
Figure 7. Scanning electron microscope of brown-rot fungal attack on wood. (A) control; (B,C) 51.1% weight loss after the 12 weeks in the ASTM soil block test; (D) acetylated pine after the soil block test.

Figure 7 shows electron micrographs of control and acetylated pine. The control sample before the test A and the control after the 12 week test with a brown-rot fungus Figure 7B,C. The control sample after test is almost completely covered with fungal hypha Figure 7B with a destroyed cell wall Figure 7C. The acetylated sample shows a few hypha growing on the inner cell wall but no weight loss is detected [3]. This finding shows that the acetylated wood is not toxic to the fungus so resistance to attack must be based on another mechanism not toxicity.

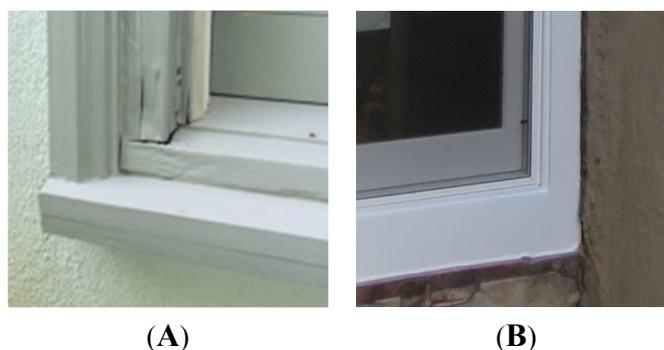
Figure 8. Decay in the corner of a control window after three years (A); no swelling or decay in the acetylated window after five years (B).

Figure 8A shows decay in the corner of a non-acetylated window and Figure 8B an acetylated window that was coated with the same paint. There was no swelling, shrinking, decay or maintenance with the acetylated coated window.

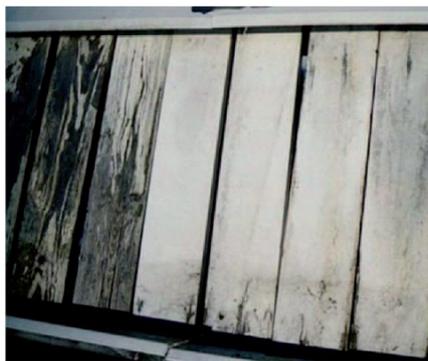
Figure 9. Performance of acetylated coated panels after 13 years of exposure. The four panels on the right are acetylated and the others are unmodified controls. Prior to testing the panels were coated with alkyd primer followed by acrylic top coating [15].

Various research groups have been studying the effect of acetylation on coating performance with field tests. Larsson-Brelid and Westin reported the results of a 13 year old outdoor exposure test in Sweden according with EN 927-3 of acetylated Scots pine finished with an alkyd and acrylic film-forming coating system [15]. The alkyd coating system (primer and topcoat) performed slightly less well on the acetylated panels compared to the unmodified Scots pine controls, believed to be caused by more acidic surface of the acetylated panels increasing aging of the alkyd coating. The acetylated panels finished with the acrylic coating system (alkyd primer + acrylic topcoat), however, were still in good shape after 13 years exposure, whereas the corresponding control panels from unmodified Scots pine needed repainting after five years (Figure 9).

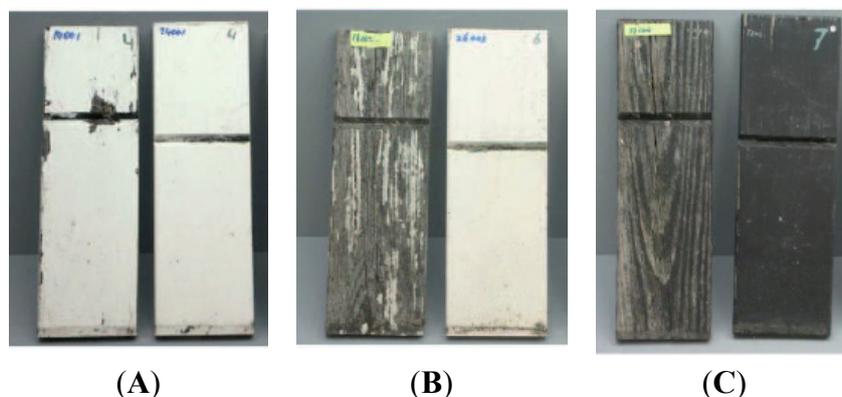
Figure 10. Photographic impression performance of opaque white (A,B) and black (C) coatings after 9½ years of outdoor exposure. (A) opaque white acrylic, left control, right acetylated; (B) opaque white alkyd, left control, right acetylated; (C) opaque black alkyd, left control, right acetylated. [16].

This significant improvement of film-forming coating performance on acetylated wood was also reported by Bongers *et al.*, based on an outdoor exposure test with acetylated Scots pine panels in the Netherlands [16]. However, a significant improvement of the performance was also found for the tested alkyd coating system. It was concluded that “The intrinsic quality of the coating itself has become the main factor affecting the durability of coatings on acetylated wood. With an acrylic opaque white coating the condition of the coating after 9½ years without any maintenance was still good (Figure 10). If a coating system is adapted to be used on acetylated wood and the application is done in the appropriate way, it is expected that the maintenance frequency can be once every ten years or even lower.

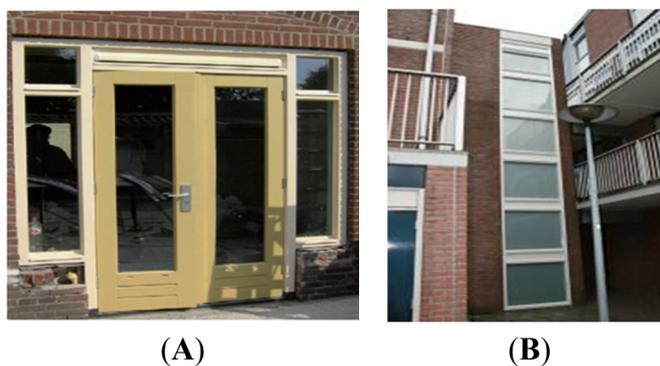
Figure 11. Acetylated radiata pine door (A) and windows (B) that were installed in Japan 2008.

Many other pictures could be included showing acetylated doors, windows, cladding, decking and other applications in service for many years. Figure 11 shows an example of a door and window unit that after seven years show no signs of swelling or decay.

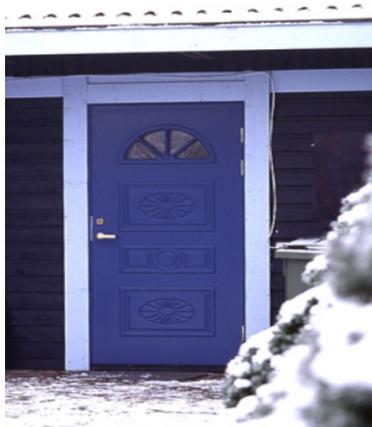
Figure 12. Acetylated door at a summer home in Sweden.

One final example of the service life of an acetylated door is shown in Figure 12. This “blue door” as it is known in Sweden was installed in 1997 in a summer home by the sea. The door was coated with a 2-component solvent borne coating system (from Becker Acroma, now Sherwin-Williams). There has been no swelling, shrinking, decay or warping and has not required any maintenance in the 18 years since it was installed.
