# Erosion Mechanism of a Cavitating Jet on Groove Roughness

**Abstract:** The erosion behavior of a cavitating jet on groove roughness was investigated experimentally using mass-loss characteristics, scanning electron microscopy (SEM) observation, time-resolved shadowgraph, and schlieren flow visualizations. The wall morphology of the cavitating-jet erosion on the groove roughness indicated an increased mass loss, which was highly increased along the groove rather than across the groove. Furthermore, increased erosion pits were observed on the groove bottom along the grooves. The shadowgraph imaging of the cavitating jet on the rough wall showed noncircular cavitation bubble distributions along and across the grooves, which corresponds to the increased number of cavitation bubbles along the grooves and the decreased number of bubbles across the grooves. This result is consistent with the erosion morphology of the groove roughness. Schlieren imaging indicated that the frequency and intensity fluctuation of the shockwave formation did not change significantly on the groove roughness along and across the grooves. The findings in the study show that the increased erosion mechanism on

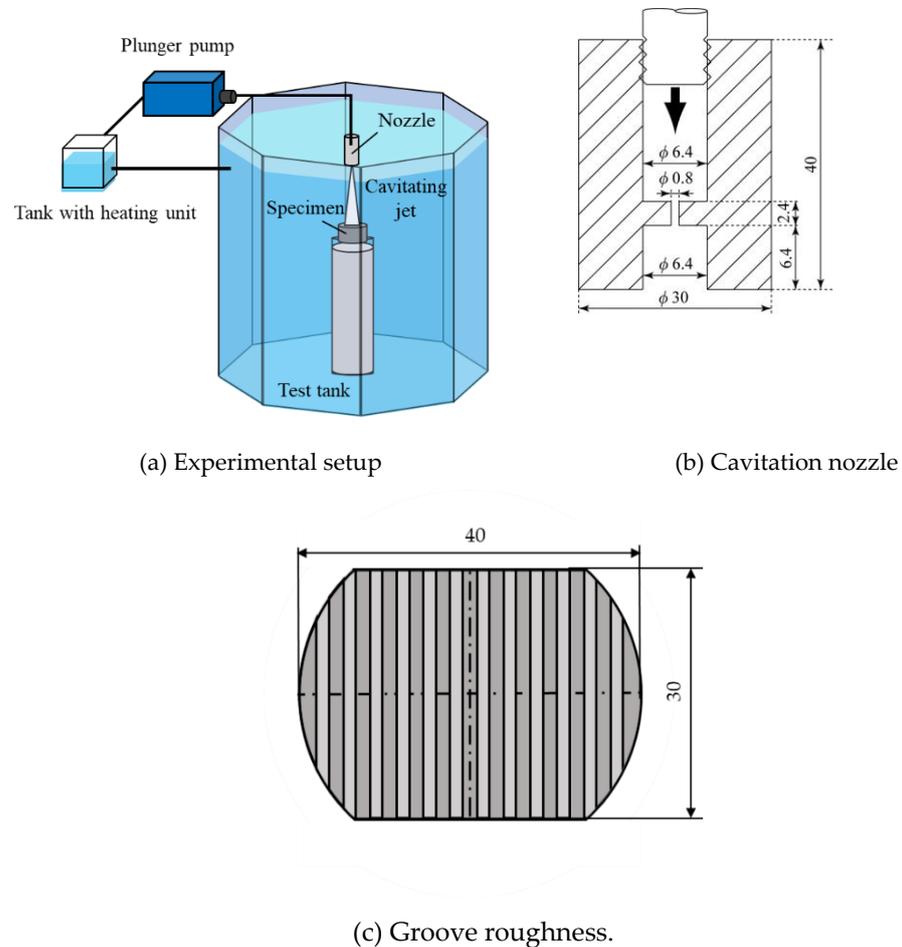
Figure 1a shows the experimental setup for a cavitating jet emerging from a cavitation nozzle into a still water environment in a cavitation test tank [6]. The cavitation nozzle consists of an orifice and a cavity that generates periodic oscillations of the shear layer along the cavitating jet [9,10]. The details of the cavitation nozzle geometry are described in Figure 1b, which shows an orifice of 0.8 mm in diameter and a cavity of 6.4 mm in diameter and height. The cavitating jet issues from a nozzle at the top of the test tank into the water in the tank, where the water surface is kept at 50 mm above the nozzle exit. The water surface was covered with a urethane plate to nullify the surface oscillations. The test tank had a hexagonal cross-sectional dimension (opposite side distance) of 400 mm with a height of 460 mm made of acrylic resin material filled with water. The working fluid water was kept at a constant temperature of  $25 \pm 0.5$  °C using a heating unit with a temperature controller. The injection pressure of the nozzle was controlled by a valve connected to a plunger pump, and the flow rate was measured by estimating the bulk flow volume in a unit time with an accuracy of  $\pm 1.5\%$ . The injection pressure can be varied in the range of 4 to 12 MPa; however, the present experiments were conducted at a fixed nozzle pressure of 12 MPa. The mean velocity through the orifice in the cavitation nozzle was 101 m/s from the bulk flow rate, and the cavitation coefficient was  $\sigma = (2(P - P_v)/\rho U^2) = 0.0083$  ( $P$  = local pressure at nozzle,  $P_v$  = vapor pressure,  $U$  = mean velocity through the orifice,  $\rho$  = density of water) [33]. The cavitating jet impinges normal to the test specimen located

inside the test tank at 30 mm, where the maximum erosion occurred when the cavitating jet was at a nozzle pressure of 12 MPa [16].

**Figure 1.** Experimental setup for cavitating jet (Unit in mm). (a) Experimental setup; (b) Cavitation nozzle; (c) Groove roughness.

The test specimen was made up of aluminum (Al 1070) and was machined to a diameter of 30 mm with a thickness of 8 mm for a smooth wall, whereas the grooved specimen was fabricated by the discharge processing machine, as shown in Figure 1c. The grooved specimen consists of semicircular grooves of depth  $d = 0.19$  mm and pitch  $p = 0.76$  mm, as illustrated in Figure 1c. These grooves were machined in the full width of the test specimen. The smooth specimen was surface-finished by emery paper (grit number #4000) after surface machining, which results in the maximum roughness height of  $1.5 \mu\text{m}$ , while the grooved specimen has a maximum roughness height of  $4.7 \mu\text{m}$ . It should be noted that these heights are much smaller than the critical roughness height of  $25 \mu\text{m}$  obtained from the cavitation erosion test in the ultrasonic-vibrometer study [28]. The Vickers hardness of the test specimens was 29.1 on the smooth specimen and 33.8 on the grooved specimen.

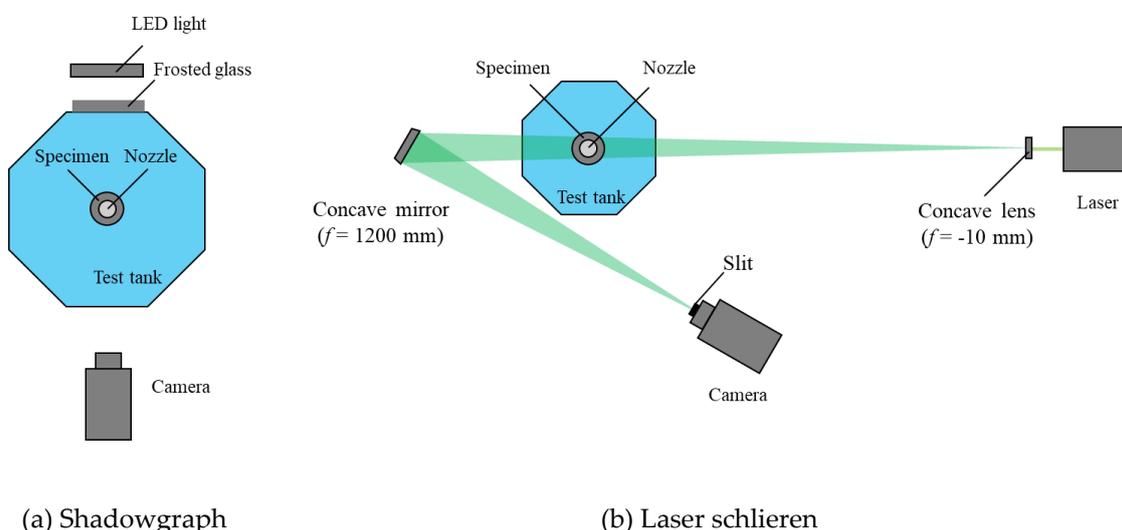
The experimental setups for the shadowgraph and schlieren flow visualizations are shown in Figure 2a,b, respectively. The time-resolved observation of cavitation bubbles in a water environment was successfully carried out using shadowgraph imaging (Figure 2a). The in-line illumination was provided by a light-emitting diode (LED) light of 1 W, and the observation was conducted using a high-speed camera with a spatial resolution of  $264 \times 384$  pixels with 8 bits operating at 100 kHz.

**Figure 2.** Experimental arrangement of flow visualization. (a) Shadowgraph; (b) Laser schlieren.

The schlieren imaging in Figure 2b enables the detection of minor density differences in the shockwave formation of the cavitating jet, which is not visible in the shadowgraph images. The experimental arrangement consisted of a CW Nd:YAG laser (5 W), beam expander, concave mirror, and complementary metal–oxide–semiconductor (CMOS) camera with a concave lens of focal length  $f = 10$  mm. It should be noted that the diameter of the concave mirror was 150 mm with a focal length  $f = 1200$  mm. The shockwave images in the cavitating jet were captured by the same high-speed camera with a spatial resolution of  $264 \times 384$  pixels with 8 bits operating at 100 kHz, as used in the shadowgraph imaging. It should also be noted that the exposure time of the high-speed camera was set to 250 ns. The camera was located in-line with the laser beam through the concave mirror and slit-type darkfield illumination. The shadowgraph and schlieren images across and along the groove direction were taken by rotating the specimen at right angles. The details of the shadowgraph and schlieren visualization methods are described in Refs. [6,34].

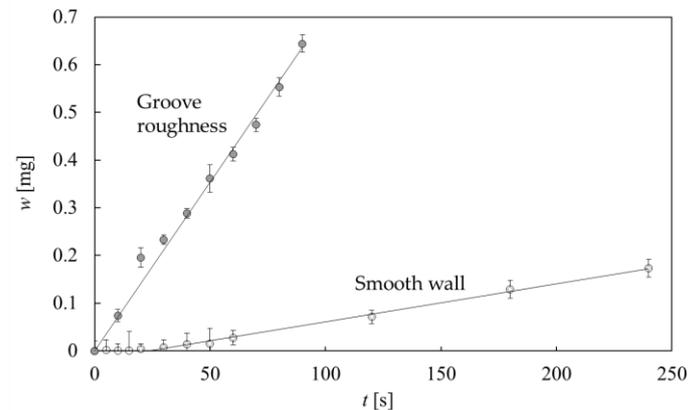
Figure 3 shows the mass-loss characteristics of the test specimen with smooth and rough walls in the cavitating jet, where the standoff distance was set to 30 mm from the nozzle exit and the nozzle pressure was at 12 MPa. The experiment of mass-loss

characteristics on a rough wall indicates that the erosion initiation starts with a large erosion rate immediately after the injection of the cavitating jet, whereas that of the smooth wall shows the presence of a certain incubation period of approximately 20 s followed by the linear growth of erosion with a smaller erosion rate. The scattering of the mass-loss measurement is shown by error bars obtained from two repeated experiments. The increased erosion rate owing to the influence of groove roughness is approximately 10 times higher than that of the smooth one. However, the mechanism of the increased erosion rate by the rough wall is not clear. This will be studied by the shadowgraph and schlieren flow visualizations in Sections 3.3 and 3.4, respectively.

**Figure 3.** Time variations of mass-loss measurement.

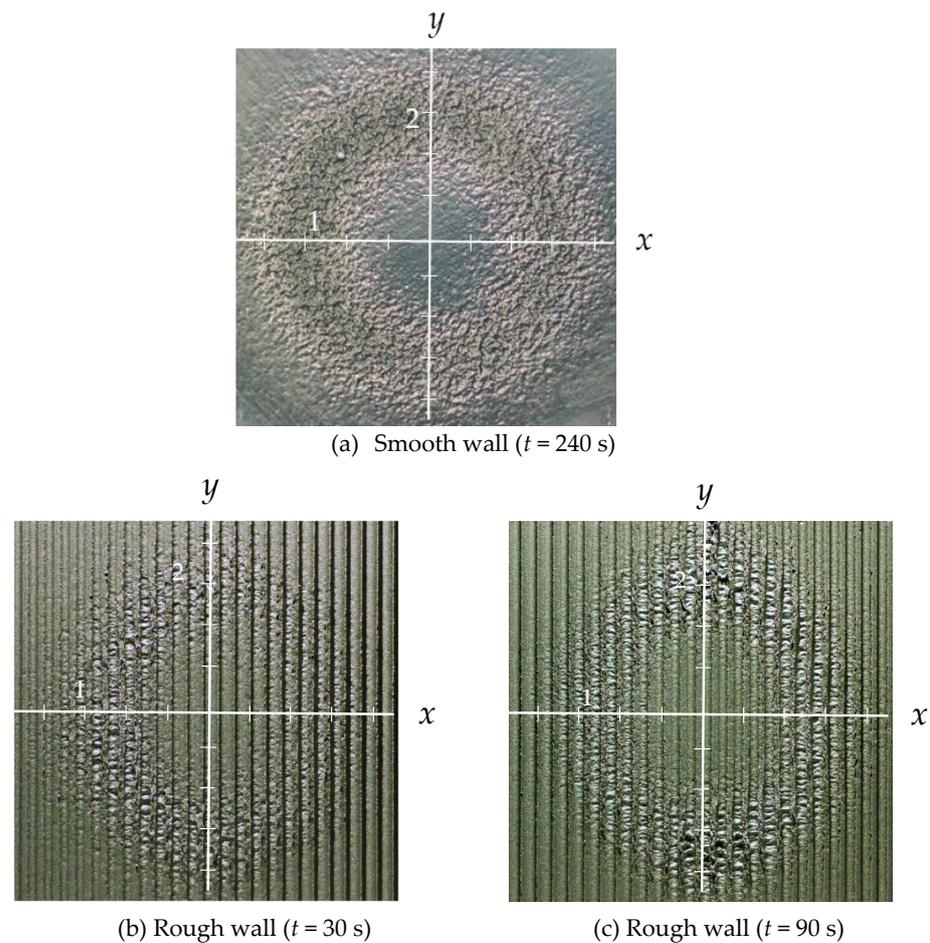
Figure 4a–c shows direct observations of cavitating-jet erosion on smooth and rough walls at a standoff distance of 30 mm and at a nozzle pressure of 12 MPa, which were taken by a digital camera with a target area of observation of  $18.5 \times 18.5 \text{ mm}^2$ . The observations were made after a cavitating-jet injection for 240 s on the smooth wall (Figure 4a), and on the rough walls after 30 s and 90 s of cavitating-jet injection (Figure 4b,c, respectively). The observation of the smooth wall shows that the erosion appears almost circular, approximately 12 mm in diameter, and the rest of the area that is in and out of the circle does not suffer from cavitating-jet erosion [17]. This result reflects the fact that the cavitation bubble collapse occurs at the distributed circular-erosion-area by the impingement of the cavitating jet. The cavitation erosion was considered to be caused by the formation of pits, which in turn was caused by the cavitation bubble collapse. The cavitation pits result from the shockwave formation arising from the cavitation bubble collapse near the wall [18].

On the other hand, the erosion pattern on the rough wall indicates a noncircular distribution of erosion, which elongates in the direction along the grooves ( $y$ -axis) and shrinks across the grooves ( $x$ -axis) in comparison with that on the smooth wall. This feature of erosion on the groove roughness can be caused by the different rates of cavitation bubbles developed along and across the grooves, owing to the influence of wall roughness, which will be discussed in the following sections. The increased erosion along the groove roughness can be caused by the increased number of cavitation bubbles along the grooves, which was observed on the top and bottom of the erosion pattern in Figure 4c. The decreased erosion across the grooves was observed on the left and right of the erosion pattern, wherein fewer cavitation bubbles were expected, as shown in Figure 4c. This can be reflected by the difference in the near-wall velocity fields of the cavitating jet on groove roughness.

**Figure 4.** Digital camera images of erosion pattern (tick marks for every 2 mm). (a) Smooth wall ( $t = 240$  s); (b) Rough wall ( $t = 30$  s); (c) Rough wall ( $t = 90$  s).

Figure 5a–c shows the depth distributions of the erosion pattern in Figure 4a–c, respectively, which were obtained from the depth measurements of the smooth wall and rough wall by laser displacement sensor traversing in the  $x$ -axis and  $y$ -axis. The uncertainty in depth measurement is  $\pm 15$   $\mu\text{m}$ . The results for the smooth wall (Figure 5a) and rough walls (Figure 5b,c) were taken at 240 s, 30 s, and 90 s, respectively. The depth distributions on the smooth wall (Figure 5a) show the presence of small depth fluctuation around  $x, y = \pm 6$  mm in the  $x$  and  $y$  axes of the erosion pattern. There is a minor decrease and increase in the wall height on both sides of the erosion area caused by the erosion and plastic deformation of the wall material, respectively. On the other hand, the erosion depth distributions on the groove roughness in Figure 5b,c show the different features of the erosion pattern in the  $x$  and  $y$  axes, which correspond to the distribution across and along the grooves. It was observed that the depth distribution across the grooves shows the maximum depth around  $x = \pm 5$  mm. However, the maximum depth along the grooves was found around  $y = \pm 7$  mm. These results indicate that the erosion pattern is shrunken across the grooves and elongated along the grooves. The high erosion peaks were observed along the grooves in Figure 5c, which resulted from the plastic deformation on the groove bottom. The wider depth distributions on the groove bottoms and sharper groove peaks reflect that the mass loss occurs on the groove bottom. Therefore, these results are almost consistent with the observations of the erosion pattern in Figure 4b,c. Hence, the cavitating-jet erosion on groove roughness is highly modified by the influence of the direction of groove roughness, which can be caused by the cavitation bubble distribution near the grooves.

To confirm the non-uniform image intensity distributions along and across the groove roughness, the average intensities of the shadowgraph images on smooth and rough walls were evaluated, and the results are shown in Figure 9, which are plotted against the time after the cavitating-jet injection. It is observed that the intensity of the shadowgraph images decreases with increasing elapsed time, independent of the wall roughness. However, the intensity distribution on the groove roughness (b) shows different decay rates in the  $x$ - $z$  and  $y$ - $z$  planes. These results indicate that a larger number of cavitation bubbles is generated in the direction along the grooves than across the grooves. A larger number of cavitation bubbles in the  $x$ - $z$  plane was considered to possibly result in an increased cavitation erosion along the grooves of the rough wall, which agrees qualitatively with the erosion pattern on groove roughness in Figure 4b,c.

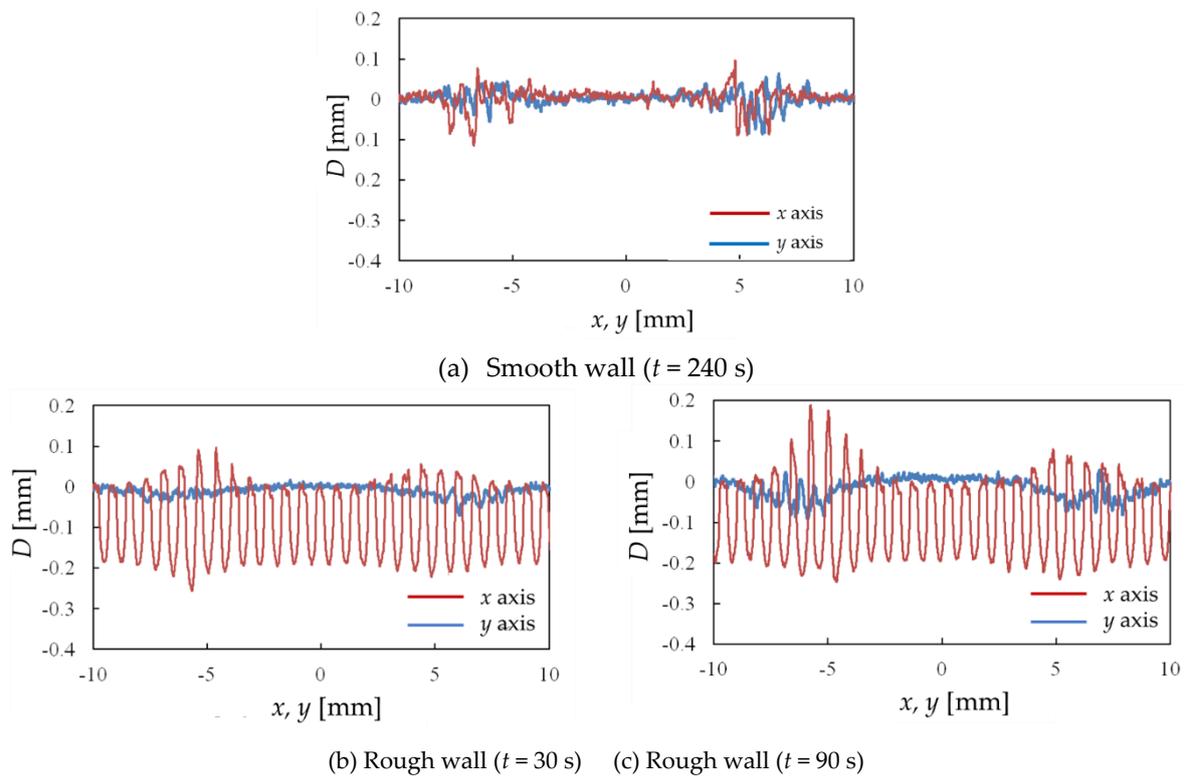
**Figure 5.** Depth distributions of erosion pattern. (a) Smooth wall ( $t = 240$  s); (b) Rough wall ( $t = 30$  s); (c) Rough wall ( $t = 90$  s).

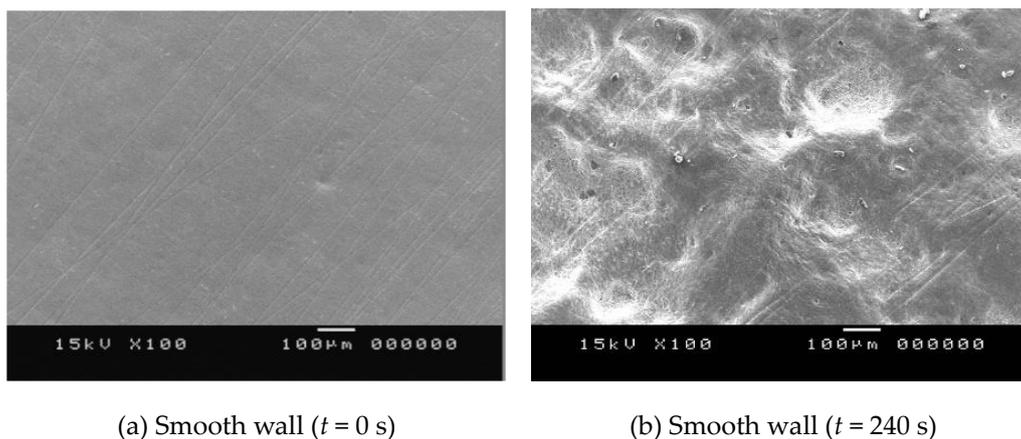
Figure 6a,b shows the SEM observations of the smooth wall before and after erosion for  $t = 240$  s of cavitating-jet injection, respectively. The SEM image of cavitating-jet erosion on a smooth wall shows the formation of small pits approximately 10–20  $\mu\text{m}$  in diameter, which is consistent with the literature [18]. The SEM observation of the smooth wall (Figure 6b) shows pits together with dents of several hundreds of micrometers in diameter.

**Figure 6.** Scanning electron microscopy (SEM) observations of cavitation erosion on smooth wall. (a) Smooth wall ( $t = 0$  s); (b) Smooth wall ( $t = 240$  s).

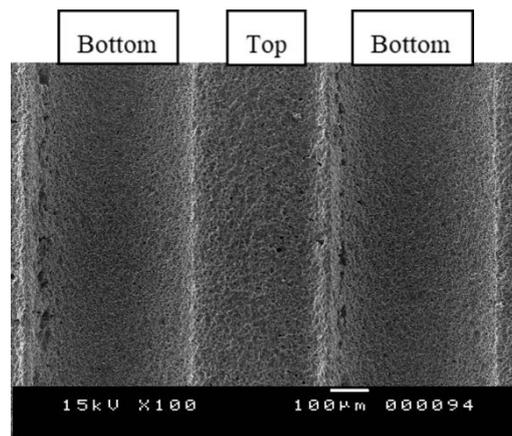
(a) Groove roughness ( $t = 0\text{ s}$ )

Figure 7a–e shows the SEM observations of cavitating-jet erosion on groove roughness before erosion (Figure 7a) and after erosion (erosion pattern 1) for  $t = 30$  s (Figure 7b) and for  $t = 90$  s (Figure 7c), and after erosion (erosion pattern 2) for  $t = 30$  s (Figure 7d) and at  $t = 90$  s (Figure 7e), which are marked by 1 and 2 in Figure 4b,c, respectively. The SEM images (Figure 7b,c) on the erosion pattern 1 show the uniform erosion on the groove bottom, and

**Figure 7.** SEM observations of cavitation erosion on groove roughness. (a) Groove roughness ( $t = 0$  s); (b) Erosion pattern 1 ( $t = 30$  s); (c) Erosion pattern 1 ( $t = 90$  s); (d) Erosion pattern 2 ( $t = 30$  s); (e) Erosion pattern 2 ( $t = 90$  s).

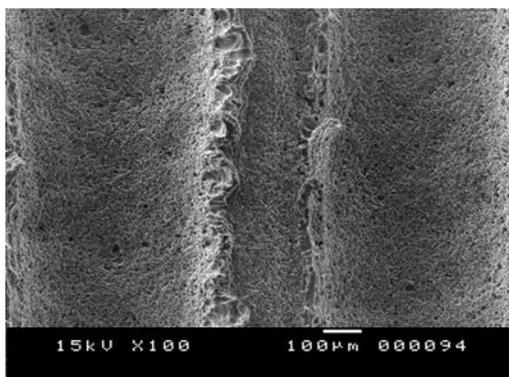
(b) Erosion pattern 1 ( $t = 30\text{ s}$ )

small pit formation of 10–20  $\mu\text{m}$  occurs on the entire walls ( $t = 30\text{ s}, 90\text{ s}$ ). The growth of the wall material over the groove top is clearly observed along the groove top, which was caused by the plastic deformation of the wall on the groove bottom. The observations on the rough wall images (Figure 7d,e) on the erosion pattern 2 show increased erosion pits of an order of hundreds of micrometers in diameter, and they are largely observed in the groove bottom. These results indicate that large erosion pits with diameters of several hundreds of micrometers corresponding to the increased erosion are generated on the groove bottom, as observed in the mass-loss measurement in Figure 3. The generation of large erosion pits on the groove bottom could be caused by the influence of the shockwave focusing effect, which was similarly observed on the groove bottom of the liquid droplet impingement erosion on a rough wall [35–38]. A detailed examination shows that the large pits were generated on the groove bottom, whereas small pits were observed on the entire wall surface, as observed on the smooth wall. It is expected that the large pits are caused by the increased cavitation erosion of dents on the smooth wall because they are of similar size. The SEM observation of the erosion pattern (e) at  $t = 90\text{ s}$  shows the growth of plastic deformation over the groove top, which is waving because of the influence of large pits. These results indicate that the cavitating-jet erosion on groove roughness grows with the increasing number of large pits on the groove bottom, while the erosion behavior is similar to that of the smooth wall.

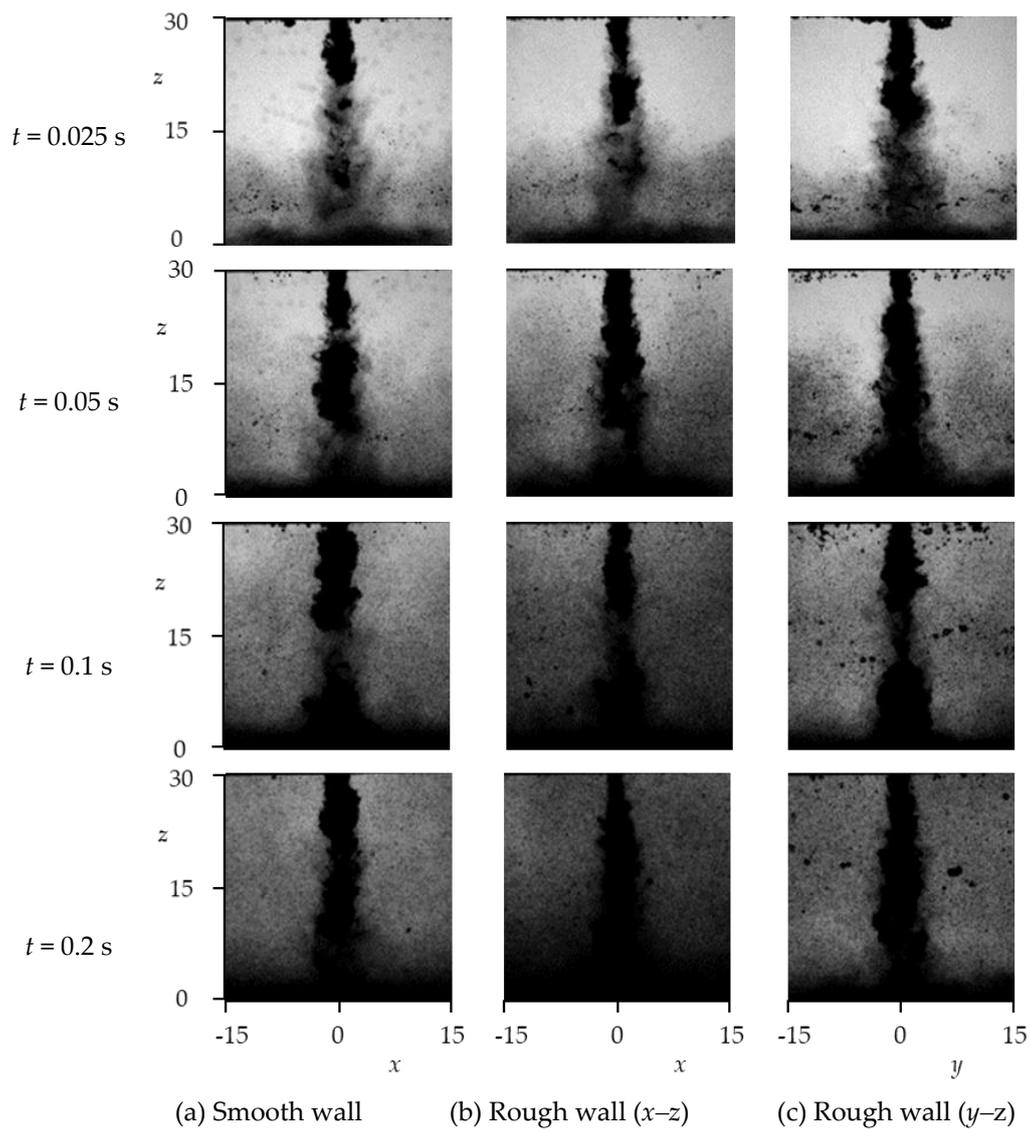
Figure 8a–c shows the shadowgraph images of the cavitating jet impinging on the smooth wall (Figure 8a) and rough wall (Figure 8b,c, respectively) for several times  $t$  after the start of cavitating-jet injection. The image size covers  $30 \times 30$  mm<sup>2</sup> of the flow field of the cavitating jet, and the upper and lower edges of the image correspond to the nozzle exit and wall, respectively. The rough wall images show the observations along the grooves (Figure 8b) and across the grooves (Figure 8c), which correspond to the flow field observations in the  $x$ - $z$  and  $y$ - $z$  planes, respectively, where  $z$  is a vertical coordinate perpendicular to the wall. These images show that the periodic behavior of the cavitating jet was observed along the shear layer of the jet followed by the impingement and spreading of the jet in the radial direction. The cavitating jet is well visible in the images, owing to the blocked illumination by the cavitation bubbles spreading over the shear layer of the jet [16]. These observations of the cavitating jet are almost independent of the groove roughness. With increasing time  $t$ , the shadowgraph images become dark because of the increased number of cavitation bubbles, which blocks the inline illumination. Therefore, the dark area starts around the test specimen in the initial periods and spreads to the region near the nozzle with increasing time. The detailed examination of shadowgraph images on smooth and rough walls in the  $x$ - $z$  and  $y$ - $z$  planes indicates that the growth rate of the number of cavitation bubbles is larger along the grooves than across the grooves. These results indicate that the erosion behavior owing to bubble collapse is more widely distributed along the grooves than across the grooves, which is consistent with the erosion behavior observed on the rough wall in Figure 4b,c. The growth rate of the number of cavitation bubbles on the smooth wall lies between those along and across the grooves.

**Figure 8.** Shadowgraph images of cavitating jet (unit in mm). (a) Smooth wall; (b) Rough wall ( $x-z$ ); (c) Rough wall ( $y-z$ ).

the flow observations of groove roughness in the  $x-z$  and  $y-z$  planes, respectively. These images show that the shockwave formation occurs near the wall independent of the groove roughness. Shockwaves were generated near the walls and resulted in semispherical intensity distributions over the walls. Shockwave formation near the wall can generate impulsive forces on the walls, independent of the roughness. However, the impulsive forces can be highly magnified on the groove bottom of the rough wall owing to the shockwave focusing effect. This may result in increased impulsive forces on the groove bottom [37,38]. As a result, pit formation was highly amplified in the groove bottom, which grew into large pits, as observed in the SEM images in Figure 7b–e. This can be the mechanism of the increased erosion rate of the cavitating jet on the groove bottom. These schlieren images show that the mean intensity of the images decreases with increasing time, and the rate of decrease is higher on the rough wall along the grooves than across the grooves, whereas, for smooth wall, the rate is located between those observed for rough walls. This is similar to the observations of shadowgraph images in Figure 8.

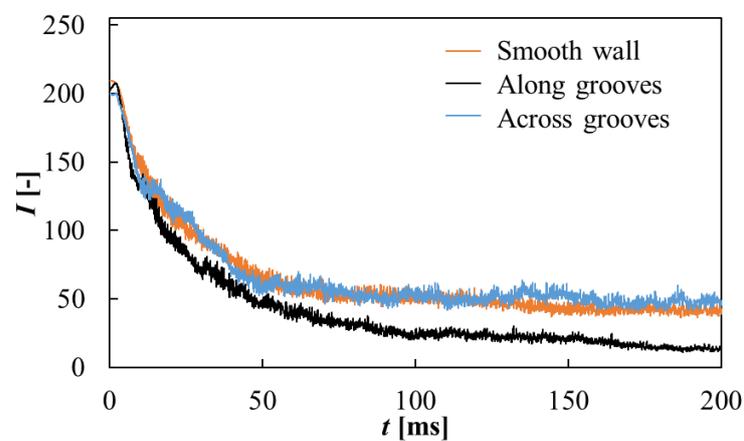
**Figure 9.** Time-variations of shadowgraph image intensities.

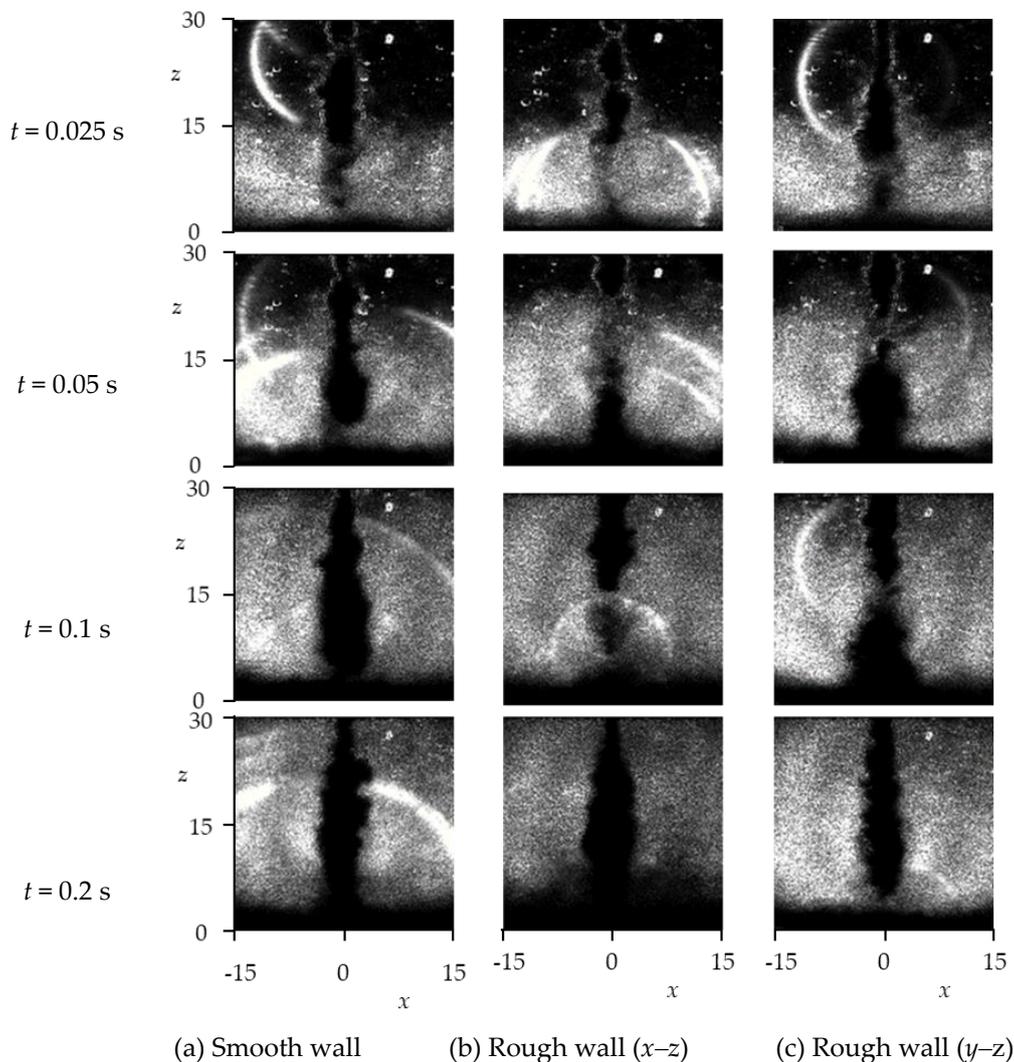
Figure 10a–c shows the schlieren images of the cavitating jet on the smooth wall (Figure 10a) and rough walls (Figure 10b,c), respectively. The images (Figure 10b,c) show

**Figure 10.** Schlieren images of cavitating jet (unit in mm). (a) Smooth wall; (b) Rough wall ( $x-z$ ); (c) Rough wall ( $y-z$ ).

Figure 11a–c shows time-variations of schlieren image intensities on the smooth wall (Figure 11a) and rough walls (Figure 11b,c), respectively. It should be noted that  $I'$  is the fluctuating intensity averaged over the image, and the results are shown for 20 ms starting from  $t = 0.1$  s of schlieren images in Figure 10. These results indicate that the appearance of shockwave formation generates high-intensity spikes near the wall, and they occur

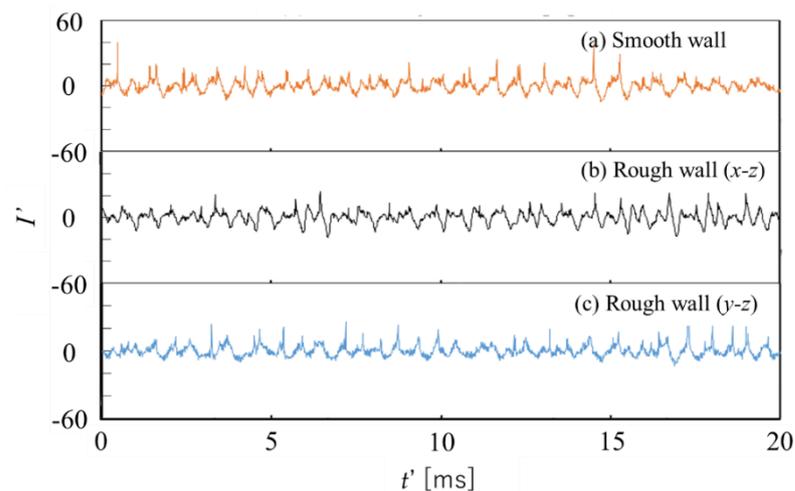
almost periodically with an average period of 0.6 ms (1600 Hz), which is independent of the wall roughness. It was found that there is no clear difference in the average frequency of high-intensity spikes on the smooth and rough walls. Furthermore, the experimental results indicate that the fluctuating intensities of the shockwave formation do not change with the groove roughness. Thus, the increased erosion mechanism of the cavitating jet along the groove roughness was caused by the increased number of cavitation bubbles along the grooves, which is consistent with the shadowgraph observations of the cavitating jet. This may result in increased pits formation on the groove bottom arising from the shockwave focusing effect.

**Figure 11.** Time-variations of schlieren image intensities in cavitating jet. (a) Smooth wall; (b) Rough wall ( $x$ - $z$ ); (c) Rough wall ( $y$ - $z$ ).
