Delaying Effect of Fatigue Crack Propagation by Single-Pulse Laser Irradiation [†]

Abstract: In this study, a single-pulse laser technique was applied to repair the cracked plate. The idea of this technique is based on delaying fatigue crack propagation by irradiating the area ahead of the crack tip by using a single-pulse laser with a high power of 1500 W. In order to verify the capability of this technique, fatigue tests were conducted on specimens with a hole on the center to induce fatigue cracks at the edge of the hole. A single-pulse laser irradiation was then applied ahead of this natural crack tip, and fatigue tests were subsequently conducted. The fatigue crack propagation behavior was monitored during cycling loading by using a digital microscope. It was confirmed that the crack irradiated by a pulse-laser is not almost progressed or is deflected around the irradiated area in subsequent cyclic loading after the repairing treatment, which means that the pulse laser technique could be located as an alternative to existing repairing techniques.

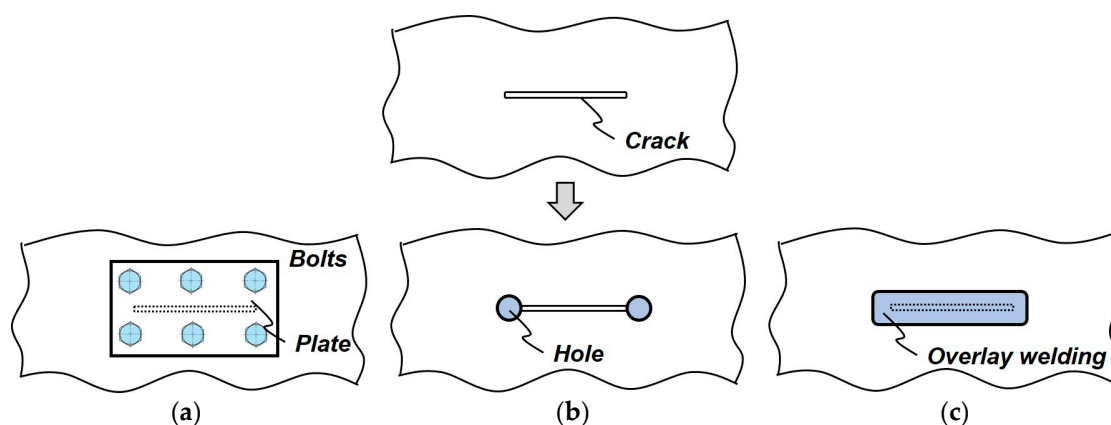
Figure 1. Current repair techniques used on damaged components. (a) Plate patching method; (b) Stop-hole method; (c) Overlay welding method.

The enormous infrastructure facilities in Japan, built during the period of rapid economic growth that lasted approximately 19 years beginning in 1954, have reached the end of their design life. Therefore, these degraded infrastructure components must be repaired to maintain reliability in the long term. There are established techniques to repair degraded parts: (i) the plate patching method to cover the cracked part [1]; (ii) the stop-hole method to delay crack propagation by drilling a hole ahead of the crack tip [2]; and (iii) the overlay welding and thermal spraying method [3,4], as shown in Figure 1.

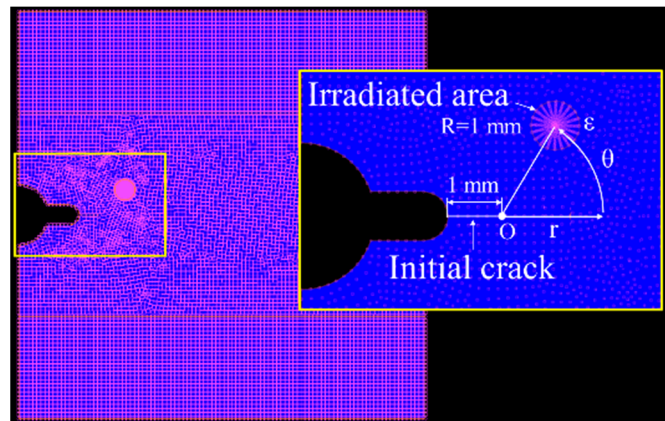
A finite element (FE) analysis was conducted using commercial software MARC 2010 (MSC. Software Corporation, Tokyo, Japan). The FE model is illustrated in Figure 2. As the model is symmetric, only the right half of the elastic plate was considered for FE analysis.

This model has a pre-crack with a length of 1 mm from the edge of the circular hole, and a circular hole of 1 mm (representing the laser pulse) located ahead of the tip of pre-crack along an arc of radius r (as shown in inset). A local coordinate system (r, θ) was used to examine the influence of the location of the press-fitted plug of radius $R + \varepsilon$ on the fatigue crack propagation.

Figure 2. Finite element (FE) model.

The FE analysis was conducted under a plane stress condition; the Young's modulus of 236 GPa, and a Poisson's ratio of 0.3 were assumed. The fatigue loading was applied at the upper edge of the model. The fatigue loading was as follows: a maximum tensile load of 3750 N, a minimum load of 0 N, and a cyclic frequency 3 Hz. The fatigue crack propagation was simulated with the virtual crack closure technique (VCCT) option installed in MARC. Paris's law parameters used for fatigue propagation were $C = 5.48 \times 10^{-14}$ and $m = 3.26$.

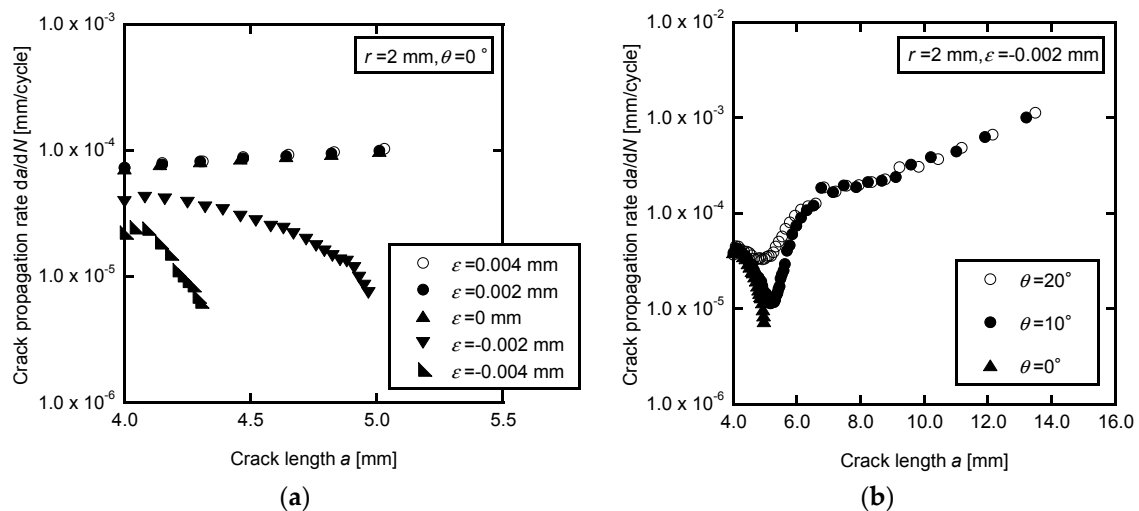
Figure 3 indicates the relationship between crack length a and crack propagation rate da/dN . Figure 3a is the result for the laser irradiation location of $r = 2$ mm and $\theta = 0^\circ$. It is apparent that a negative ϵ , that is the plug radius being smaller than that of the circular hole, dramatically reduces the crack propagation rate, indicating that compressive residual stresses formed around the press-fit area are very effective in delaying fatigue crack propagation. A zero or positive ϵ on the other hand does not seem to influence the crack propagation rate.

Figure 3b indicates the crack propagation rate for the laser irradiation location of $r = 2$ mm and $\epsilon = -0.002$ mm. This result reveals that the crack propagation rate increases as angle θ increases for a laser irradiation location off the crack plane axis.

Figure 3. Relationship between crack length a and crack propagation rate da/dN simulated by finite element analysis. (a) Case: $r = 2$ mm and $\theta = 0^\circ$; (b) Case: $r = 2$ mm and $\epsilon = -0.002$.

Therefore, a delaying effect due to laser irradiation can be achieved by: (i) formation of compressive residual stresses around the irradiation area and (ii) irradiating close to the crack tip on the crack plane axis.

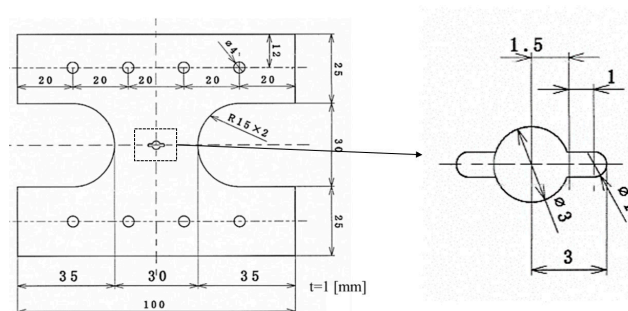
A type 304 stainless steel plate was cut as the required specimen geometry (Figure 4) with a hole at the center with the following dimensions: plate thickness: 1 mm, testing area: 30×30 mm and hole diameter: 3.0 mm. Fatigue tests were performed using the servo pulser (EHF-EB50kN-20L, Shimadzu, Kyoto, Japan) under a cyclic load-controlled condition (maximum load: 7500 N, minimum load: 0 N and frequency: 3 Hz). The crack propagation process was monitored using a digital microscope

Figure 4. Specimen geometry used for fatigue test.

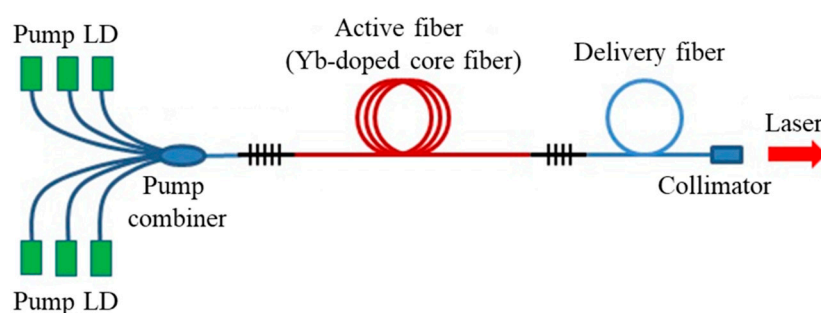
(ARTRAY, Tokyo, Japan). When the crack length reached approximately 1.0 mm, a single-pulse laser with a spot diameter of approximately 1.0 mm was aimed at the area ahead of the crack tip. Single-pulse laser was irradiated by on/off control of a continuous wave (CW) fiber laser. The CW fiber laser system is illustrated in Figure 5.

The laser system utilized in this study has a maximum power of 1500 W. In this study, the following laser parameters were used: power of 675 W and ON TIME of 0.02 s.

Figure 5. Configuration of fiber laser system utilized in this study.

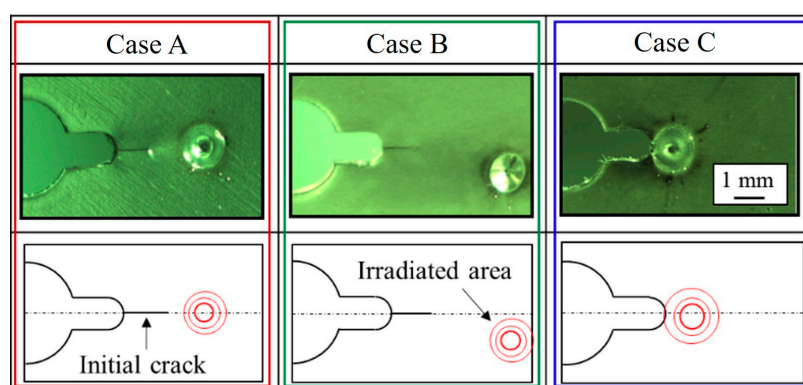
The irradiation distance from the crack tip was varied as shown in Figure 6. After laser irradiation, fatigue tests were conducted. The fatigue crack propagation rates of both irradiated and non-irradiated specimens were compared under identical test conditions to deduce the effect of irradiation.

Figure 6. Pulsed laser irradiation positions.

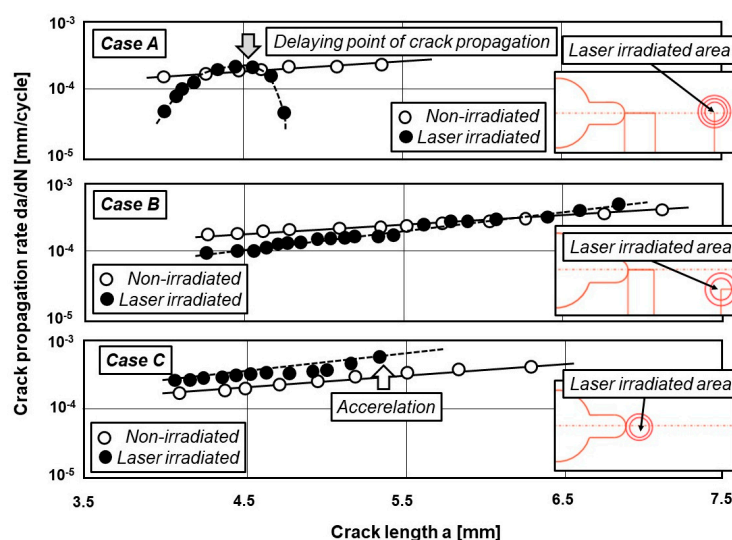
Figure 7 indicates the plot of the fatigue crack propagation rate (da/dN) vs. the crack length (a). The open circles represent the propagation rate of the non-irradiated specimen, and the solid circles represent the single-pulse laser irradiated specimen. The single-pulse laser irradiated positions were ahead of the crack tip (case A), slightly below and ahead of the crack tip (case B), and on the crack tip

itself (case C). In case B, the fatigue crack propagation rate is almost the same as that of the non-irradiated specimen, meaning that single-pulse laser irradiation has no effect when applied at this position. When the crack tip itself is irradiated by the single-pulse laser (case C), the crack propagation rate is slightly increased, from which we may conclude that the irradiation caused a brittle fracture. On the other hand, it is clear that case A is very effective in reducing the crack propagation rate. It is presumed that the formation of residual stresses around the laser-irradiated area strongly affected the crack propagation behavior. Consequently, the most suitable position for laser irradiation was area close to the tip of fatigue crack on the crack plane.

Figure 7. Effect of pulse laser irradiation location on fatigue crack propagation rate.
