# Evaluation of Fracture Process in Concrete by Means of Acoustic Approaches <sup>†</sup>

† Presented at the 18th International Conference on Experimental Mechanics (ICEM18), Brussels, Belgium, 1–5 July 2018.

**Keywords:** concrete; wheel loads; acoustic approaches; fatigue failure; fracture process

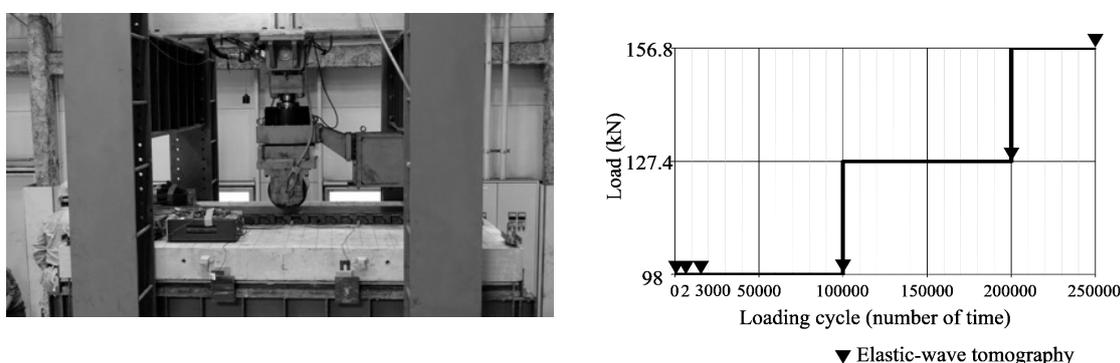
Figure 1. Wheel loading apparatus (left) and load application program (right).

In order to simulate the cracks observed in the slabs due to fatigue, repeated loading with a steel wheel was conducted. As shown in Figure 1, a foundation put on the slab was cyclically moved in a lateral direction, which is different from the wheel-loading apparatus installed in a movable loading-wheel [3]. In the apparatus, a steel wheel with a diameter of 300 mm and a width of 400 mm can be loaded up to 250 kN in the case of repeated lateral loading and 534 kN in the case of static vertical loading. The foundation can move horizontally from ±500 mm to ±1000 mm. In the experiment, the motion of ±500 mm and the repeat rate of 8.97 rpm were applied. Here, step-wise cyclic loadings were employed, as shown in Figure 1. In the first steps, the load of 98 kN was repeatedly applied up to 100,000 times. In the second step, the load of 127.4 kN was applied up to 200,000 times. Then, the third step loading was conducted up to 250,000 times with 156.8 kN load, where the fatigue limit of the specimen was estimated to be 235,000 loading times.

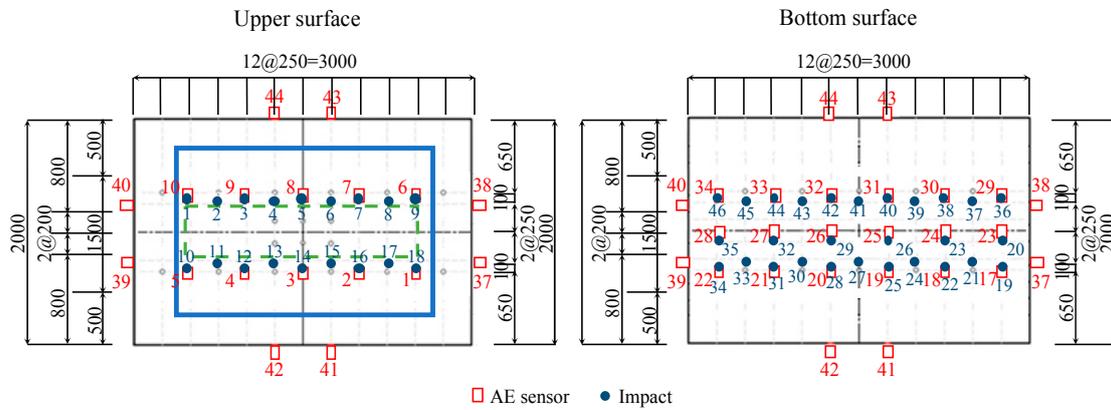
**Figure 2.** Locations of AE (Acoustic Emission) sensors and excitation points denoted by red squares and blue circles, respectively.

The arrangement of AE sensors and excitation locations is depicted in Figure 2. Thirty-six AE sensors of 60 kHz resonance were arranged on the specimen, namely 10 for the top, 18 for the bottom, and eight for the sides. For elastic wave tomography, excitations were made by a 35-mm diameter steel ball for 18 points on the top, so as to avoid the loading area depicted by the green broken rectangle, and 28 points on the bottom. The measurement of elastic wave excitations was conducted six times: before loading, after 2, after 3000, after 100,000, and after 200,000 load applications, as well

as after failure. Detected signals by the sensors were amplified by 40 dB by a preamplifier and acquired by a 48-channel Express-8 monitoring system (Physical Acoustics Corp) with a 1-MHz sampling rate. Seventeen displacement-meters were set on the bottom. Seven electric strain gauges for detecting the vertical deformation were embedded inside the concrete.

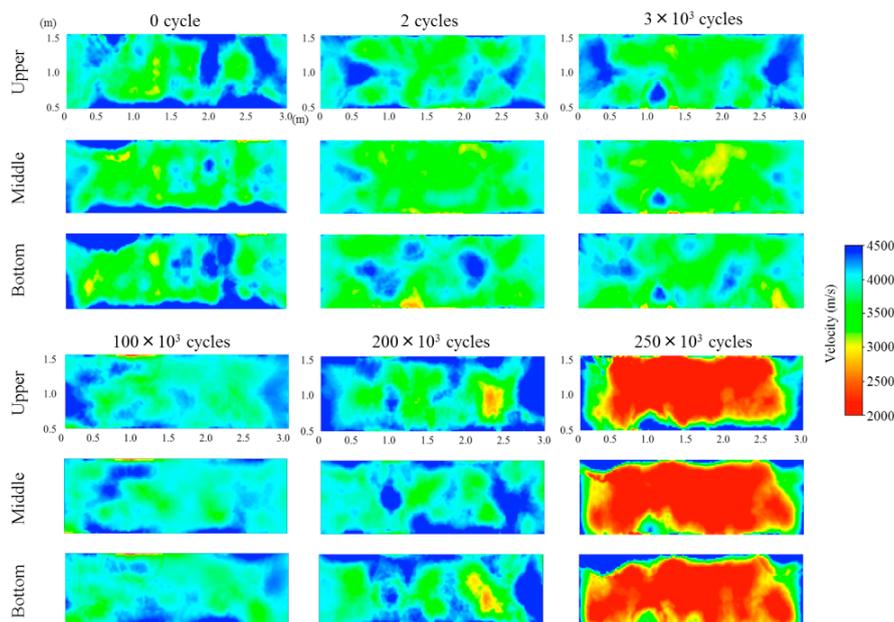
**Figure 3.** Three-dimensional (3D) velocity distributions of the slab in each cycle under the dry condition.

Contour maps of the distributions of the velocities are shown in Figure 3. Prior to the experiment, the velocity zones of approximately 3500 m/s were widely observed and a relatively-low velocity zone (about 3000 to 3500 m/s) was identified in a lattice pattern. This lattice pattern might be attributed to the sensor cable arrangements in the concrete slab [6]. After two loading cycles, the relatively-low velocity area toward the center of slab, which might represent the punching-shear damage of the concrete slab due to wheel loading, as shown in Figure 4, appeared due to the lattice pattern. The situations were similar after 3000 and 100,000 cycles. However, after 200,000 cycles, the zone of the velocities lower than 2700 m/s was identified at a distance of 2.3 m in the axial direction. After 250,000 cycles, which included cycles beyond the fatigue limit, the zones of the velocities lower than 2500 m/s were widely spread over the concrete slab. From Figure 3, the trend of decreasing velocities was observed to be dominant after 250,000 cycles. It was found that the velocity

distributions showed minor variations up to 100,000 cycles, while the generation of low-velocity zones was initiated after 200,000 cycles, leading to the fatigue limit before 250,000 cycles.

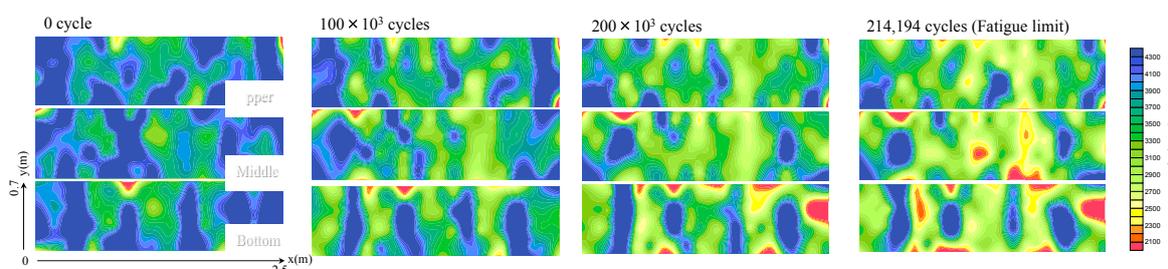
Figure 5. 3D velocity distributions of the slab in the case allowing water infiltration.

Velocity distributions based on three-dimensional elastic wave tomography were obtained before loading, after 100,000 and 200,000 load repetitions, and after failure. The area of analysis was divided into  $6 \times 22 \times 3$  cells, with a focus on the central area of  $0.7 \times 2.5 \times 0.16$  m, as shown in Figure 5. Reliable elastic wave signals, which have DD (The degree of the certainty)-value [9] of more than 0.05 [10], were involved in the tomography analysis. Tomograms of each load steps are shown in Figure 5. In the case before loading (see 0 cycles), areas of a slightly small velocity of 3300 m/s were obtained, whereas the overall velocity was 4400m/s, and therefore the specimen appeared to be intact at this moment. After 100,000 cycles, the areas of small velocities less than 3000 m/s became more distinct and continuously emerged in the transversal direction, resulting in an average velocity of 4000 m/s. After 200,000 cycles, areas of small velocities less than 3000 m/s were widely spread over the area of interest, and damaged areas, as indicated by velocities less than 2700 m/s, according to our past paper [6], were observed both in the middle and the bottom layers. As areas demonstrating large velocities of more than 4000 m/s still remained in places at this step, this appeared to be the stage at which damaged and intact areas are mixed. At this stage the average velocity was 3800 m/s. After the fatigue limit, further damaged areas were spread widely over the area of interest. The damage was more obvious for the middle and the bottom layers than the top layer; however, the average velocity was 3700 m/s, showing a very small difference from the average velocity of 3800 m/s in the previous step. In consideration of the velocity decrease with steps as well as specific distributions of small velocity, it is implied that the damage is only generated at the specific areas.

As shown in Figure 5, the fatigue damage process can be reasonably evaluated by the tomograms, specifically for the middle and bottom layers; however, an expected aggregation area, which developed in the upper region at the fatigue limit cycles, was not well assessed because the area beneath the load area had an insufficient density of wave paths, and therefore the AE sources obtained during the static load application were utilized in addition to the data derived from elastic wave tomography. As in Figure 7, different tomograms of upper and middle layers were obtained from sources only evaluated by elastic wave tomography (see Figure 5), suggesting the realistic result of tomograms in these areas. Although direct comparison with Figure 5 cannot be carried out because of the difference of analytical resolution, the trend of a small velocity in the bottom and a developing transversal direction of damage is almost identical to that of Figure 5. Hereafter, transversal sections denoted as A to D in Figure 13 are elucidated by corresponding images, as shown in Figure 7 right. From Figure 7, near agreement was found between the low velocity area and the corresponding area of damage indicated in the photos, e.g., in section B of Figure 7 right, extraordinary aggregation can be observed in the boundary between the upper and middle layer, and moreover diagonally developed cracks heading to the bottom are distinctly observed. In addition, the cracks lay more in the left side—namely, the area of 0–0.325 m in section B. Surprisingly, these crack conditions correspond relatively well to the concentrated damage areas evaluated by the tomogram in section B of Figure 7 left (see 0–0.325 m in section Y). Through the comparison between sectional observations and corresponding tomograms, it can be concluded that the location of aggregation can be reasonably estimated by velocities smaller than 2300 m/s, which are obtained using tomography with a sufficient density of wave/ray paths. For in situ bridge deck evaluation, when sufficient AE sources are

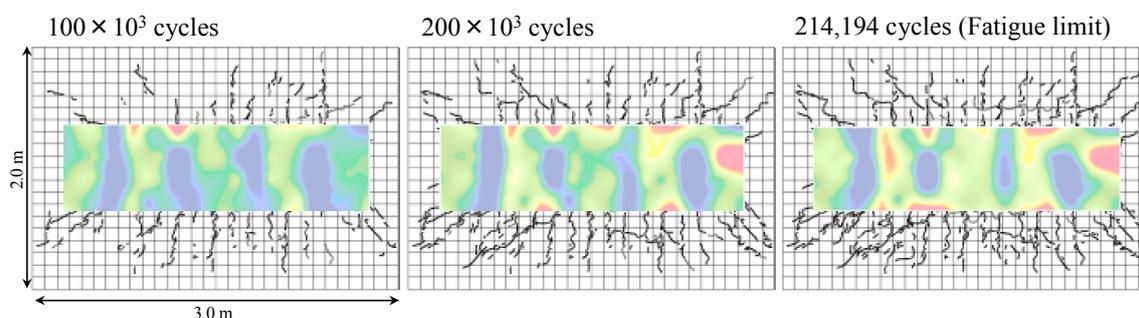
Figure 6. Crack traces on the bottom surface overlaid with tomograms.

In Figure 6, crack traces overlaid with tomograms are exhibited for each case. Transversal cracks were developed first, namely at 100,000 cycles, then evolved in the same direction, finally forming a

cell-like pattern. As for the tomograms, they were enlarged horizontally/longitudinally from each veridical/transversal smaller velocity area, which were initially developed in 100,000 cycles. Note that the number of cycles (equivalent cycles of 98 kN loading) showing the final fatigue limit was 17,025,097 in the dry condition and 8,654,440 in the water-filled condition; under the water-filled condition, the fatigue strength becomes half that of the dry condition. This suggests that water infiltrating into the initially developed cracks evidently enhances or accelerates the fatigue damage evolution. The transversal cracks and their lateral expansion as well as the same trend of tomograms agree well with this conclusion.

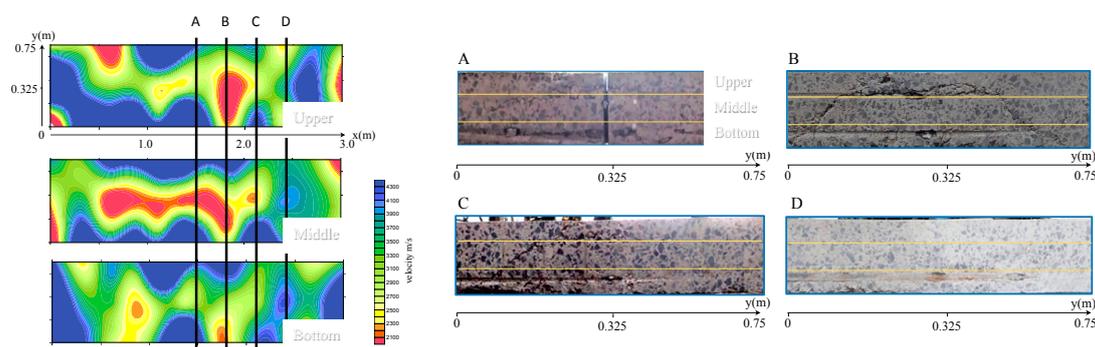
**Figure 7.** Tomograms combined with AE activity and sectional photos (A–D) after failure.
