# Monitoring the Prestressed Rods in the Basel Border Bridge Maintenance Project: Data Analysis during the Passage of Trucks

Harald Schuler and Florian Meier \*

**Abstract:** More than 40 years ago, the expansion joints on the Basel border bridge were constructed using corbels and dapped ends. The consoles had to be reinforced as part of the renovation measures due to damage caused by chloride entry and due to the increased loads. Diagonal rods, which were prestressed, were used. Fiber-optic sensors were additionally installed to these highly stressed rods in order to measure the strains and temperatures. This now makes it possible to measure the actual strains in the strengthening of the corbel, estimate fatigue loads, and set up a warning system in case of overstressing. This article presents the design of the measurement system and the analysis of the data. Furthermore, the reference measurements that can establish the relationship between the measured strains and the loads passed over are presented.

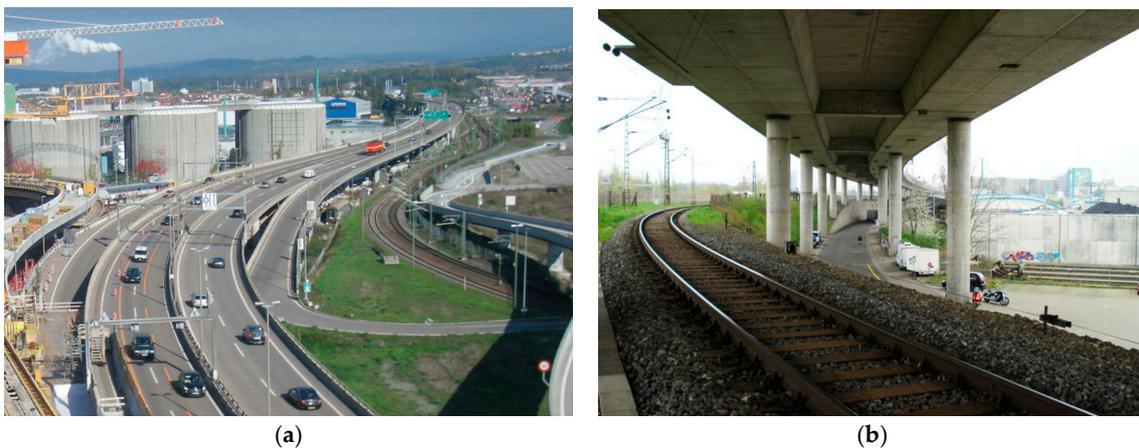
Figure 1. Basel border bridge: (a) view from above; (b) view from below.

Motorway 2 (A2) is one of the busiest north–south traffic axes in Switzerland. It runs from the Italian border at Chiasso through the Gotthard to Basel and connects to the German Autobahn 5 (A5) at the German–Swiss border. In this area, it is routed for a length of 1480 m over the Basel border bridge, of which approx. 950 m is on Swiss territory (Figure 1) and 530 m on German territory. The bridge consists of 42 spans. Figure 2 shows a longitudinal section of one span and the cross-section. The width is about 11 m in

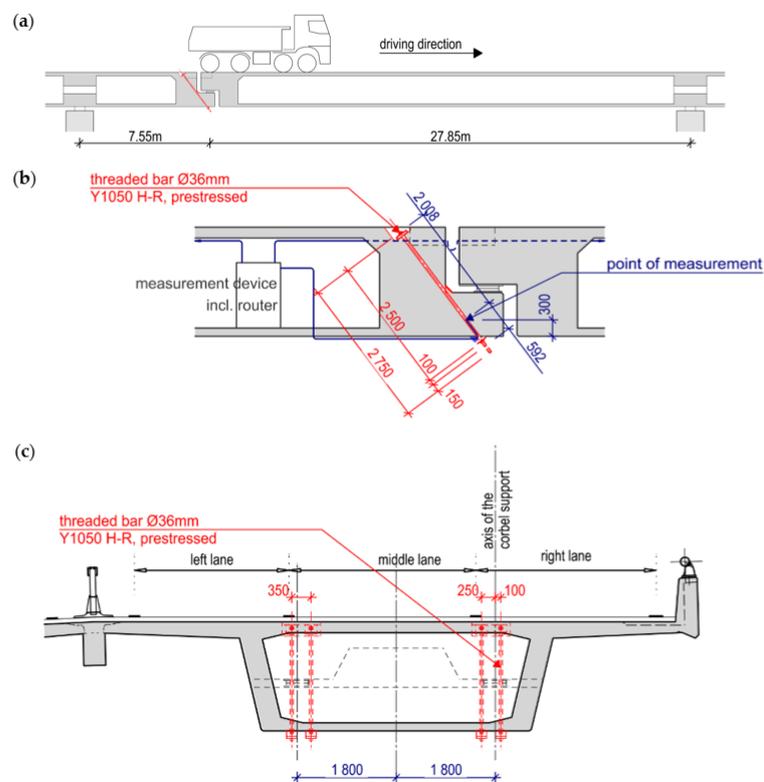
Figure 2. (a) One span which includes a Gerber hinge; (b) Reinforcement measure with a prestressed threaded rod; (c) cross-section of one direction of travel.

The Gerber joints consist of a corbel in the supporting element and a dapped end in the overlying element (Figure 2a,b). In between, there are two bridge supports per box girder. The two supports have a lateral distance of 3.6 m (Figure 2c). In order to increase the insufficient load-bearing capacity of the corbels, two DYWIDAG tension rods ( $\varnothing 36$  mm, Y1050) were installed and prestressed at each support. In the transverse direction, the two rods are close to the supports, so that the force on the corbel is transmitted almost directly to the rods. Figure 2 shows the retrofitted tension rods in red and the position where the sensors are placed. During the insertion of the rods into the borehole, extreme caution was necessary to avoid damaging the sensors. The protection measures for the sensors and the prestressing of the rods are described in [7].

This rule applies to the Gerber joint C and for trucks driving in the right lane (see Figure 2c). For trucks in the middle lane, the amplitude is about half as large, and in the left lane, no deflection is expected when a truck passes the measuring point.

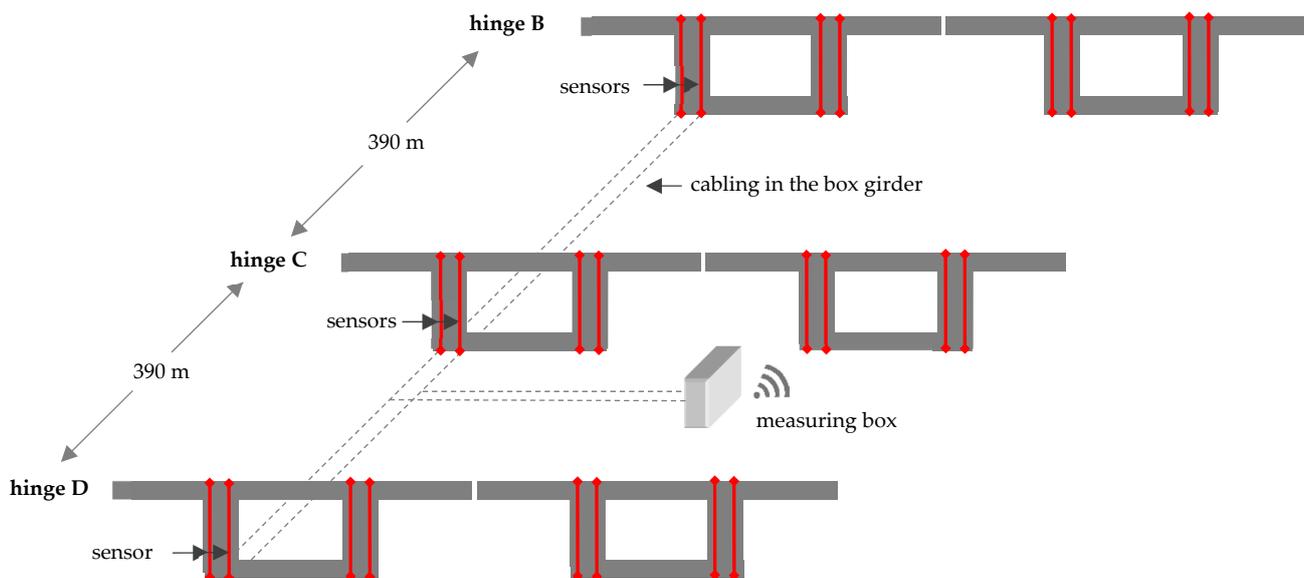
Figure 3. Set-up of the strain and temperature measurement.

In this section, the measurement set-up along the Basel border bridge is explained. As mentioned in the previous section, the Gerber joints with a corbel and a dapped end are located in every eleventh span. The distance between these expansion joints is 390 m. As Figure 3 shows, only two of eight rods are instrumented at each expansion joint. The sensors are located on the side where the slow lane for the trucks is planned. The bars on this side are the most stressed. The fiber-optic cables are laid in the girder box along the longitudinal direction and merge in the measuring box at the Gerber joint C. The fiber optical measurement system was installed by Marmota Engineering AG. A HYPERION si155 from Luna Innovations (former Micron Optics) was used as interrogator, combined with (os1100) strain and (os4300) temperature sensors also from Luna Inc. The theoretical accuracy of the installed Systems is about  $1 \mu\epsilon$  resp.  $0.1 \text{ }^\circ\text{C}$ . The thermo-optic compensation as well as the referencing was applied according to state-of-the-art and best practice. Further information on fiber optical measurements can be found in [8,9]. In total, six rods are instrumented with four strain sensors, and two temperature sensors each. Two of each are arranged opposite each other. This means that bending stresses can also be estimated. The deviation of the strains between sides A and B was less than 20%. Figure 4a,b shows the application and position of the strain and temperature sensors. Not all sensors provide plausible results. About 10% failed and 30% produced unrealistic results. The reason could be damage to the sensor or the adhesive during insertion of the rod into the borehole (Figure 4c) or during injection of the grout.

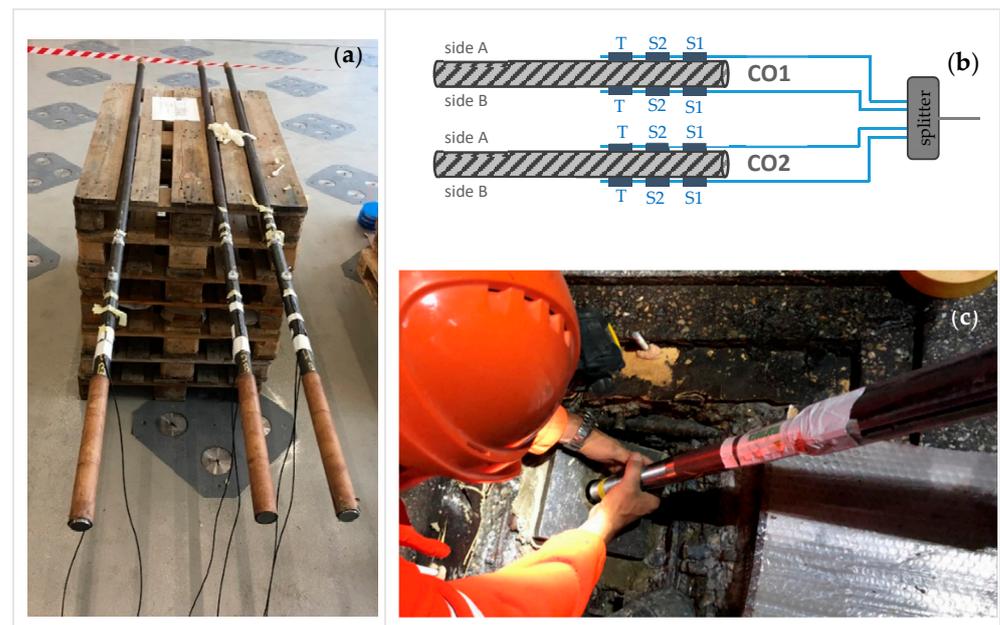
**Figure 4.** (a) Assembling of the optical sensors in the laboratory; (b) location of the strain (S) and temperature (T) sensors at each Gerber hinge, here, hinge C; (c) inserting a rod into the borehole.

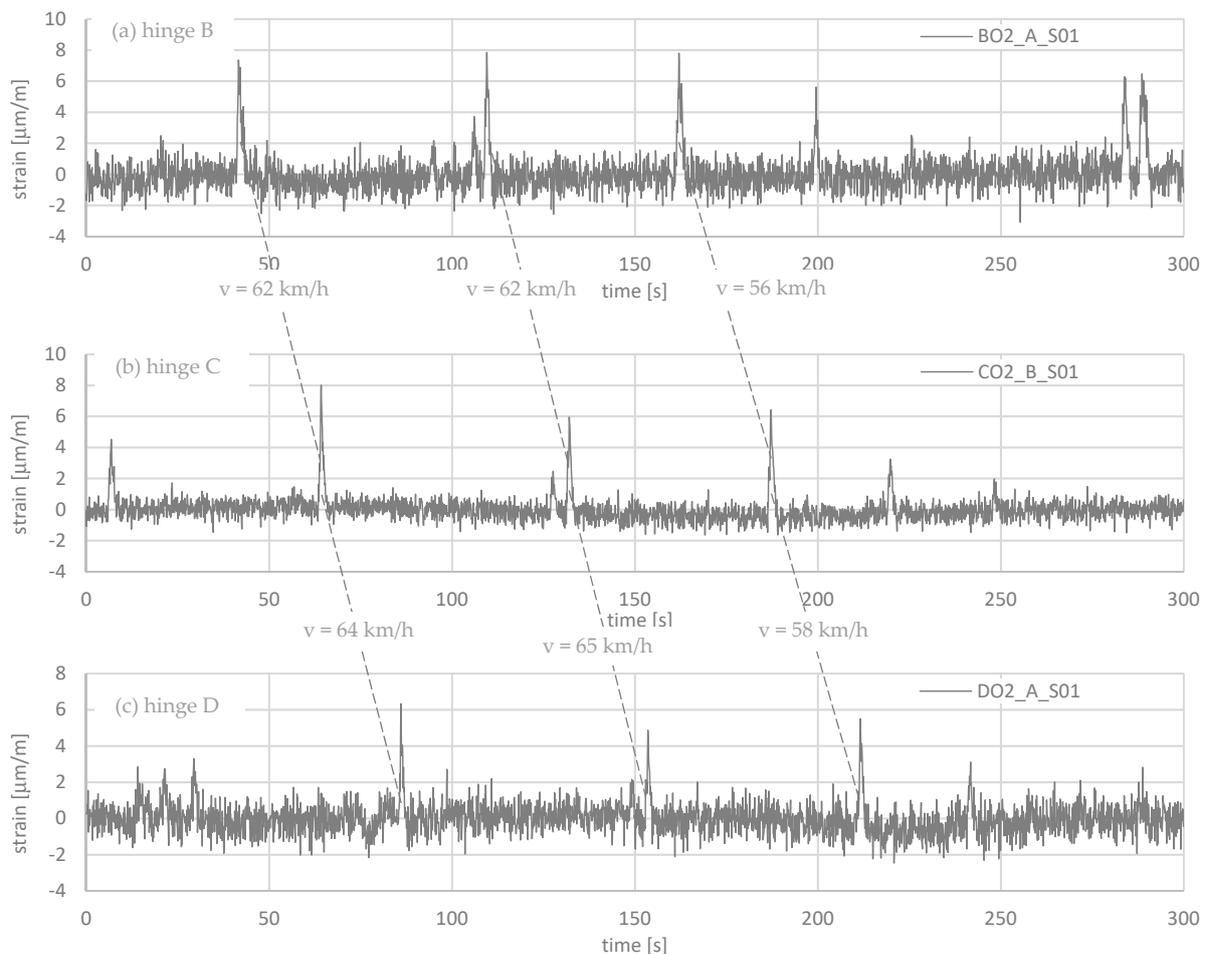
**Figure 5.** Strain measurement over a period of 5 min with a sampling rate of 1/10 s: (a) Gerber hinge B; (b) Gerber hinge C; (c) Gerber hinge D. The distance between the Gerber hinges is 390 m.

1.0 s. With a length from the Gerber joint to the next support (27.85 m) and an estimated velocity (16.7 m/s = 60 km/h cp; Figure 5), the load duration for a passing truck can be calculated roughly:  $t = 27.85 \text{ m}/16.7 \text{ m/s} = 1.7 \text{ s}$ . This corresponds quite well to the measured duration in Figure 7. As can be seen, for lower sampling rates of 0.5 and 1.0 s, the course flattens, and the duration becomes larger. Hence, to capture the duration precisely, the recording must be obtained every 0.2 s or more often.

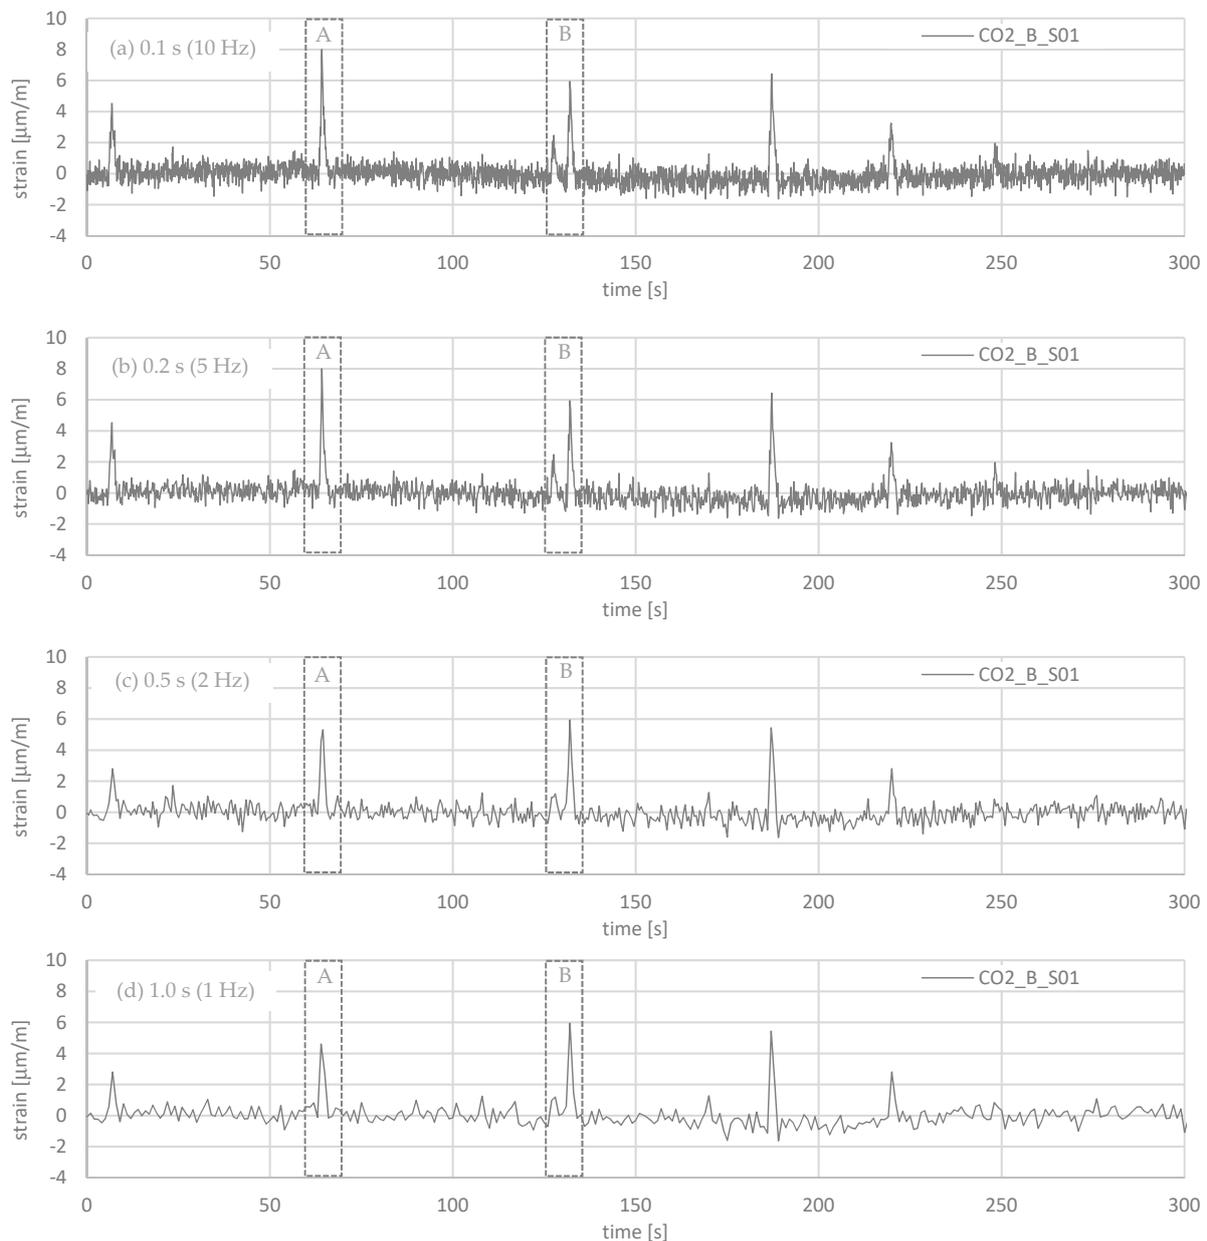
**Figure 6.** Influence of the sampling rate to the strain measurement over a period of 5 min at Gerber hinge C: (a) 0.1 s (10 Hz); (b) 0.2 s (5 Hz); (c) 0.5 s (2 Hz); (d) 1.0 s (1 Hz).

The influence of the sampling rate to the recorded signals was studied at Gerber joint C. Four sampling rates were considered: 0.1 s (10 Hz), 0.2 s (5 Hz), 0.5 s (2 Hz), and 1.0 s

(1 Hz). As Figure 6a,b shows, a sampling rate of 0.2 s can reproduce the amplitude of the signals almost as well as a sampling rate of 0.1 s. As Figure 6c,d shows, for sampling rates of 0.5 and 1.0 s, the amplitudes are reduced significantly. Hence, a precise measurement of the strains is not possible with these sampling rates. To study this more precisely, a shorter period is considered.

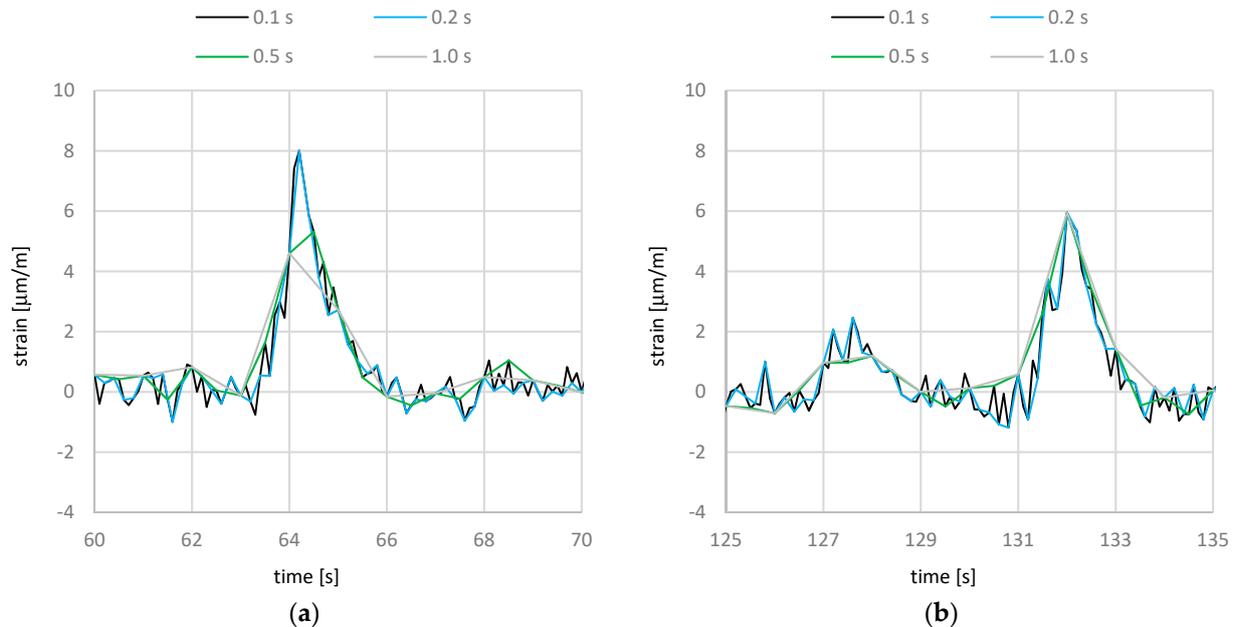
**Figure 7.** Influence of the sampling rate to the strain measurement over a duration of 10 s at Gerber hinge C: (a) time period A from Figure 6; (b) time period B from Figure 6.

Considering a duration of 10 s (Figure 7), the influence of the sampling rate on the recording could be analyzed precisely. As expected from the previous figure, the difference between a sampling rate of 0.1 and 0.2 s is small (cp. Figure 7). For 0.1 s, the oscillations are more pronounced, which results, however, mainly from the measurement. The measurements with sampling rates of 0.5 and 1.0 s are not precise enough to capture the course and the amplitude of the strain measurements in the rods. Compared to the sampling rate with 0.1 s, the amplitude is less than 70% for 0.5 s and less than 60% for

A comparison of the amplitude in normal operation in Figure 7a with the amplitude of the 40 ton truck in the reference measurements in Figure 9 shows a higher value of about 7% ( $8 \mu\text{m/m}/7.5 \mu\text{m/m} = 1.07$ ). Assuming that the permissible total mass of 40

tons was not exceeded in Figure 7a, a dynamic increase can be assumed. The difference in speed between normal operation and the reference measurements was 60 to 12 km/h. The observation of further amplitudes in normal operation, which are not shown in this publication, confirm a dynamic increase for higher speeds.

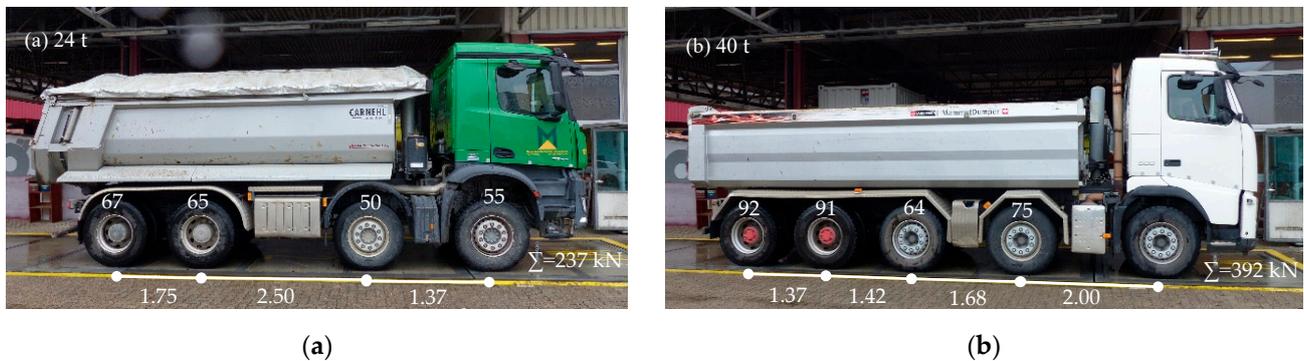
**Figure 8.** Axle loads (kN) and axle distances (m) of the trucks in the reference measurements: (a) truck with a total mass of 24 t; (b) truck with a total mass of 40 t.

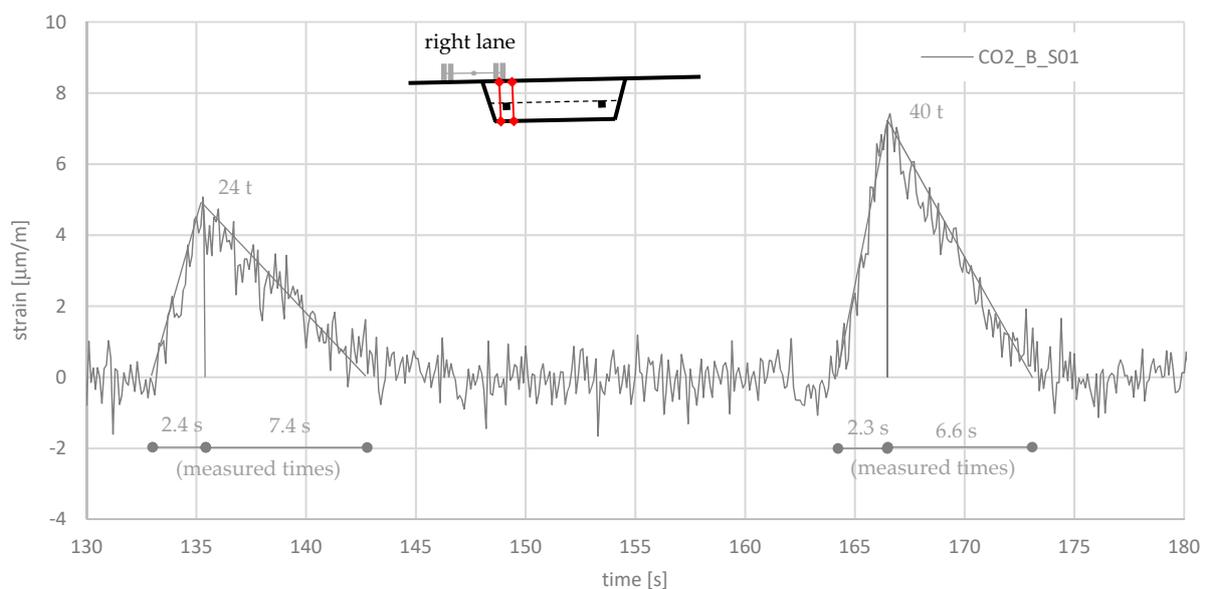
**Figure 9.** Strain measurement of the reference trucks, where after the 24 ton truck, the 40 ton truck followed.

The load introduction from a passing truck into the prestressed steel rods is complicated and almost impossible to recalculate. A simple approach with a truss model was tried in [7]. In order to obtain a correlation between passing truckloads and the measured strains, reference measurements were conducted. Therefore, two trucks with defined loads were driven over the bridge. The axle loads and axle distances were measured and are shown in Figure 8. The total mass of each trucks was 40 and 24 tons. The trucks were driven over the bridge with a velocity of about 12 km/h. Simultaneously, the strain was measured at the Gerber hinges. Figure 9 shows the measured strains at Gerber hinge C, where the 24 ton truck drove first and the 40 ton truck drove second. The difference in the strain measurements is clearly visible, although the amplitudes are very small ( $\leq 10 \mu\text{m/m}$ ). The ratio of the strain amplitudes,  $5/7.5 \mu\text{m/m} = 0.67$ , is almost equal to the ratio of the loads,  $24/40 \text{ t} = 0.6$ , which motivated us to use a linear relationship between loads and measured strains. We attempted to recalculate the shape of the measured signal. For the 24 ton truck with a length of 5.62 m, the rise time was  $5.62 \text{ m}/((12/3.6) \text{ m/s}) = 1.7 \text{ s}$ . For the 40 ton truck, the rise time was  $6.47 \text{ m}/((12/3.6) \text{ m/s}) = 1.9 \text{ s}$ . As Figure 9 shows, the measured rise times were slightly greater than the calculated one. For the descending branch, the calculated duration was for the 24 ton truck  $(27.85 \text{ m} - 5.62 \text{ m}/2)/((12/3.6) \text{ m/s}) = 7.5 \text{ s}$ . For the 40 ton truck, the duration was  $(27.85 \text{ m} - 6.47 \text{ m}/2)/(12/3.6 \text{ m/s}) = 7.4 \text{ s}$ . In summary, the measurement and calculation agreed quite well with each other (see Figure 9). The plausibility of the measurements can be confirmed by a simple calculation.
