# Investigation of Critical Geotechnical, Petrological and Mineralogical Parameters for Landslides in Deeply Weathered Dunite Rock (Medellín, Colombia)

**Abstract:** The current study site of the project Inform@Risk is located at a landslide prone area at the eastern slopes of the city of Medellín, Colombia, which are composed of the deeply weathered Medellín Dunite, an ultramafic Triassic rock. The dunite rock mass can be characterized by small-scale changes, which influence the landslide exposition to a major extent. Due to the main aim of the project, to establish a low-cost landslide early warning system (EWS) in this area, detailed field studies, drillings, laboratory and mineralogical tests were conducted. The results suggest that the dunite rock mass shows a high degree of serpentinization and is heavily weathered up to 50 m depth. The rock is permeated by pseudokarst, which was already found in other regions of this unit. Within the actual project, a hypothesis has for the first time been established, explaining the generation of the pseudokarst features caused by weathering and dissolution processes. These parameters result in a highly inhomogeneous rock mass and nearly n

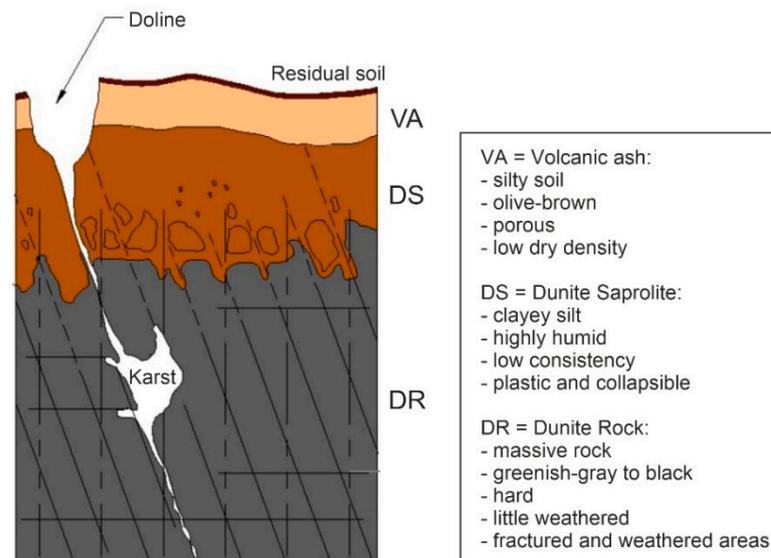
**Figure 2.** Idealized column profile of the Medellín Dunite with pseudokarst structures; dimensions are not given, because they vary to an evident extent [12] (after Figure 7.6).

continuously [13]. The higher the content of olivine in the rock (“pure” dunite), the stronger the weathering [14]. Therefore, the weathering highly depends on the specific petrological composition of the rock and can change within the Medellín Dunite. The typical weathering profile of the unit (Figure 2) consists of organic soil and volcanic ashes on the surface overlaying the saprolite deposits which show a decreasing weathering with increasing depth. This saprolite mostly consists of blocks of at least 50 cm in diameter in a silt-clay matrix with a ratio of approximately 1:1 (block-in-matrix structure). The content of loose material decreases with the depth. The depth of the top of the fractured dunite below the saprolite varies extremely within 0–20 m [12].

This simplified and idealized cross section is influenced by landslide processes taking place along the slope surface (uppermost 10 m), creating a further block-in-matrix structure which occurs to be similar to the one formed by weathering processes (Figure 2) [12].

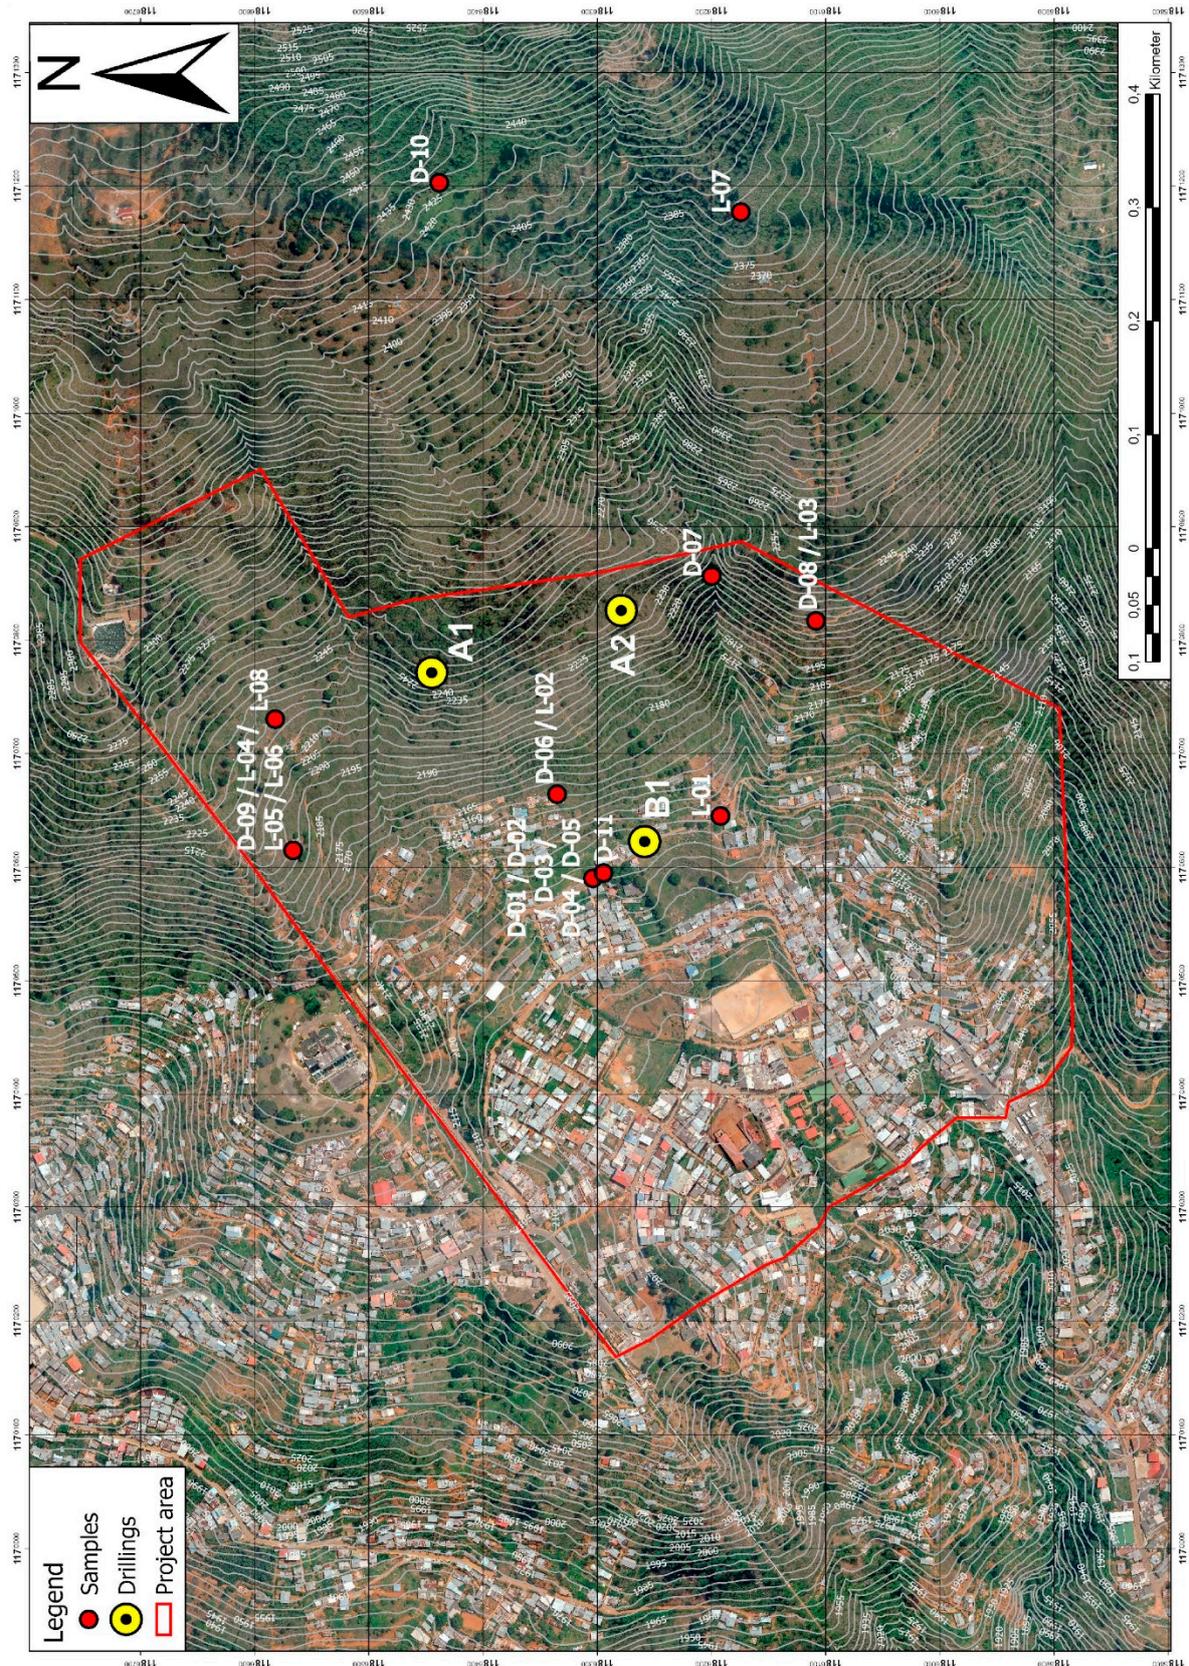
**Figure 3.** Map of the study site depicting the locations of the drilling and the sample locations (projected coordinate system: MAGNA Medellin Antioquia 2010).

The first drilling campaign was planned for May 2020. Due to the COVID-19-caused lockdown in both Germany and Colombia starting in March 2020, the drillings have been performed in October 2020. The three drilling locations can be seen in Figure 3. All drilling locations were chosen regarding the expected thickness of soil cover (at least 10 m) and their contribution to the early warning system with CSM cables, piezometers and inclinometers being installed after the drilling campaign [17]. A drilling depth of 30.4 m for A1, 30.3 m for A2 and 50.0 m for B1 could be achieved. Drilling B1 is one of the deepest drillings ever performed in the Medellín Dunite [15]. All drillings were performed using the double core rope drilling method without oriented cores. The inner diameter of drilling B1 is 101.6 mm, the inner diameter of the drillings A1 and A2 is 63.5 mm. The bigger diameter in drilling B1 was chosen to fit an inclinometer casing in the borehole in addition to two CSM cables and four piezometers. A1 and A2 do not include an inclinometer casing. All drilling cores were evaluated regarding the core loss, weathering profile, RQD [18], fracture ratio, joint sets and weathering type. Based on all these parameters, six homogeneous areas were established, which are described in Figures S1–S3. A second drilling campaign is planned for the first half of 2021 to complete the picture.

Further samples collected from the ground surface during the field investigation in August 2019 were examined mineralogically using X-ray diffraction on soil samples and petrographic thin section microscopy on collected rock samples. The X-ray diffraction was carried out on 8 samples using Cu-K $\alpha$  radiation and analyzed with graphs created with the software Profex 4.1.0, the microscopy was performed on 11 thin sections from 10 rock samples using a petrographic polarized light microscope. The locations of the sampling are shown in Figure 3.

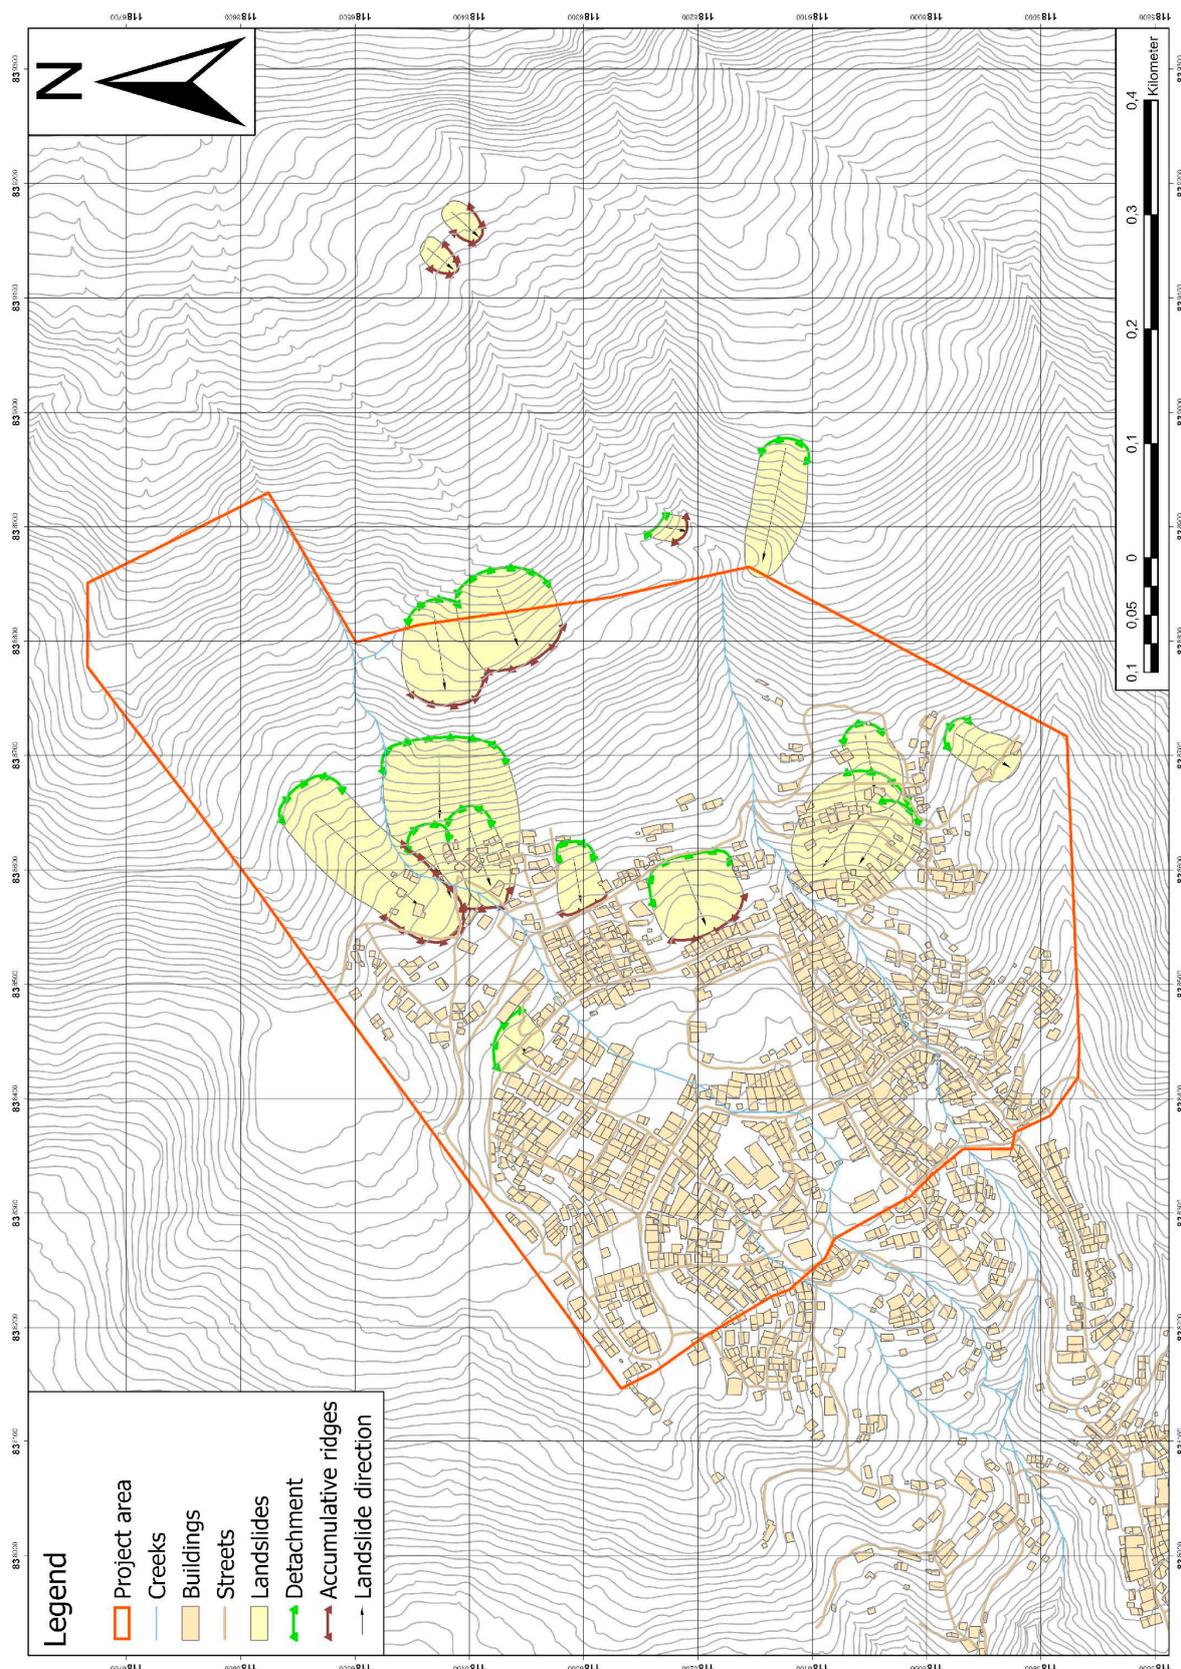
**Figure 4.** Map of landslide features at the project site, which is marked with the red colored line. The red border represents the project area, the detachment areas are marked in green, the accumulation areas in black. Most of the landslides could be characterized as rotational slides (projected coordinate system: MAGNA Medellin Antioquia 2010).

During the first field trip, an extensive map of the landslide phenomena at the study site was created (Figure 4) on an original scale of 1:3500. The map shows the outlines of former landslide events (the oldest being about 110 years old, the youngest occurred in 2017), their detachment and accumulation areas. Older landslides may be existent but are masked by younger ones.

As a main outcome, it is suggested that most of the landslides are rotational slides, occurring to an increased extent in soil or highly weathered rock [25]; the depths of the landslides can be specified in a range of 5–10 m, which could be classified as shallow to mid-seated [26]. Within the borders of the study area, there are no indications of deep-seated landslides in the past, even though the bedrock is expected to be highly weathered and fractured up to a depth of 60 m or more. However, a deep-seated landslide could not be excluded since the morphological elements would have been eliminated due to anthropogenic influence, such as road, building and plantation construction.

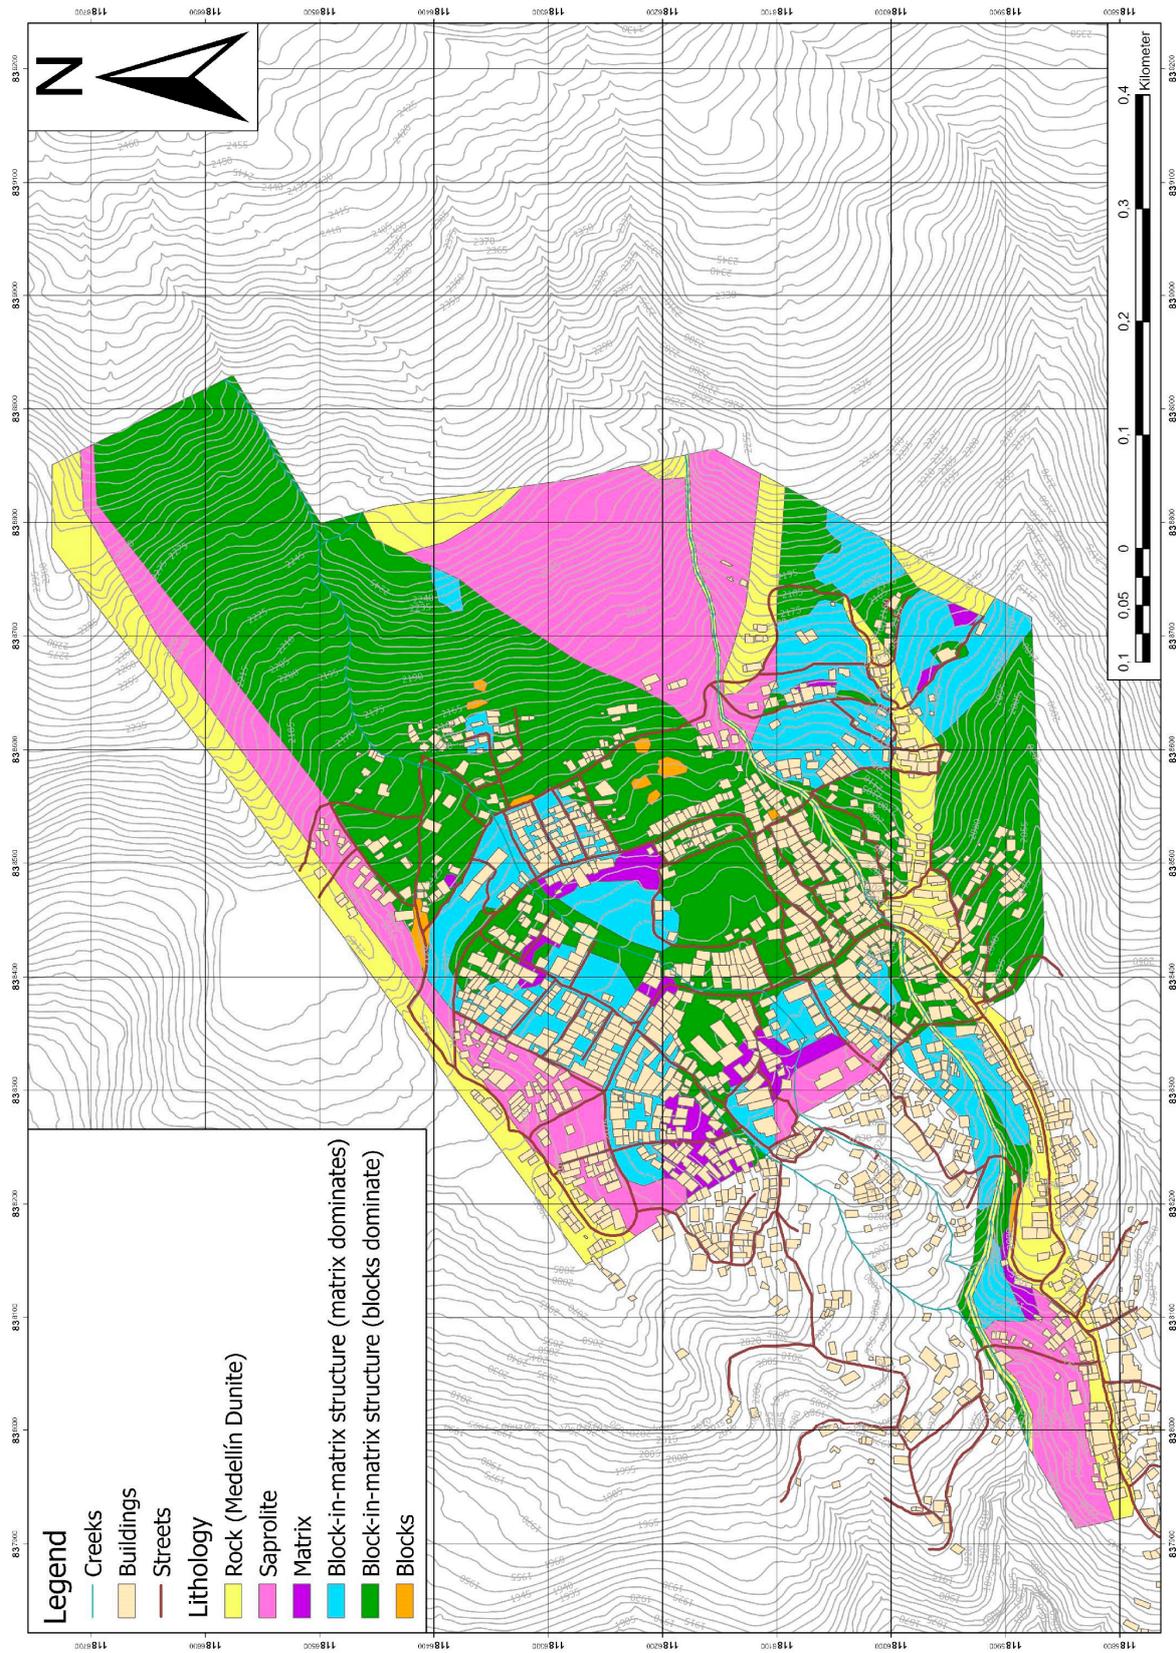
**Figure 5.** Geological map of the study site. The yellow colors indicate the bedrock ridges mainly in the north and south of the project site (projected coordinate system: MAGNA Medellín Antioquia 2010).

The geological map of the study site is shown in Figure 5 (original scale 1:3500). Two outcrops of in situ rock are ridge structures on the north-western border of the study site and in the south, both structures striking more or less SW-NE. A few other outcrops exist in the eastern part of the site (uphill). All these structures are visible on the surface as ridges, which indicates that these parts of the slope are more resistant and were not moved, e.g., due to landslides, in the past. Another prominent fact is that the strike direction of these ridges could be parallelized with one of the third joint set mentioned in Chapter 1. Therefore, the ridges could have been lifted tectonically creating a horst-and-graben structure in the study site with the trenches being filled by weathering products (block-and-matrix structure) of the described ridges. The in situ rock is heavily weathered and can hardly be distinguished from the saprolite formation.

The saprolite borders the outcrop on the north-western border and also occurs in the mid-eastern part of the study site. Two other outcrops are to the west in the main body of the site and to the far west. The saprolite and the in situ rock are not separated by a sharp line, but by a smooth transition from one to the other. Like the in situ rock, the saprolite has not been moved in the past but is likely to fail in the future.

The block-in-matrix structures that make up the rest of the area (trenches) are subdivided by their block-matrix ratio. Though the main part of the area (green) is dominated by blocks, there are also areas (blue) dominated by matrix. All areas made up of these block-and-matrix structures are very prone to landslides as already discussed in Section 1. A distinction between block-and-matrix structure created by former landslides or created by weathering cannot be made. The origin of the structure, however, does not influence its geotechnical behavior, which is why it is not of immediate importance.

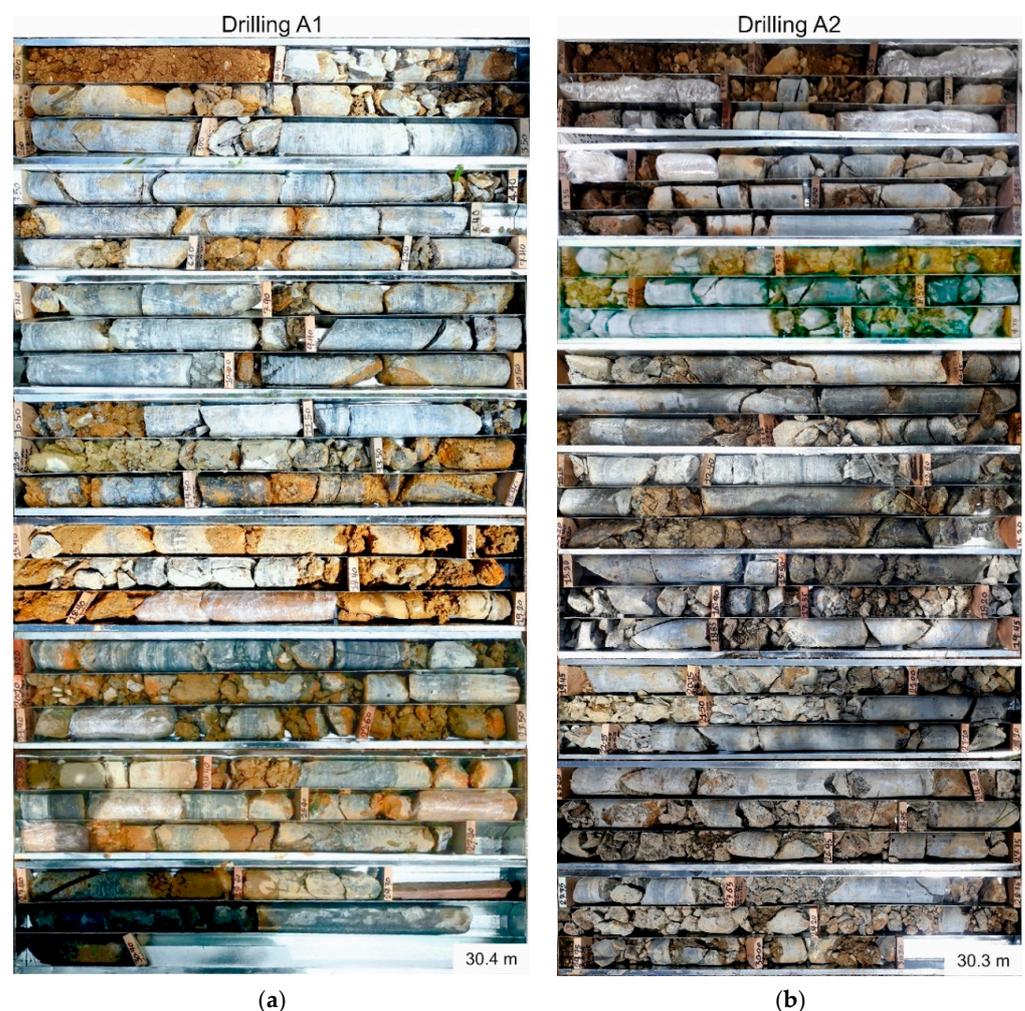
**Figure 6.** (a) Picture of the drilling core of drilling A1; (b) Picture of the drilling core of drilling A2. The cores have a length of 1 m each and run from top left to bottom right.

Figures 6 and 7 show pictures of the drillings cores, Figures S1–S3 include the drilling core documentation (drilling profile) and evaluation with several columns (core loss, weathering profile, RQD, fracture ratio, joint set, alteration type and homogeneous area). The evaluation of the drillings was done in collaboration with a Master's thesis supervised within the project [27].

As depicted in Figures 6 and 7, the thickness of the soil on the surface hardly reaches 2 m, except for drilling B1. In all drillings, there is significant core loss (Figures S1–S3). Except for the first 3.0 m of drilling B1, this core loss is most likely a combination of flushed out, loose material due to the drilling flushing and holes in the ground created by pseudokarst. The first 3 m of drilling B1 are fillings from the road construction; the core loss here is most likely a combination of flushed out loose material and holes due to insufficiently compacted ground.

Some cores (for the shear and Atterberg limits tests) were wrapped into plastic foil to preserve their original humidity (Figures 6 and 7).

In this drilling, the residual soil only reaches 40 cm depth. The material shows a deep brown color and mostly consists of sand, silt and clay. The rest of the core has the best rock quality of all the cores (Figures 6a and S1).

In general, this drilling core shows less brown fine material compared to the core of drilling A1, but the material is more fractured and fragmented. It also shows more small-scale changes, since the rock quality, weathering and joint numbers change significantly within a few centimeters (Figures 6b and S2).

Meters 2.0–6.4 show a weathering stage of II to IV, an RQD of 16–60 (very poor to fairly good) and all three joint sets mentioned before (only one fracture of joint set 2). Only one area shows serpentinization, the weathered material mostly shows brown colors. As it is only lightly weathered, this area belongs to homogeneous area 3, except for a small part around 3.5 m which belongs to 4 (in Figure 6b, this part is already wrapped in plastic foil).

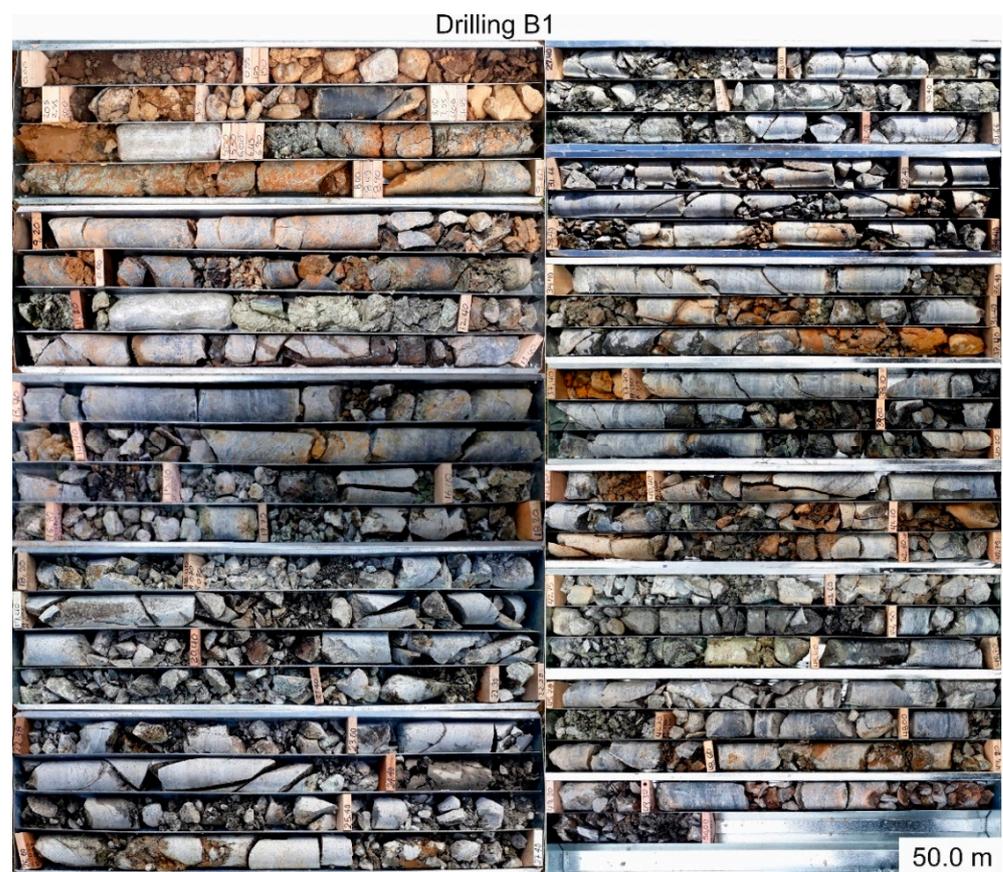
**Figure 7.** Picture of the drilling core B1, depicted in two rows. The left row shows the drilling core from 0–27.4 m, the right row shows the drilling core from 27.4–50.0 m. The core boxes have a length of 1 m each and run from top left to bottom right.

The deepest drilling is also the most complex one (Figures 7 and S3). As the drilling A2, it shows significant small-scale changes and extreme differences regarding the weathering type. All three dominant joint sets are present throughout the core. To a depth of 8.9 m, core loss is the dominating feature. Only 3.05 m of this section are recovered. This phenomenon is most likely caused by flushed out loose material and in the upper 3.0 m additionally by insufficiently compacted ground.

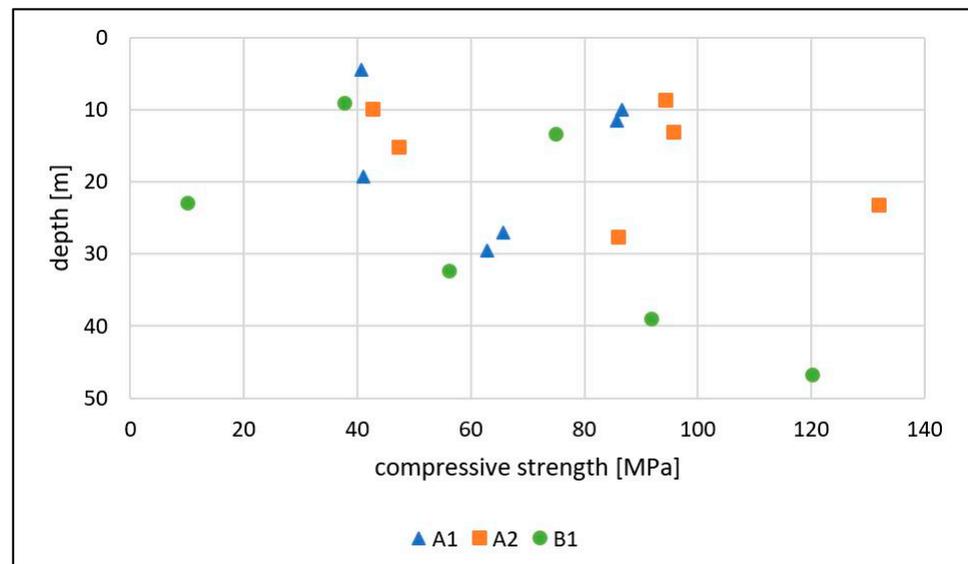
**Figure 8.** Results of the uniaxial compressive strength tests plotted vs. the sampling depth.

All values of the uniaxial compressive strength are depicted in Figure 8. The compressive strength decreases with increasing weathering [13]. Therefore, it is expected to show lower values with increasing weathering. All samples show weathering stage II on the exterior with little differences.

As visible in Figure 8, there is no correlation between depth and compressive strength in any of the three drillings. The values in general vary from 10 MPa to 132 MPa, which shows the high variation of the materials in the Medellín Dunite.

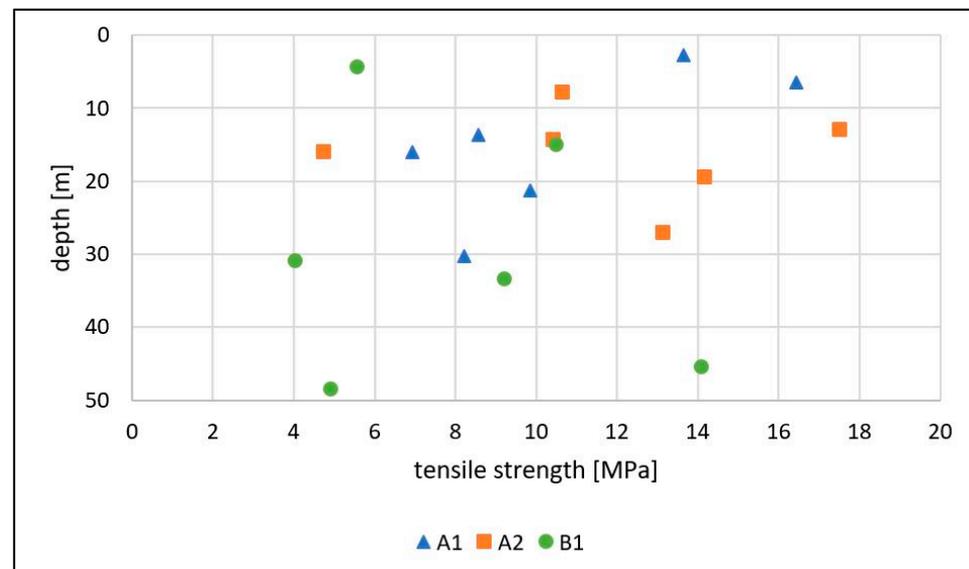
**Figure 9.** Results of the tensile strength tests (Brazilian tests) plotted vs. the depth of the sampling.

The results of the Brazilian test are depicted in Figure 9. Like the results of the uniaxial compressive strength test, the tensile strength of a sample is expected to decrease with increased weathering [13], but all samples show weathering stage II from the outside with little differences.

Although compressive strength showed at least a slight correlation with depth, tensile strength seems not to increase with the sampling depth at all. This also might correspond to the fact that the primary rock conditions were already affected by serpentinization and tectonic damage before weathering. The values of the tensile strength vary to a high extent between 4.1 and 17.5 MPa.

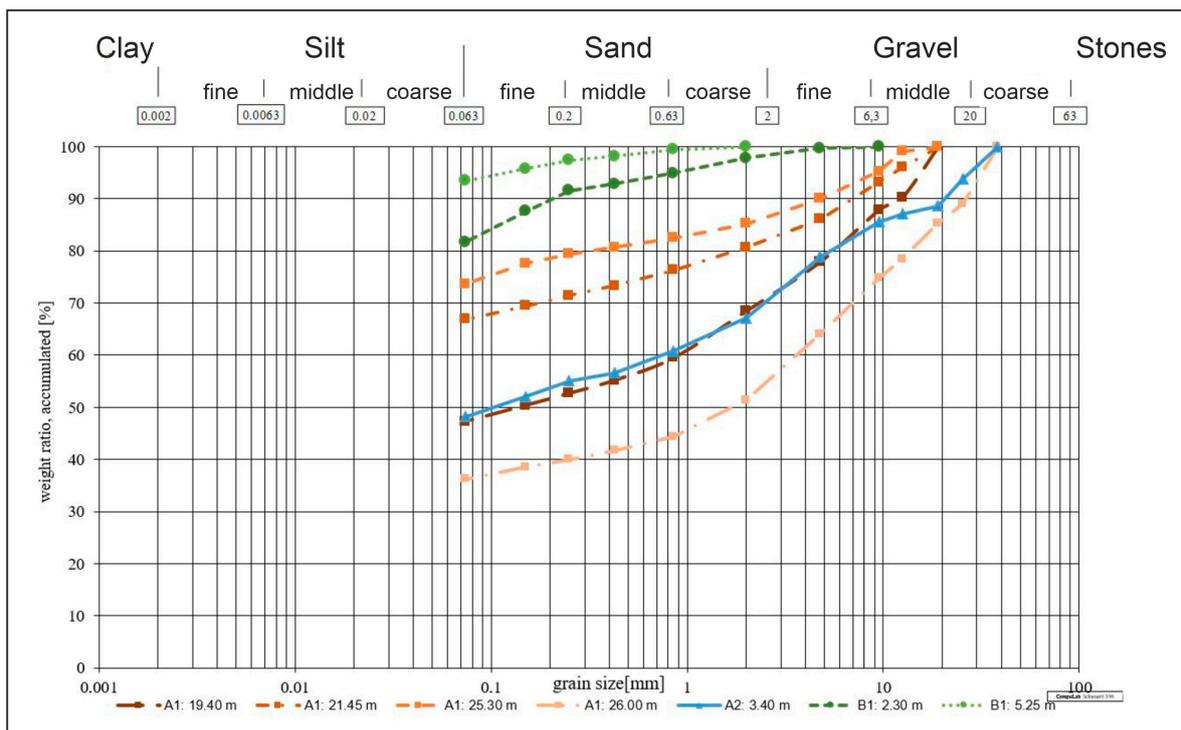
Figure 10. Grain size distribution of all drillings depicted according to DIN EN ISO 14688-1 (2020) [30].

The grain size distribution was determined on seven samples in all three drillings, four of them in drilling A1, one in drilling A2 and two in drilling B1, which are depicted in Figure 10 and Table 2. Even though the tests were performed after INV E 123 (2013) [21], the evaluation was done after DIN EN ISO 14688-1(2020) [30], due to the intercultural collaboration and because ISO standards provide an international standardization level for rock and soil testing and evaluation.

The results of the sieving tests indicate that the loose material in the drilling cores consists of at least 37% silt and clay, in most cases much more. One sample (drilling B1, 5.25 m) even shows an amount of about 93% silt and clay.

Like the rock tests before, this investigation shows no correlation between depth and the values determined. In a weathering profile, the grain size would be expected to increase with increasing depth. This fact could not be observed, which underlines the presence of pseudokarst and disturbance due to landslides.

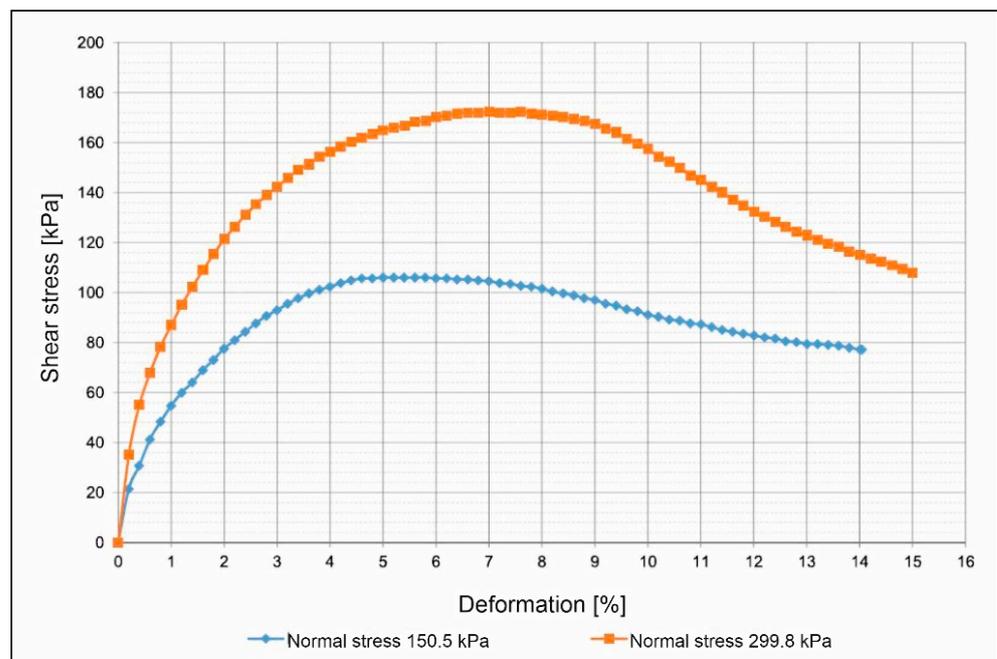
Figure 11. Shear-displacement curves.

Figure 11 shows the shear-displacement curves: the orange one at a normal stress of 299.8 kPa, corresponding to a load of 588.6 N, the blue one at a normal stress of 150.5 kPa, corresponding to a load of 295.5 N. The form of the curves indicates that the soil is densely packed since the curves drop after reaching their maximum shear stress at the point of failure. In addition to the shear-displacement curves, the shear-consolidation curves (Figure 12) show a consolidation of the samples during the shear test, indicating a compaction of the soil. This shows that despite the dense compaction shown in Figure 11, the soil is not over-consolidated and can still be further compacted.

The point of failure of the sample sheared at a normal stress of 299.8 kPa is 172.4 kPa and the failure point of the sample sheared at a normal stress of 150.5 kPa is 106.1 kPa, resulting in an effective friction angle  $\varphi$  of  $24.0^\circ$  and a cohesion  $c$  of 39.2 kPa.

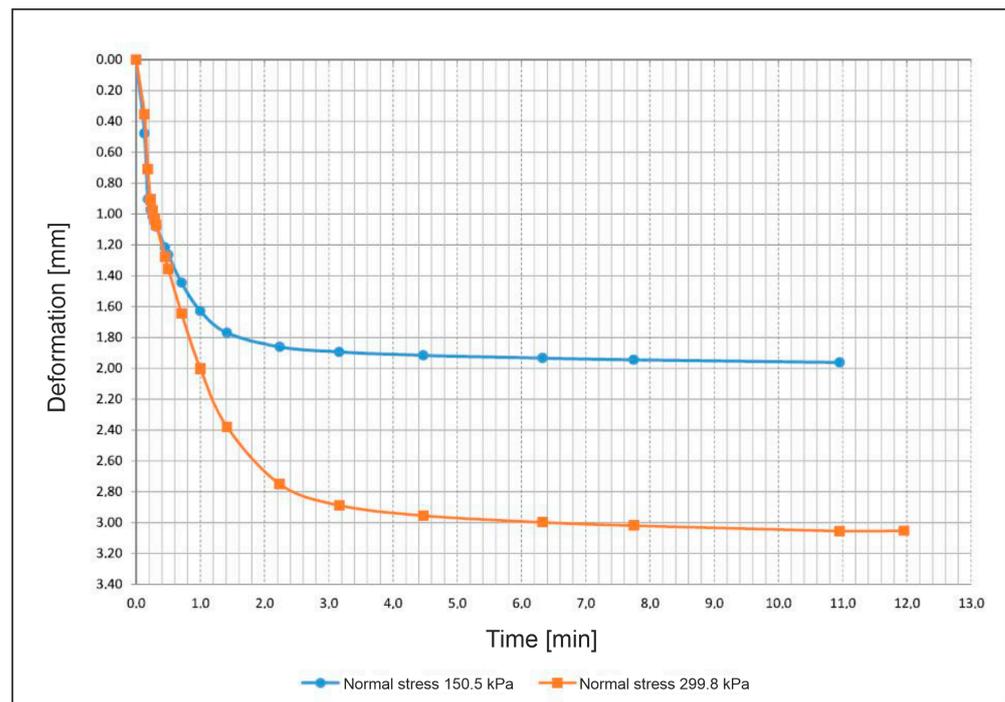
Figure 12. Shear-consolidation curves.

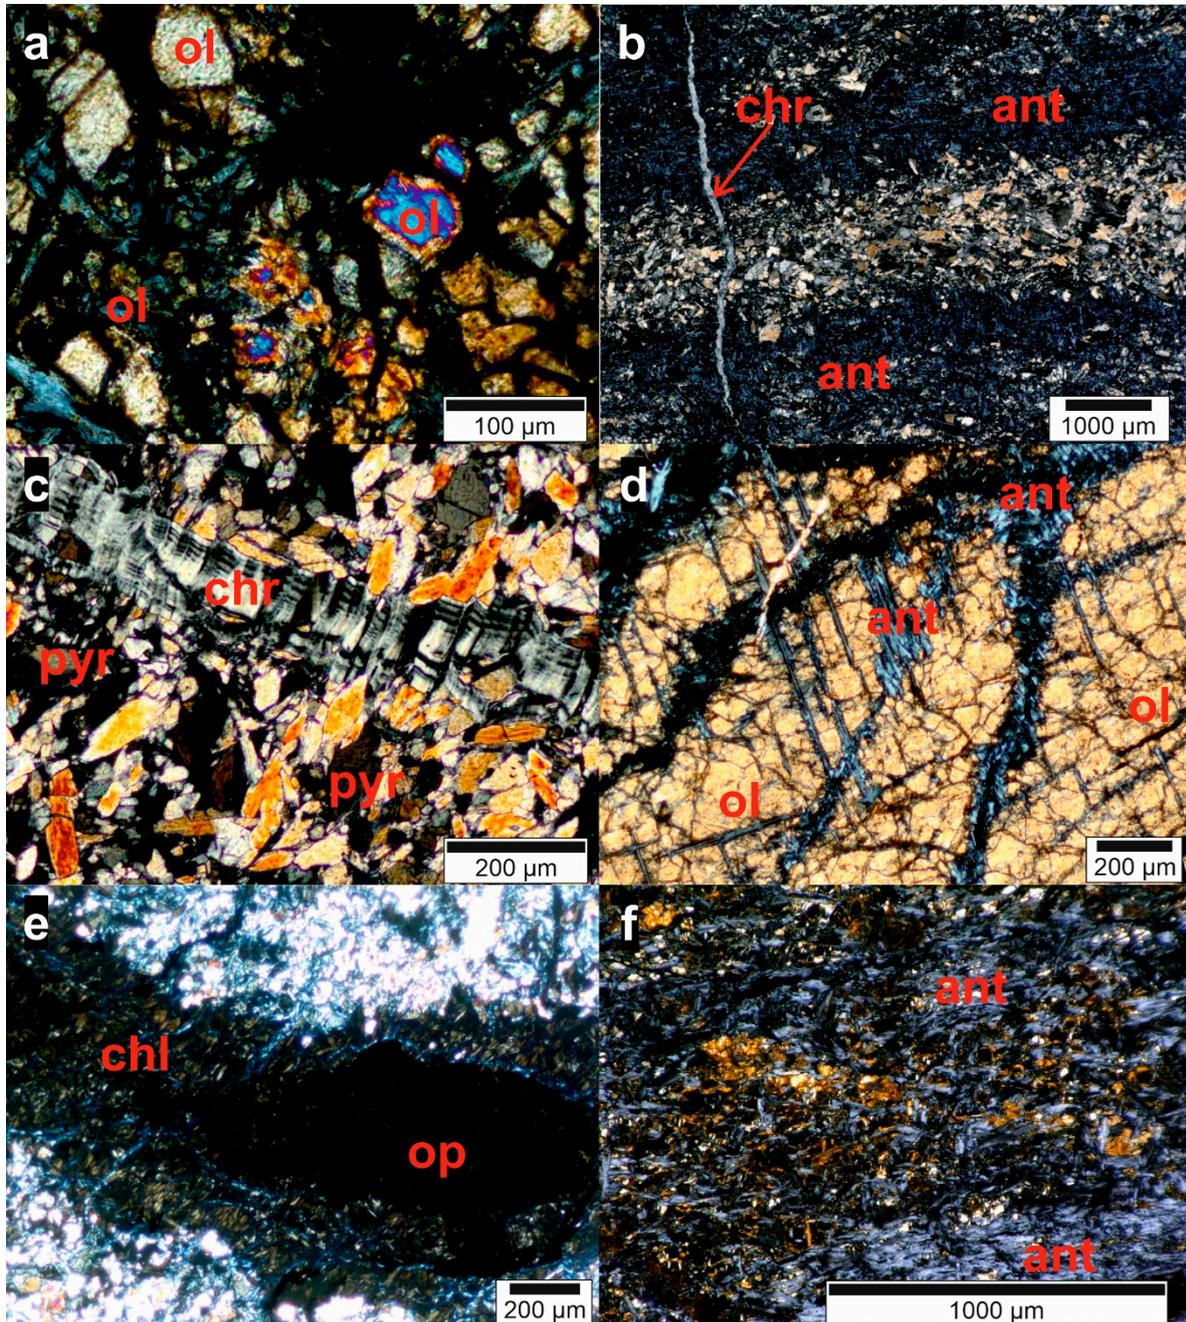
**Figure 13.** Microscopic photos of the thin sections related to the sample numbers: (a) = D-01; (b) = D-02; (c) = D-03; (d) = D-04; (e) = D-05; (f) = D-06 (ol = olivine, ant = antigorite, chr = chrysotile, pyr = pyroxene, amp = amphibole, chl = chlorite, op = opaque phase) [34].

The olivine crystals in the samples are mostly broken and heavily weathered at their exterior, as is visible in Figures 13a,d and 14f.

Pyroxene (Figures 13c and 14c) is not present in all samples, suggesting these parts of the rock might either be dunite in a strict sense without any pyroxene or that the pyroxene minerals have already been altered by serpentinization or weathering.

Figure 14b shows serpentinization of an amphibole from the outside. Serpentine was found in most samples, either chrysotile (fiber serpentine, Figures 13b,c and 14a,b) or antigorite (foil serpentine, Figures 13b,f and 14d). The serpentinization starts at fractures (Figures 13d and 14a) and grows into the minerals from there.

Chlorite (Figure 13e) is found in all samples. It is a common mineral in metamorphized ultramafic rocks and, therefore, was expected to appear in the Medellín Dunite [35]. It is also a weathering product of silicates such as olivine [35].

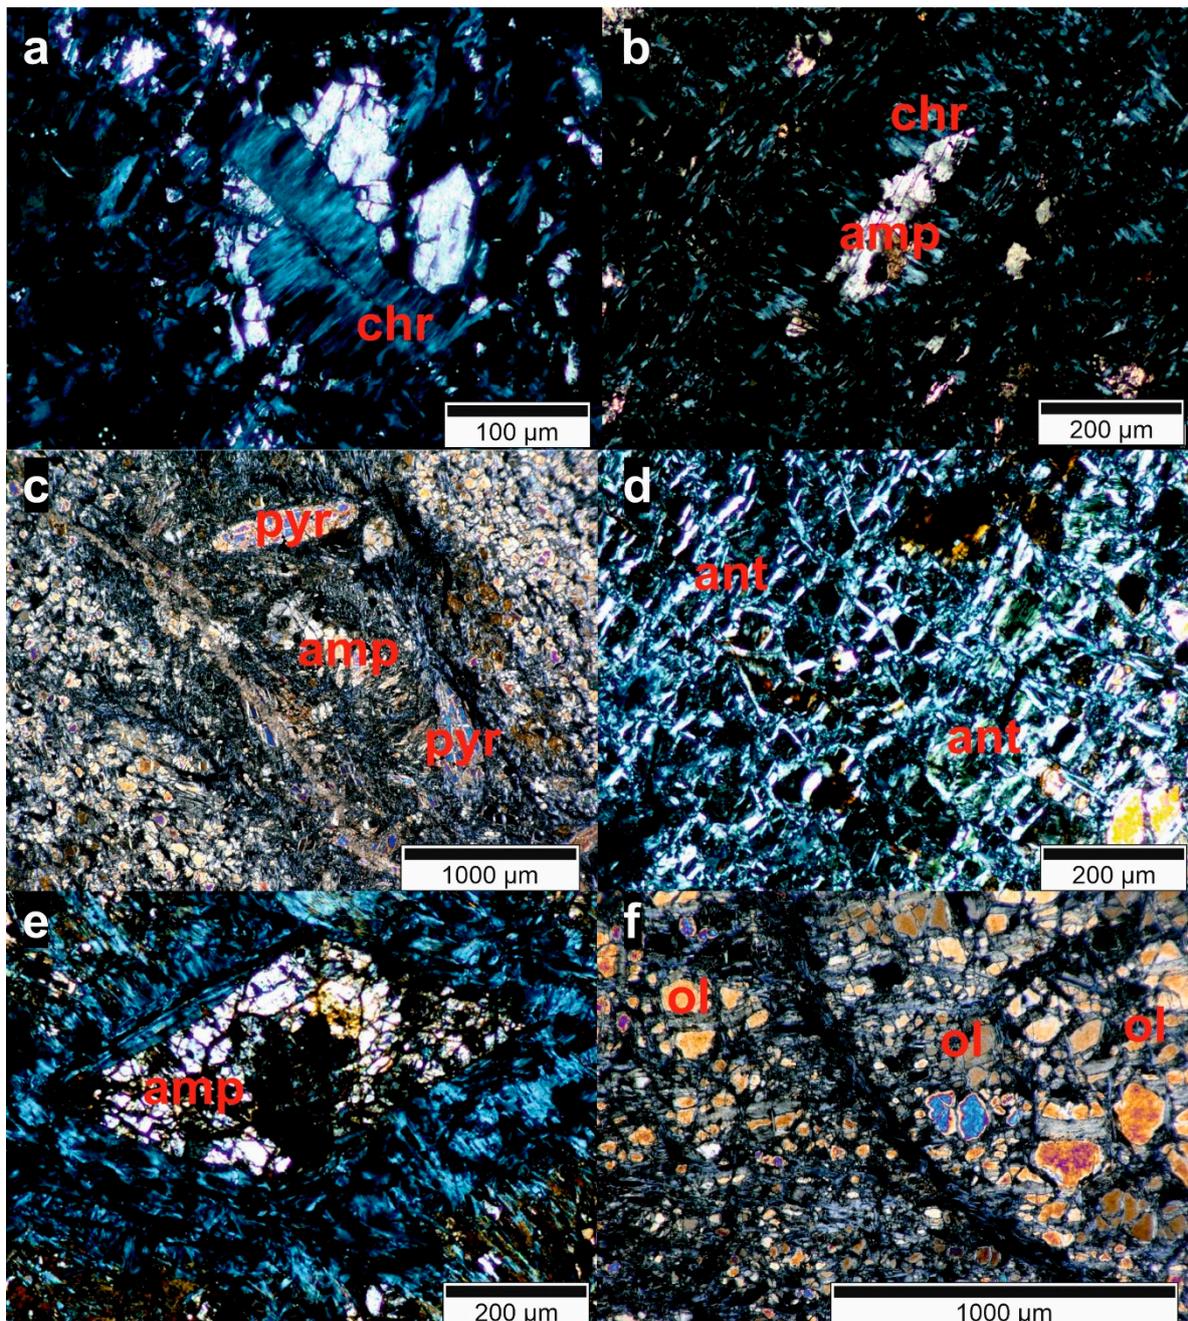
**Figure 14.** Microscopic photos of the thin sections related to the sample numbers: (a) + (b) = D-07; (c) = D-08.1; (d) = D-08.2; (e) = D-09; (f) = D-10 (ol = olivine, ant = antigorite, chr = chrysotile, pyr = pyroxene, amp = amphibole, chl = chlorite, op = opaque phase) [34].

Five samples contain amphibole (Figure 14c,e), which is commonly present in ultramafic rocks. Its absence in the other thin sections indicates that it is already serpentinized.
