Analysis of Deterioration Characteristics of Service-Aged XLPE Cables According to Installation Location of Combined Heat and Power Plant

Keywords: service-aged XLPE cable; correlation with Tan δ ; BFP; cooling tower; deaerator booster pump

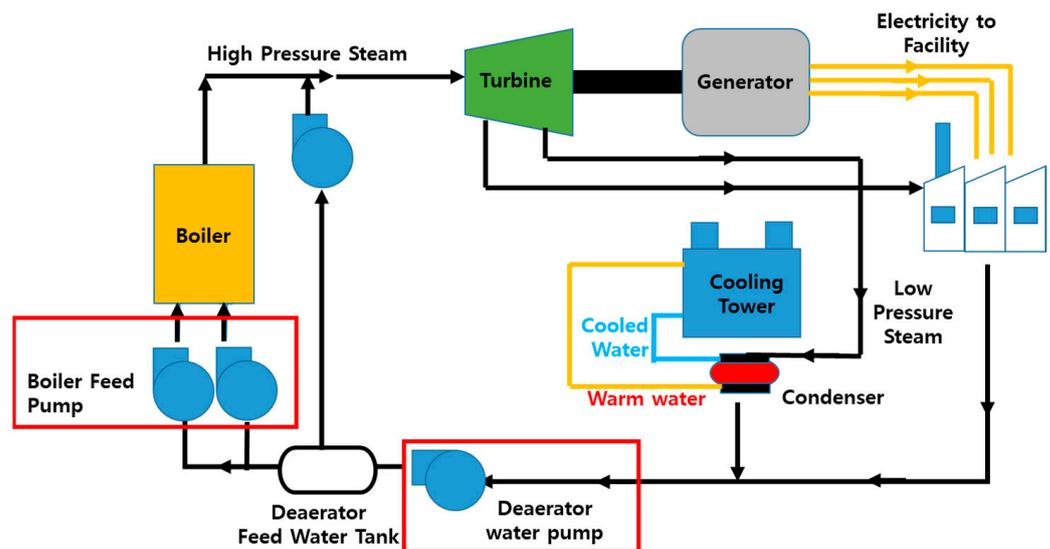
The combined heat and power plant is shown in Figure 1. The BFP is one of the important auxiliary devices because it supplies feedwater to the boiler [20]. Fundamentally, it transports hot water from the BFP to the boiler, creating steam that then powers the turbine. Consequently, it is exposed to environments of high temperature, high pressure, and steam. The deaerator booster pump ensures the quality of feedwater by removing oxygen and other noncondensable gases before supplying it to the boiler [21]. If the supplied feedwater contains oxygen or other gases, it can cause corrosion of the metals in the boiler and turbine. The cooling tower cools the steam used to rotate the steam turbines, condensing it back into water, and then recirculates it to the boiler. During the process of condensing high-temperature steam into water, a significant amount of water vapor is released, exposing the cooling tower to a continuous steam environment [22].

Figure 1. Location of cables installed in the combined heat and power plant.

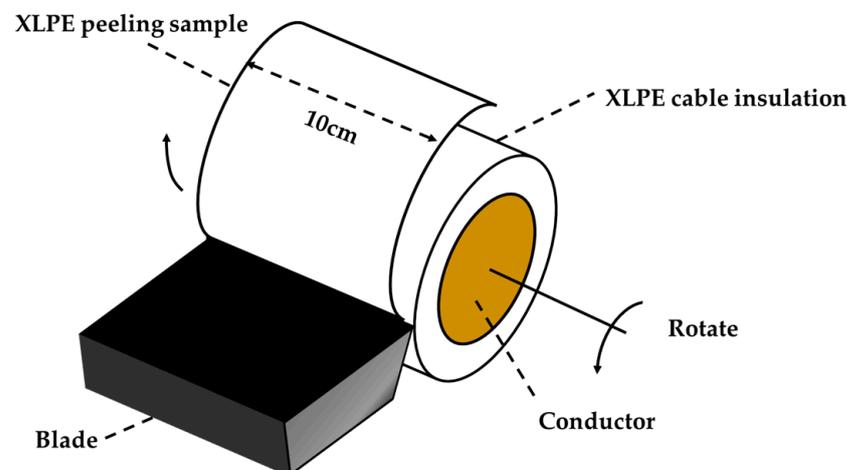
For all cables listed in Table 1, after measuring the VLF Tan δ and conducting dielectric breakdown evaluations of the XLPE cables, specimens were processed into ribbon-shaped tape samples from the XLPE insulation layer for the measurement of mechanical, chemical, and electrical evaluations, as illustrated in Figure 2. The size of the specimen is $100 \text{ mm} \times 100 \text{ mm}$, and the thickness is $80 \pm 10 \text{ } [\mu\text{m}]$.

Figure 2. Peeling of 10 cm wide XLPE specimens.

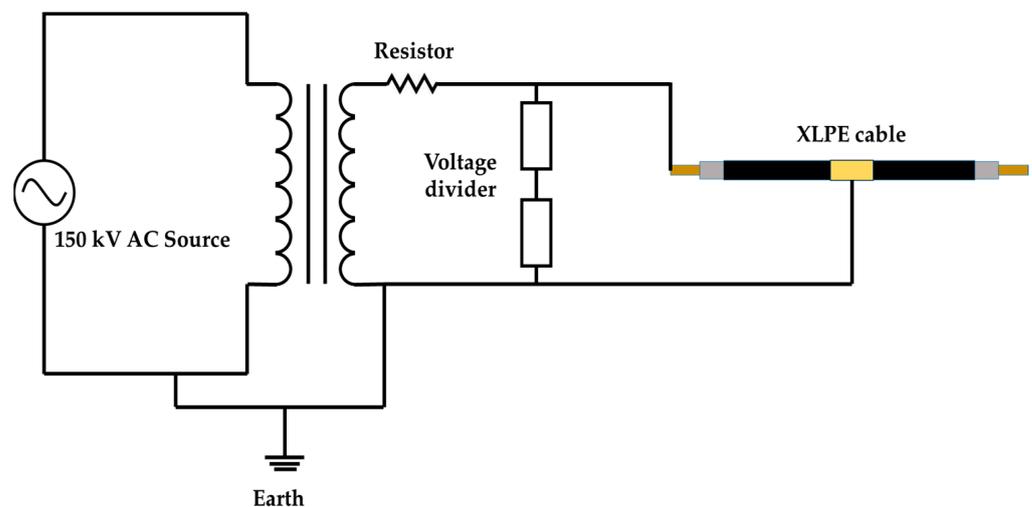
After the VLF Tan δ measurement was completed, a dielectric breakdown test of the XLPE cable was performed. The experimental setup consists of a 150 kV AC voltage source and a 6 m XLPE cable as shown in Figure 3. The voltage was increased from 0 V to 10 kV and then applied for 10 min. If dielectric breakdown did not occur, the voltage was raised to 10 kV and continued for 10 min. This process was repeated until dielectric breakdown occurred. It takes a lot of time to conduct a dielectric breakdown test for all cables starting from 0 V. Therefore, the test was conducted by applying voltage starting from 50% of the anticipated breakdown voltage. It was derived from the breakdown voltage of the cable measured starting from 0 V. After that, the voltage was gradually increased to 50% of the anticipated breakdown voltage and then applied for 10 min. The process was repeated by increasing the voltage by 10 kV and maintaining it for 10 min until dielectric breakdown occurred. When dielectric breakdown was measured, the location of the XLPE cable breakdown was confirmed as shown in Figure 4. If breakdown in the XLPE insulation was as depicted in Figure 4a, the cable was replaced with another XLPE cable. Cutting the section with breakdown and terminating the XLPE cable results in a shortened length, preventing further experimentation. However, in cases where it happened at the semiconductor layer–XLPE interface, as shown in Figure 4b, the cable was cut and terminations were made to facilitate additional experimentation.

Figure 3. Schematic diagram of cable dielectric breakdown.

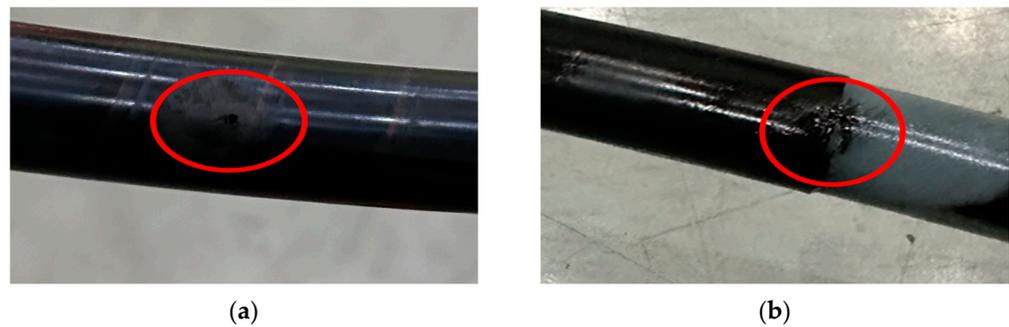
Figure 4. Location of where dielectric breakdown occurred: (a) dielectric breakdown occurred in XLPE insulation; (b) dielectric breakdown occurred at the semiconductor layer–XLPE interface.

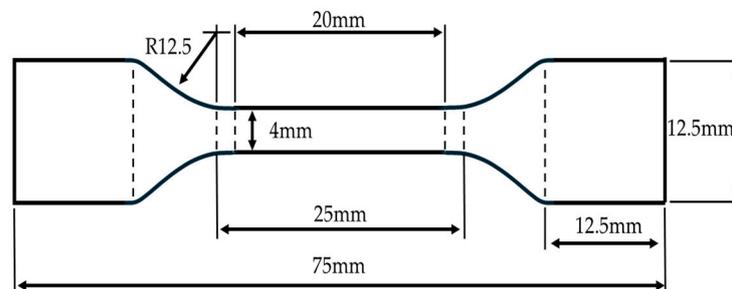
Upon completion of the dielectric breakdown experiment on the XLPE cable, the cable was cut and processed into ribbon-shaped tape samples. According to IEC 60811-1 [23], the thickness of the specimens must be selected between 0.8 mm and 2.0 mm. Therefore, after verifying the thickness of the prepared specimens, dumbbell-shaped samples were fabricated as illustrated in Figure 5. Before measuring mechanical evaluations, it is necessary to measure the average thickness of the prepared dumbbell specimens to ensure reliable analysis results. The thickness at both ends and the center of the 4 mm wide section was measured, and the average of these measurements was defined as the thickness of the dumbbell specimen. Afterward, the tensile strength and elongation at break were measured using a tensile tester. The tests were conducted at room temperature with an elongation rate of 250 mm/min. The tensile strength and elongation at break were determined based on the average of three tests conducted using the same method.

Figure 5. Dumbbell-shaped specimen.

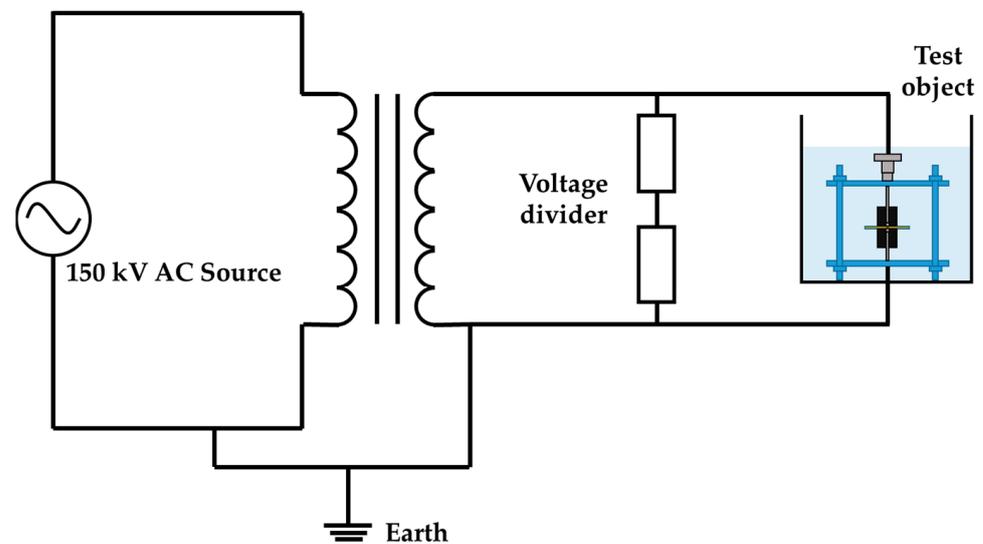
When performing a dielectric breakdown test on a 6 m XLPE cable, it is possible to measure only one breakdown voltage. Additional dielectric breakdown tests are difficult to execute due to the shortened cable length. Creating specimens enables repetitive experiments, allowing for breakdown tests to be conducted on XLPE specimens. The experimental setup consists of a 150 kV AC voltage source, a water tank, mineral oil, an XLPE specimen, jigs, and epoxy molding electrodes, as shown in Figure 6. Mineral oil was used to prevent surface discharge of the XLPE specimen. The jigs and epoxy molding electrodes are as shown in Figure 7. The applied electrode was made of a 10 mm diameter sphere electrode molded with epoxy. This design minimizes surface discharge and ensures that dielectric breakdown occurs at the shortest distance between electrodes, enhancing the reliability of the dielectric breakdown test.

Figure 6. Schematic diagram of the dielectric breakdown of the XLPE specimen.

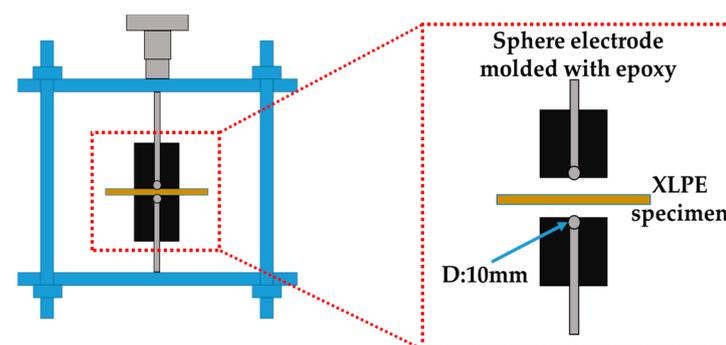
Figure 7. Jigs and electrodes.

The specimen's dimensions were 50 mm × 50 mm, and its thickness was determined by averaging four measurements taken around the point where dielectric breakdown occurred. The voltage was increased by 1 kV and maintained for 10 s. If dielectric breakdown was not measured, the process of applying voltage was repeated by increasing by 1 kV and holding for 10 s each time. Since the dielectric breakdown test takes a lot of time, the anticipated breakdown voltage was derived from the measured breakdown voltage. Voltage was applied up to 50% of the expected breakdown voltage. Afterward, the process of increasing the voltage was repeated until dielectric breakdown occurred. The dielectric breakdown test was measured a total of 10 times, and the average value of 8 tests excluding the maximum and minimum values was selected as the breakdown voltage.

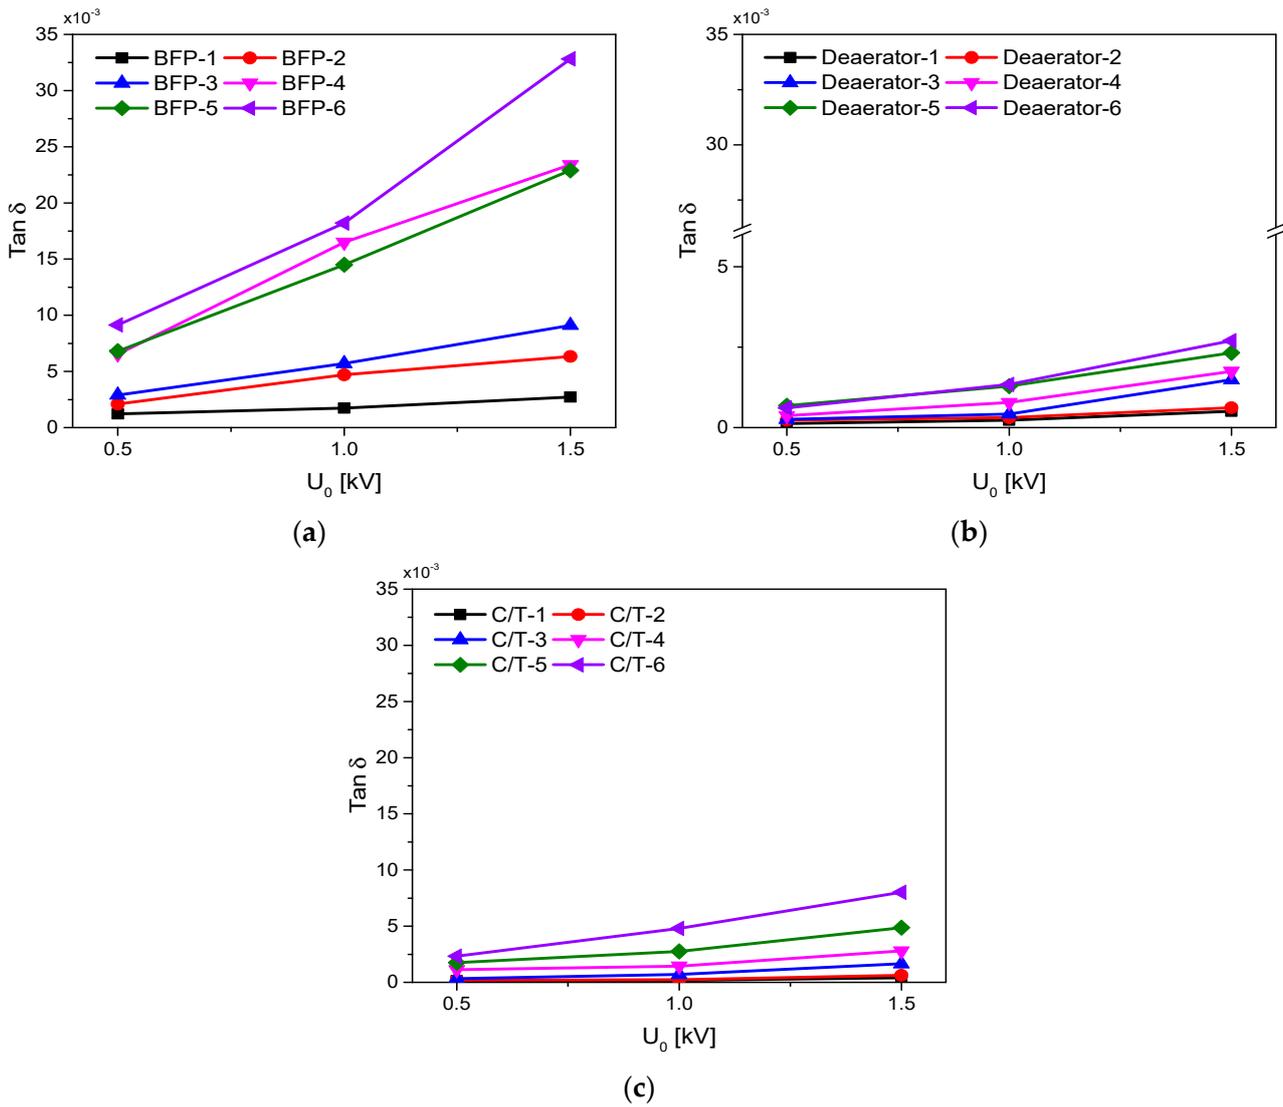
The VLF Tan δ of the XLPE cables installed in the combined heat and power plant was measured, as shown in Table 2 and Figure 8. When comparing the BFP, the deaerator booster pump, and the cooling tower, it was observed that the VLF Tan δ deviation of the BFP was significantly large. The cooling tower also showed deviation, and the variance of the deaerator booster pump was the smallest. It was observed that the VLF Tan δ of the XLPE cable installed in the BFP, the deaerator, and the cooling tower increases linearly as U_0 increases. The rise in the VLF Tan δ with the increment in U_0 signifies an increase in losses within the insulator. The DTD ($1.5 U_0 - 0.5 U_0$) was also calculated to determine whether the high Tan δ is due to insulation degradation. If DTD is low while both $0.5 U_0$ and $1.5 U_0$ are high, it is due to measurement environmental effects. Therefore, the DTD value is important in analyzing insulation performance. It is confirmed that the cable installed in the BFP has the highest values of VLF Tan δ and DTD, so the deterioration in insulation performance is the greatest. Based on IEEE Std 400.2, if the DTD is 5 or more, further study is advised. Therefore, BFP-3 to BFP-6 require caution. The VLF Tan δ of the XLPE cable installed in the deaerator booster pump is as shown in Figure 8b. According to $1.0 U_0$ and DTD, it is the lowest VLF Tan δ compared to cables in other installation locations. However, through the DTD from deaerator-3 to deaerator-6, it is confirmed that the cable has gradually degraded. Deaerator-5 was identified as the XLPE cable installed in the deaerator booster pump that has experienced the most significant degradation. However, it is similar to the VLF Tan δ of the cable with the best insulation condition in the BFP. Therefore, the deaerator cables, having the lowest VLF Tan δ and DTD values compared to cables in other locations, exhibit the best insulation performance. Figure 8c shows the VLF Tan δ of the XLPE cable installed in the cooling tower. In the case of C/T, $1.0 U_0$ and DTD were measured to be higher than the deaerator and lower than the BFP. Similar to the deaerator, degradation progresses from C/T-3 to C/T-6. The cooling tower cable has better insulation performance than the BFP, but lower than the deaerator. According to IEEE Std 400.2, further study is only advised for C/T-6.

Figure 8. VLF $\tan \delta$ depending on the installation location: (a) BFP; (b) deaerator booster pump; (c) cooling tower.

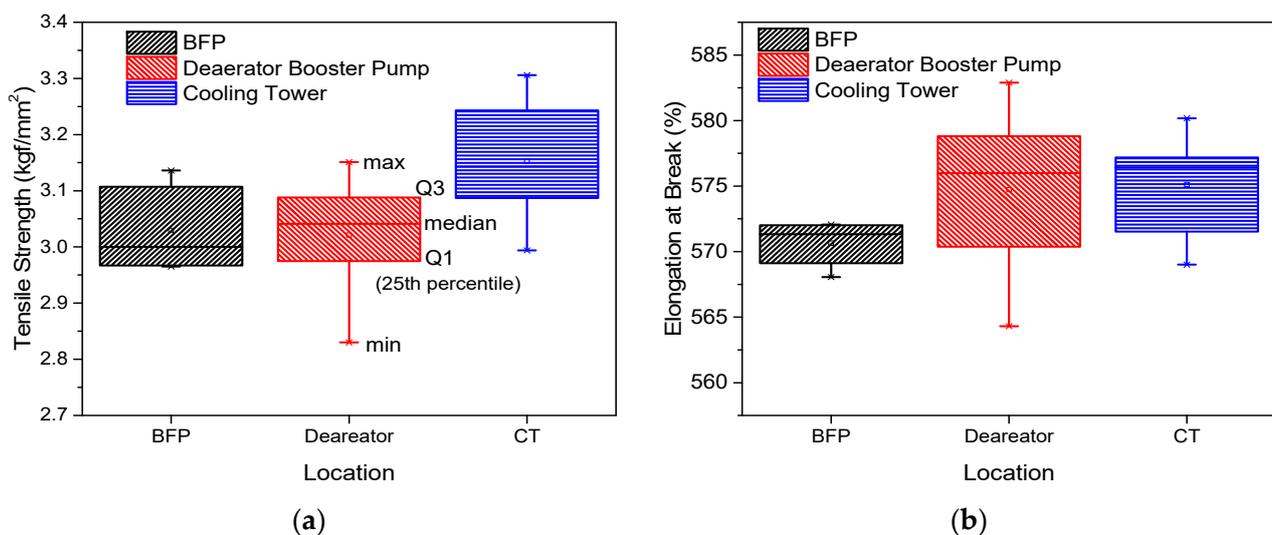
Figure 9 shows the graph of the tensile strength and elongation at break according to the installation location. The tensile strength is highest in the cooling tower and lowest in the deaerator booster pump, with approximately a 15% deviation. By removing the extreme values for comparison, it becomes difficult to distinguish differences in tensile strength according to the installation location. The deviation between the maximum and minimum values of the elongation at break is around 4%. Therefore, similar to tensile strength, it is challenging to compare differences in the elongation at break according to the installation location.

**Figure 9.** Mechanical evaluation according to the installation location: (a) tensile strength; (b) elongation at break.

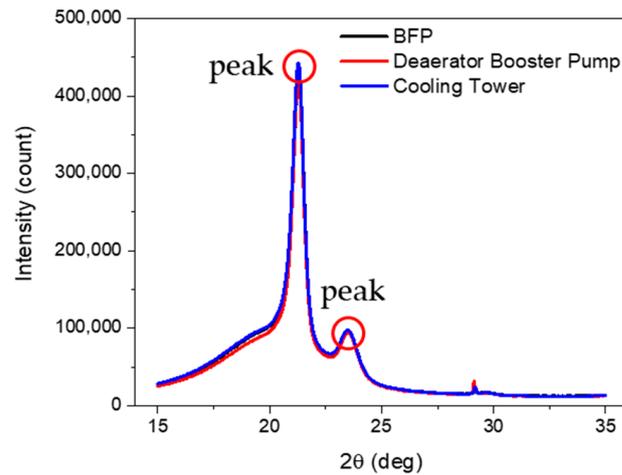
The XRD measurement data of the XLPE specimens according to the installation location is as shown in Figure 10. The XRD analysis identified peaks at 21.3° and 23.4°.

There was no difference in the peak angles of intensity according to the installation location. For additional examination, each area is calculated through normal distribution as shown in Figure 10. The derived crystallinity is shown in Figure 11. When assessing the crystallinity according to the installation location, the BFP and cooling tower were similar. The difference between the highest and lowest values of crystallinity at each installation location was the largest for the cooling tower and BFP. However, removing the extreme values, the greatest deviation was observed in the BFP. This confirms that there is a significant difference in degradation. The crystallinity was highest for the XLPE cable installed in the deaerator booster pump. Additionally, the variation in data was relatively low. This means that the deterioration progressed less than in other locations.

Figure 10. XRD depending on the installation location.

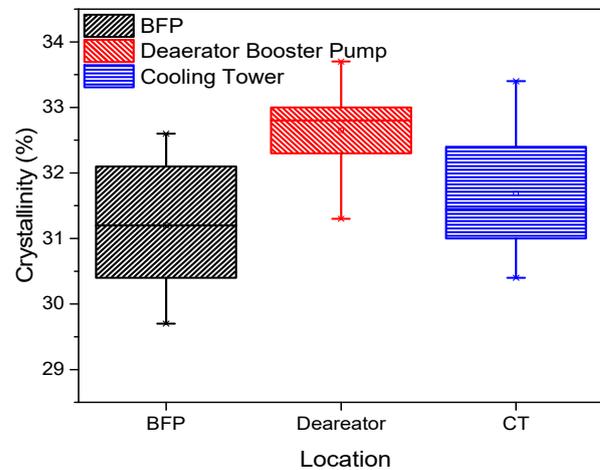
Figure 11. Crystallinity of the XLPE specimens depending on the installation location.

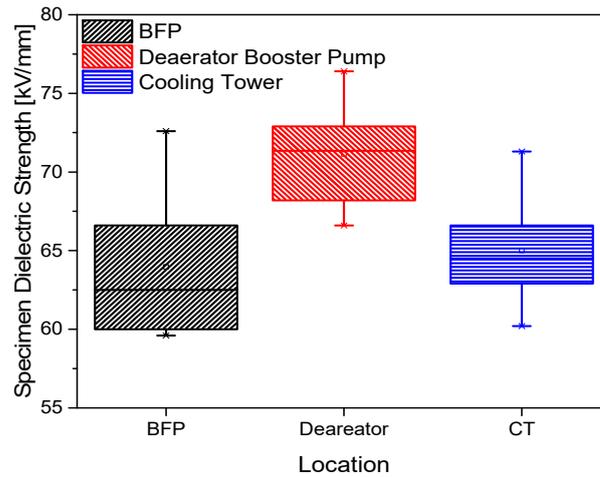
The dielectric strength of the specimens is as shown in Figure 12. The dielectric strength distribution of the XLPE cable specimens installed in the BFP is the lowest. However, it was confirmed that the variation in dielectric strength was the largest. The dielectric strength of the specimens in the cooling tower was similar to that of the BFP, but slightly higher. The difference in dielectric strength was also similar to that of the BFP, but the deviation in the data, removing the extreme values, was the smallest. The deaerator booster pump shows the highest dielectric strength distribution, with about 10% higher insulation performance.

Figure 12. Dielectric strength of the XLPE specimens depending on the installation location.

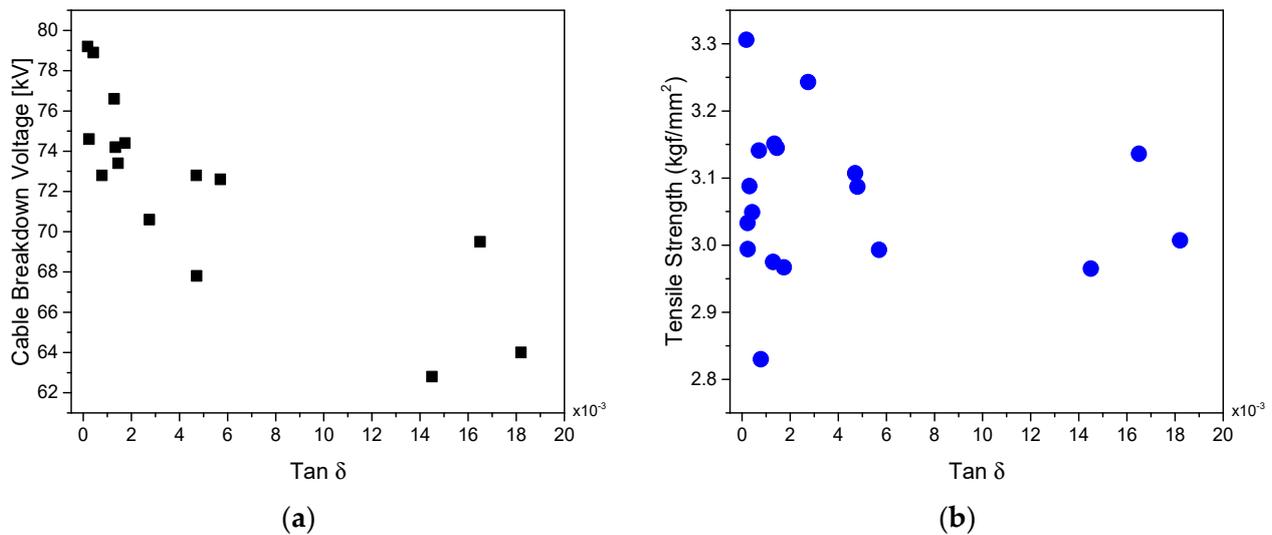
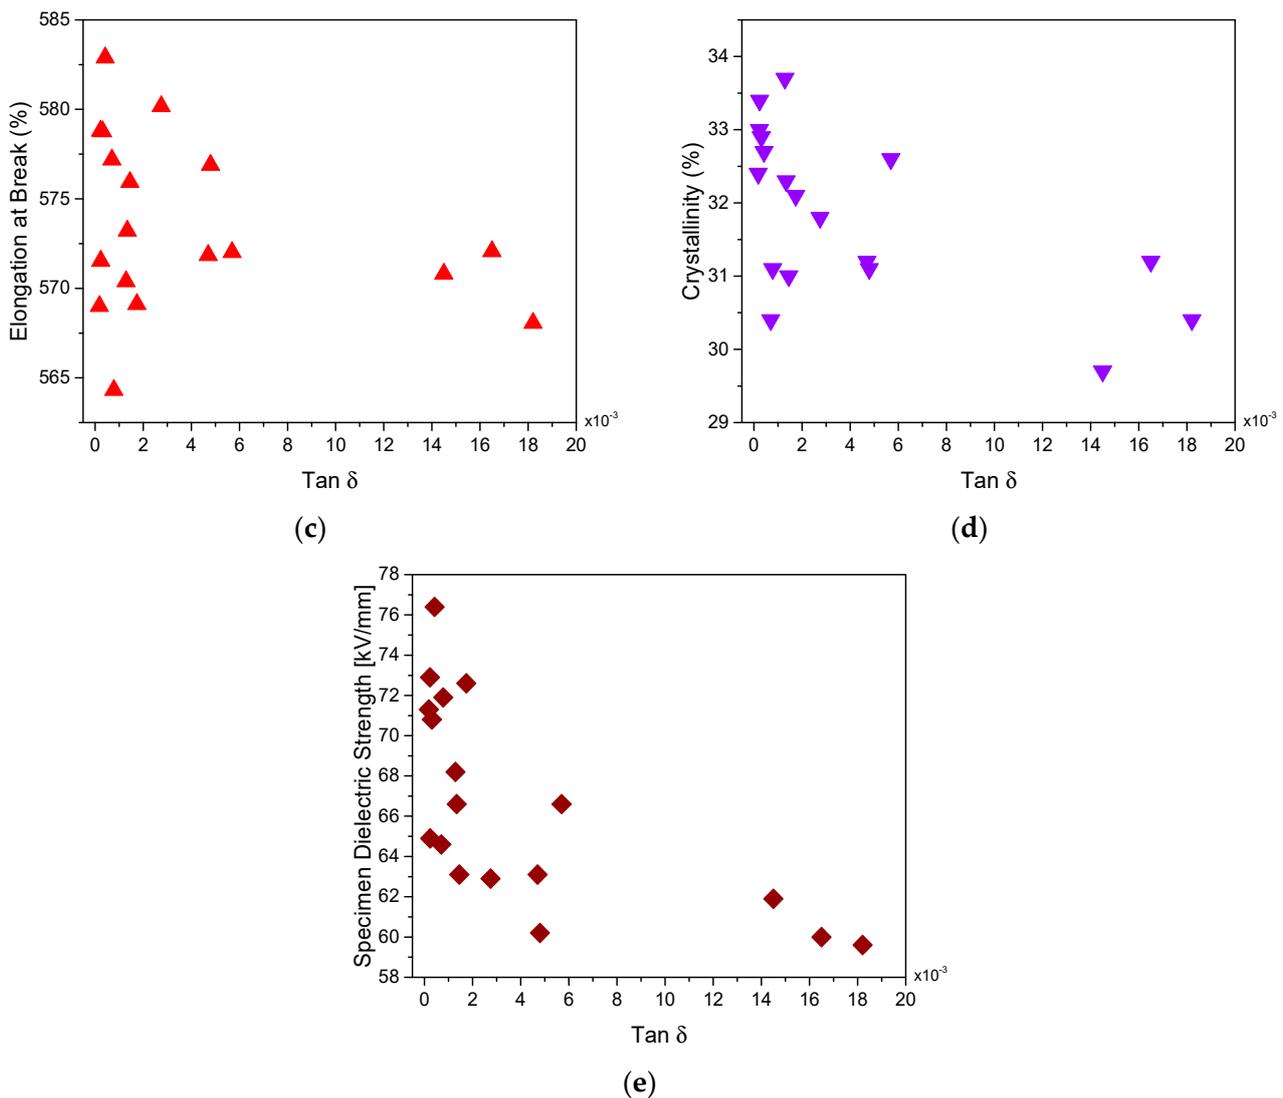
The correlation between the VLF Tan δ and the dielectric breakdown of the cable is shown in Figure 13a, while the relationship between the VLF Tan δ and the characteristic evaluation of the specimen appears in Figure 13b–e. In Figure 13a, data for Deareator-1, Deareator-2, and C/T-3 were excluded. The VLF Tan δ values for the excluded data are 0.23, 0.31, and 0.7 based on 1.0 U_0 . The reason for exclusion is that during the cable dielectric breakdown test, flashovers occurred, or dielectric breakdown happened at the interface between the semiconductor layer and the XLPE insulator. It was observed that as it increases, the breakdown voltage of the cable decreases. The highest breakdown voltage was 79.2 kV, and the lowest voltage was 62.8, a decrease of about 20%. The VLF Tan δ at each voltage is 0.18 and 14.5. If the VLF Tan δ data are distributed between 0.183 and 1.74, the breakdown voltages range from 72.8 to 79.2 [kV]. For Tan δ values within the range of 2.75 to 5.7, the breakdown voltages were measured between 67.8 and 72.8 [kV]. The remaining data is 14.5~18.2, and the breakdown voltage is 62.8~69.5 [kV]. Although repeated dielectric breakdown tests could not be performed due to the insufficient number of cables with high value, it was possible to observe the distribution of dielectric breakdown voltage according to the Tan δ . This confirmed that there is a correlation between the Tan δ and the breakdown voltage of the cable.

Figure 13. Correlation with the Tan δ : (a) Tan δ and cable insulation breakdown; (b) Tan δ and tensile strength; (c) Tan δ and elongation at break; (d) Tan δ and crystallinity; (e) Tan δ and specimen dielectric strength.

The tensile strength and elongation at break according to the VLF Tan δ are as shown in Figure 13b,c. Even as the Tan δ increases, the tensile strength and elongation at break show a consistent distribution. The tensile strength was mostly measured around 3.0 to 3.2 [kgf/mm²]. The elongation at break is also distributed between approximately 568% and 580%, but unlike the tensile strength, it ranges from about 568% to 572% as it increases. Therefore, the elongation at break showed a tendency to decrease as it raised. However, it was found that it has a minor correlation with both the tensile strength and elongation at break.

The crystallinity according to the Tan δ is as shown in Figure 13d. When the Tan δ is below 2, the crystallinity is distributed around 31% to 33%. However, a crystallinity of approximately 31% to 32% was derived when the Tan δ ranges from 2 to 6. If it was 14 to 18, the crystallinity was calculated to be around 30% to 31%. Among the 18 Tan δ values, 11 are distributed within values below 2. Although the number of crystallinity measurements at higher Tan δ values is limited, it was observed that as it increases, there is a trend of decreasing crystallinity.

The dielectric strength graph for the specimens is depicted in Figure 13e. With an increasing VLF Tan δ , a corresponding decrease in specimen dielectric strength was observed.

When the VLF Tan δ was analyzed for characteristic evaluation of cables and specimens, it was confirmed that it has inverse correlation with the breakdown voltage of the cable, the dielectric strength of the specimen, and the crystallinity. This analysis indicates that electrical and chemical performance begin to deteriorate when the Tan δ exceeds 2, based on a $1.0 U_0$. Subsequently, when the Tan δ is more than 14, the electrical performance decreased by approximately 20% compared to the best values observed. However, several improvements are necessary for reliable diagnostics. The BFP and cooling tower have a large deviation in measurement; therefore, six cables are not enough to evaluate deterioration depending on the installation location. More than half of the Tan δ data are below 2, and there are only seven ranging from 2.75 to 18.21. Therefore, the amount of data is insufficient to accurately determine trends when degradation has occurred. Additionally, it was not possible to determine how close the cable was installed to the BFP, cooling tower, and deaerator booster pump. Therefore, accurate analysis was difficult due to the existence of deviations in experimental values. Future research should focus on considering more cables and study the impact of exact locations on the reliability of the experimental results.

- It was found that the cable's breakdown voltage, the specimen's crystallinity, and the specimen's dielectric strength decrease as the Tan δ increases. However, the tensile strength and elongation at break showed less association with the Tan δ .
