Article

Time-Lapse Helical X-ray Computed Tomography (CT) Study of Tensile Fatigue Damage Formation in Composites for Wind Turbine Blades

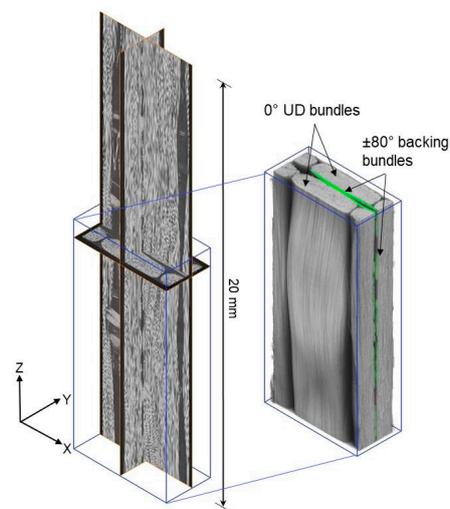
Figure 1. Orthogonal virtual X-ray CT sections (**left**) and a 3D volume rendering (**right**) showing the fibre architecture of the GFRP material where the $\pm 80^\circ$ backing fibre bundles are rendered in green.

The composite material studied is a glass fibre/polyester composite system typically used in wind-turbine rotor blades. The GFRP sample has a lay-up of $[0/b]_S$, where '0' represents a 0° UD fibre layer and 'b' corresponds to a thin ($\sim 100\text{--}200\ \mu\text{m}$) $\pm 80^\circ$ backing fibre layer. Figure 1 shows the orthogonal virtual CT sections and a 3D rendered CT image of the fibre architecture. The composite panel was manufactured using vacuum assisted resin transfer moulding (VARTM). Specimens having dimensions of $2\ \text{mm} \times 5\ \text{mm} \times 110\ \text{mm}$ were cut from the composite panel and GFRP tabs were added to the ends of the test-pieces (see Figure 2a,b). This miniaturised specimen geometry was used in order to obtain a high spatial resolution, given that the full specimen width should ideally lie within the FoV during the scan if the reconstruction algorithm is not to introduce artefacts [9].

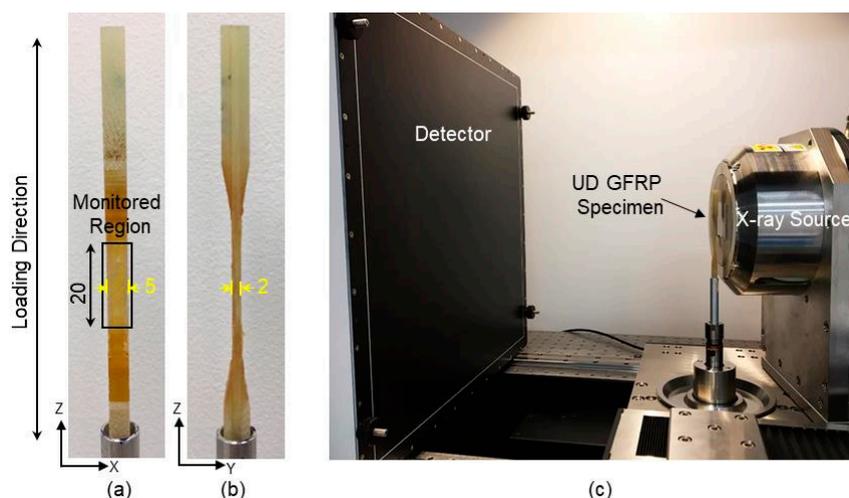
Figure 2. (a,b) Photographs illustrating the GFRP specimen geometry and the X-ray CT monitored region through interrupted fatigue test (dimensions in mm). (c) Photograph showing the helical X-ray CT imaging set-up in the ThermoFisher HeliScan Micro-CT scanner.

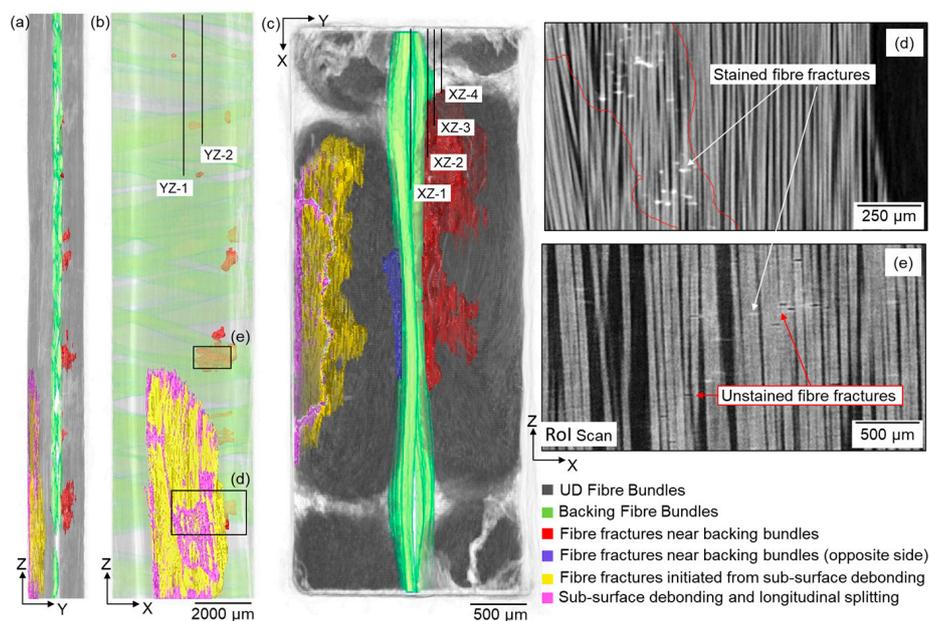
Figure 3. X-ray CT 3D volume rendering of the extracted damage after 500,000 cycles (N_2), where the fibre fractures, longitudinal splits and debonding are visualised with respect to the UD and backing fibre bundles, (a) YZ view, (b) XZ view, (c) XY view (refer to Figure 2a,b for definition of the coordinate system). (d) Typical virtual X-ray CT XZ of the region marked in (b), illustrating the manual annotation of fibre fracture damage in the CT image. (e) High-resolution RoI X-ray CT virtual XZ section of the damage region marked in (b) where some fibre fractures were not stained.

The nucleation of UD fibre fractures was found to correlate with two micro-structural features; regions where backing fibre bundles cross-over (near mid-thickness of the specimen, see Figure 3a–c) and regions where stitching threads cross-over (near the specimen surface, see the red boxes in Figure 5b and Figure 8c). The development and distribution of UD fibre fractures from these two regions were tracked in the time-lapse CT images, and the results are presented and discussed in this section.

As mentioned above, the regions of UD fibre fractures were manually delineated (see Figure 3d) to help visualise the 3D morphology of this damage mode. Fibre fractures were observed in the UD fibres adjacent to the cross-over regions of backing fibre bundles after 50,000 cycles, which is consistent with the observations of previous studies [5,8]. The onset of UD fibre fracture appears to be localised next to backing bundle cross-over regions (see Figure 6b,d). After 500,000 cycles, seven fibre fracture regions were observed on the right-hand side of the specimen width; these were approximately evenly distributed (~2–3 mm) along the 20 mm length. Out of the seven damage regions, six were next to the backing bundle cross-over regions, while one small region was located next to -80° backing fibres only (see Figure 6c). As can be seen in Figure 3c, it should be noted that most of the UD fibre fractures (rendered red) developed near the UD fibre fracture site (rendered blue) developing on the other side of the backing layer. This site is at the same height (in Z) as the site of damage initiation of fibre fractures after 50,000 cycles (see Figure 6b–e). This is the location where UD fibre fractures propagated most widely within the specimen after 500,000 cycles.

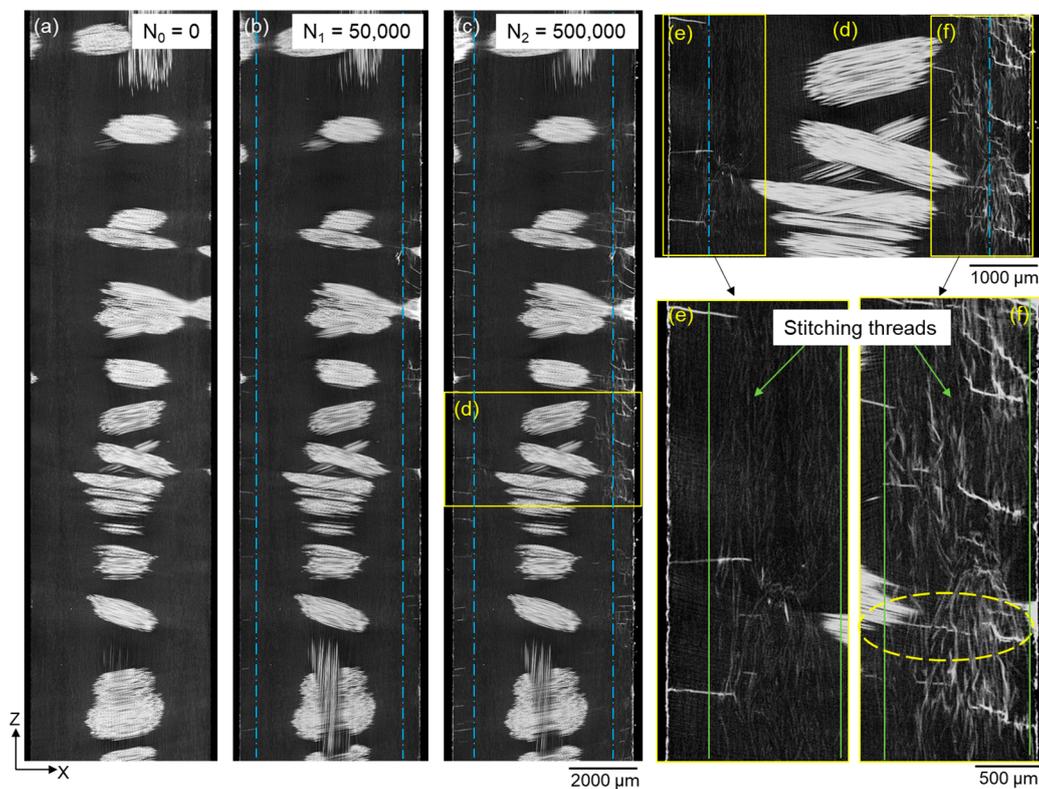
Figure 4. X-ray CT virtual XZ-1 section (position indicated in Figure 3c) of the sample after (a) 0, (b) 50,000 and (c) 500,000 cycles showing the evolution of off-axis matrix cracks initiated from specimen edges. (d) Magnified view of the highlighted region in (c) showing the off-axis matrix cracks in relation to stitching threads. (e,f) Magnified views of the highlighted regions in (d) showing the polymer stitching threads (light grey) and stained debonding along stitching threads (white). Dashed blue lines indicate the front of off-axis cracks and solid green lines mark the column where the stitching threads are located.

Stained off-axis cracks in the matrix were found to have initiated from specimen edges after 50,000 cycles (N_1) as a result of the axial tensile stress (see Figure 4b). After exposure to more fatigue cycles (N_2), the crack density increases dramatically. The observed increase in off-axis cracking has also been reported by Jespersen et al. [15] in a similar material. It is difficult to see the polymer stitching threads as their X-ray absorption capability is similar to that of the matrix material, as can be seen in the magnified views in Figure 4e,f. It has been observed in Figure 4d,f that the off-axis cracks in the matrix tend to be deflected when propagating into the stitching threads. This highlights the effect of stitching threads on delaying the propagation of off-axis matrix cracks from the edges by debonding. Once a crack crosses the column of material containing the stitching threads, it joins the off-axis cracks between backing fibres, as shown in the highlighted ellipse in Figure 4f.

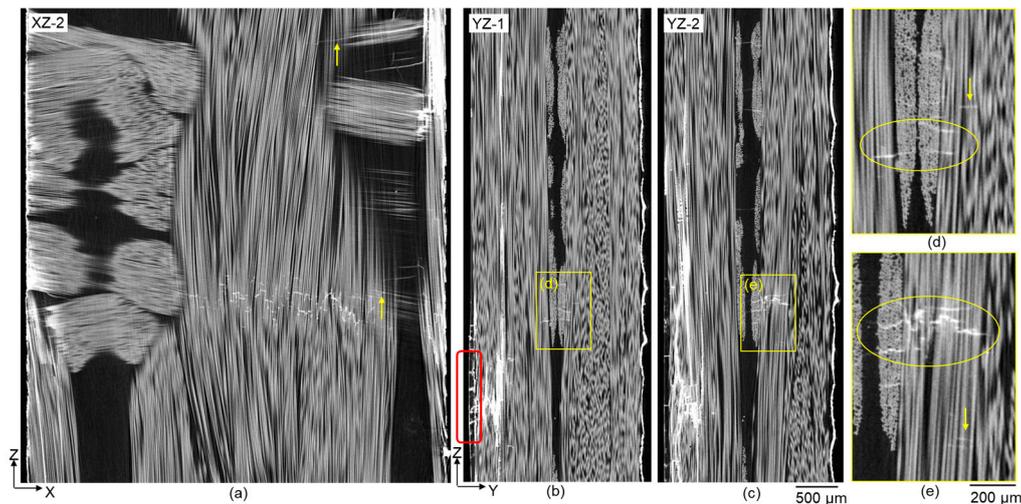
Figure 5. X-ray CT virtual (a) XZ-2 and (b) YZ-1 and (c) YZ-2 sections (positions indicated in Figure 3b,c) recorded after 500,000 cycles showing crack paths connecting off-axis cracks in the backing fibre bundles and fibre fractures in the UD fibre bundles. (d,e) Magnified views of the highlighted regions in (b,c) showing the connected off-axis cracks (marked with ellipses) and also isolated UD fibre fractures (marked with downward-arrows).

The presence of off-axis cracks in between backing fibres has been reported in a number of fatigue studies on this material [5,15] and is observed here after 500,000 cycles (see Figure 5). Only off-axis cracks that are stained were detectable with the current CT acquisition set-up. These stained off-axis cracks are distributed at different heights in the specimen and multiple ones sometimes occur within a single backing fibre bundle; these tend to be distributed vertically relative to one another due to stress

shielding [16]. The regions denoted by the upward arrows in Figure 5a and the highlighted ellipses in the YZ sections shown in Figure 5d,e highlight the joining of stained off-axis matrix cracks in the backing layer and stained fibre fractures in the UD bundles. This confirms the presence of a connecting path between the two damage modes. This observation supports the hypothesis [5] that off-axis cracking in backing fibre bundles triggers fibre fractures in the adjacent UD fibre bundles. It is worth noting that the stained fibre fractures were not necessarily directly connected to the off-axis cracks in some cases, as highlighted by the downward-arrows in Figure 5d,e. However, the fact that these fibre fractures were stained successfully means that they were connected to the free surface, either through cracks running into the specimen surfaces, or tunnel-cracks (through backing bundles) extending to the edges.

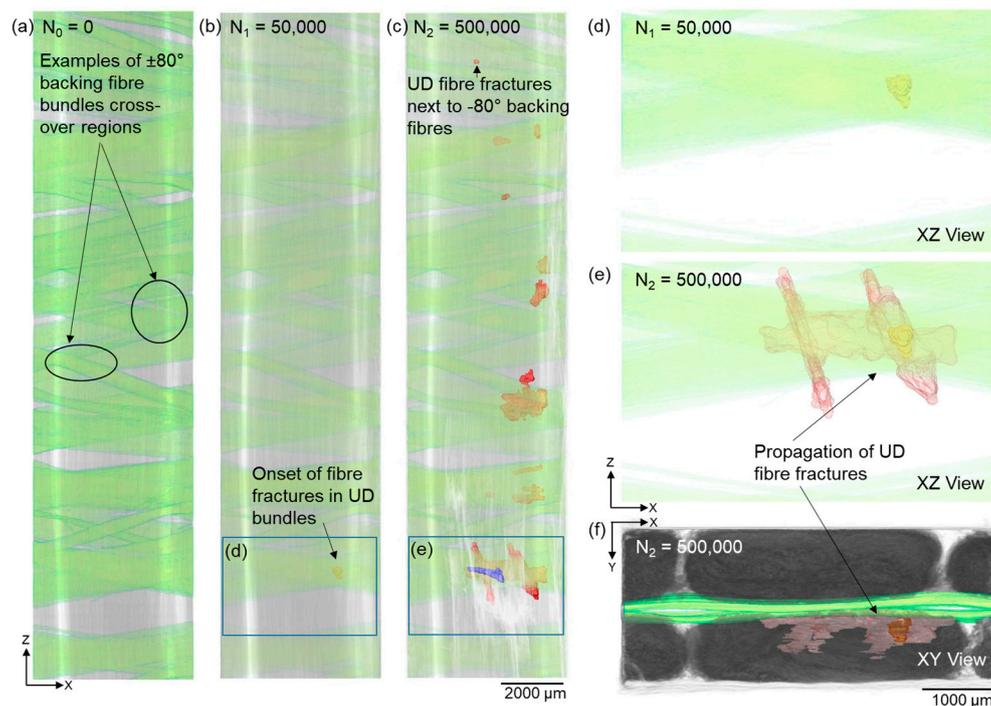
Figure 6. X-ray CT volume rendering of the backing fibre bundles (a) after 0 cycles showing the cross-over of the $\pm 80^\circ$ backing fibre bundles, as well as UD fibre fractures next to backing fibre bundles after (b) 50,000 and (c) 500,000 cycles, together with magnified views in (d,e) and in (f) the evolution and distribution of UD fibre fractures initiated from backing bundles after 500,000 cycles (refer to Figure 3 for explanations of colour coding). For 3D visualisation see the supplementary video.

Figure 6e,f shows the propagation of fibre fractures (shown red) between 50,000 and 500,000 cycles. The propagation here was seen to be mostly along the length and width directions rather than through thickness. In the case with backing fibres oriented at $\pm 45^\circ / 90^\circ$ [8] fatigued at maximum strain of 1%, fibre fracture was observed across the full width of the cross-over region and then propagated in the thickness direction. This difference in propagation sequence indicates the necessity of choosing the appropriate arrangement of backing fibres in the composite design for different wind turbine blade requirements. As can be seen in Figure 6e, this damage region has two elongated branches. A local variation in fibre orientation is evident in the 0° fibre bundle (see Figure 7g), which could be the cause of this damage morphology. In other words, 0° fibre alignment could be important in controlling the propagation of UD fibre fractures.

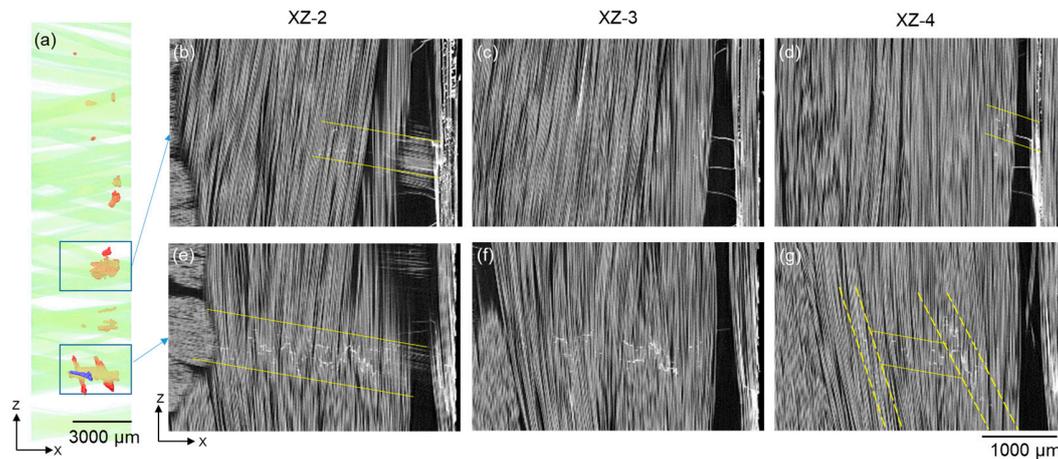
Figure 7. (a) XZ view of the rendered UD fibre fracture damage near the backing bundles after 500,000 cycles. (b–g) X-ray CT virtual XZ sections illustrating the distribution of UD fibre fractures at different positions through thickness in the specimen. The Y-positions of the XZ sections are shown in Figure 3c.

The distribution of UD fibre fractures in relation to the local microstructure within one damage region is revealed by the raw X-ray CT images where individual fibre fractures can be seen (see Figure 7). In the XZ sections near the backing fibre bundles, the distribution of fibre fractures tends to be aligned with the backing fibre bundle in contact with the UD fibres, as shown in the XZ-2 sections. This is also true for the UD fibre fractures at the edge of the UD bundle (see Figure 7a). Further away from the backing bundles, the distribution of fibre fractures is less dependent on backing fibre orientation but more affected by local fibre orientation in the UD bundle, as in the case for the XZ-3 and XZ-4 sections in Figure 7. It is noteworthy that the UD fibre fractures are seldom aligned in a continuous line; instead they tend to cluster in small numbers at different heights.

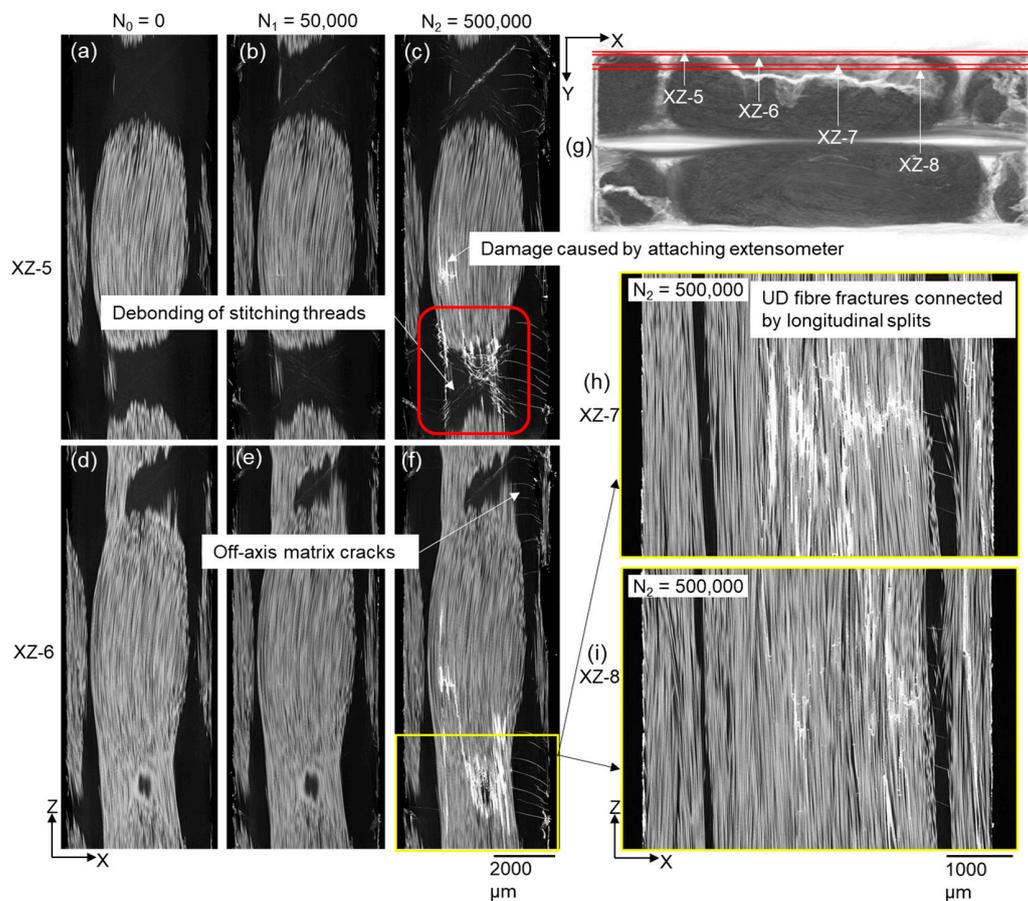
Figure 8. (a–f) and (h,i) Sub-surface X-ray CT virtual XZ sections showing the development of UD fibre fractures from the debonding of stitching threads. The Y-positions of the XZ slices are shown in (g).

UD fibre fractures were also observed to occur near one specimen surface after 500,000 cycles (see Figures 3 and 5). Figure 8 shows sub-surface XZ sections in this region through the fatigue cycling. It is evident that sub-surface debonding of stitching threads (see Figure 8b,c) is associated with fracture of the adjacent UD fibres in this region, presumably because of higher local stresses. It is worth noting that a number of longitudinal splits developed, connecting the UD fibre fractures that were relatively more distanced from each other (see Figure 8h). As shown in Figure 3a, this damage site is located on

the opposite side of the backing fibre bundles to that where fibre fractures initiate near the cross-overs after 50,000 cycles; this means that the damage sites are in two UD fibre bundles. However, these two damage sites are at a similar height, and the extents of propagation through the bundle thickness are similar. It is worth mentioning that another damage region was found further above the debonded stitching threads, which was caused by attaching the extensometer during the fatigue test.

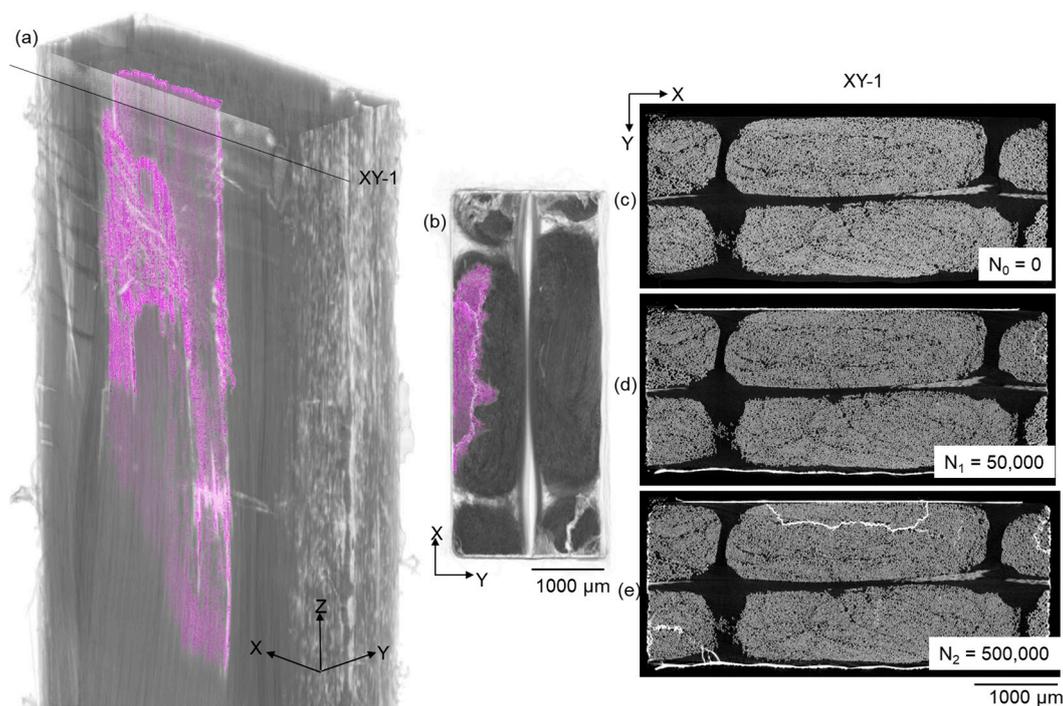
Figure 9. (a) Perspective and (b) plan view of the X-ray CT 3D volume rendering showing the extent of longitudinal splitting (purple), and an X-ray CT virtual XY section (position indicated in (a)) after (c) 0, (d) 50,000 and (e) 500,000 cycles showing the evolution of longitudinal splits.

Extensive longitudinal splitting has been observed in the UD bundle where sub-surface debonding of stitching threads at the cross-over region of the threads has occurred. The longitudinal splits in the UD fibre bundle are extracted and visualised in Figure 9. Longitudinal splitting tends to initially occur in the edge UD bundles due to the edge effect (see Figure 9d). After 500,000 cycles, a longitudinal split originated from a sub-surface debonded region (see Figures 5 and 9). A section of the UD fibre bundle is separated from the full bundle as shown in the XY-1 plane after 500,000 cycles, and also in the 3D view in Figure 9a. Apart from the fact that these splits are closely correlated with the UD fibre fractures, the splits lower the lateral constraint of the originally closely packed UD fibres, which could potentially make the composite susceptible to compressive loads and moisture. It could be inferred that if the wind turbine blades experience bending fatigue, longitudinal splitting could be a detrimental damage mode.
