# Damage of Hygrothermally Conditioned Carbon Epoxy Composites under High-Velocity Impact

**Abstract:** The influence of hygrothermal aging on high-velocity impact damage of carbon fiber-reinforced polymer (CFRP) laminates is investigated. Composite laminate specimens were preconditioned in water at 70 °C. The laminates were subsequently impacted by flat-, sphere-, and cone-ended projectiles with velocities of 45, 68, and 86 m/s. The incident and residual velocities were collected during the impact test. The impact-induced damages were measured by ultrasonic C-scan, a digital microscope system, and a scanning electron microscope. The results show that the hygrothermally conditioned laminates offer a higher energy absorption during high-velocity impact. Due to the weakening of the interlaminar properties, the hygrothermally conditioned laminates are more susceptible to delamination failure, and shear-induced debonding dominates. The projected delamination area increases with the increment of impact velocity. The damaged region becomes close to a circular shape after hydrothermal conditioning, and close to a rhomboidal shape for the dry specimens.

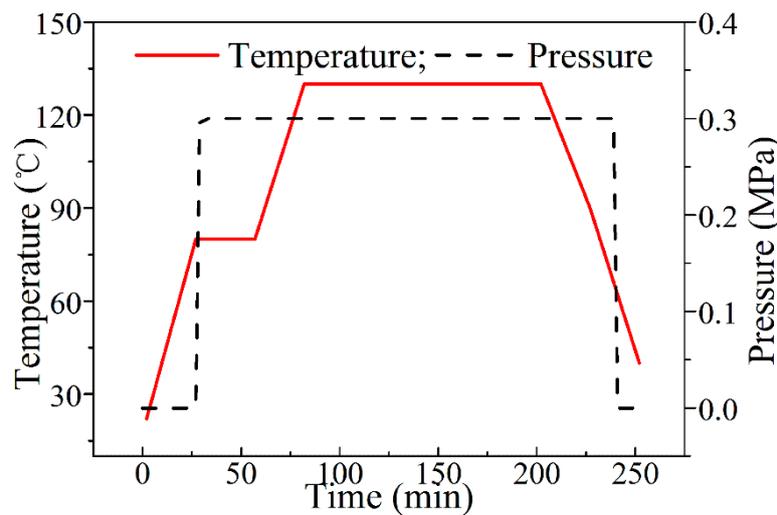
**Figure 1.** Curing cycle adopted for curing of carbon fiber-reinforced polymer (CFRP) laminates in an autoclave.

Laminates were fabricated by unidirectional carbon/epoxy prepreg T300/EM112 (manufactured by Jiangsu Hengshen Inc., Danyang, China) that had a resin content of 66% by weight and a cured layer thickness of 0.137 mm. The prepregs were cut into sizes of 115 × 115 mm<sup>2</sup> and stacked with a sequence of [0/90]<sub>8</sub>. The prepreg laminates were cured in an autoclave (RYG-21, Lontek Inc, Xi'an, China) with the curing cycle plotted in Figure 1. A two holding stages curve was used, where the dwelling stages were 80 °C for 30 min and 130 °C for 120 min, the heating rate was 2 °C/min and the cooling rate was −2 °C/min. The pressure of 0.3 MPa was applied during curing.

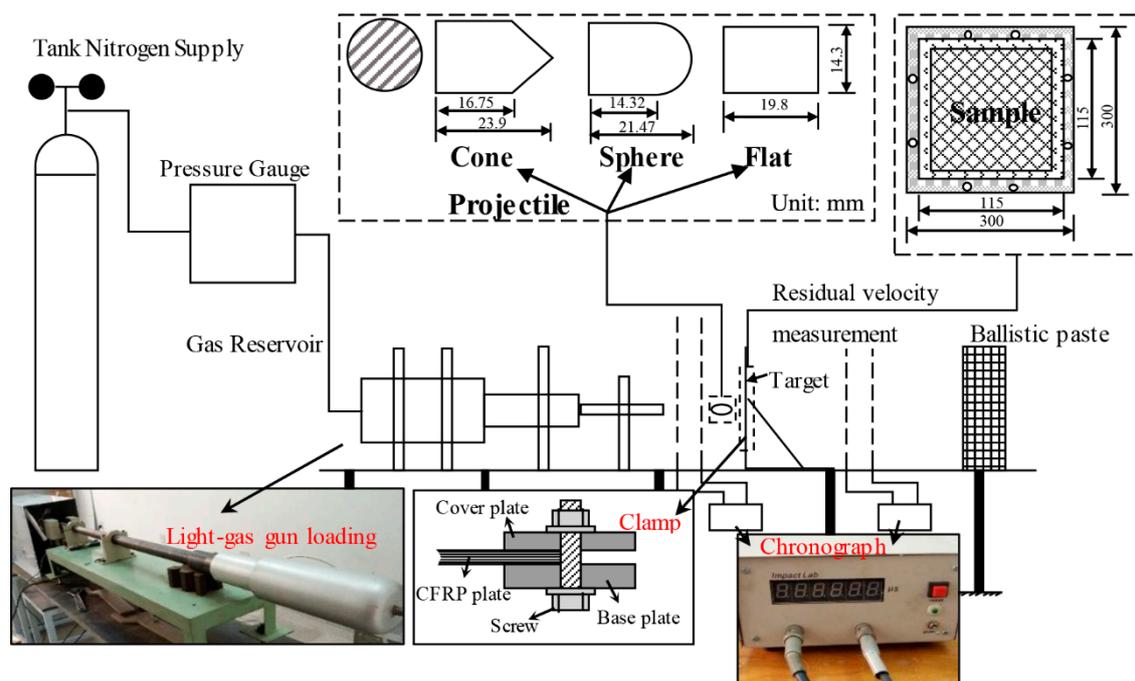
Figure 2. Schematic illustration of high speed impacting system.

Hygrothermal conditioned samples were subjected to high-velocity impact using a 14.5 mm diameter, 1.2 m long light-gas gun loading system. As shown in Figure 2, the impact testing device consists of a tank nitrogen gas supplier, a pressure gauge, a sample holder, two projectile velocity measuring units, and a ballistic paste. The samples were clamped on the holder. Three different projectiles with a diameter of 14.3 mm were used to investigate the effect of the geometry of impactor, including flat-, sphere-, and cone-shaped ends, as shown in Table 1. The incident velocity of the projectile was calibrated for nitrogen gas at various gas pressures. The residual velocity was measured by VISAR (Velocity Interferometer System for Any Reflector) technique. In this study, the saturated samples were subjected to incident velocities of 45, 68, and 86 m/s, respectively. Each test was repeated about 8–12 times.

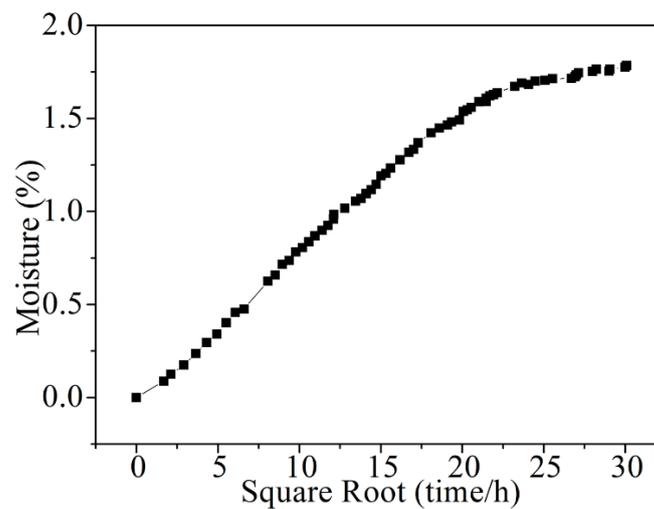
**Figure 3.** Moisture uptake profile of the CFRP laminates exposed to water at 70 °C.

The moisture absorption behavior is shown in Figure 3, where the percent weight gain is plotted as a function of the immersion time (s). The weight gain value for such a case at 600 h (25 days) was  $1.748 \pm 0.04\%$ . Afterwards, the moisture absorption goes to a stable stage. Since no significant increase of moisture content was observed after 40 days, the samples at 40 days were used as saturated ones

in this study. The average value of saturated moisture absorption was 1.775%. Using Fick's law [19], the diffusion rate was  $6.182 \times 10^{-7} \text{ mm}^2/\text{s}$ .

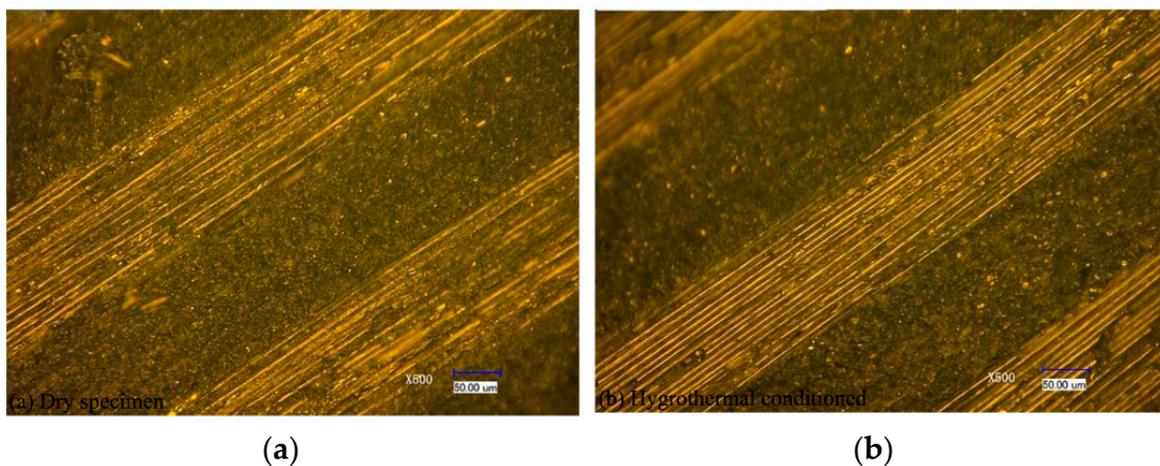
**Figure 4.** Images of the CFRP laminates in “dry” (a) and “wet” (b), hygrothermal (70 °C) conditions for 720 h using the three dimensional-super depth digital microscope (3D-SDDM) technique.

Figure 4 shows the microscopic images (magnified 500 times) of the specimen under a dry condition and a wet condition at 70 °C for 30 days using the 3D-SDDM technique. It shows that no damages (i.e., matrix cracking, interlayer splitting, and fiber disconnection) were observed, which indicates that the hygrothermal conditioning at 70 °C for 30 days had no significant influence on the sample surface finish and caused no irreversible material structural damage.

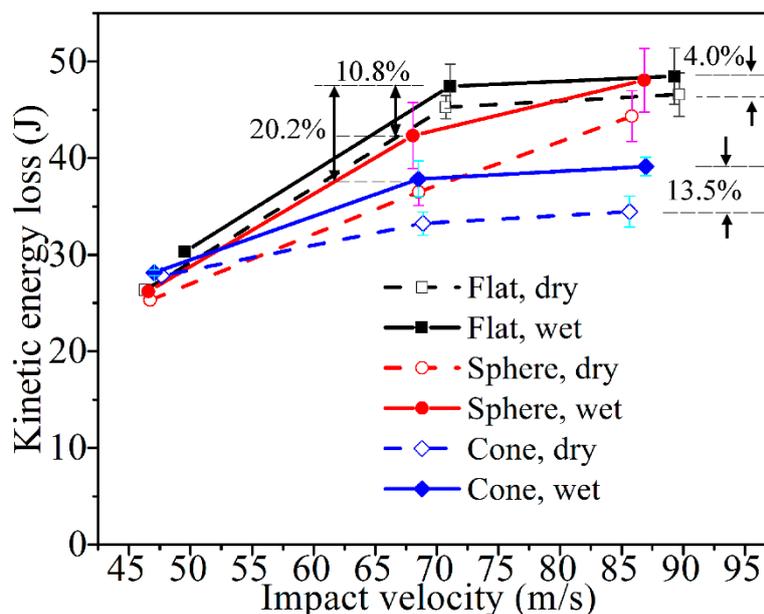
Figure 5. Incident impact energy loss of the CFRP laminates in “dry” and “wet”.

Figure 5 presents the energy absorbing performances of all the laminates. The impact velocities were not exactly equal with the presented 45, 68, and 86 m/s, respectively, because the projectile mass was different while the nitrogen gas pressure was fixed for three pressure levels. Because of the ricochet of the projectiles, the residual velocity was not collected effectively, and data points are calculated inadequately in several cases. For example, with the impact velocity of 45 m/s, it was found in the experiments that the flat- and sphere- ended projectile did not perforate the laminates and ricocheted. Particularly for the flat end, the ricochet was sensitive to the non-uniform reaction on the contact surface [20]. The corresponding ricochet route could be irregularly oblique. Along with the small velocity, it was difficult to accurately and effectively capture the ricochet path. Then the time intervals in those cases could not be recorded effectively. Thus, the limited corresponding residual velocities, which were inadequately measured, were only qualitatively given for the trending analysis.

For other impact cases with velocities of 68 and 86 m/s, the projectiles perforated the CFRP laminates. With the incident and residual velocities, the corresponding kinetic energy loss was calculated using Equations (2)–(4). Compared with the dry specimens, the saturated specimens have higher kinetic energy loss, indicating that more energy was absorbed during the impact incidents of the wet ones. When the dry specimen is impacted by the cone-ended projectile at a velocity of 86 m/s, the energy loss is 13.5% greater than that for the dry one; when the projectile is a flat-ended projectile, the energy loss for the wet specimen is 4.0% greater than that for the dry specimen. In some cases, evident standard deviations could be found. This is owing to a few scattered data in the single case, which is supposedly induced by the difficulty in controlling the incident angle, which may lead to

Moreover, this law could be appropriate for the presented different projectile ends. Of the cases with the same incident velocity and environmental condition, the loss of kinetic energy for the flat-ended projectile was the highest, followed by the sphere-ended one, and the cone-ended one was the lowest. For instance, when the wet specimen was impacted by the flat-ended projectile at a velocity of 68 m/s, the energy loss was 10.8% greater than that of the specimens impacted by the sphere-ended one, and 20.2% greater than that of the case with the cone-ended projectile. It indicates that the saturated specimens have the strongest resistance to the incident impact of the flat-ended projectile, while the weakest resistance refers to the cone-ended projectile.

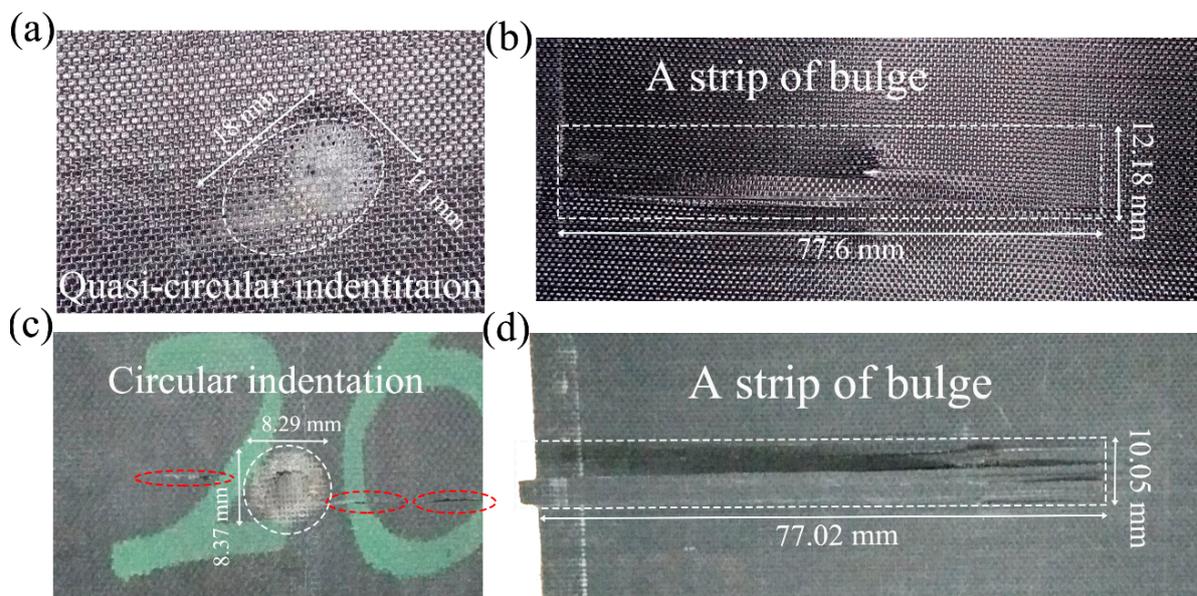
**Figure 6.** Photos of (a) the front and (b) back faces of a dry specimen, (c) the front and (d) back faces of a saturated specimen under an impact velocity of 45 m/s with the sphere-ended projectile.

As seen in Figure 6, an indentation left in the front face of the dry laminates after the impact of the sphere-ended projectile with the velocity of 45 m/s, followed by a bulge in the back face. In the saturated specimens, due to the hygrothermal effect, the indentation was centralized in a smaller region, along with a more evident rupture. In the front faces, the collapse was also deeper than the dry one, and several transverse cracks occurred near the indentation. Correspondingly, the bulge was progressive in the back face, and the edge of some fibers appeared tilted, which suggests that fiber and matrix slipped relative to each other. At the other end of these fibers, strips of transverse cracks occurred, and it further indicates the weak bonding between fiber and matrix.

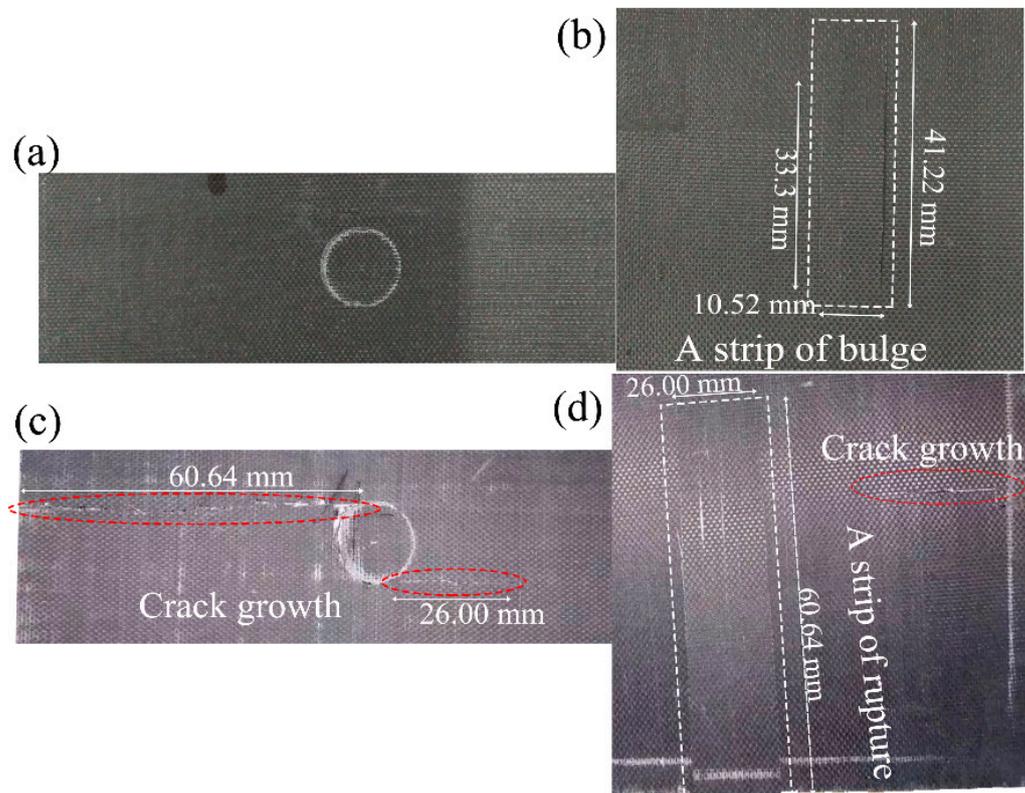
**Figure 7.** Photos of (a) the front and (b) back faces of a dry specimen, (c) the front and (d) back faces of a saturated specimen under an impact velocity of 68 m/s with the flat-ended projectile.

Figure 7 presents the morphology of the laminates after the impact of the flat-ended projectile with the velocity of 68 m/s. Although the impact velocity was higher, the projectile bounced back, and no apparent indentations were visualized in the front face after the flat-ended projectile impacted

the dry specimen. Only a bulge of length 10.52 mm and width 33.3~41.22 mm could be observed in the back face. For the saturated specimen, an indentation in the front face was left after impact. Near the indentation edge, two transverse cracks of lengths 60.64 and 26.00 mm appeared. The bulge formed in the back face occurred tilted, with a length of 60.64 mm, which was consistent with the indication that the weak bonding between fiber and matrix exists in the wet specimens.

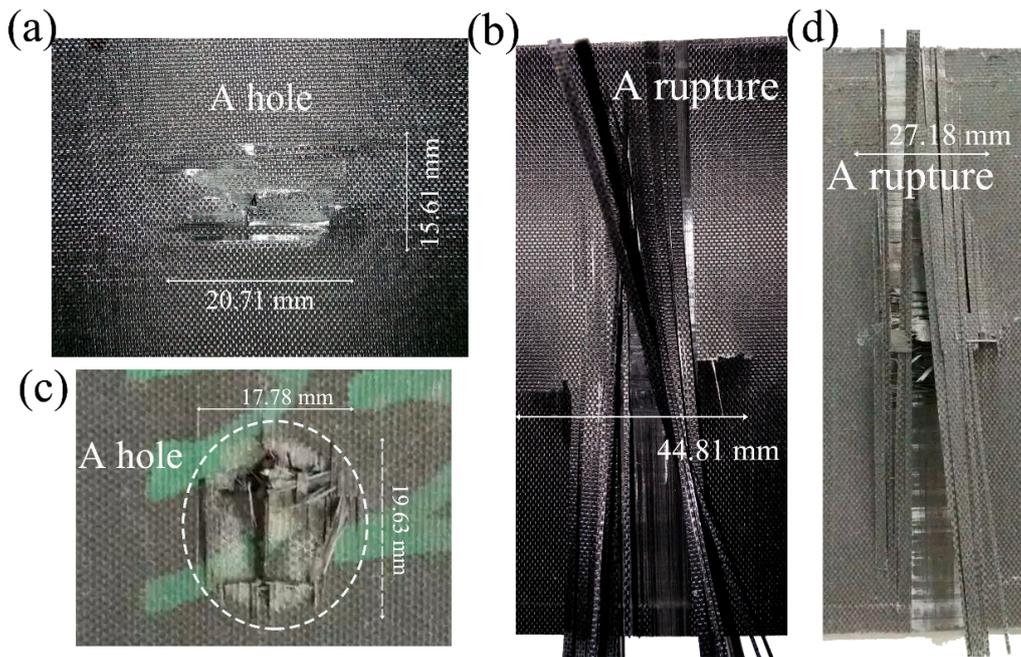
**Figure 8.** Photos of (a) the front and (b) back faces of a dry specimen, (c) the front and (d) back faces of a saturated specimen under an impact velocity of 86 m/s with the cone-ended projectile.

The morphology of the laminate faces after the impact of the cone projectile at 86 m/s is presented in Figure 8. Due to the perforation, a hole was left in the front faces. A combination of the interlaminar separation (delamination) and tensile crack propagation was followed in the back faces, along with cruciform-type bulges. In the dry samples, the free edge of the damaged front layer still overlapped on the fracture edge after the perforation. Near the hole, several extended cracks accompanied. In the back face, a 44.81 mm length of transverse crack occurred, along with many separated fibers tilted. Instead, for the wet sample, the fibers near the fracture were clearly broken and disconnected from the neighboring panel. The fracture morphology was shaped like a “window”. The transverse fibers upon the back face were also broken, while the fracture below the last layer can be visualized.

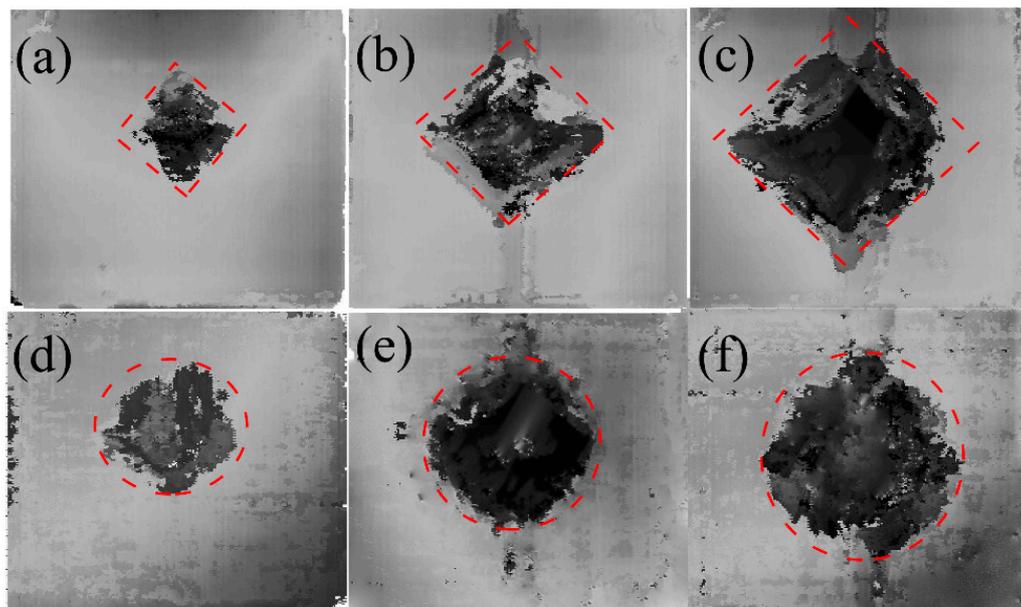
**Figure 9.** C-scan characteristic of the specimen after the impact velocities of (a) 45 m/s, (b) 68 m/s, and (c) 86 m/s in “dry” and of (d) 45 m/s, (e) 68 m/s, and (f) 86 m/s in “wet” for the flat-ended projectile.

Figure 9 plots the C-scan characteristic of the specimens after the impact of the flat-ended projectile at 45, 68, and 86 m/s in Figure 9a–c “dry” and Figure 9d–f “wet”. In such cases, the damaged areas in the saturated specimens in Figure 9d–f were close to the ellipse shape, whereas those in the dry one in Figure 9a–c were approximately rhomboidal in shape. Such differences of the damaged areas between

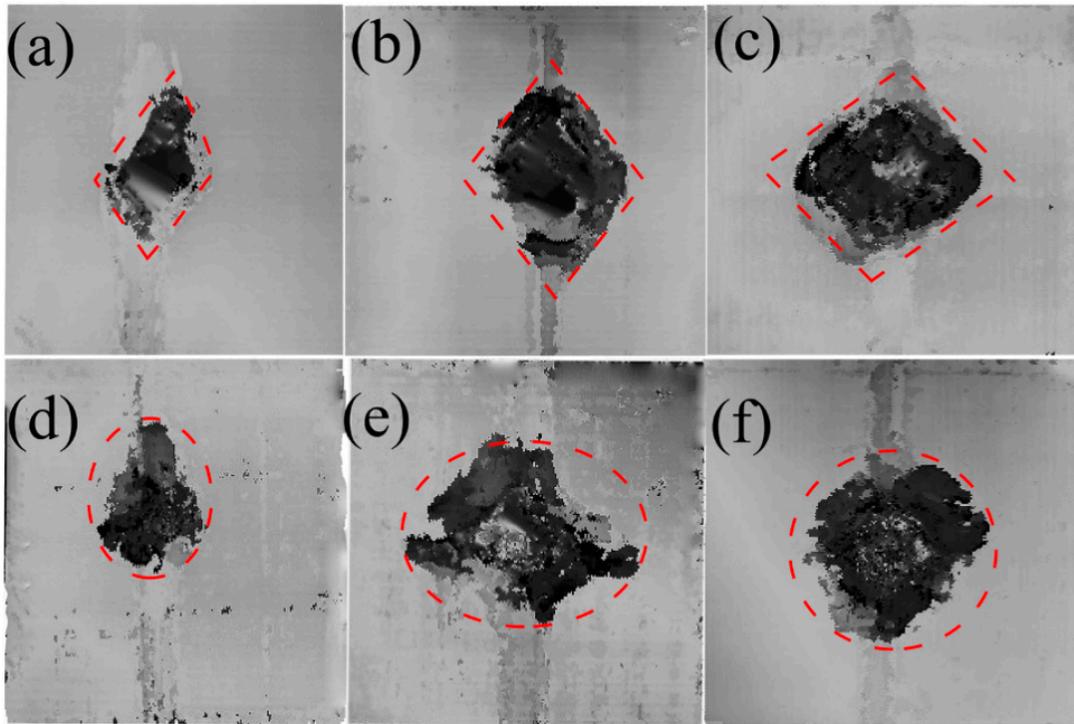
**Figure 10.** C-scan characteristic of the specimen after the impact velocities of (a) 45 m/s, (b) 68 m/s, and (c) 86 m/s in “dry” and of (d) 45 m/s, (e) 68 m/s, and (f) 86 m/s in “wet” for the sphere-ended projectile.

the dry samples and the saturated sample could be also seen in other projectile ends, as shown in Figures 10 and 11.

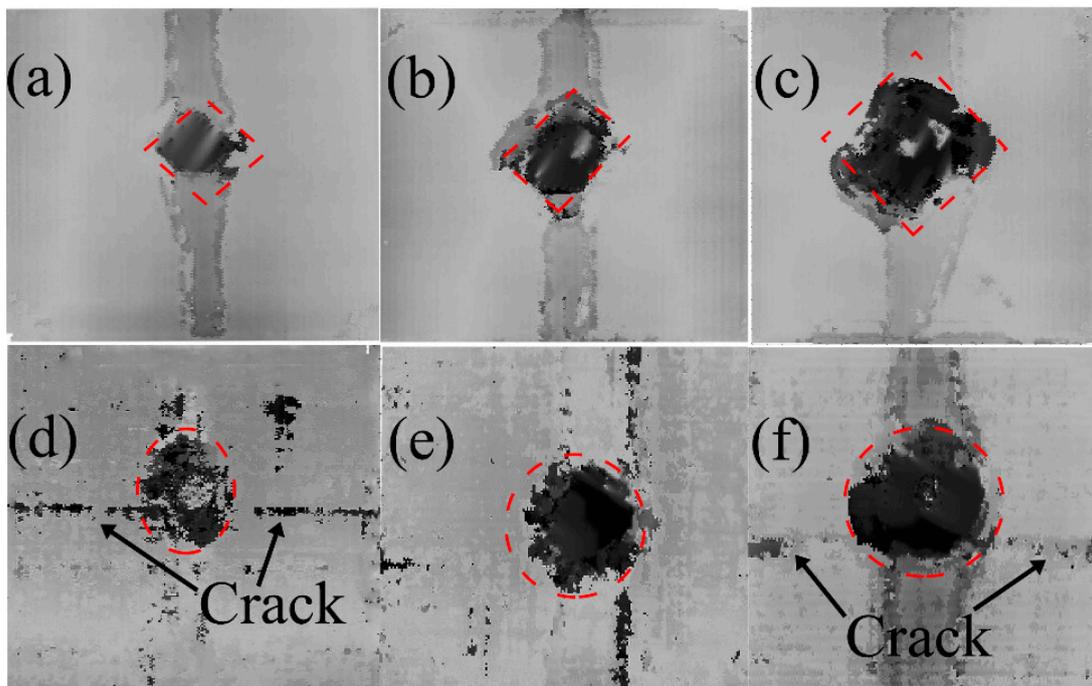
**Figure 11.** C-scan characteristic of the specimen after the impact velocities of (a) 45 m/s, (b) 68 m/s, and (c) 86 m/s in “dry” and of (d) 45 m/s, (e) 68 m/s, and (f) 86 m/s in “wet” for the cone-ended projectile.

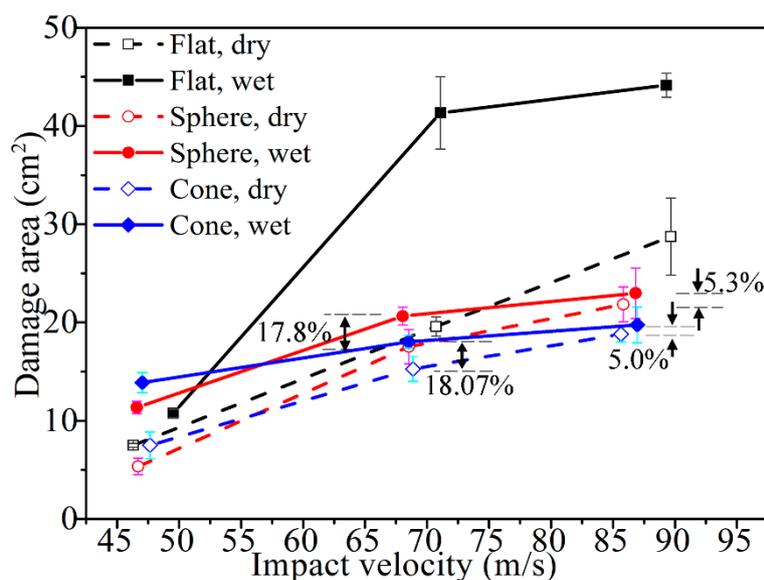
Figure 12. Projected damaged areas of the CFRP laminates in “dry” and “wet”.

To quantitatively understand the delamination area, the damaged areas for all those cases are presented in Figure 12. The damage geometry as observed through the C-scan images yielded higher values than those calculated from visual observation. Along with Figures 9–11, this figure displays that the damage extent increases from the dry samples to the saturated samples, when the impact velocities or the projectiles are different. Under the impact of the same velocity of 68 m/s with the sphere-ended projectile, the wet specimen has a 17.8% increase in the damaged area relative to the dry specimen; the damaged area of the wet specimen increases 18.07% when the projectile is cone-shaped. These results indicate that the delamination damage is more likely to occur due to the severe degradation of the interlayer performance when the specimen is hygrothermally conditioned. However, this law is found to be somewhat different from that of the energy absorption in Figure 5, which further indicates that the kinetic energy dissipates in other ways other than the occurrence of delamination, such as fiber fracture and the matrix cracking. The results also show this increase grows limitedly when the impact velocity becomes high to a certain level or the projectile end becomes sharp to a certain extent. For example, the wet specimen impacted at a velocity of 68 m/s with the cone-ended projectile had a 5.0% increase in the damaged area, compared to the dry specimen. It could be found that the wet specimens impacted by the velocities of 68 and 86 m/s with the flat ended projectile had a relatively higher damaged area than others, which might be related with the different impact responses of the wet laminates by the flat-ended projectile. However, the reason is still unclear.

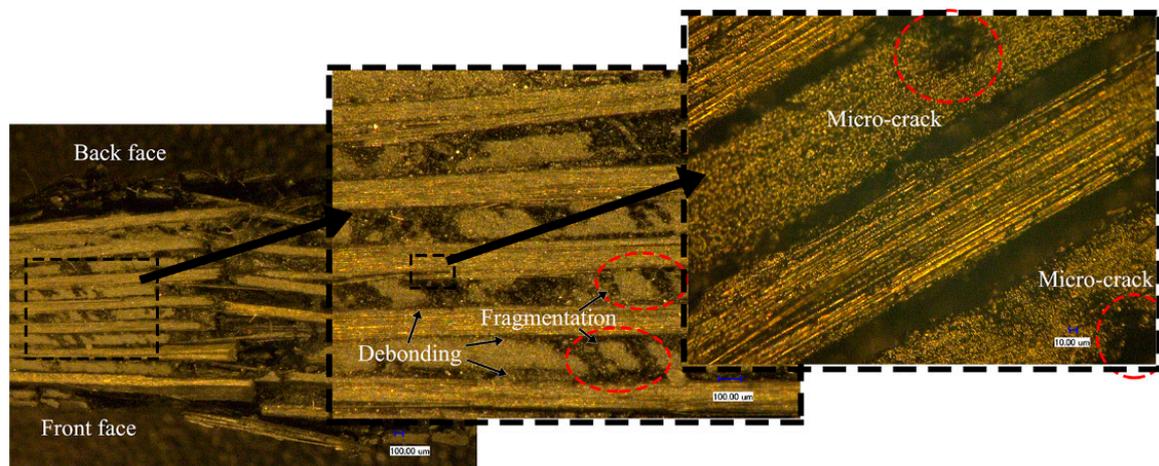
**Figure 13.** Impact-damaged images of the dry specimen subjected to the impact velocity of 45 m/s using the 3D-SDDM technique.

The cross-sectional features of the fiber/matrix interface using the 3D-SDDM technique ( $10\ \mu\text{m}\sim 1\ \text{mm}$ ) are presented in Figures 13 and 14 where the impact case of the cone projectile at 45 m/s is given. The hygrothermal effect can be presented by comparing the micro images of the dry specimen, as shown in Figure 13, with those of the wet specimen, as shown in Figure 14.

Comparing Figure 13 with Figure 14 shows that the rupture development in the dry specimen includes matrix cracking, interface debonding, and fiber breaking through the cross section. Micro-cracks in the matrix were produced due to the impact. Part of the matrix near the indentation was broken into particles and scattered between the fibers. The fiber/matrix debonding and delamination were clearly visualized. Relatively, the saturated specimen mainly exhibited evident deflection in the back face, indicating the easiness for the cone projectile to wedge through the composite face. Thus, the perforation should be featured with more fiber stretching, higher tensile and flexural modulus, fiber breakage, and consequently higher energy absorption. It indicates the composite should have higher resistance to fracture or impact damage.

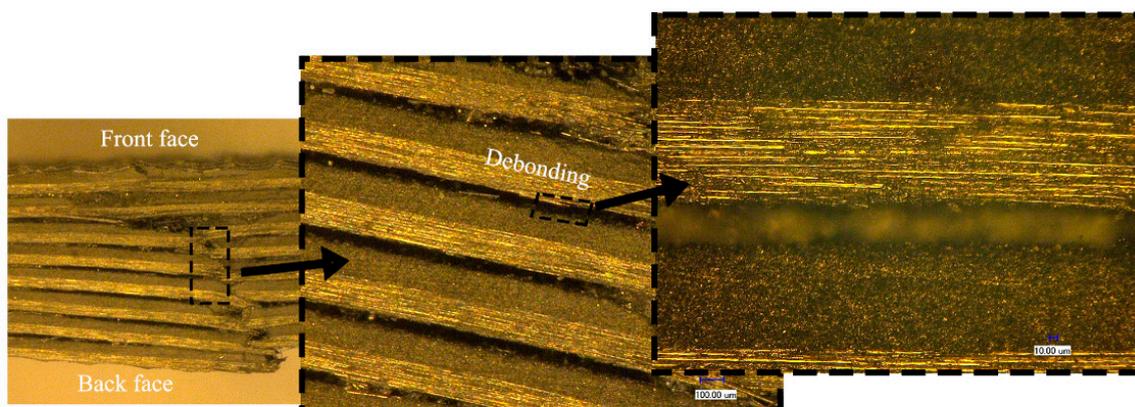
**Figure 14.** Impact-damaged images of the saturated specimen subjected to the impact velocity of 45 m/s using the 3D-SDDM technique.

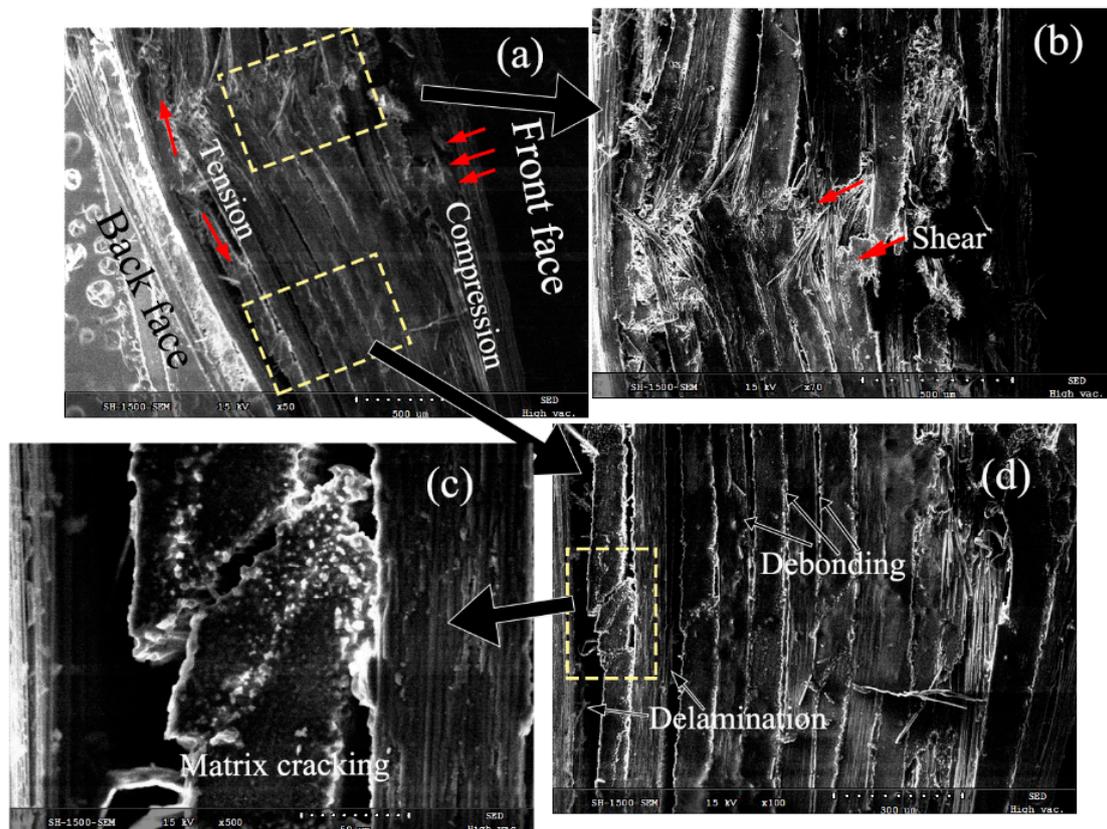
**Figure 15.** Fracture patterns of the dry specimen subjected to the impact velocity of 45 m/s using the SEM technique. (a) Compressive damage; (b) Shear damage; (c) Matrix cracking; (d) Extensive debonding and delamination.

To further understand the damage mechanism, Figures 15 and 16 present the SEM characteristics of the laminates at the core fracture regions of the dry and saturated samples. They particularly provide the damage features of the fiber fracture, the matrix crack, and the interlaminar fracture.

In Figure 15, the compressive, as shown in Figure 15a, and shear damages, as shown in Figure 15b, in the dry specimens were evidently found on the front laminate layer. It indicates that the fiber/matrix cracking in the front face was caused by compression and shear action. Subsequently, the broken fibers in the core fracture were seen still connected, and the extensive debonding and delamination could be observed along the fiber, as shown in Figure 15d. It could be explained by that the fibers and matrix moved with the projectile, while still bonding to the panel and retaining the resistance to the impact. The effective mass of the impactor increased due to the addition of the shear plugging [23] so that the penetration velocity decreased. The friction force or the shear stress imposed on the laminates also decreased. Moreover, crack propagation was transmitted to the neighboring undamaged matrix and fibers. The damaged features, as shown in Figure 15a, indicates that the fiber/matrix cracking in the back face is caused by stretching and delamination. As the damage in the front layer is more serious with spallation state, the compression and shear action in the front face was dominant in the damage process for the dry samples.

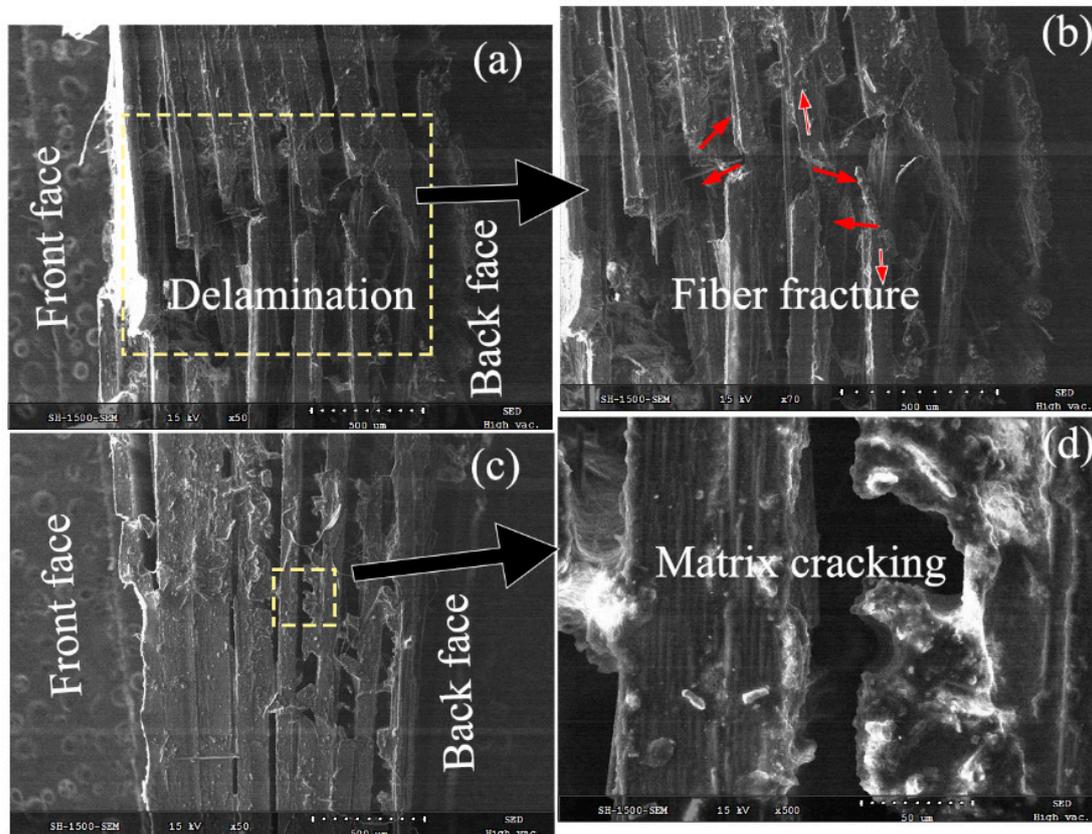
**Figure 16.** Fracture patterns of the saturated specimen subjected to the impact velocity of 45 m/s using the SEM technique. (a) Delamination damage; (b) Fiber fracture; (c) Matrix/fiber interface; (d) Matrix cracking.

As plotted in Figure 16, the matrix near the fracture was crashed into pieces and almost shed from the fiber, as shown in Figure 16b. Most of the matrix in the back faces slid and only a small part was still attached to the fiber, as shown in Figure 16c. The fiber fracture appeared as a blunt shape without fiber connection. Combined with the perforation and the delamination area, the prevailing failure modes of the impact damage in the saturated specimens are a shear-induced delamination failure of the fiber/matrix interface and tensile failure of the fibers. However, when the velocity was much higher, it could be known that the delamination failure might have completed before some fibers stretching could respond, as shown in Figure 8c. Without the responses of the matrix cracking and fragmentation to resist damage initiation, the fibers were solely broken due to the imposed action

exceeding their strength limits. Thus, the shear-induced delamination was the main failure mode in the high-velocity impact in wet samples, as the tension of the composite plies could provide auxiliary resistance to damage.
