Article

Hydrogen-Assisted Crack Growth in the Heat-Affected Zone of X80 Steels during in Situ Hydrogen Charging

Keywords: heat-affected zone; hydrogen embrittlement; electron backscatter diffraction; crack propagation path

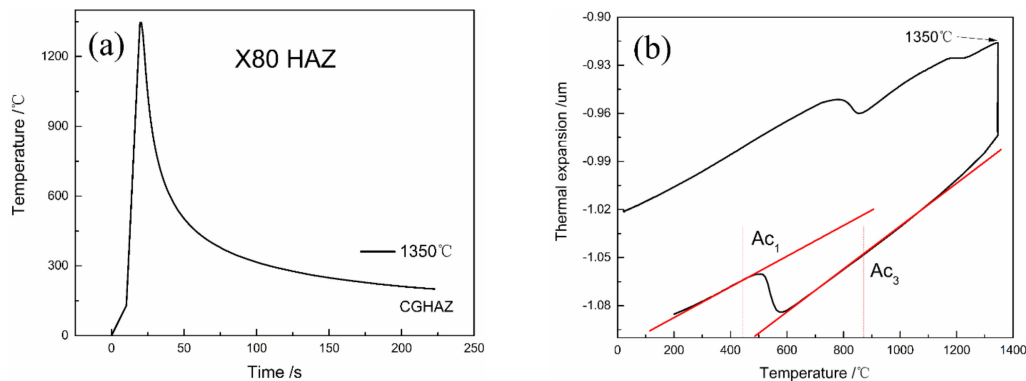
Figure 1. Schematic of the (a) welding thermal cycles and (b) transformation point.

Owing to its high HE susceptibility, coarse-grained HAZ was used as a representative area for the HAZ [37]. The simulated samples were heated up to 1350 °C, held at that temperature for 5 s, and then cooled to room temperature using a Gleeble 3500 thermomechanical simulator (Dynamic Systems, New York, NY, USA), as shown in Figure 1a. The transformation point in the welding thermal cycles was also measured using Gleeble 3500 apparatus (Dynamic Systems, New York, NY, USA), and the results are shown in Figure 1b. The A_{c3} was approximately 860 °C, which resulted in phase transformation.

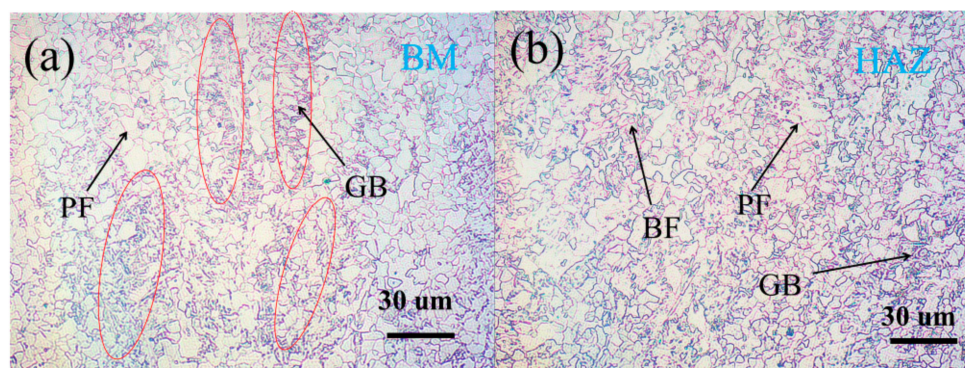
Figure 2. Microstructure of the X80 steel observed by optical microscope (OM) in the rolling-transverse direction: (a) the base metal (BM) and (b) heat-affected zone (HAZ).

The microstructures of the base metal and HAZ are shown in Figure 2. The X80 steel used herein is a dual-phase steel, wherein the base metal is comprised of polygonal ferrite (PF) with fine grains and granular bainite (GB), which is comprised of fine lath ferrite and some island constituents [40] (Figure 2a). The fraction of PF microstructure in the base metal was about 60 vol.% and the average grain size was estimated to be 8 μm . The GB and PF microstructures were alternated in the steel, which is caused by steel rolling process. The microstructure of the HAZ comprised bainite ferrite (BF), GB, and PF (Figure 2b). Moreover, decreased and increased GB and BF contents, respectively, were observed in the HAZ, and GB was randomly distributed in comparison with the base metal. The fraction of PF microstructure in HAZ was about 80 vol.% and the average grain size was estimated to be 11 μm .

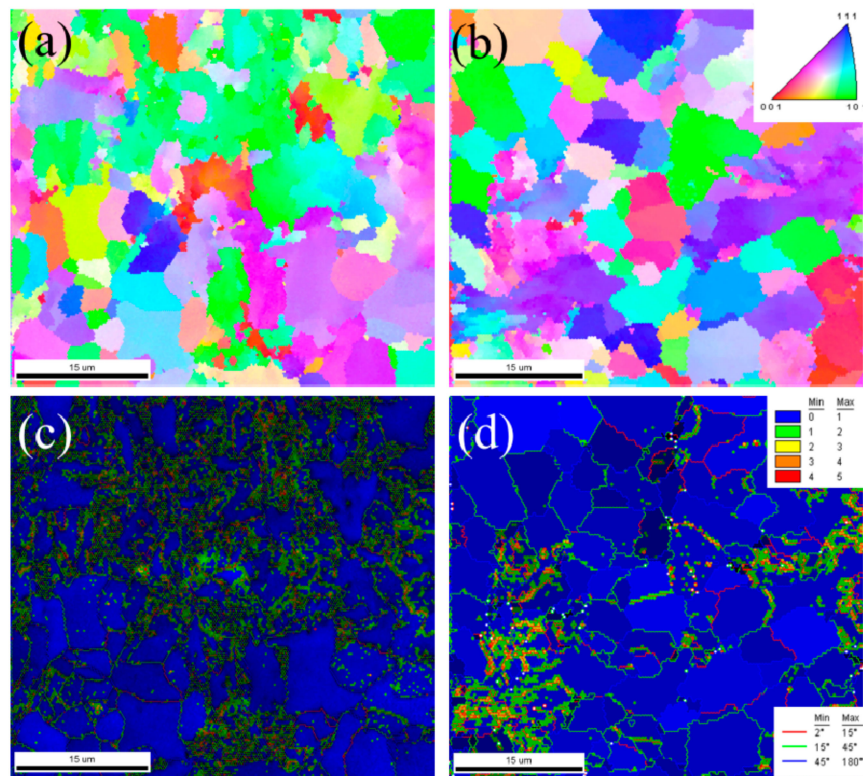
Figure 3. Inverse pole figure (IPF) maps of the (a) BM and (b) HAZ. image quality (IQ) maps with kernel average micro-orientation (KAM) maps and grain boundary misorientation distribution of the (c) BM and (d) HAZ.

The inverse pole figure (IPF) maps, corresponding image quality (IQ) maps with kernel average micro-orientation (KAM) maps, and grain boundary misorientation distribution of the HAZ microstructure are shown in Figure 3. The analysis results obtained from EBSD are consistent with OM observations, and more crystallographic information was determined through EBSD measurements. The degree of local strain in the GB zone is greater than PF zone owing to the high grain boundary density (Figure 3c,d). A PF grain with a grain size of approximately 10 μm is present as a soft phase due to the low local strain. The GB character has a significant effect on the cracking paths [40] and hydrogen diffusion [41]. GBs are the preferential sites, where hydrogen atoms are trapped, due to the high density of dislocations. Therefore, the base metal shows a lower HE susceptibility than the HAZ [32]. Typical load-displacement curves of the base metal and HAZ are shown in Figure 4. The nanohardness of the HAZ is 2.71 GPa, which is 32% lower than that of the base metal. Increased grain

size and local strain, as well as the decreased GB content [42] lead to a decreased hardness of the HAZ samples.

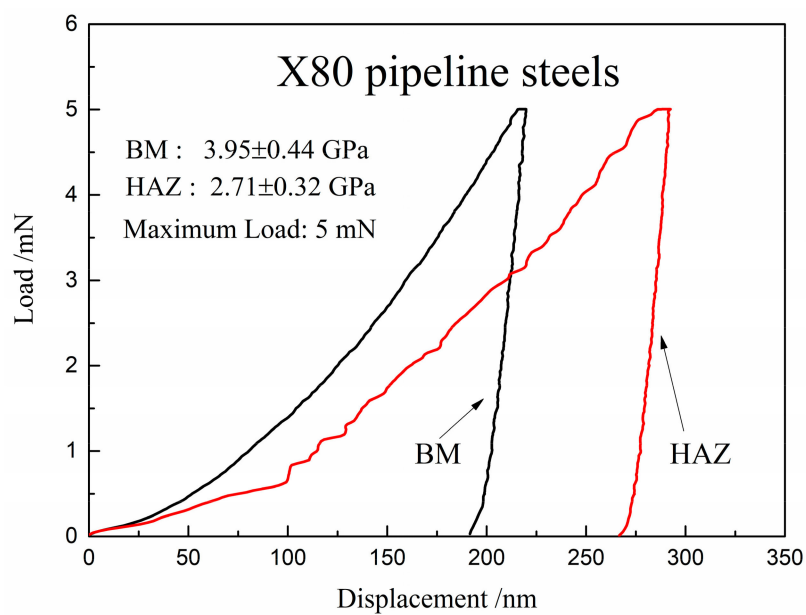
Figure 4. The displacement-load curves of the X80 base metal and HAZ.

generally associated with the strength and hardness of the X80 steel, as shown in Figures 4 and 5. Zhao et al. showed that the hydrogen diffusivity of a simulated HAZ was higher than that of a base metal, which indicated a higher HE susceptibility [37]. Alvaro et al. investigated the HE susceptibility of the HAZ of X70 steel with the results confirming that the critical hydrogen pressure for the onset of HE was between 0.1 and 0.6 MPa, which was lower than that of the base metal [35]. The above discussion confirmed that HAZ has a low GB ratio, which increases the hydrogen diffusivity rate in comparison with that of the base metal. The HE susceptibility of the HAZ is higher than that of the base metal, as shown in Figure 5. Koyama et al. [62] reviewed the recent progress in the microstructure-specific hydrogen mapping techniques and many important results were obtained. The relation between the microstructure of the HAZ and HE susceptibility requires further study by using those advanced techniques.

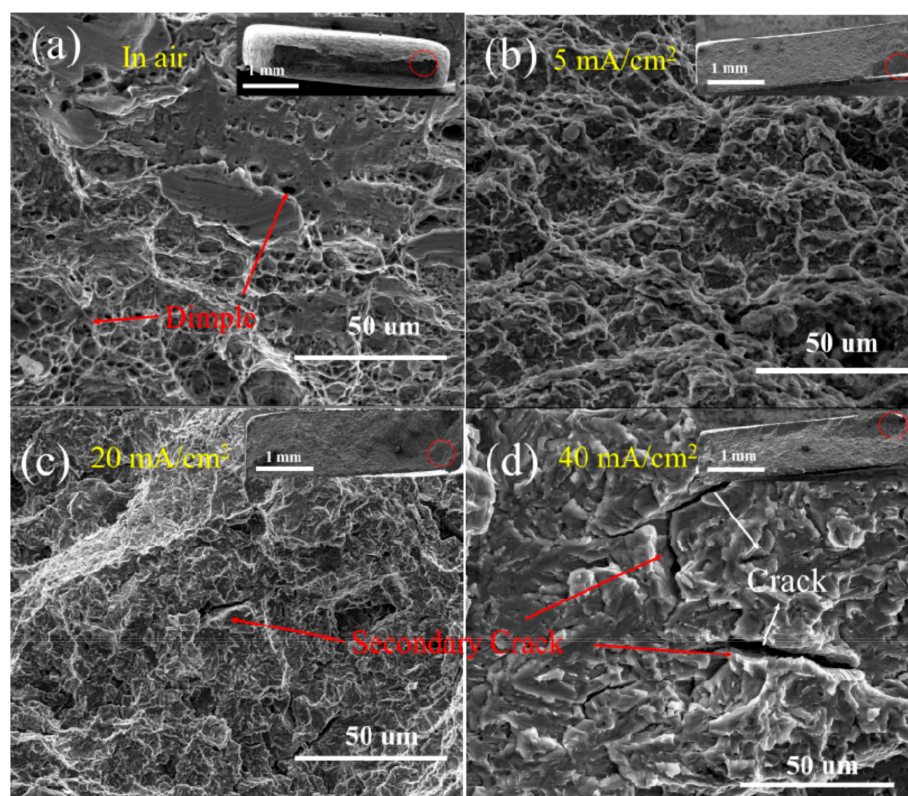
Figure 7. The fracture surface of the HAZ samples tested in (a) air and during in situ hydrogen charging at different current densities of (b) 5, (c) 20, and (d) 40 mA/cm².

Fractographic details of the tensile fracture surfaces of the hydrogen-charged HAZ samples at different current densities can be seen in Figure 7. Typical necking was observed in the macroscopic fracture morphologies of the samples tested in air (Figure 7a), with the dominant feature being the ductile dimples. The observed fracture surfaces of the hydrogen-charged HAZ samples at different charging current densities were notably different (Figure 7b–d). Hydrogen significantly reduced the necking in the samples, and fracturing around the root of the surface comprised secondary cracks and flat facets, which are typical HE features. The length and size of the secondary cracks increased with an increase in the current density, which suggests a higher HE susceptibility. Ductile dimples were the dominant feature in the center of the fracture surface.

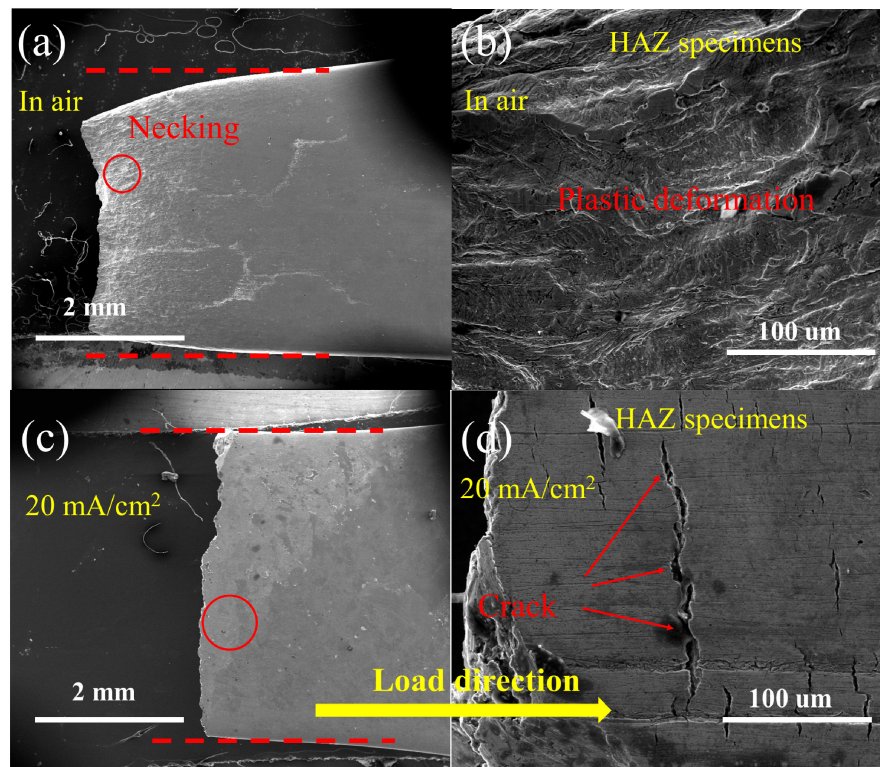
Figure 8. The morphology of the lateral morphologies of the heat-affected zone (HAZ) (a,b) in air and (c,d) during in situ hydrogen charging at a current density of 20 mA/cm².

Figure 8 shows the fracture lateral morphologies of the HAZ samples in the absence and presence of hydrogen. Necking can be observed in the macroscopic fracture surface of the HAZ sample tested

in air, as shown in Figure 8a,b. Figure 8c,d show that the surface consists of some cracks that are rather homogeneously distributed. The important issue is the crack propagation path. Figure 8d shows that five or more cracks may join together to yield a longer crack. The fracture features in the presence of hydrogen prove that it induces two main damage modes. Cracks located in the bulk of the samples were visible on the fracture surface of the samples at a constant current of 40 mA/cm² (Figure 7c,d). Brittle circumferential cracks located at the surface of the sample are perpendicular to the loading direction (Figure 8d). The surface cracks in or near the surfaces are attributed to the hydrogen-induced degradation of the steel. Therefore, the failure process of steels can be deduced by studying the paths of the cracks in the fracture surface.

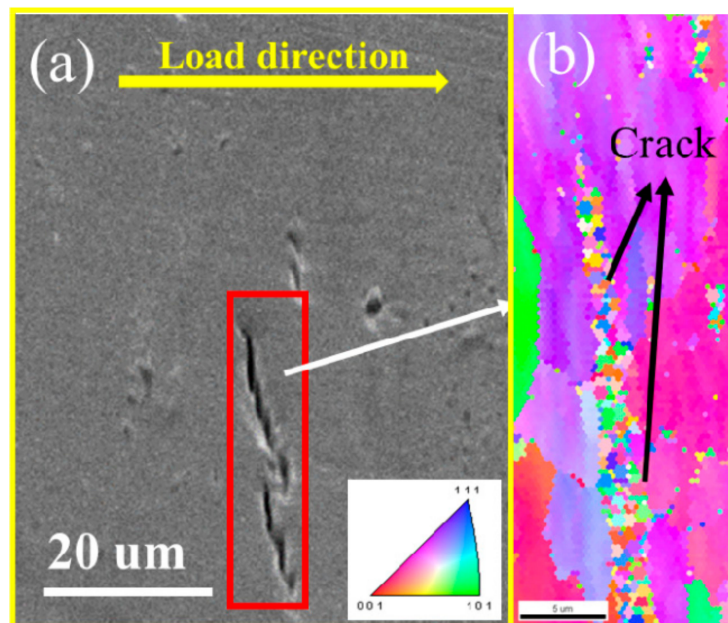
Figure 9. Microstructure of the lateral surface of a HAZ sample in the vicinity of the hydrogen-induced cracking (HIC): (a) Scanning electron microscopy (SEM) image and (b) The inverse pole figure (IPF) map.

Hydrogen induced cracking (HIC) always initiates at the surface in this steel. Figure 9 shows the typical crack propagation in the surface of the HAZ after tensile tests at a current density of 20 mA/cm². The two crack paths are not linear along a direction. A small crack forms between the two cracks where a high-strain field and two cracks are about to be connected. Figure 9b shows the IPF maps of two cracks that may join together. The same color in IPF maps indicate the same grain orientation. The upper crack propagates through the coarse grain and stops in this grain. The coarse grain, which may be the ferrite grain, reduces both the hydrostatic stress and the effective stress. This increases the tearing resistance and the crack propagation stops. The other crack is due to intergranular cracking, the propagation path of which runs along the grain boundaries. Hydrogen-assisted crack propagation along the special grain boundaries has been reported in many studies [26,27]. Mohtadi-Bonab et al. investigated the crack nucleation and propagation sites of X70 due to hydrogen and showed that the grains that were oriented for relatively easy slip were subject to intergranular cracking, and those grains tended to be resistant to yielding [26]. The grains that did not yield easily were more prone to transgranular cracking. Dadfarnia et al. found that cracks without hydrogen grew by successive growth and linked the void closest to the crack tip with the crack tip. However, several voids grew

and coalesced simultaneously in the presence of hydrogen [48]. Those cracks grew in a stepwise manner [40].

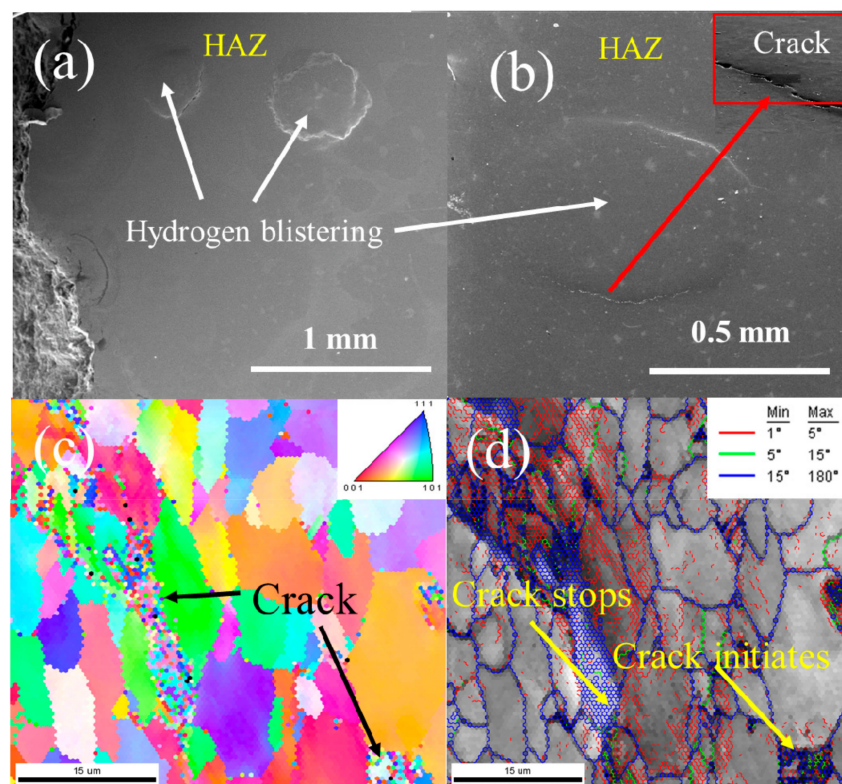
Figure 10. Hydrogen blistering and a crack on the surface of the HAZ samples after tensile tests at a current density of 40 mA/cm²: (a,b) SEM image of the hydrogen blistering; (c) IPF map of the crack, and (d) IQ maps with the grain boundary misorientation distribution of the cracks.

Some blisters were present in the lateral surface of the HAZ sample after tensile tests were conducted at a current density of 40 mA/cm^2 with sizes of over 0.5 mm in length, as shown in Figure 10. Some cracks were formed at the edge of the blisters, and the corresponding IPF and IQ maps with grain boundary misorientation distributions can be observed in Figure 10c,d, respectively. Blisters may form in the surface after atomic hydrogen diffuses into the steel. Blisters only appear after long hydrogen charging times or at a higher current density. Blisters appeared after the end of the tensile tests and tensile time was approximately 5 h . Tiegel et al. evaluated the formation of cracks and blisters in purified iron with the results showing that the hydrogen partial pressure that resulted in blister formation was approximately 1800 MPa , with the pressure in cracks measured to be 50 MPa [10]. Therefore, the hydrogen partial pressure in the blisters generates high localized stress (Figure 10a,b), which initiates cracking along the lines of weakness in the steel. Elboujdaini et al. showed that blisters often occur when the crack is unable to further propagate inside the steel [49]. Figure 10c also shows a mixture of intergranular and transgranular fractures and larger cracks formed by the coalescing of small cracks. Therefore, the formation of hydrogen blisters leads to earlier failure prior to the plastic yield deformation of the sample.
