Microstructure and Pitting Corrosion of Austenite Stainless Steel after Crack Arrest

Abstract: With synergy of plastic deformation near crack tip and pulse current treatment, complex phase transformation and recrystallization occur in the metallographic structure, with the austenite transforming to fine grain structure and deformation-induced martensite; but, without the plastic deformation, the phase transformation, and recrystallization it was difficult for the crack arrest process to take place only undergoing the pulse current treatment. The nano-indentation experiment showed that the phase transformation region contained the maximum residual compressive stress consisting of four parts: the plastic stress, the explosion stress, the thermal stress, and the transformation stress, which was beneficial to restrain the crack growth. However, the solidification structure and the deformation-induced martensite structure was vulnerable to pitting corrosion through scanning microelectrode technology (SMET) and pitting corrosion experiment, but the pitting corrosion resistance could be improved through the solution heat treatment.

Keywords: austenitic stainless steel; crack arrest; nan

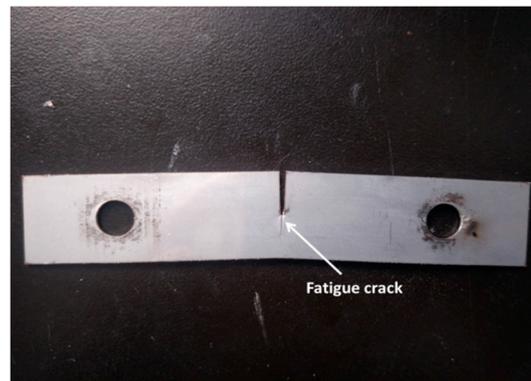
Figure 1. Specimen with a crack.

The 304 stainless steel plate was cut into specimens with a size of 110 mm × 20 mm × 1 mm, and with a gap of 10 mm in length using wire-electrode cutting in the middle of the specimens grouped as A, B, C, and D. Then the fatigue cracks of a certain length were made using hydraulic servo fatigue tester. A specimen with a crack was showed in Figure 1. Specimen A only prefabricated fatigue crack without any other treatment; specimen B with a prefabricating fatigue crack was treated using plus current to form a melting hole at the crack tip. The pulse current was applied at both ends of the specimen in a direction perpendicular to the crack, so that the crack tip exploded to form a melting hole reaching crack arrest target. A specimen after crack arrest was showed in Figure 2. The crack arrest was carried out using pulse current experiment platform. Specimen C underwent solution heat treatment after prefabricating fatigue crack, and then was treated using plus current to form a melting hole at the crack tip. The heat treatment was carried out in a box atmosphere furnace with the temperature 1050 °C and holding 30 min, and then the specimen was removed from the heat treatment furnace and

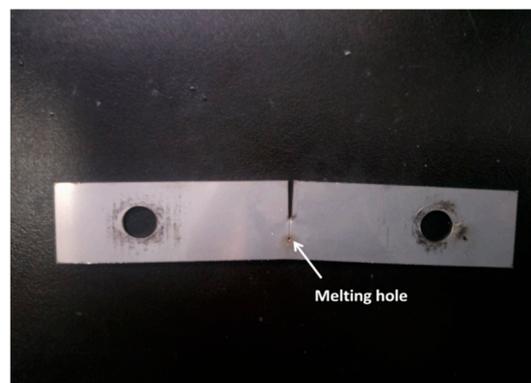
Figure 2. Specimen after crack arrest.

cooled with water immediately. Specimen D with a prefabricating fatigue crack was treated using plus current to form a melting hole at the crack tip, and then underwent solution heat treatment. The specimens were cut with a square of 10 mm × 10 mm with the crack tip or the melting hole as the center. The square specimens were polished successively with 180, 240, 600, 800, 1000, 1200 grade SiC paper and then to a mirror finish using 2.5- μm and 1- μm diamond powder. Finally, the specimens were washed with ethanol water for 10 min, and then dried and placed in a drying vessel.

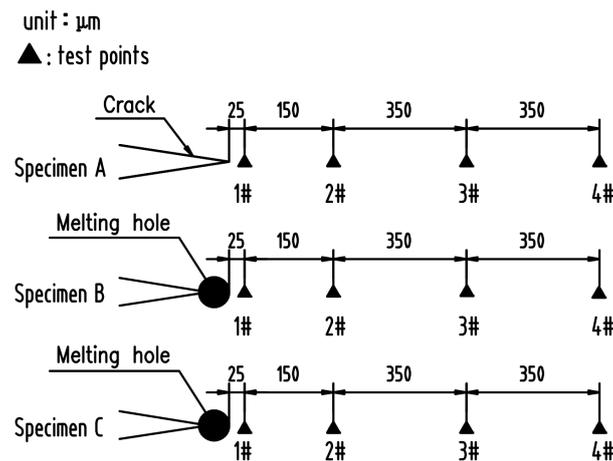
Figure 3. Distribution of nano-indentation test points.

Metallographic observations were performed using OM and FEI QUANTA 250 SEM (FEI, Hillsboro, OR, USA). The specimens were electrolytically etched with 50% nitric acid solution. The Anton Paar NHT2 nanometer indentation tester (Anton Paar, Corcelles, Switzerland) was used to measure the residual stress near the crack tip or melting hole. The distribution of measurement points is shown in Figure 3.

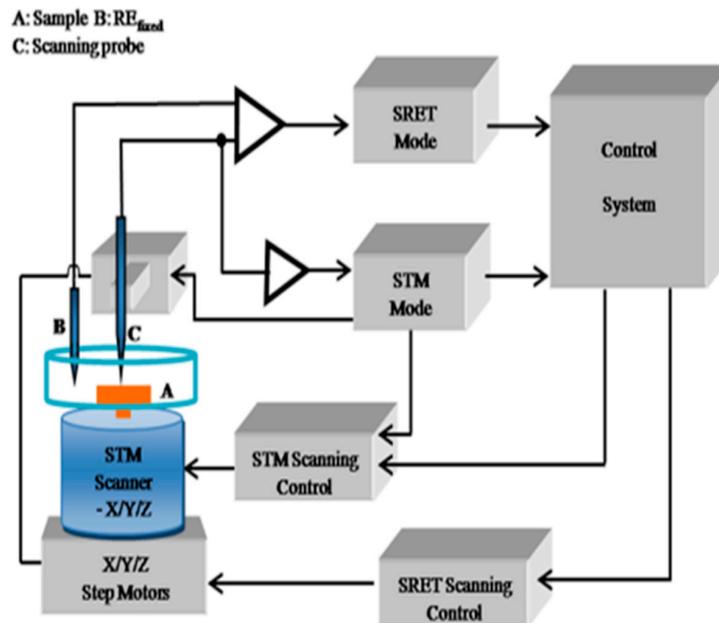
Figure 4. The schematic diagram of the scanning system.

The pitting corrosion test near melting hole was carried out on the XMU-BY scanning electrochemical workstation produced by Xiamen Legang Material Technology Co., Ltd. (Xiamen, China) (Figure 4). Prior to the experiment, 10 mm × 10 mm square specimens (including the melting hole) were spot-welded with a stainless steel nut, and then were covered with epoxy resin except for testing surface. In scanning tunneling microscope (STM) mode, the probe was automatically placed within 1 nm of the specimen surface, and then the probe was retracted by 500 steps (50 nm per step) using a three-dimensional platform. The scanning parameters were set on the micro-area potential platform, and the scanning area was 3 mm × 3 mm, and the scanning frequency was 0.4 Hz, and the signal amplification factor was 100 times. A 10% FeCl₃ solution was added to the corrosion bath until the specimen was completely immersed, and then the surface potential near the melting hole of the 304 stainless steel was scanned.

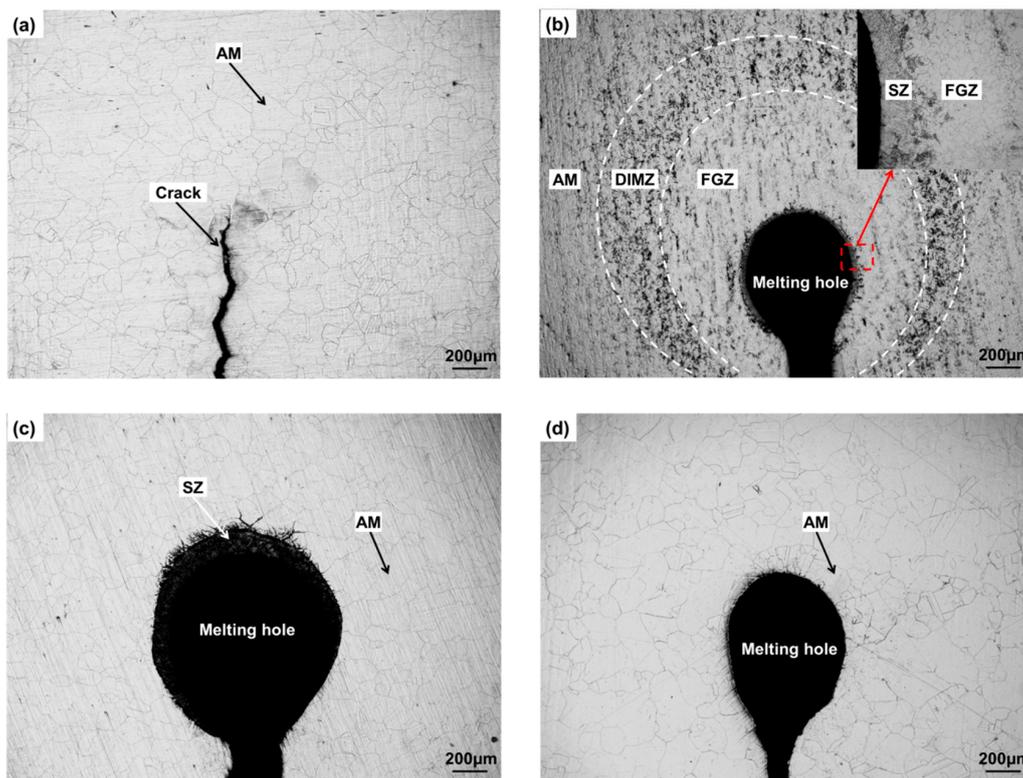
The metallographic structure near the crack tip or melting hole of specimen A, B, C, and D is shown in Figure 5. The metallographic structure near the crack tip of specimen A was austenite matrix (AM) (Figure 5a). As shown in Figure 5b, specimen B formed a melting hole after pulse current treatment, because temperature at the crack tip exceeded the melting point of 304 stainless steel attributed to the current concentration around the crack tip. In addition, solidification zone (SZ), fine grain zone (FGZ), deformation-induced martensite zone (DIMZ), and AM was observed successively with the increase of distance from the melting hole edge. The metallographic structure of specimen C near melting hole are only SZ and AM, because the specimen C has undergone solution heat treatment before the crack arrest which eliminated the residual stress of the plastic zone near melting hole (Figure 5c). The metallographic structure of the specimen D is AM near melting hole, because the different microstructure zones around melting hole has been eliminated in the process of solution heat treatment after the crack arrest.

Figure 5. Photos of metallographic structure near crack tip or melting hole. (a) Specimen A, (b) Specimen B, (c) Specimen C, (d) Specimen D.

The solidification zone could be observed around the melting hole if the specimens, such as B and C, underwent pulse current treatment resulting in temperature of the crack tip reaching melting point, but could be eliminated through the solution heat treatment, i.e., specimen D. The plastic zone formed in the process of prefabricated fatigue crack, i.e., specimen A, but no FGZ and DIMZ were observed near crack tip, indicated that the plastic deformation near crack tip was insufficient to cause the martensite transformation. In addition, FGZ and DIMZ were also not observed in specimen C, implied that the thermal stress generated by temperature field after the pulse current treatment was also not enough to cause the recrystallization and the martensite transformation near melting hole. However, FGZ and DIMZ could be observed in specimen B, illustrated that the recrystallization and the martensite transformation were the result of combined action of the plastic deformation near the crack tip and the pulse current treatment.

The fine grain structure, an austenite recrystallized structure, existed only near the melting hole of specimen B (Figure 5b), the driving force of recrystallization from the plastic deformation near the crack tip and the pulse current treatment. In addition, a large degree of supercooling and thermal stress near the hole were generated because of the fast cooling rate after the pulse current treatment, which restrained the growth of austenite grain resulting in the size of the grains being relatively small.

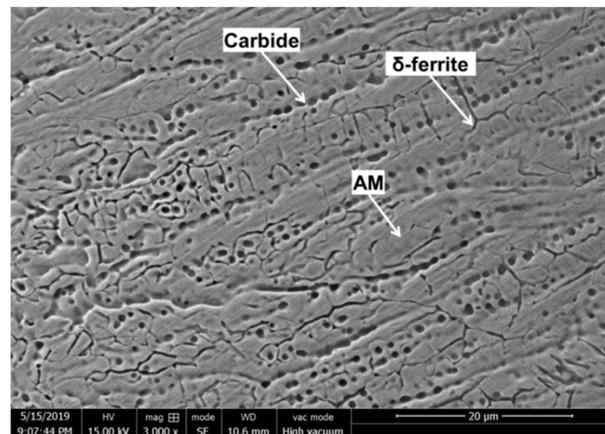
As shown in Figure 6, the microstructure of the solidification zone was a large number of worm-like δ ferrite and round carbide particles distributing on the austenite matrix. The solidification structure of austenite depended on its solidification mode, which was related to Cr_{eq}/Ni_{eq} in steel. The experimental 304 stainless steel had a $Cr_{eq} = 18.1$ wt.%, $Ni_{eq} = 10.5$ wt.%, and $Cr_{eq}/Ni_{eq} = 1.72$, according to Equations (1) and (2) proposed by Hammar and Svensson [15]. Therefore, the equilibrium solidification mode should be the FA mode (the solidification sequence is L (liquid) $\rightarrow L + \delta \rightarrow L + \delta + \gamma$ (γ : austenite) $\rightarrow \delta + \gamma$), which meant that the δ ferrite separated out first [16]. However, the temperature near crack tip dropped rapidly resulting in the transformation from δ to γ being restrained, attributed to the fast process of pulse current discharge, the small range of heat source near the crack tip and the good heat conduction of the 304 steel. Moreover, during the melting process, a large amount of carbides were dissolved, but in the process of rapidly cooling, the carbides were quickly and extensively nucleated and grew. The large temperature gradient and the short cooling process led to a huge degree of supercooling, which impelled a large nucleation rate of the carbide [8].

Figure 6. SEM photo of the solidified microstructure.

corrosion occurred. As shown in Figure 6, a large amount of δ ferrite and carbide were formed during the solidification of austenitic stainless steel, which easily led pitting corrosion to take place [19–21].

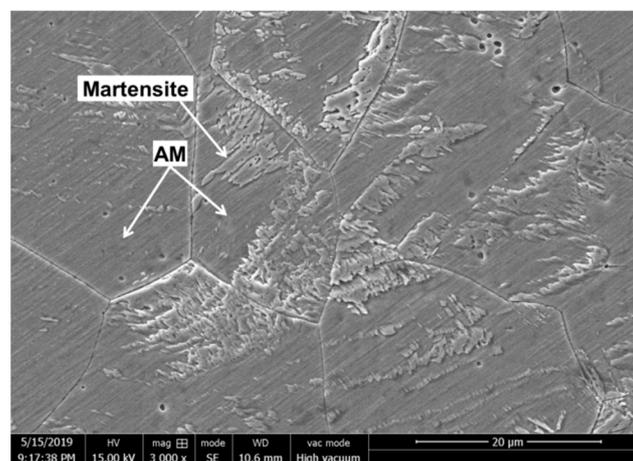
The deformation-induced martensite was also found only around the melting hole of specimen B. As shown in Figure 7, microstructure of the deformation-induced martensite was lath martensite distributing on the austenite matrix. The lath martensite was embossed on surface of the austenite matrix. The structure of 304 stainless steel was metastable austenite, thus the face-centered cubic austenite in the plastic zone would transform to the body-centered cubic martensite, when the highest temperature of local region near melting hole was below M_d in the process of pulse current treatment (the highest temperature of deformation-induced martensite) [17]. However, if the highest temperature was above the M_d , it was difficult to induce the martensitic transformation in the plastic zone only through the pulse current treatment, i.e., specimen C.

Figure 7. SEM photo of deformation-induced martensite.

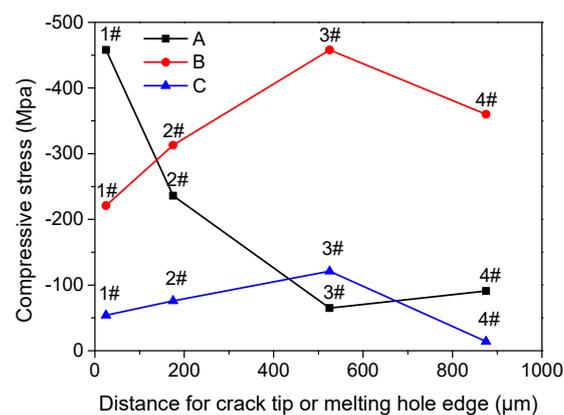
Since the compressive stress zones near crack tip or melting hole were extremely small, the conventional methods for residual stress measuring could not achieve sufficient accuracy. The specimen A, B, and C were tested according to Suresh's residual stress measurement method using the nanometer indentation tester [18]. The compressive stress values near crack tip or melting hole edge detected using the nano-indentation are shown in Table 2. It can be seen that the maximum compressive stress near crack tip of the specimen A was located at 1# point (Figure 8) that meant large plastic deformation there, and that the stress was rapidly attenuated with the increase of distance from the crack tip. The compressive stress values of specimen B rise with the increase of distance from melting hole edge, and the maximum compressive value was located at 3# point in the martensite zone attributed to the martensite phase transformation stress. The compressive stress distribution of specimen C was similar to specimen B, but the compressive stress values were lower than specimen B as a whole.

The residual stress near melting hole came from two ways. One was plastic stress in the plastic zone near crack tip generating in the process of precrack, such as the specimen A. The other one was generated through the pulse current treatment composing of three parts: explosion stress in the process of crack tip melting, thermal stress from the huge temperature gradient in the heat-affected zone, and martensite transformation stress. The residual stress of specimen B was from the both ways consisting of four parts: the plastic stress, the explosion stress, the thermal stress and the transformation stress, but the residual stress of specimen C only consisting of two parts: the explosion stress and the thermal stress leading to lower compressive stress values as a whole.

Figure 8. Residual stress distribution of specimen A, B, and C.

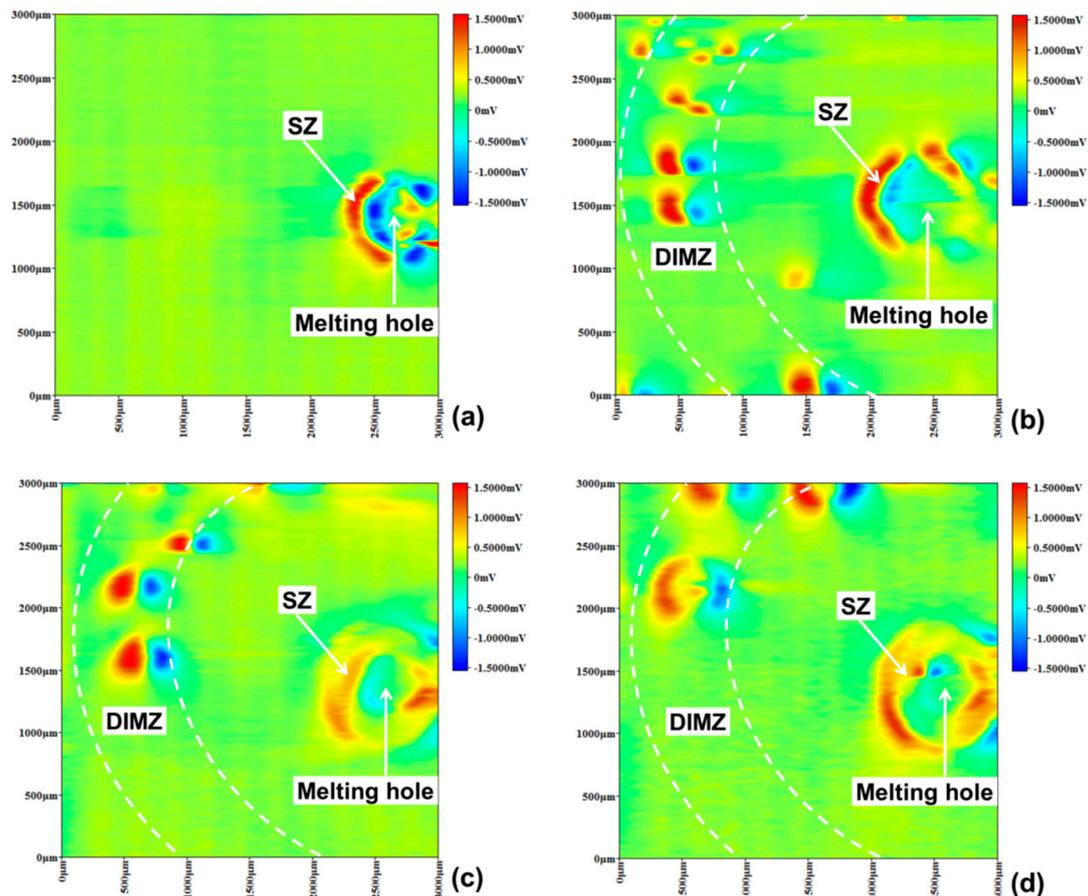
As shown in Figure 9, micro-area potential of specimen B changed over time near melting hole immersed in a 10% FeCl₃ solution using SMET, which indicated different pitting corrosion trend. The points of pitting corrosion were tiny as active anodes, so that the electric field lines were densely concentrated in the points exhibiting high potential peaks in red state. First, after the specimen B was immersed in the solution for 15 min, a high potential region in red could be observed in the solidification zone, indicated the region's surface passivation state was destroyed and lots of pitting

Then, after specimen B was immersed for 30 min, the high potential peak area of the solidification zone became larger; what was important that large numbers of high potential peaks appeared in the martensite region meaning that severe pitting corrosion happened in this region. Because, the deformation-induced martensite region had high density dislocations, which would result in energy of the martensite phase higher than austenitic phase [22–24]. In addition, as shown in Figure 7, the lath martensite could be observed embossing on the surface of the austenite matrix, which contained many defects such as dislocations, vacancies, interstitial atoms, and stacking faults [25]. The defects and embossing shape would bring about weaker part in passivation film, and more possibly resulted in pitting corrosion caused by Cl^- , martensite as anode and austenite as cathode in the corrosion process.

When specimen B was immersed for 45 min, the corrosion potential peak of the solidification zone began to decrease, illustrating that this region entered uniform corrosion state. However, the pitting corrosion of the martensite region was still intensive. Finally, with the immersion time extending to 60 min, the potential distribution in the solidification zone did not change much, but the potential peaks of the martensite region declined meaning that the pitting corrosion developed to small area surface corrosion.

Figure 9. Specimen B micro-area potential distribution using scanning microelectrode technology (SMET). (a) 15 min, (b) 30 min, (c) 45 min, (d) 60 min.

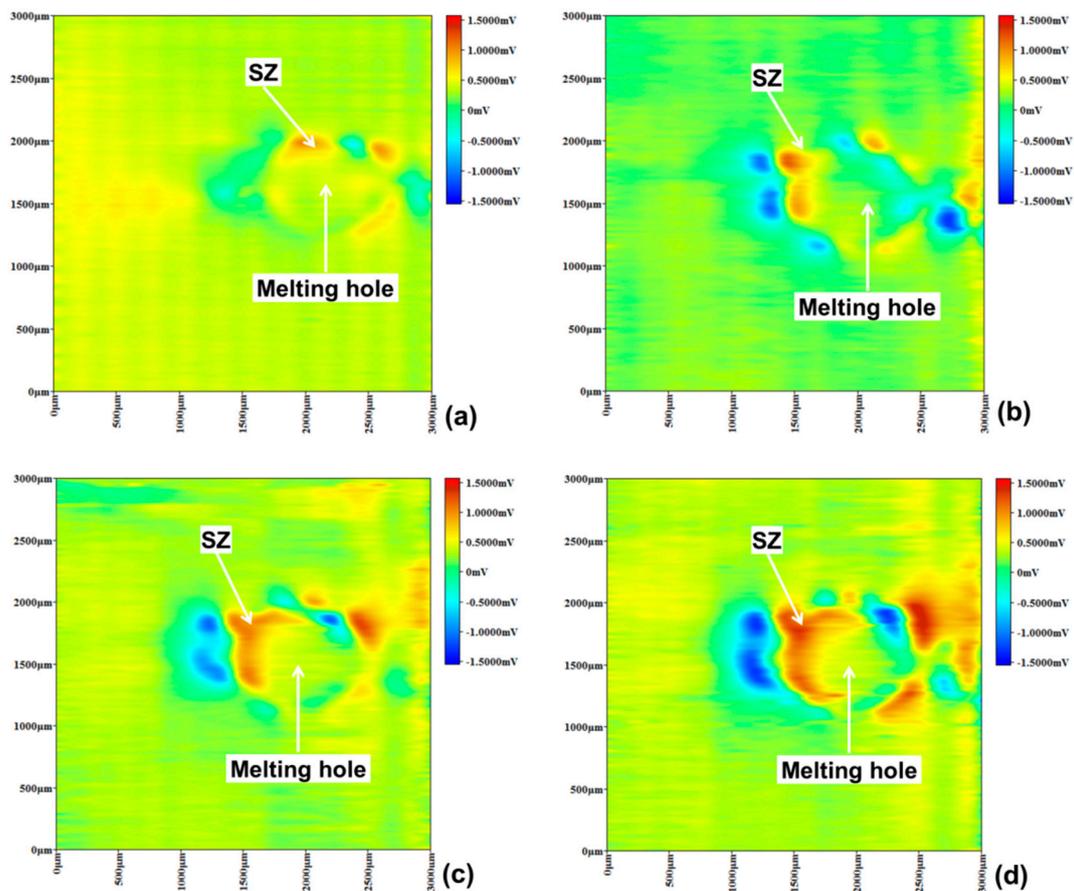
As shown in Figure 10, micro-area potential of specimen C changed over time near the melting hole immersed in a 10% FeCl_3 solution, indicated that pitting corrosion also occurred in the solidification zone according to the red potential region after 15 min. Then, area of the pitting corrosion in the solidification zone has grown with time, which was similar to specimen B. However, more pitting

corrosion has not been observed in other region, implying that the passive film was not destroyed and the martensite transformation did not occur there.

Figure 10. Specimen C micro-area potential distribution using SMET. (a) 15 min, (b) 30 min, (c) 45 min, (d) 60 min.

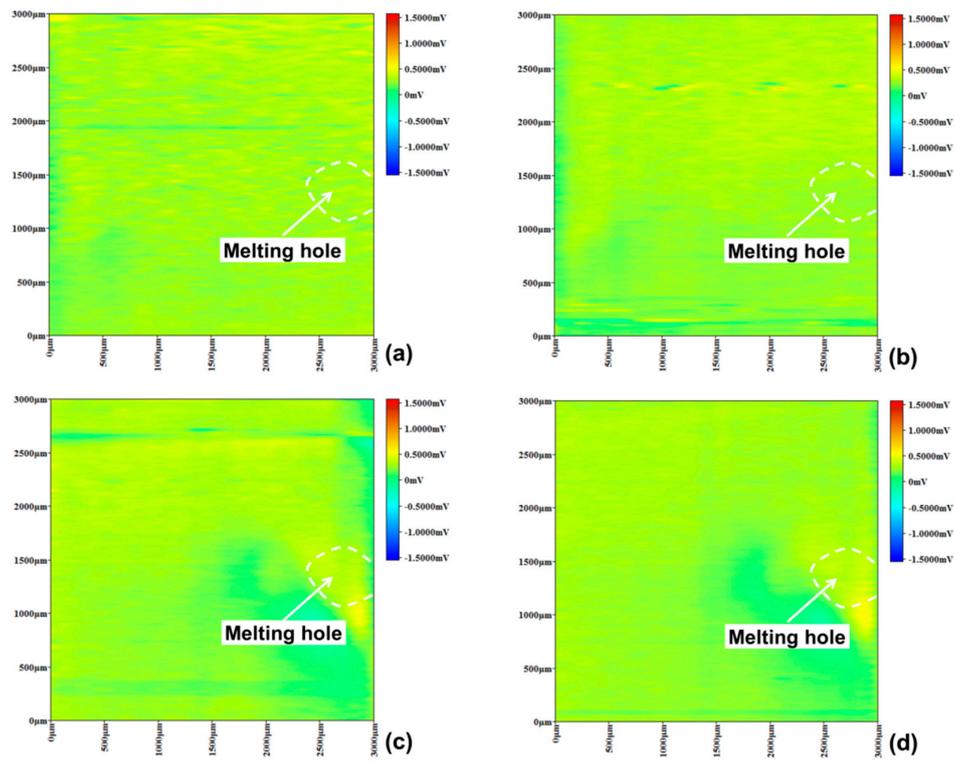
According to uniform potential distribution state, specimen D did not exhibit a high potential peak of pitting corrosion after immersed in a 10% FeCl_3 solution for 15 min (Figure 11). Then, some small pitting corrosion points have been observed after 30 min, but disappeared quickly with time. Moreover, additional pitting corrosion point has not been observed after being immersed for 60 min, illustrating that the passive film of specimen D maintained integrity and could be self-healed if being destroyed. The results implied that the solution heat treatment could effectively restrain pitting corrosion near the melting hole after the crack arrest.

Figure 11. Specimen D micro-area potential distribution using SMET. (a) 15 min, (b) 30 min, (c) 45 min, (d) 60 min.

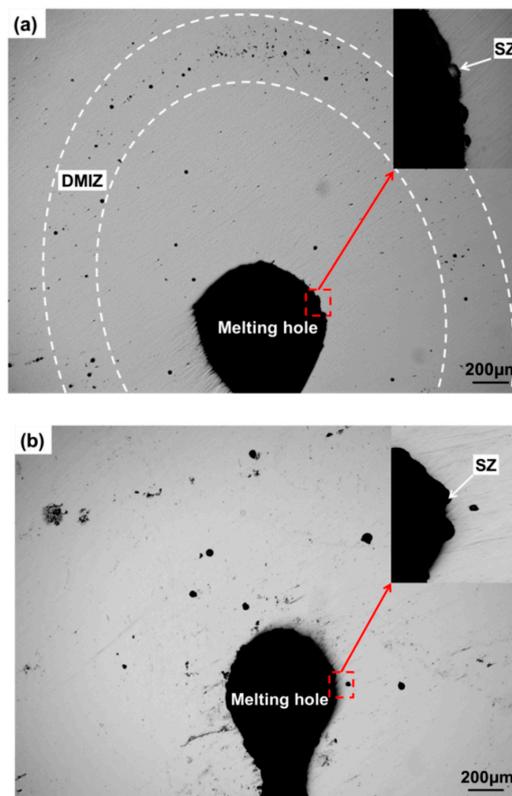
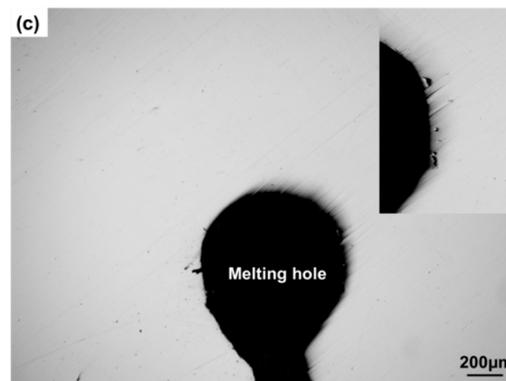
A large number of pitting corrosion points could be observed in the martensite region along with the melting hole edge of the specimen B after soaking for 1 h in 10% FeCl_3 solution (Figure 12a). The specimen C showed different phenomenon that pitting corrosion points were mainly in the solidification zone and randomly distributed around the melting hole attributed to some inclusions or carbides in the stainless steel (Figure 12b). However, no visible corrosion pits could be found in the specimen D, except few corrosion pits at the melting hole edge, because of the solution heat treatment to eliminate asymmetrical metallographic structure of the stainless steel after the crack arrest (Figure 12c). Compared with the potential distribution using SMET as shown in Figures 8–10, the pitting corrosion point distribution of the specimens had consistent regularities.

Figure 12. Surface images of specimens after soaking 1 h in 10% FeCl₃ solution. (a) Specimen B, (b) Specimen C, (c) Specimen D.
