Non-Destructive Characterization of Railway Materials and Components with Infrared Thermography Technique

Jeongguk Kim

Advanced Railroad Vehicle Division, Korea Railroad Research Institute, Uiwang 16105, Korea; jkim@krii.re.kr; Tel.: +82-31-460-5518

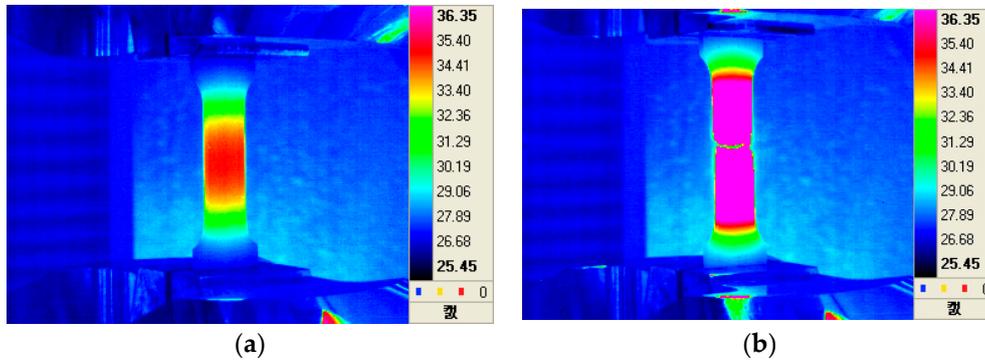
Figure 1. The thermographic images of axle steels in diesel electric locomotives during tensile tests: (a) at just 10 seconds before fracture and (b) at the time of failure.

Figure 1a,b show the results of a full thermal image of the axle material on a diesel electric locomotive during the tensile test at 10 s before and at break, respectively. Figure 2 shows the stress–strain behavior of the tensile test on the diesel electric locomotive axle and wheel materials. The temperature changes during the tensile test are shown in Figure 3.

In Figure 1a,b, it can be seen that there were no significant differences in the surface temperature of the two tensile specimens at break. This result means that the final breakdown occurred very

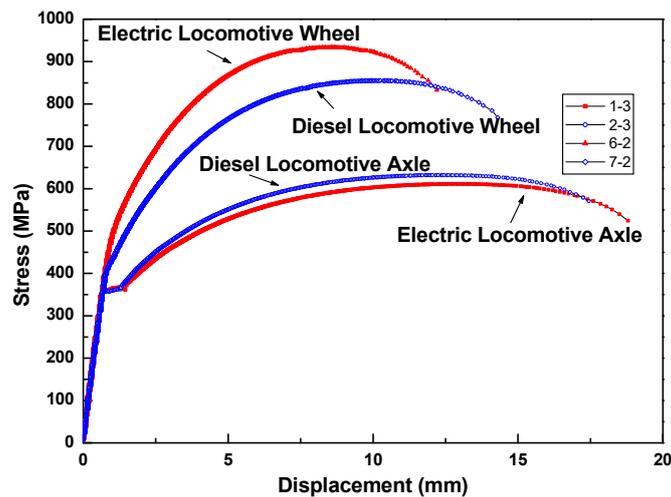
Figure 2. The stress–strain behavior during the tensile tests of the axle material.

smoothly without any signs before final failure as shown in Figure 2. As shown in Figure 3, the final fracture shows an abrupt peak of temperature rise at break and occurs instantaneously. This means that the temperature rise peak at break was observed due to the specimen failure at the final failure of the specimen. These results indicate that IR thermal imaging can be a useful tool for analyzing the tensile failure behavior of railway axle materials.

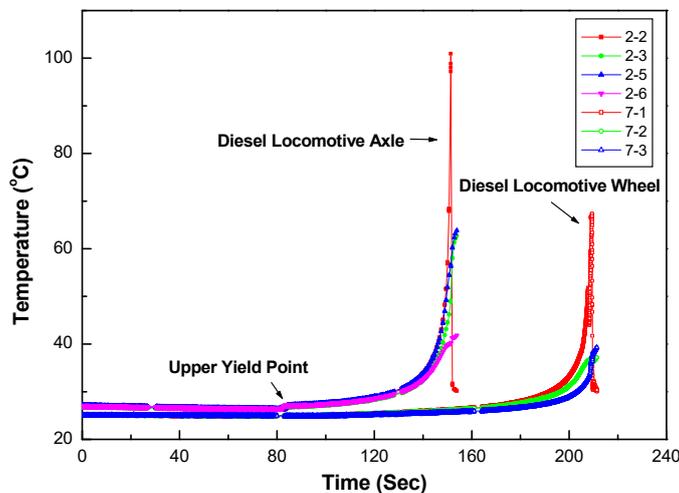
Figure 3. The temperature changes in the railway steel specimens' surfaces during tensile test.

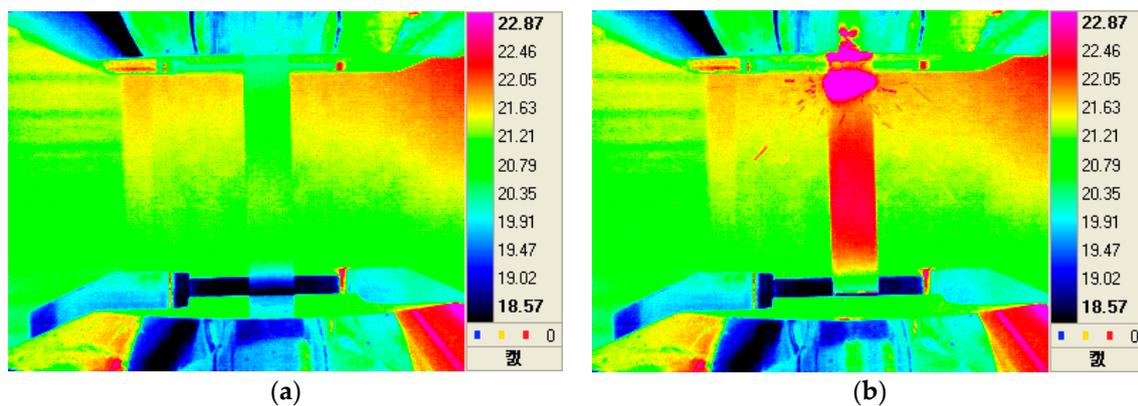
Figure 4. The infrared thermographic images during tensile test: (a) at 0.01 second before failure and (b) at the final failure.

Figure 4a,b show infrared thermal images taken every 0.01 seconds at the final fracture of the polymer composite specimen. Since the material used in this study was an E-glass fiber-reinforced epoxy polymer matrix composite (PMC), it was newly used as a bogie frame material for the weight lightening of railway vehicles in railway applications. As can be seen from the stress–strain behavior of the PMC material (Figure 5), the results of the tensile test indicate a brittle fracture mode without showing a plastic deformation area. The stress–strain results can be compared with the IR thermal images as shown in Figure 4a,b. The IR camera speed was 100 Hz, which means that each thermal image was obtained every 0.01 seconds. The immediate (within 0.01 second) and brittle form of failure was well documented by looking at the IR thermal image. In Figure 4b, some of the debris from the epoxy matrix illustrates how the final breakage was being made.

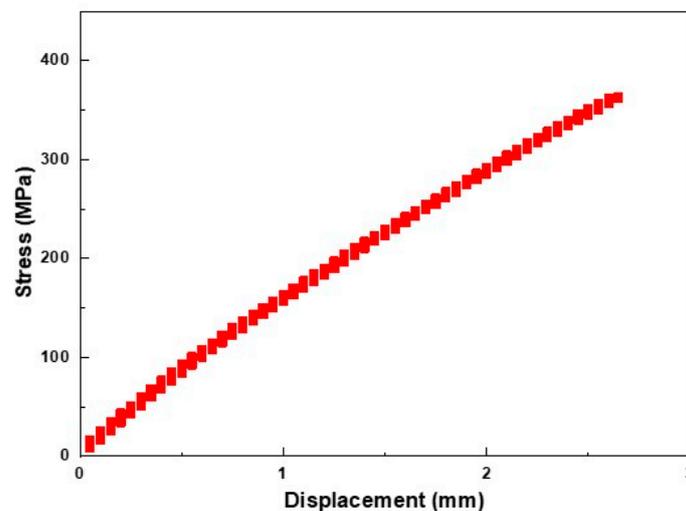
Figure 5. The stress–strain behavior of the polymer matrix composites.

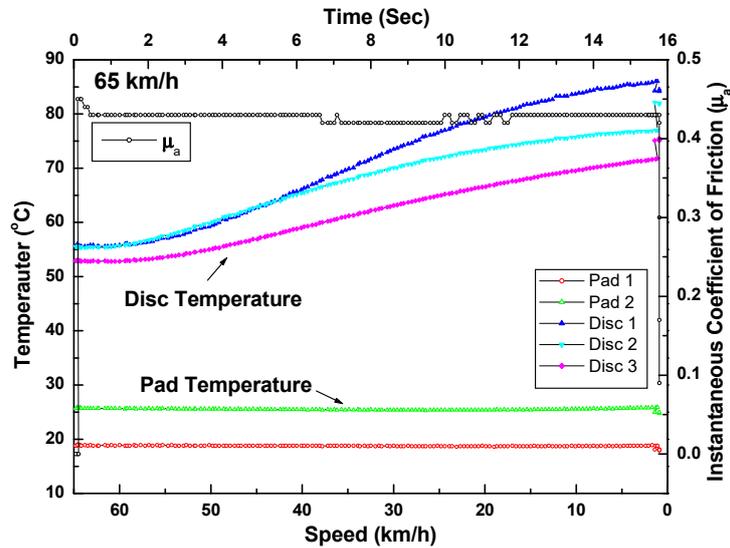
Figure 6. The brake disc temperature evolution using thermocouples with instantaneous coefficient of friction. Note that the initial braking speed was 65 km/h.

Figure 6 shows the results of the railway brake disc temperature monitoring using thermocouples and instantaneous friction coefficient values. In Figure 6, the surface temperature was measured by thermocouples embedded below the disc surface at different points. As the braking time increased, the temperature of the disc surface rose. However, the disc pad temperature remained almost constant due to the material properties of the non-asbestos disc brake pads.

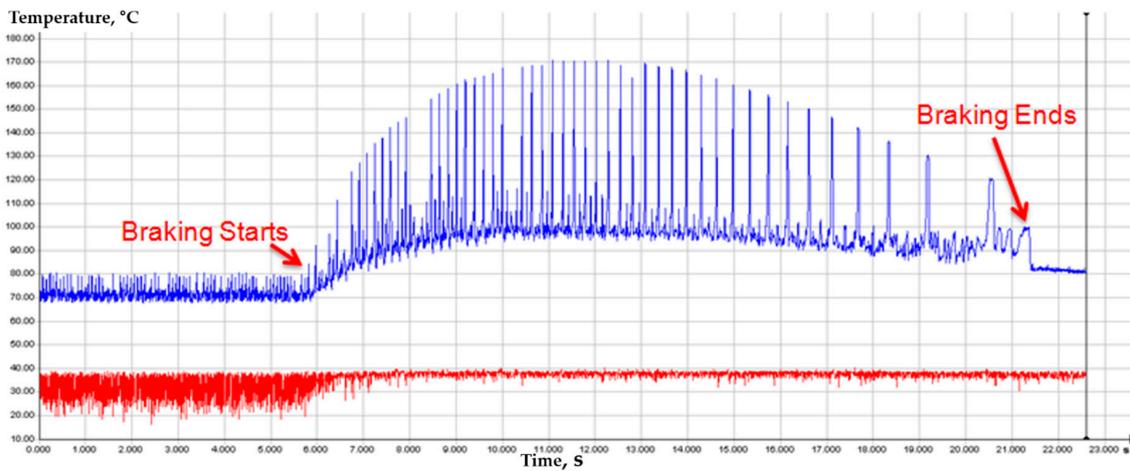
Figure 7. The disc surface temperature monitoring results using a high-speed IR camera.

Figure 7 shows the disc surface temperature monitoring results using an IR camera. As shown in Figure 7, the braking phenomenon was successfully described in terms of temperature increase. The braking start point was obtained in about 6 s and the braking was finished in about 21.4 s. In

addition, the maximum temperature of the disc surface was shown in 11 s at about 170 °C (Figure 7). Figure 8 shows a typical thermal image when braking is started, at the highest temperature, and when braking is stopped. Hot spots were observed at peak temperatures as shown in Figure 8.

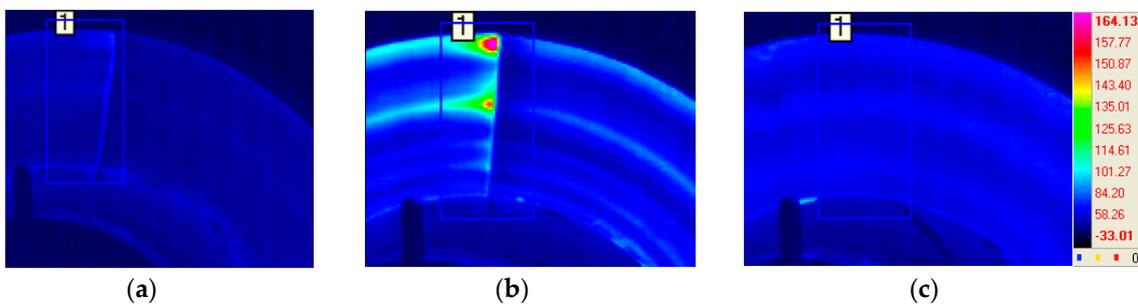
Figure 8. Infrared thermographic images: (a) at the beginning of braking, (b) at the peak temperature, and (c) at the time of braking stop.

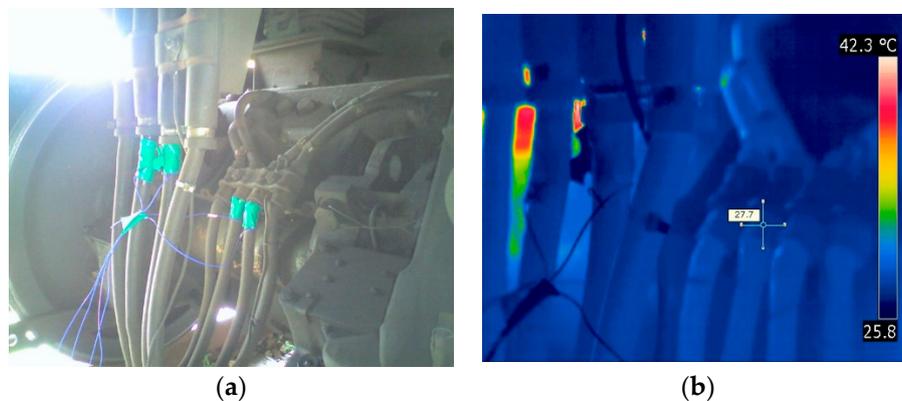
Figure 9. The thermographic inspection results of high-voltage cables in traction motor with (a) digital camera images and (b) IR thermographic images.

Figures 9 and 10 show a demonstration of the precision inspection of high-voltage cables under the Korean Railroad Safety Law as described in the Experimental Procedures (Section 2). Infrared cameras were used to check for rapid temperature changes or hot spots on the high-voltage cables connected to the traction motors in diesel electric locomotives. The high-voltage cable test was done with the power fully applied. Fortunately, no items, such as the special abnormal heat, or apparent abnormalities were found when inspecting the high-voltage cables (Figures 9 and 10). The thermal imaging results of the high-voltage cable of the traction motor are shown by comparing the thermal image with the digital camera image. In the thermal image, as shown in Figures 9b and 10b, the surface temperatures of the cables were 27.7 °C and 24.2 °C, respectively.

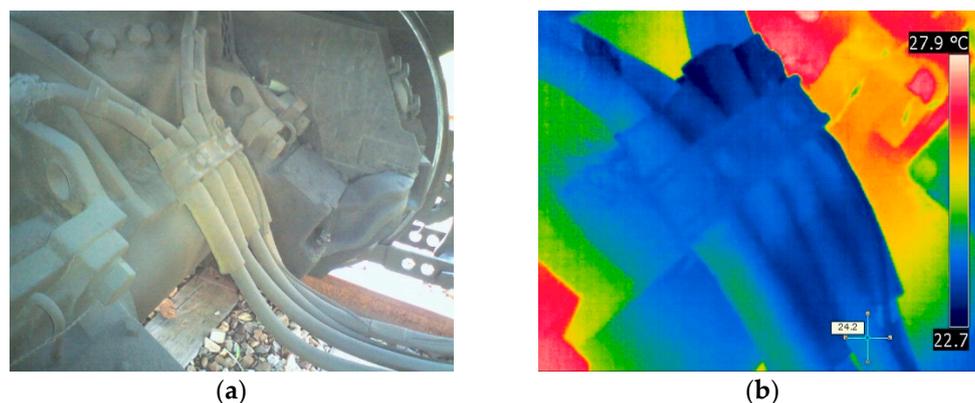
Figure 10. The thermographic inspection results of high-voltage cables in traction motor with (a) digital camera images and (b) IR thermographic images.

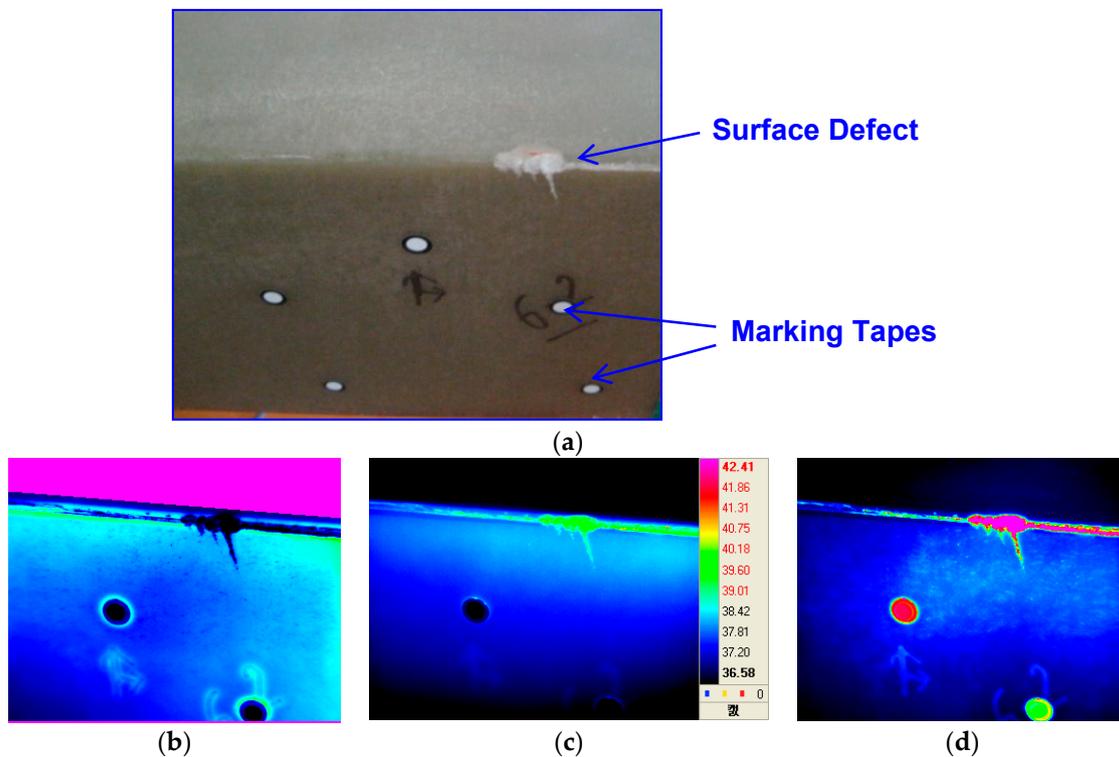
Figure 11. The lock-in thermography evaluation results for railway bogie with E-glass fiber-reinforced epoxy polymer matrix composites: (a) actual image, (b) phase IR image, (c) temperature IR image, and (d) amplitude IR image.

Figure 11 shows the results of lock-in thermography and evaluation for railway bogies using E-glass fiber-reinforced epoxy polymer matrix composites. The conditions for performing lock-in thermography were as follows. Two halogen lamps (500 W) were applied as an external heat source, and the experiment was conducted by periodically applying heat to the specimen surface using a function generator. The excitation frequency used was in the range 0.1–0.01 Hz, and the optimum

frequency was found. After applying the halogen heat source periodically, the surface defects of the PMC bogie were successfully displayed in phase, temperature, and amplitude as shown in Figure 11.

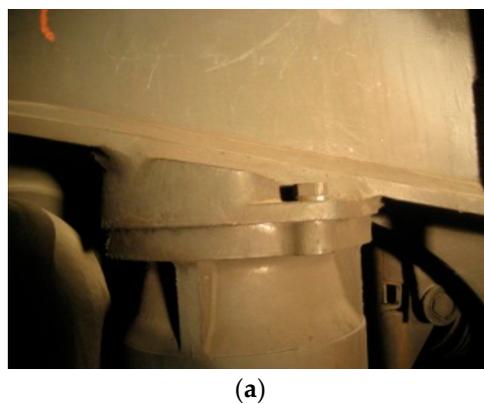
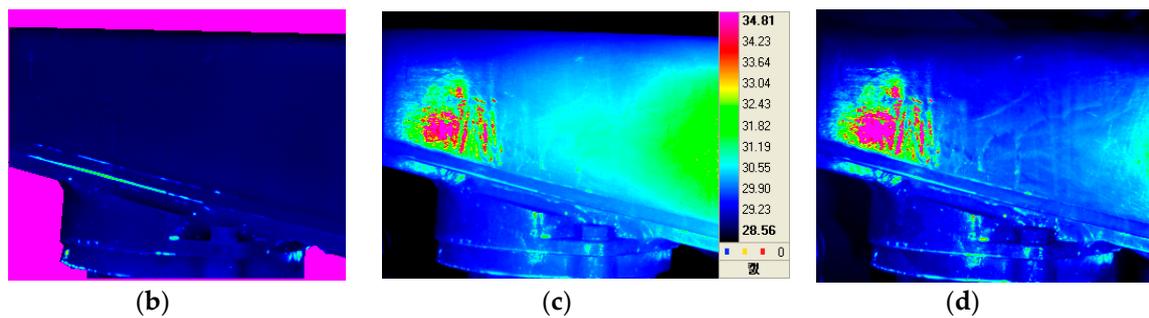
Figure 12. The lock-in thermography evaluation results for railway steel bogie: (a) actual image, (b) phase IR image, (c) temperature IR image, and (d) amplitude IR image.

The optimum frequency for the lock-in thermographic image obtained in this study was 0.07 Hz. Similar experiments were applied to railway steel bogies that could be applied to commercial railway passenger cars. The results are shown in Figure 12. In Figure 12, abnormal areas were detected in the 0.06 Hz phase image, and these types of defects were found in the weldments on the bogies. Further investigation is likely to be needed for further study. Both temperature and amplitude thermal images show similar aspects.
